The Brookwood Disaster and Electrical Requirements for Hazardous (Classified) Locations

Thomas H. Dubaniewicz, Jr.
National Institute for Occupational Safety and Health
P.O. Box 18070
Pittsburgh, PA 15236 USA
tcd5@cdc.gov

Abstract - Thirteen miners died as a result of 2 explosions in the Jim Walter Resources No. 5 mine near Brookwood AL in September 2001. Both explosions were ignited in intake air entries, and both were probably ignited by electrical equipment. With few exceptions, permissible equipment is not required in intake air entries of US underground coal mines. Researchers with the National Institute for Occupational Safety and Health, Pittsburgh Research Laboratory, studied the electrical equipment ignition sources for the Brookwood and other disasters to develop recommendations for preventing similar disasters. Adherence to National Electrical Code® requirements for flexible cords installed in hazardous (classified) locations may have prevented the second massive Brookwood explosion. The 30 CFR Part 7 requirements for battery assemblies should be reevaluated, taking into consideration United Mine Workers of America recommendations and the Zone 1 "increased safety" stan

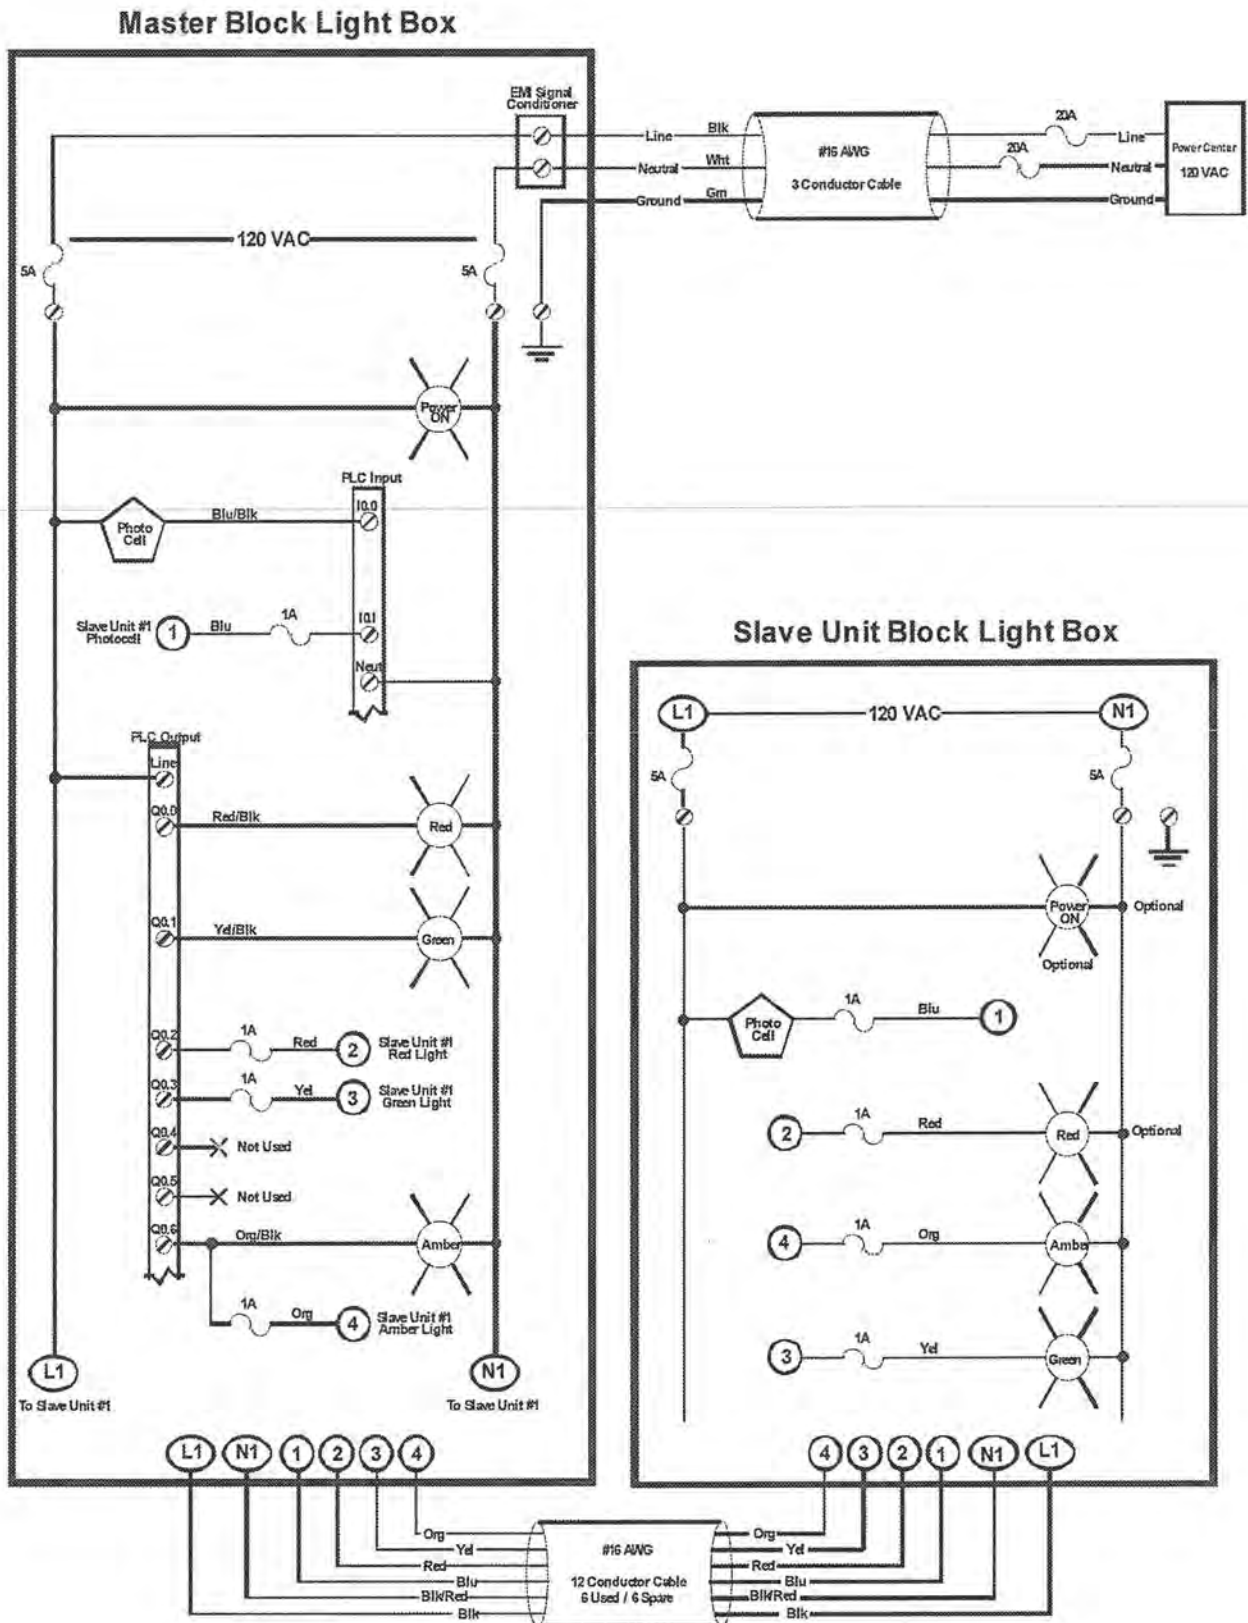
Fig. 1. Block light electrical circuit diagram.

The block light installation apparently did not meet several NEC[®] requirements for Class I hazardous locations. The installation of long lengths of slack, unsecured block light cable that became entangled and most likely provided the ignition source for the 2nd massive explosion may not have met 1999 NEC 501.11 which states that flexible cord used in a Class I Division 1 or 2 hazardous location is to be protected by location or a suitable guard from damage². Spare conductors in the unshielded block light cable apparently were not grounded. Fig. 1 shows no separate grounding conductor in the block light cable between the

nonmetallic enclosures, or an equipment bonding jumper in the master enclosure for such a grounding conductor. The 1999 NEC 501.11 requires flexible cord to contain, in addition to the conductors of the circuit, a grounding conductor. The block light type SDT cable is not listed in NEC Table 400-4 as a type considered acceptable for extra hard usage. The 1999 NEC 501.11 requires flexible cord to be listed for extra hard usage. Robust protection provided by extra hard usage cord jacketing material combined with a grounding conductor and grounded spares inside the cord may have allowed a short to ground to activate the circuit protection fuse before the outer jacketing material was compromised, exposing the conductors to the flammable atmosphere (The 1999 NEC 501-6 provides requirements for fuses in Class I Division 1 and 2.). The live high voltage cable discussed above was determined not to be an ignition source for the first explosion for comparable reasons. Adherence to these NEC[®] requirements written specifically for preventing explosions may have prevented the massive second Brookwood explosion.
