## Coal Bumps and Odd Dynamic Phenomena - A Numerical Investigation

**Jeffrey K Whyatt**, Mining Engineer  
NIOSH Research Laboratory  
Spokane, WA

### ABSTRACT

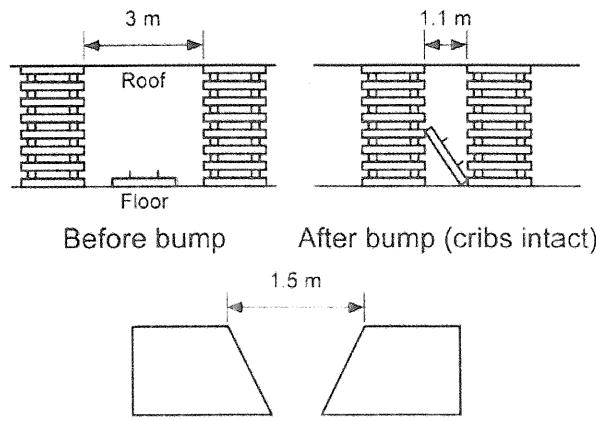
1. Two men were mining a pillar when a bump occurred. The rescue party found the "roof, floor and ribs, so far as visual indications were concerned, in their normal conditions, but the cogs, instead of being 10 ft. apart were only 3 1/2 ft apart yet were intact." (Figure 1) Track running between the cogs (packs) was nearly on edge. Further mining revealed a "channel or crevice 5 ft wide at the top and about 2 ft wide at the bottom" within the pillar.

Figure 1. Displacement of packs and track attributed to a bump event that also appeared to have created a 1.5 m split in a pillar (after Ashmead, 1924).

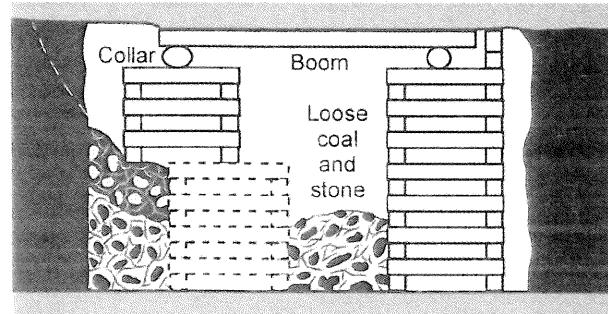
McCall (1934) updated Herd's descriptions of Springhill Mine observations, including particular instances. In the first (Figure 2), "all east side chocks in this place have been moved about two feet westward." Also, with few exceptions, "individual sticks have not been displaced." Finally, "the booms and the collar boom which supports the booms between chocks have not moved but the lower portion has moved as a unit." In the second location, this same event displaced empty and full mine cars without other damage (Figure 3).

Figure 2. Section of a timber pack displaced as a unit during a coal bump (after McCall, 1934).

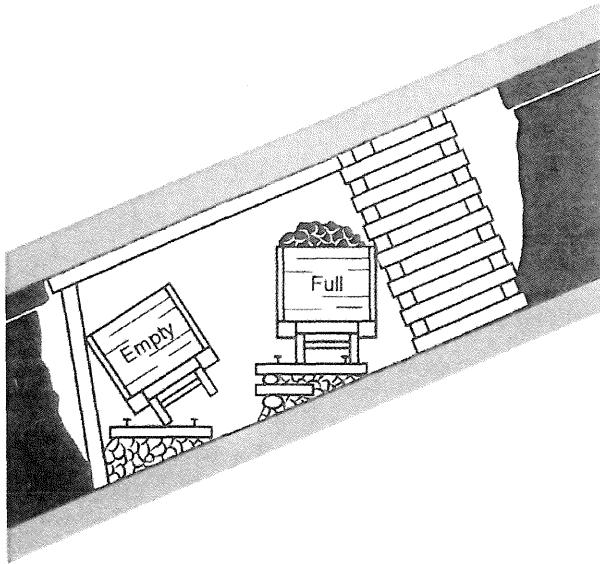
**Figure 3.** Displacement of mine cars by a coal bump (after McCall, 1934).

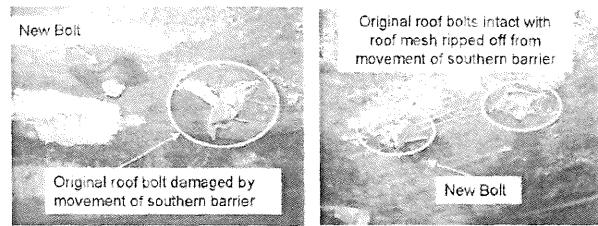
Gates et al., (2008) reported observations made during efforts to re-establish the No. 1 Entry. The first of these was that "as loading advanced inby crosscut 123, rescuers observed that part of the barrier south of the No. 1 entry had moved northward as a result of the August 6 ground failure. The barrier rib had shifted northward as a unit, as much as 10 feet. In some areas, the displaced barrier slid along the immediate roof and tore loose the original roof mesh"

(see Figure 4). "In other areas, the immediate roof was carried northward and damaged the original installed roof bolts" (Figures 4 and 5).

**Figure 4.** Damaged roof bolts and torn mesh after August 6 accident resulting from northward movement of southern barrier (after Gates et al., 2008).

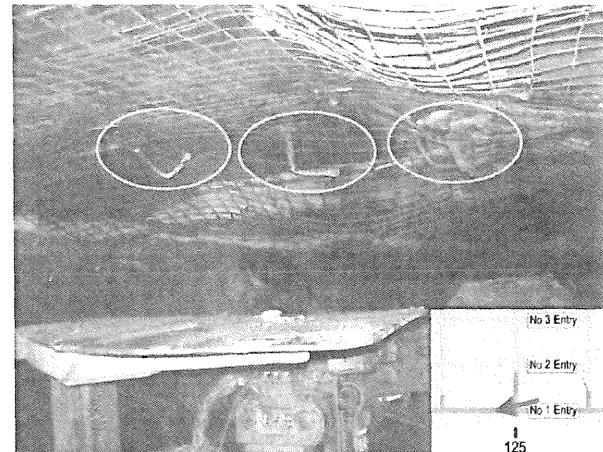
**Figure 5.** Damaged roof bolts in No. 1 entry after August 6 accident resulting from northern movement of southern barrier. Mesh shown was installed during rescue operations, over damaged original bolts. Camera view is indicated by arrow in index map insert (after Gates et al., 2008).

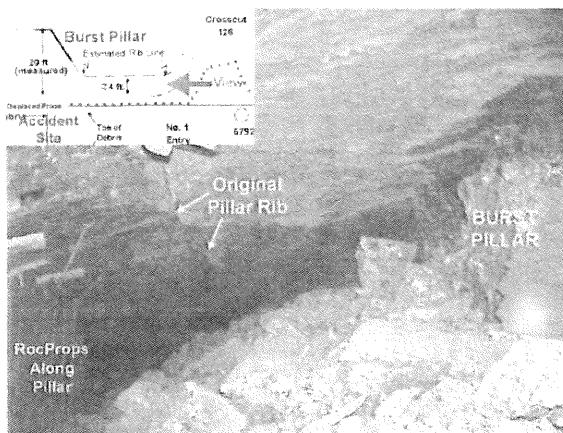
Gate et al., (p. 27) described a "void up to 20 feet deep into pillar at the roof line" (see Figures 6 and 7) created by the bump that ended rescue efforts. Gates et al., also mention that "coal was thrown violently across the No. 1 entry." And finally, that this "dislodged coal threw eight RocProps, steel cables, chain-link fence, and a steel channel toward the left side of the entry, striking rescue workers and filling the entry with about four feet of debris." One injured miner was found "entangled in chain-link fencing."

Figure 6. Damage to outby portion of pillar on right side of No. 1 entry, outby August 16 accident site (After Gates et al., 2008).

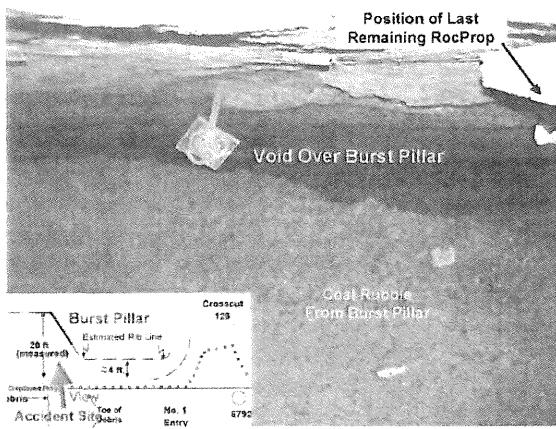
Figure 7. 20-ft deep void over pillar on right side of No. 1 entry following August 16 accident (After Gates et al., 2008).

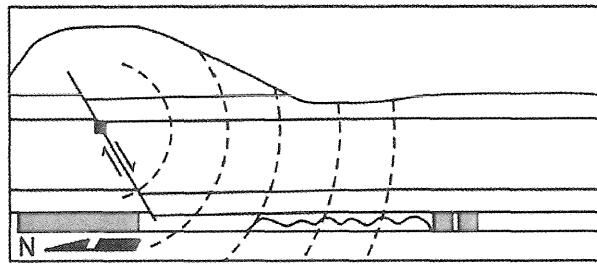
The Book Cliffs case study by Boler et al., 1997, reviewed previously, provides a convenient test case. Seismic records analyzed by Boler et al., indicated slip on a normal fault somewhere above the damaged panel, most likely in the overlying Castlegate Sandstone, was the most likely cause (Figure 8).

Figure 8. Preferred failure mechanism for the Book Cliffs mine case proposed by Boler et al., (1997).

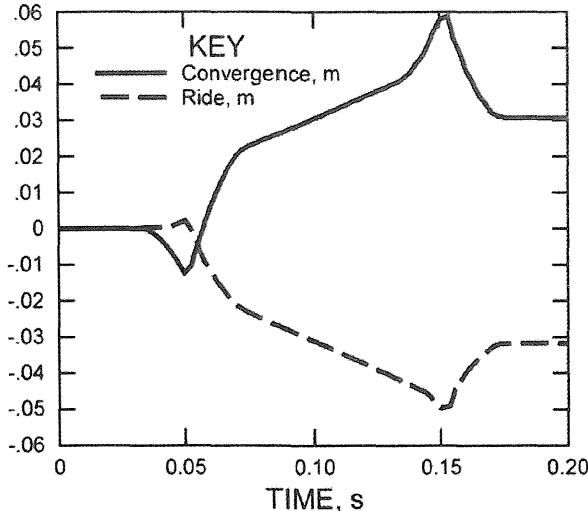
The calculated relative displacement history (closure) at the center of the panel is plotted in Figure 10. It consists of an initial dilation followed by closure to a short-lived maximum and then rebound to the static closure value. Dilation, or opening of the panel, is roughly 15% of maximum dynamic closure and nearly half the resulting static closure. Relative horizontal displacement (ride) is also plotted. Ride is very small during initial dilation but is significant at later times.

This pattern correlates well with the in-mine observations reviewed earlier. Recapping, these were (1) dilation of the coal seam that temporarily freed timber props without strong lateral movement and (2) dynamic compression of pillars by an elastic roof that rebounded from its maximum closure, leaving a gap between pillar remnant and roof. Boler et al.'s inference that movement between timbers and wedges indicated dilation before compressive "retrapping" of the timber-wedge column is consistent with figure 11; thus the model captures both the observed behavior and their inferred order of occurrence. The sensitivity of this result

Figure 10. Calculated dynamic closure and ride (relative lateral displacement) between roof and floor at mid-panel.
