Ground Failures in Coal Mines with Weak Roof

Greg Molinda, MS

Chris Mark, PhD

*Principal Research Engineer (cnm7@cdc.gov)
National Institute for Occupational Safety and Health (NIOSH)
P.O. Box 18070, Cochrans Mill Rd. Pgh., PA 15236*

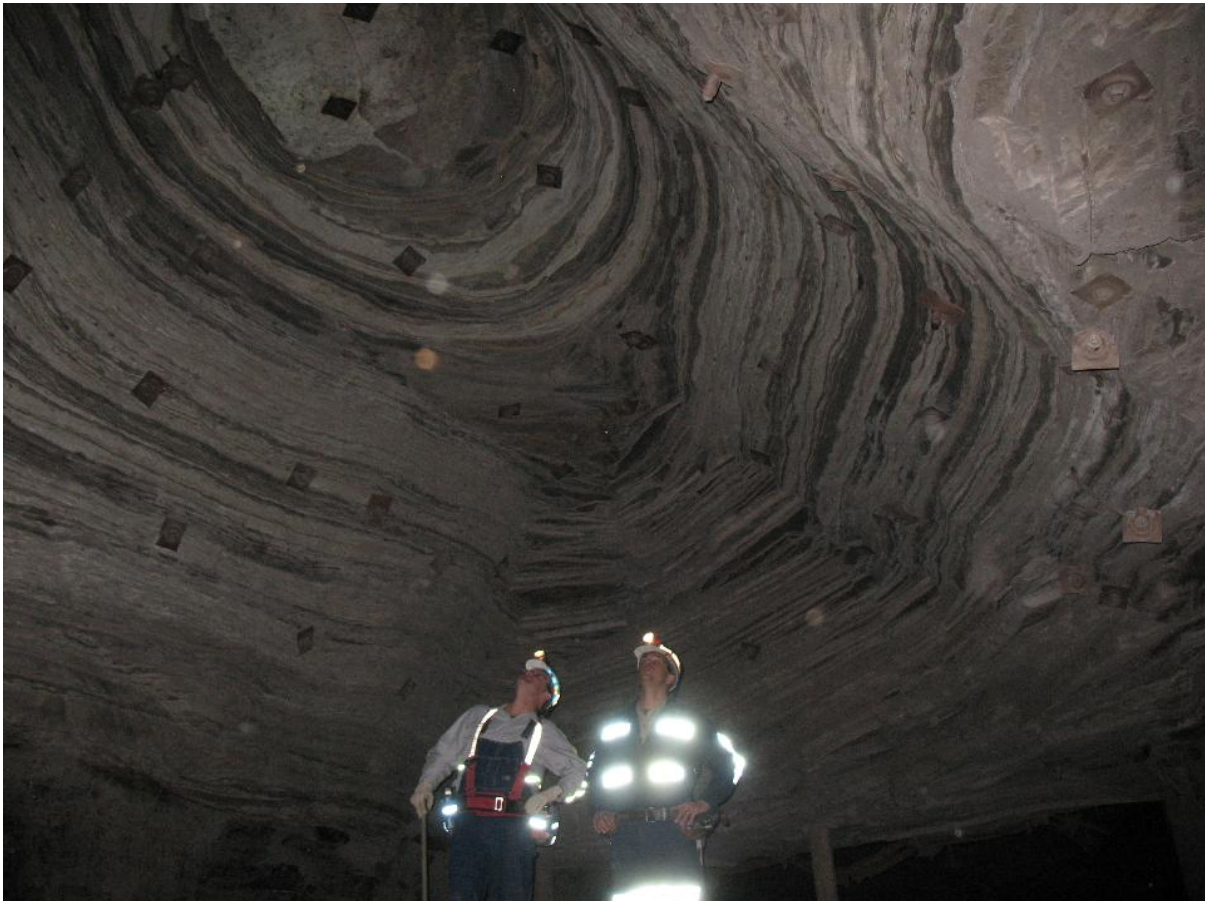
Figure 1: Roof fall in a stackrock sequence.

In another area where the stackrock comes right down on the coal seam, large domed falls reaching 20-30 ft high occur (Fig. 1). Horizontal slippage and failure along bedding causes mid-entry crushing leading to the roof falls. The two channel sandstone washouts of the coal seam are part of the same surface drainage system present at the time of coal deposition. The stackrock sequences represent overbank transition zones along the margins of the channels and intersect between the channels (Fig. 6). When sandstone channels come close to the coal seam, stackrock sequences can be expected in the vicinity.

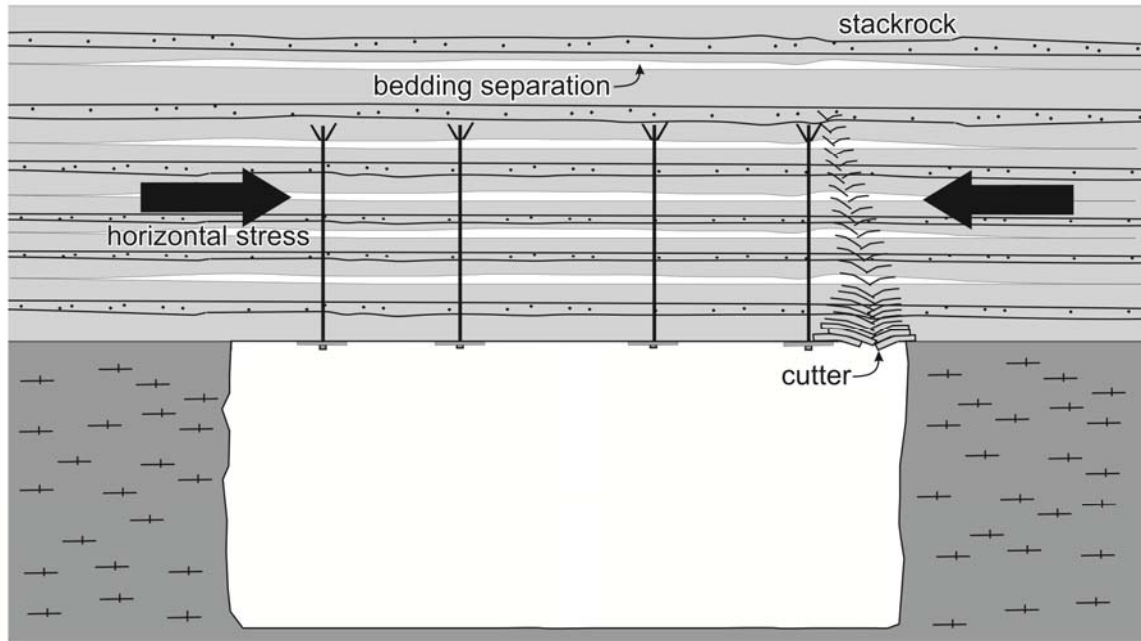
Figure 2: Stackrock delaminates and cutters form when roof is subjected to horizontal stress

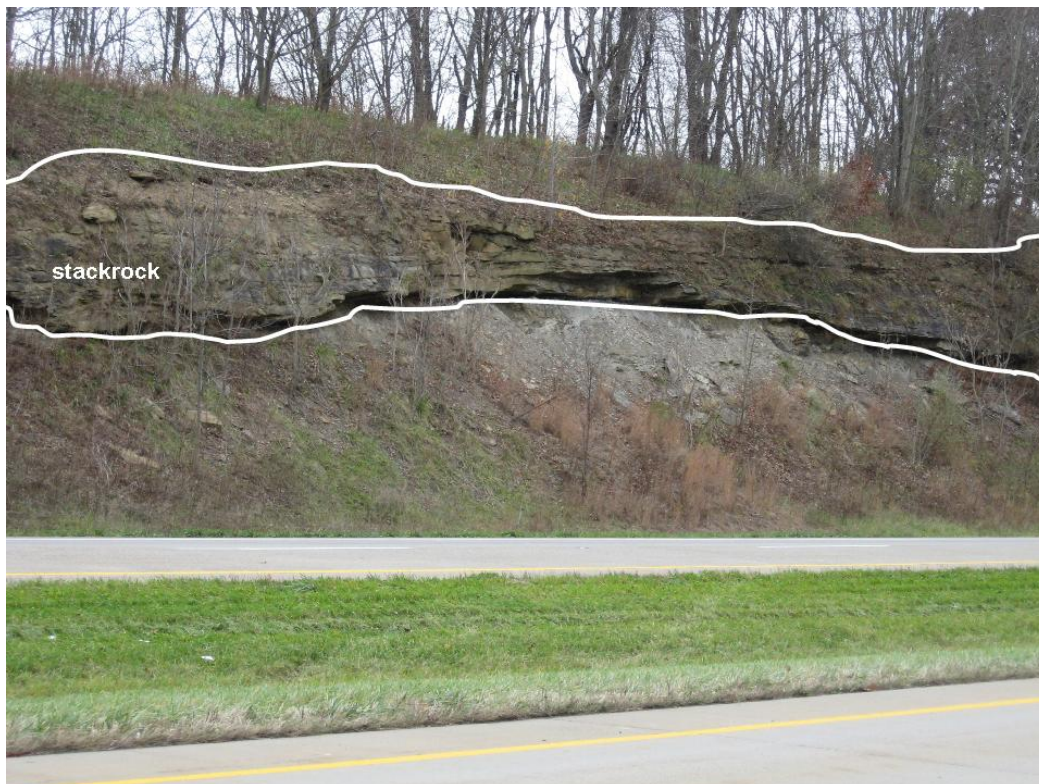
At a mine in the Upper Freeport seam in eastern Ohio, massive sandstone lenses (20-50 ft thick) invade the roof intermittently (Fig. 4). The mine is also subjected to a high horizontal stress oriented E-W. When the sandstone forms the immediate roof, conditions are excellent. Massive sandstone roof that has been exposed by mining for 40 years has survived with very little damage. Along the margins of these channel lenses however, the stackrock sequences occur at various levels ranging from immediate roof to 10-20 ft into the roof. Horizontal stress attacks these sequences resulting in roof falls oriented N-S. The strong E-W stress field is also indicated by roof cutters and roof falls ripping N-S despite having to jigsaw around pillars. Cutter roof is common and often leads into roof falls. Where stackrock approaches the roof, stress damage is more frequent. In addition, water associated with the sandstone may also begin to drip through the roof, further weakening the rock.

Figure 4: Stackrock sequence occur on the margins of sandstone channels.

At the Ohio mine, roof cutters are worse where roof bolt spans to the rib are large. Roof bolts were observed to be up to 48 in from the rib in some places. Installing bolts close to ribs will help to control cutter roof and prevent its propagation. Angling longer corner bolts through the cutter to anchor over the rib is also a preferred control for cutter roof. Some mines have added an additional “cutter” bolt to the row pattern just to fulfill this function. In difficult cases, roof trusses have been effective, provided they maintain contact with the roof and have adequate surface control.

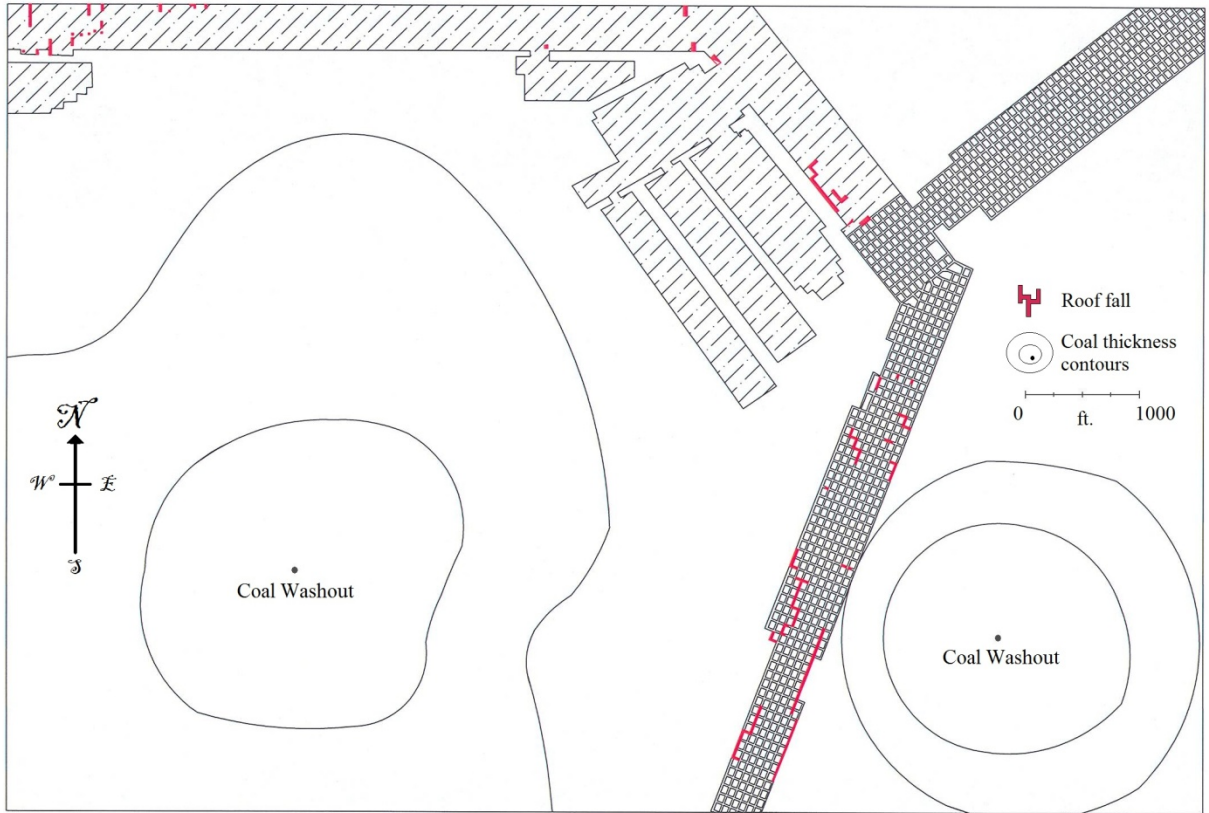
Figure 5: Poor roof conditions occurred when mining in stackrock between two channel washouts.

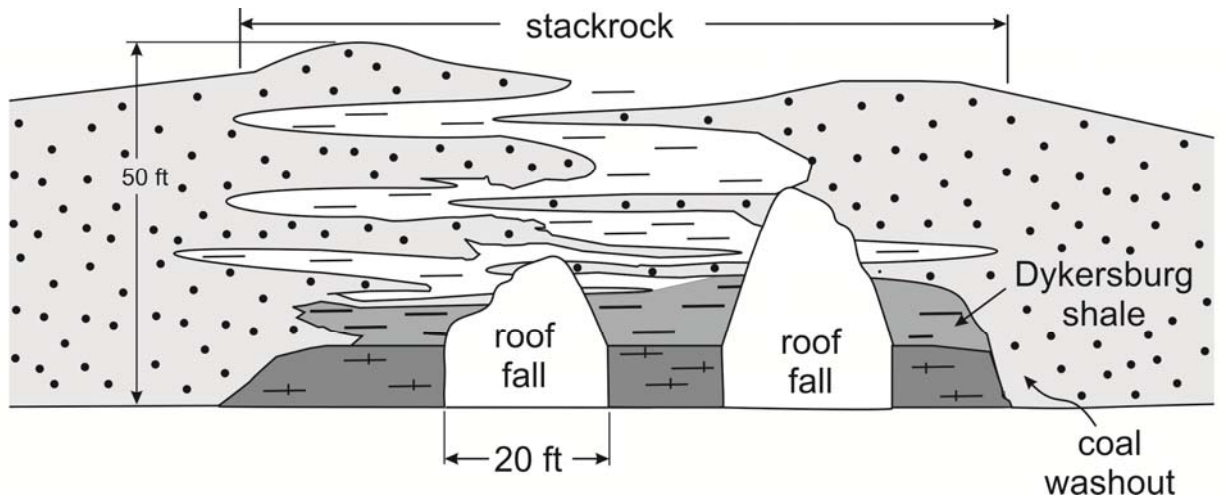
Figure 6: Cross section of stackrock sequences causing poor roof conditions on the margins of paleochannels.

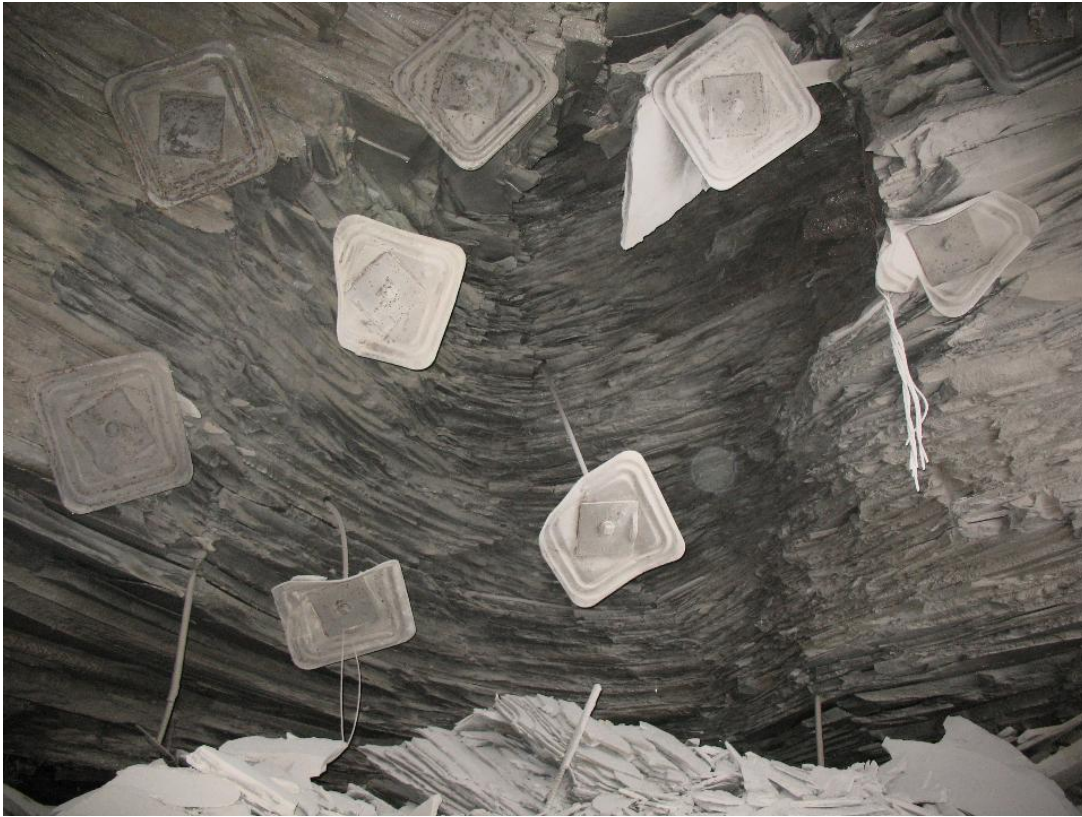
Figure 7: Roof buckling and cutter roof due to horizontal stress.

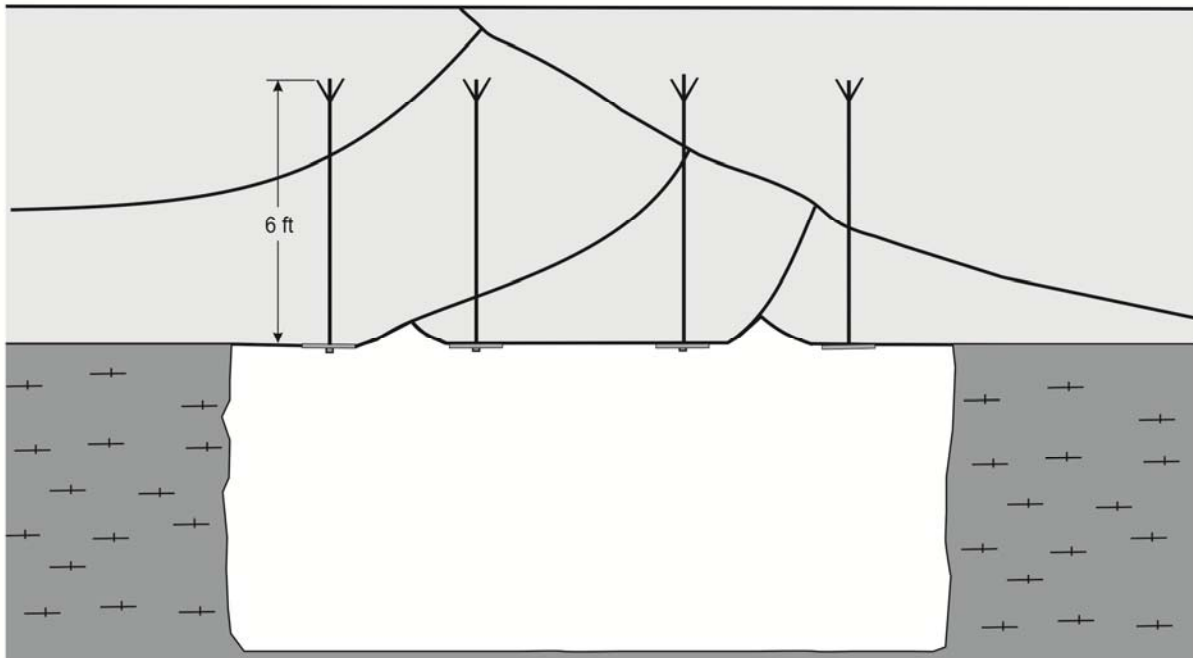
Figure 8: Roof shears can destroy the continuity of the roof beam.

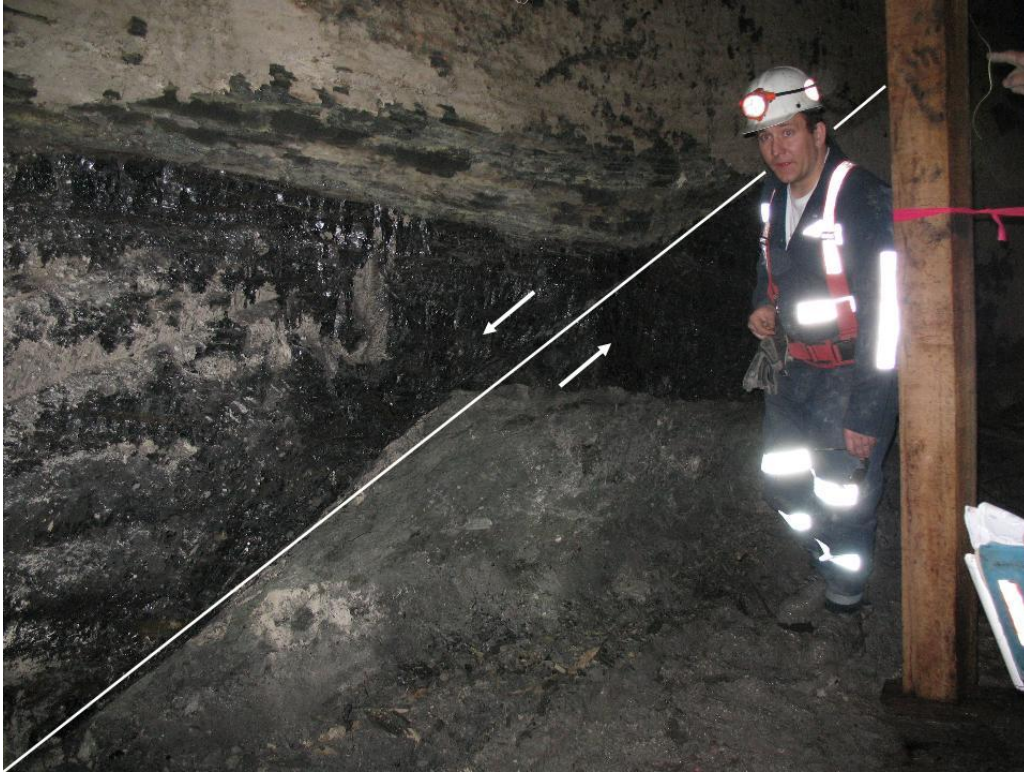
Figure 9: Normal fault causes roof damage in an Indiana coal mine.

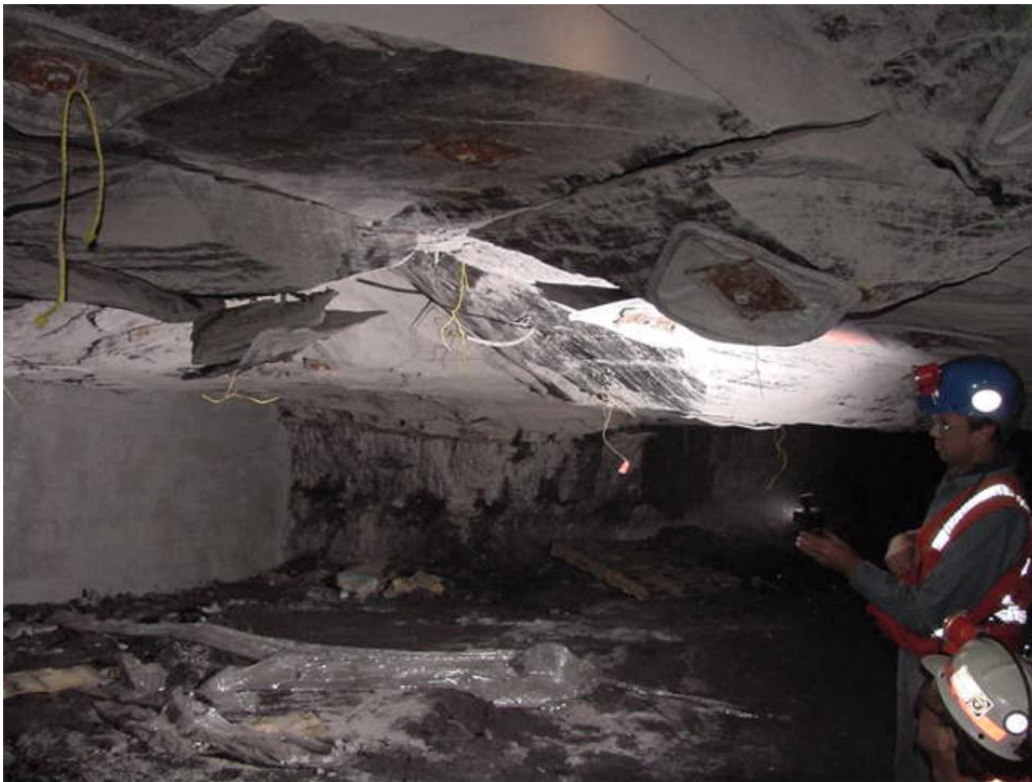
Figure 10: Slickensided failure planes cause hazardous roof conditions.

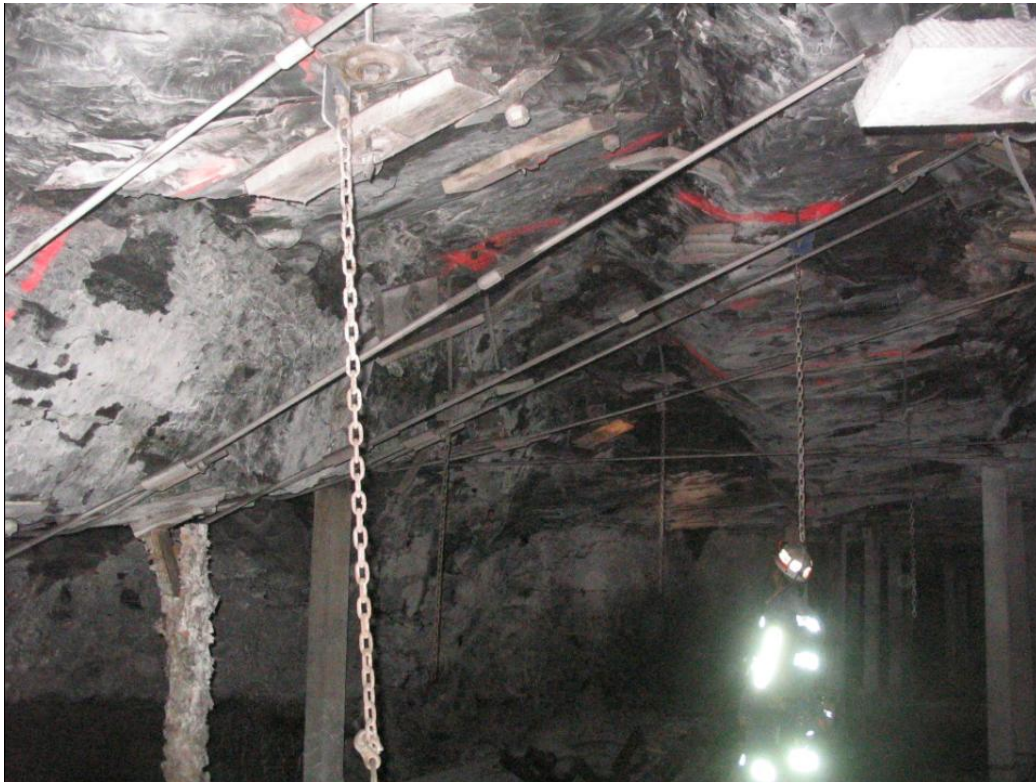
Figure 11: Slickensided failure planes cause hazardous roof conditions.

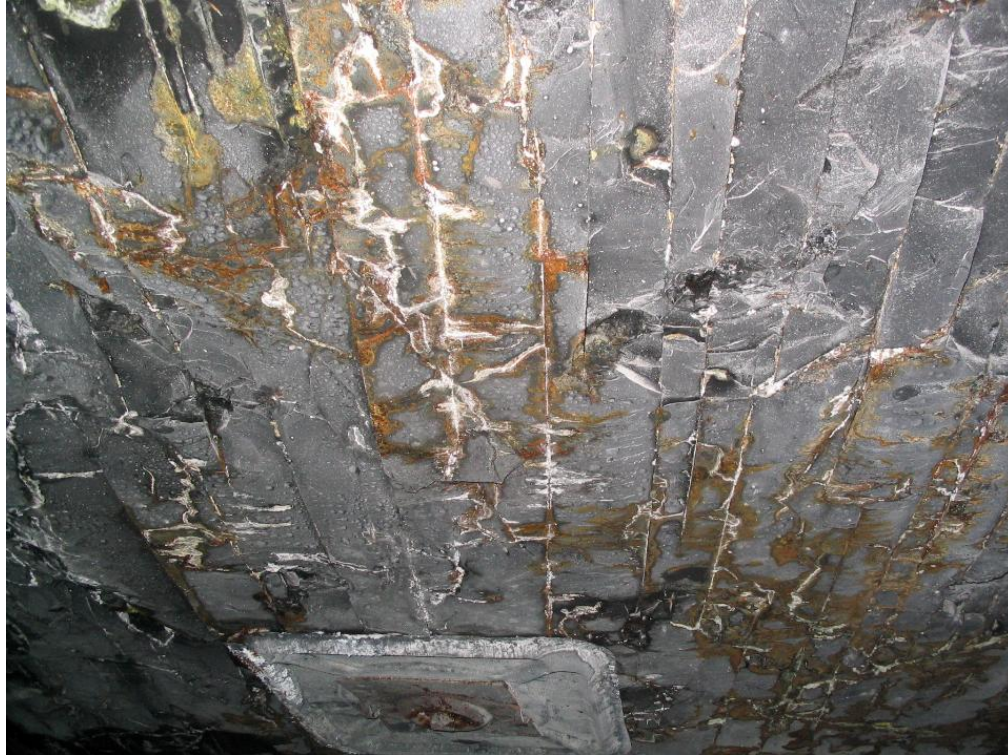
Figure 12: Joints in black shale can loosen with time causing spalling roof.

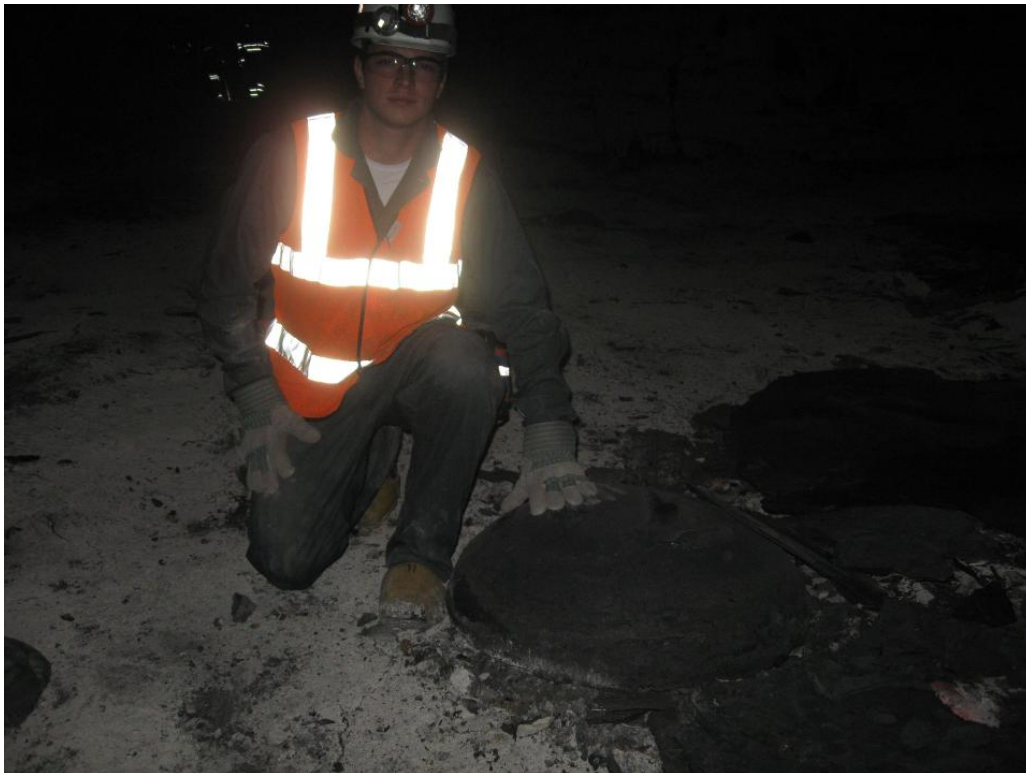
Figure 13: Siderite nodules present roof hazards.

A number of mines in both the #5 and #6 seam have black shale as the immediate roof strata. The black shale is highly resistant to moisture-induced deterioration and so resists slaking [Molinda *et al.* 2008; Molinda and Klemetti 2008, Molinda *et al.* 2006]. However, black shales in general are characterized by well-developed vertical jointing (spacing approx. 4 in) (Fig. 12). With time the joints relax, separate, and the rock between them falls away from the roof. This causes loss of bolt tension and also exposes moisture-sensitive shales above to mine humidity. The black shales also are well known for the occurrence of bands of siderite nodules. These nodules can be up to 3-4 ft across and are extremely hard to cut and drill. Continuous miner bits have been broken off when contacting the nodules (Fig. 13).

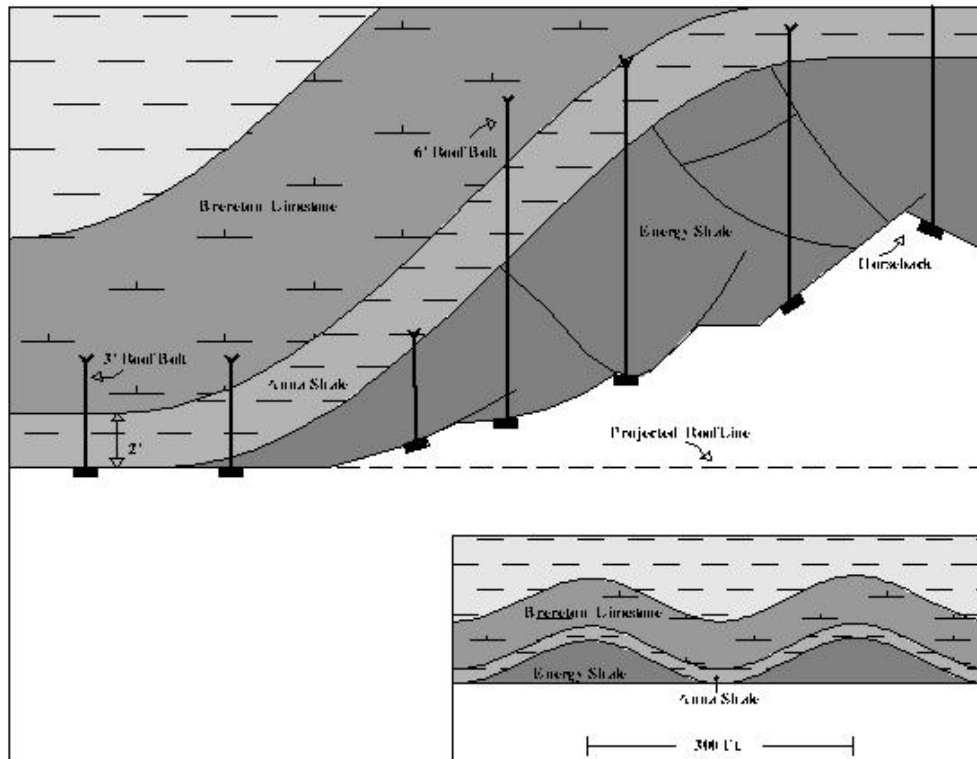
Figure 14: Energy shale wedges are marked by large shears which form horsebacks.

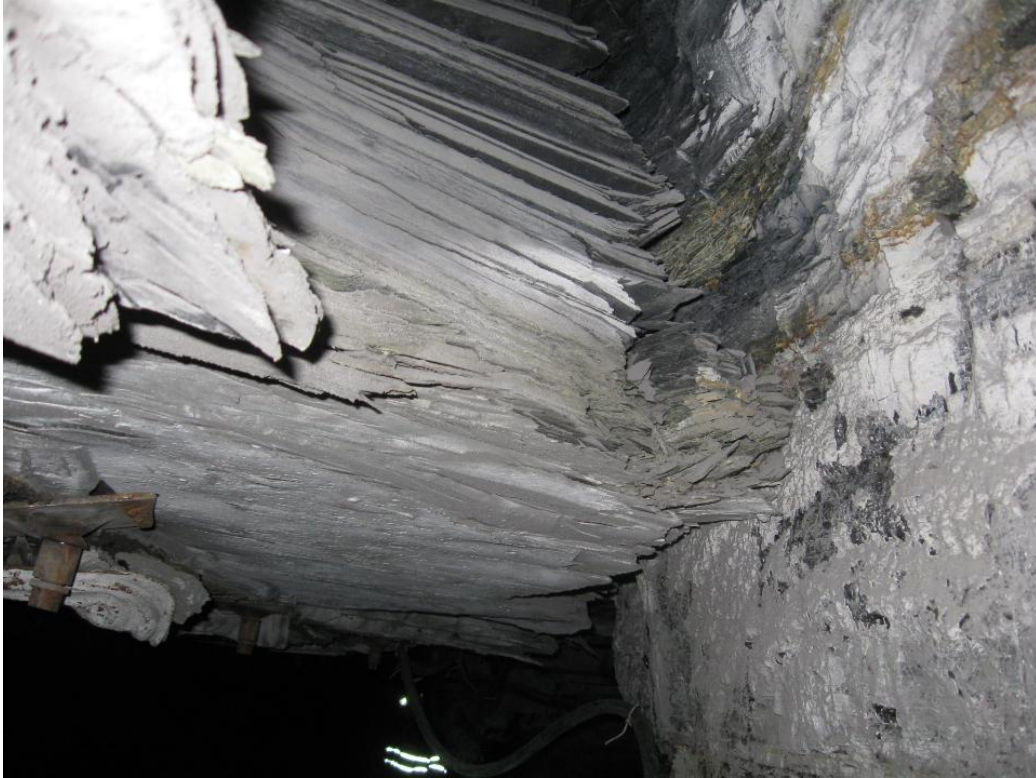
Figure 15: Cutter roof in thick shale roof sequence.

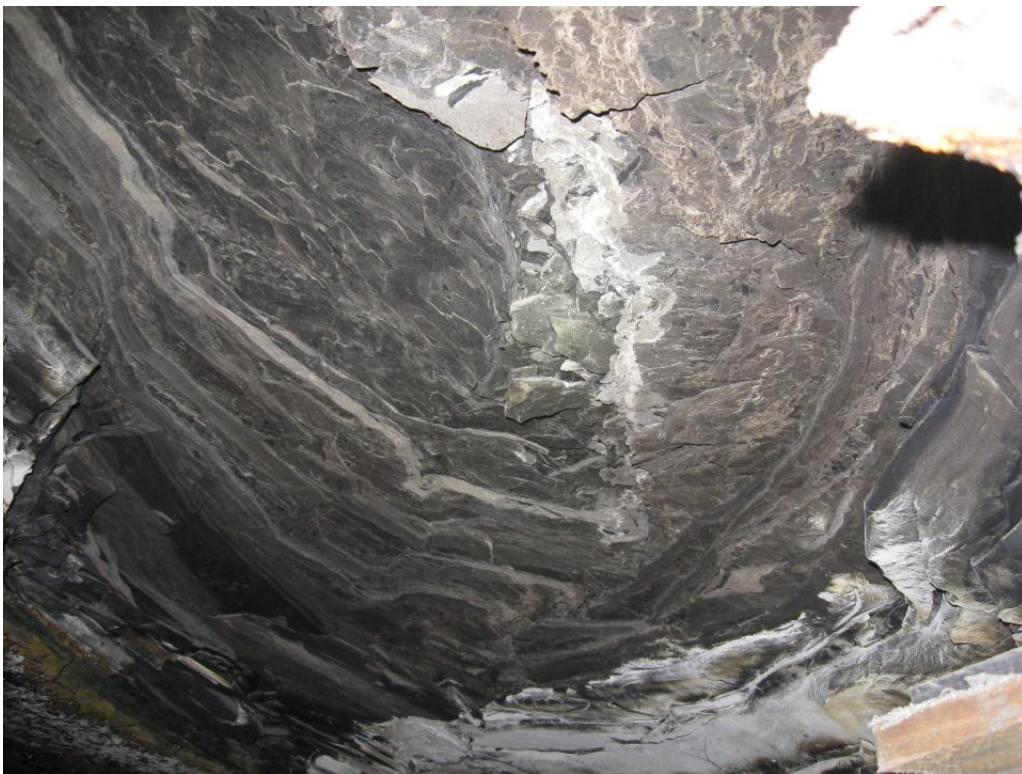
Cutter roof refers to damage of coal mine roof caused by horizontal compression and crushing of roof rock. This most often occurs at the intersection of roof and rib, but can occur in the center of the entry or anywhere in the entry. The damage is caused by horizontal stress acting to shorten and crush the roof [Gale 1986; Mark 1991; Hasenfus and Su 2006; Mark and Gadde 2008]. The damage is more common in weak rocks but has been documented to occur in stackrock (as described earlier), and even in limestone in near-surface stone mines [Iannachione et al. 2001]. Cutter roof is a progressive failure and can lead to guttering, which is more extensive rock damage along the roof and rib intersection. This guttering can extend above the roof bolt anchorage horizon. In thick shale sequences the roof beam stays intact and the cutter works upward along the ribline causing a cantilevered roof and finally a roof fall (Fig. 2). Cutting usually occurs on the working section either running out of the newly exposed face, or shortly after mining (Fig. 15). While cutter roof often damages the roof at the working face, roof falls may not occur until months after mining when guttering has progressively severed the roof beam. Investigation of the roof surrounding the fall will often show cutter roof leading up to the roof fall, indicating cutter roof to be the cause of the fall. The initial failure, usually begins in an intersection. After the intersection falls out, the fall can progress to long, running falls perpendicular to the direction of maximum principal stress. A number of roof damage features, including potting, stitching, rock flour, cutting, and guttering indicate of the presence of horizontal stress and its orientation [Mark and Mucho 1994] (Fig. 16).

Figure 16: Roof pot and rock stitching caused by horizontal stress.

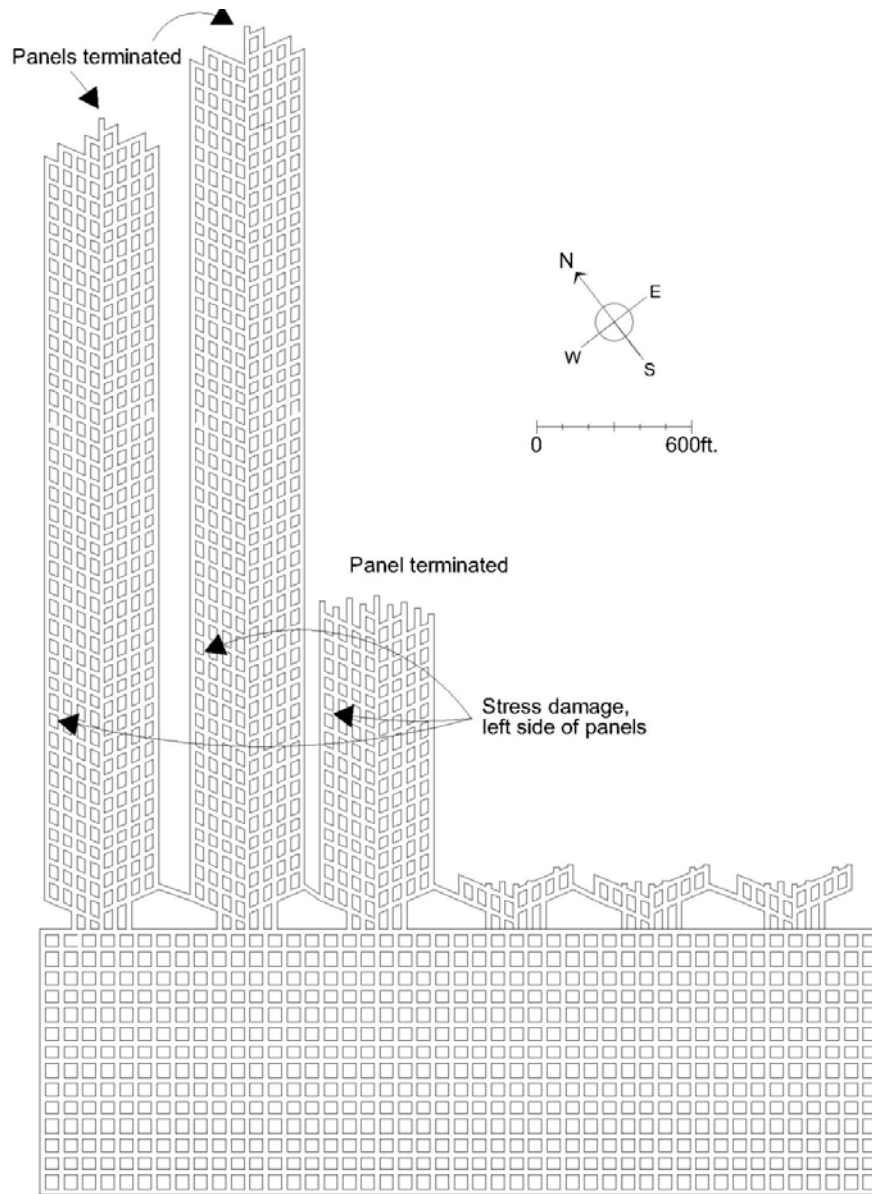
A mine in the Illinois Basin is working the #9 seam under approximately 350 ft of cover. Seam height is 70 inches with 8-10 inches of drawrock taken, for a total mining height of 80 inches. The roof geology consists of 4 ft of dark gray to black laminated shale, overlain by an 8 in thick mud layer, overlain by a massive, poorly bedded shale. The black shale immediate roof is typically resistant to moisture-deterioration, but the overlying gray shale is moisture-sensitive. The roof is attacked by a horizontal stress field oriented approximately East – West to N. 80 E. This stress field orientation is consistent with other horizontal stress measurements in the basin [Ingram and Molinda 1990] Roof potting, guttering, and other stress damage was observed to lead into roof falls. Crosscuts on the left side of several production panels showed far more damage than crosscuts on the right side. The crosscuts on the left side are oriented at a larger angle to the E-W stress field (62 degrees) than those on the right side of panel (10 degrees). As a result, roof potting and guttering is more severe. (Fig. 17).

Figure 17: Stress damage is more severe on the left side of a production panel than on the right side.

Reorientation of developments or angling of crosscuts is the first remedy to minimizing damage from horizontal stress. Roof bolts nearest the rib can be angled to intersect the cutter and anchor over the stable rib. Cable bolts are often installed systematically in intersections to suspend the roof beam from a stable anchorage.

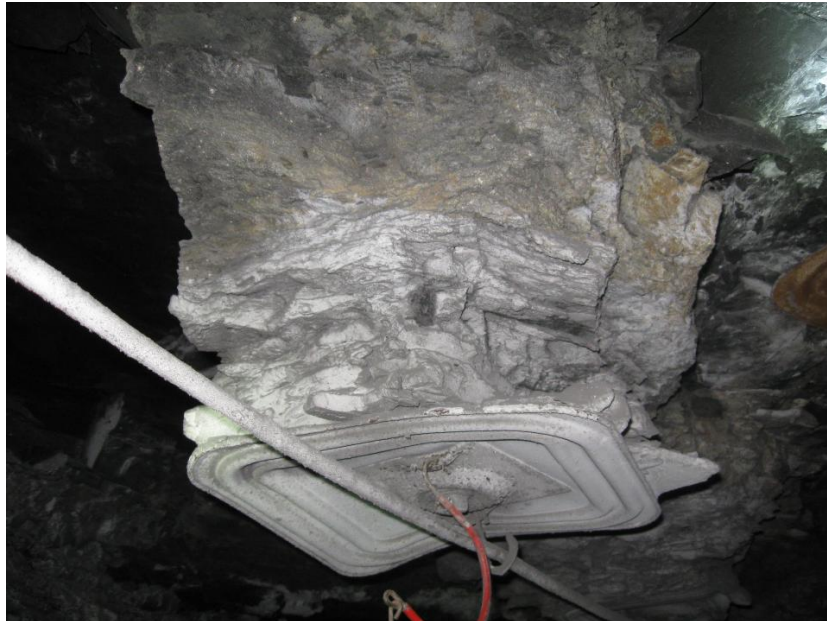
Figure 18: Exposure of moisture-sensitive gray shale leads to chandelier bolts.

Evidence for this spalling type of disaggregating failure between bolts in weak rock can be seen in the rock pile below a roof fall. It is not uncommon to see small pieces of rock (8-15 inches across) which are piled up almost as though dumped from a truck (Figure 23). It is unlikely that the rock was broken this way from the impact of hitting the ground. Instead, the whole rock mass probably became fragmented between bolts and unraveled intermittently as small pieces. In very weak rock, spalling between bolts is common (Figure 24). In such potted roof, the rock mass was not even coherent enough to load the bolts and pull them from their anchorage. In fact, it is unlikely that these roof bolts ever saw any significant loads. As the rock unraveled, sometimes to the point that the plate is left with no rock contact, the reinforcing value of the roof bolts is reduced. A roof bolt plate that spins indicates no plate load and re-support may be necessary. Roof marked by chandelier bolts (hanging roof bolts or roof bolts that have columns of rock isolated around them) is often described as both “undersupported” and “unsupported”, depending on the depth of “chandeliering” (Fig. 18).

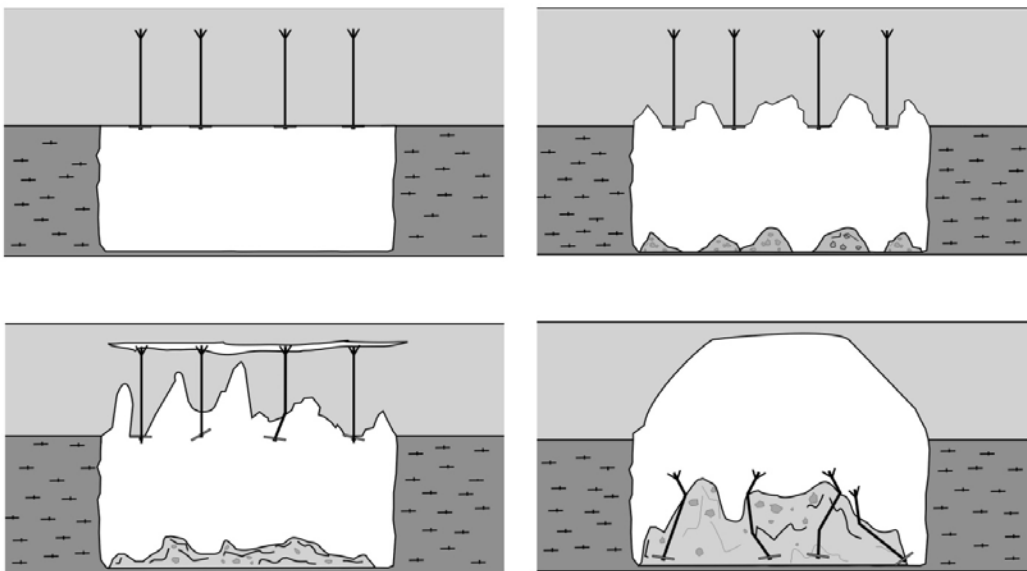
Figure 19: Unraveling of rock between bolts leads to roof fall.

Roof spalling is the fall of rock between bolts. It can progress upwards, eventually above the roof bolt anchorage (Fig. 19). Rock spalling between bolts can be due to several factors. Poor bedding cohesion or a weak rock matrix can allow separation and scale to form between bolts (Fig. 20, 21). The separation can be driven by horizontal stress or by gravity. Roof separation above bolt anchorage then compromises the roof beam and can lead to roof fall. The other mechanism is weathering of moisture-sensitive rocks. Moisture can weaken clay-rich shales and cause swelling, creating downward pressure on the roof, fracturing already-weak rocks [Molinda *et al.* 2006]. This unraveling can eventually progress to a roof fall. A number of mines in the Illinois Basin have time-dependant deterioration of the roof leading to roof falls. Roof falls can continue to happen years after mining. Many studies show that mudrocks weaken with exposure to moisture [Mark *et al.* 2004a; Huang 1986; Cummings and Singh 1981; Aughenbaugh and Bruzewski 1976]. It may be this moisture-deterioration which explains some long-term roof falls.

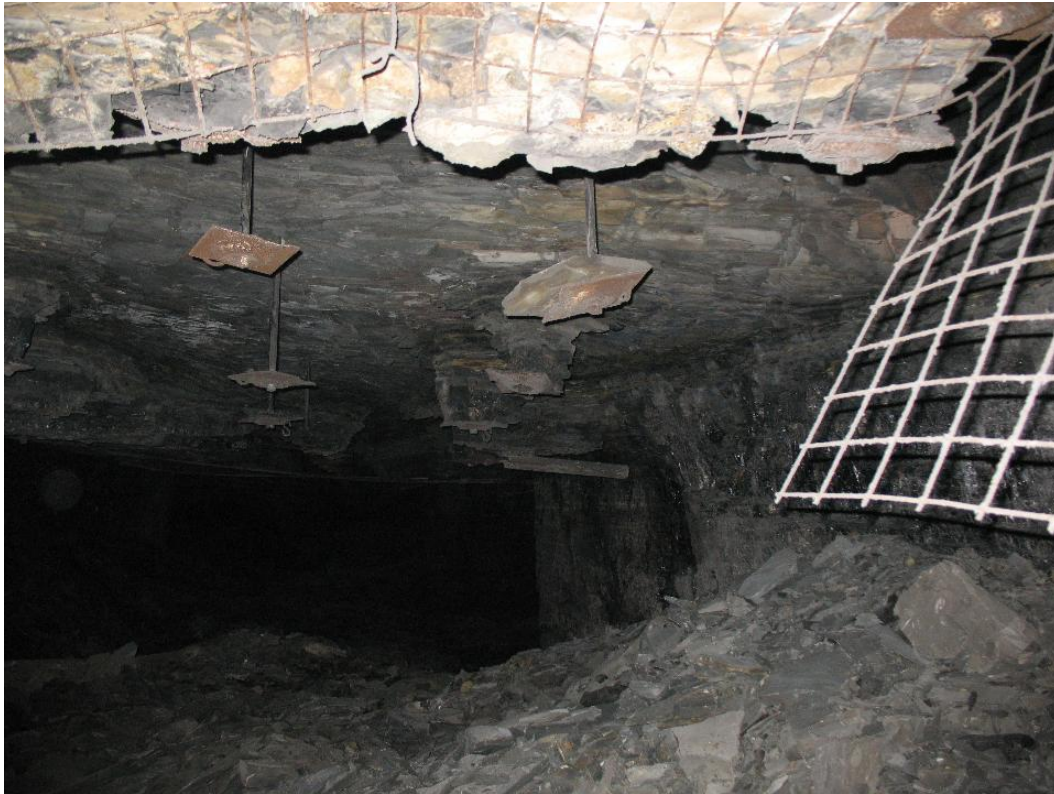
Figure 20: Progressive roof spalling leads to roof fall.

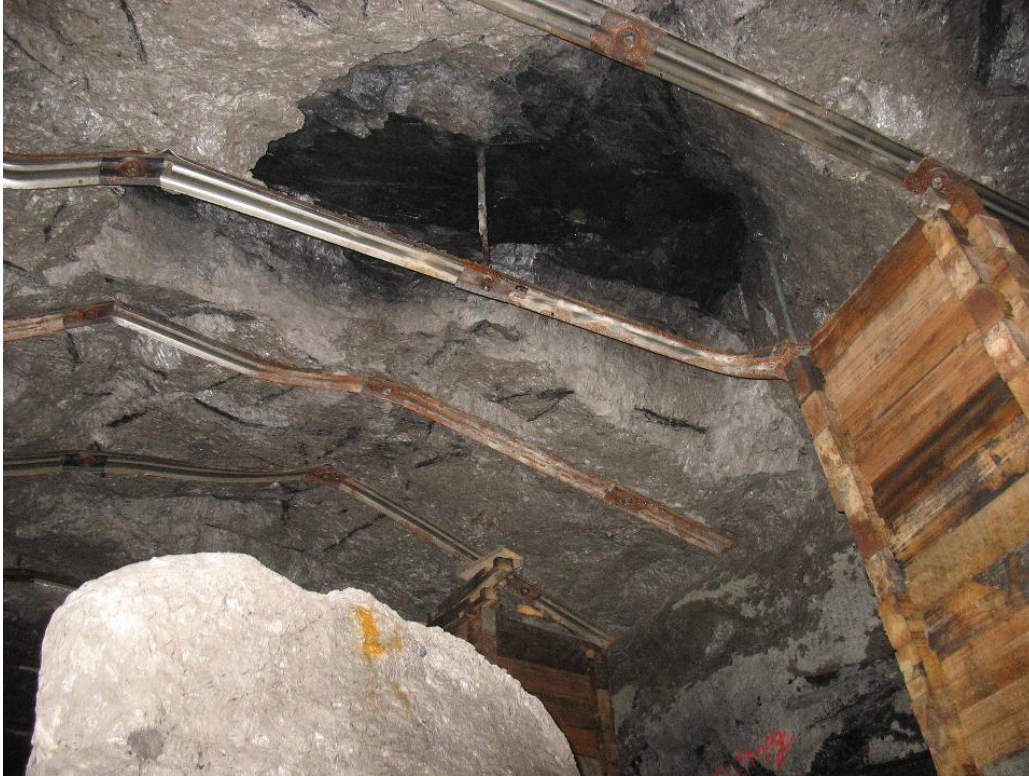
Figure 21: Weak cohesion in a roof fireclay leads to fall between bolts.

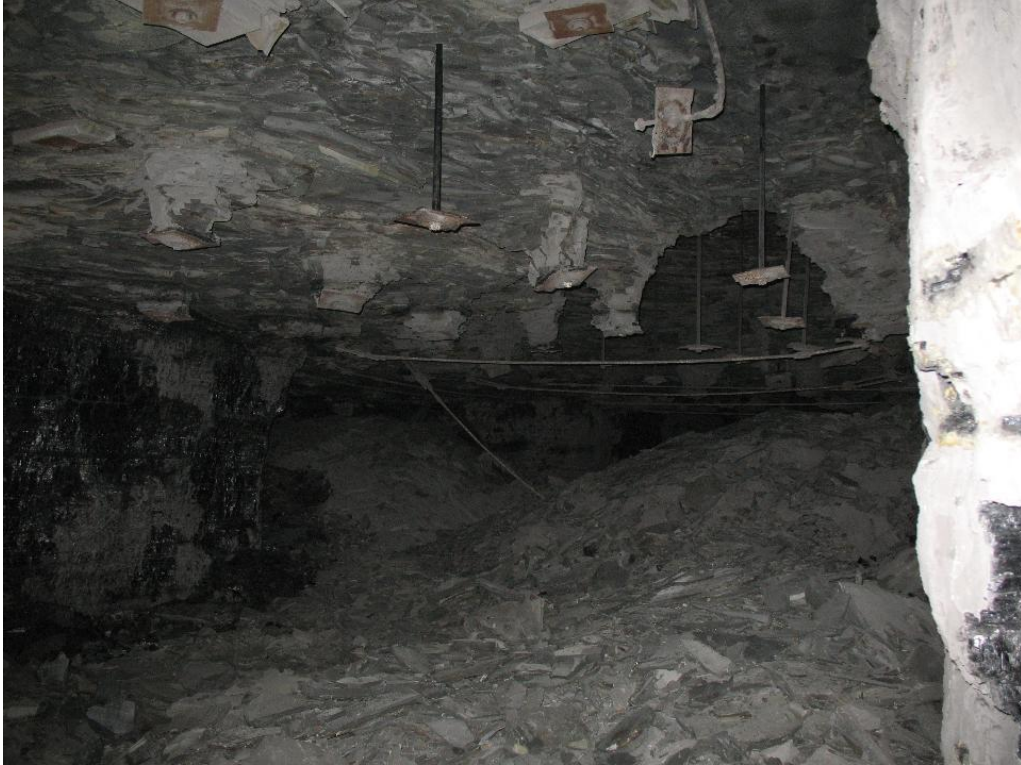
Figure 22: Progressive spalling between roof bolts in a moisture-sensitive roof shale.

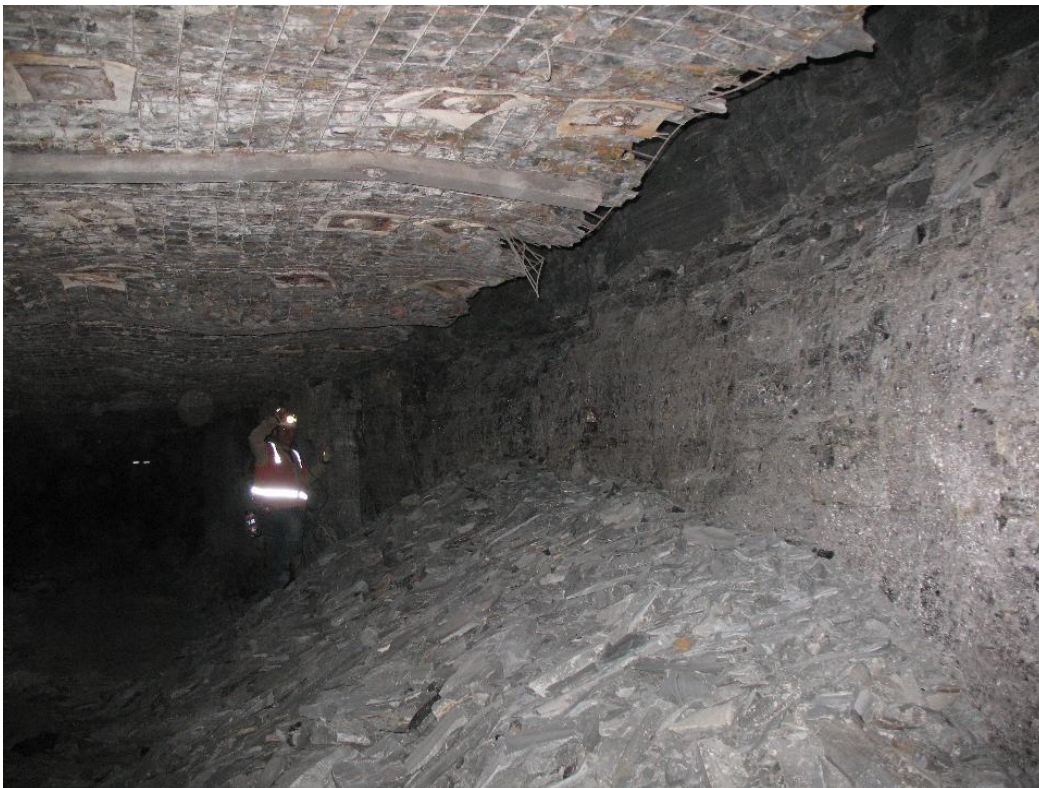
Figure 23: Rock pile below rib gutter is due to disaggregation of weak roof shale.

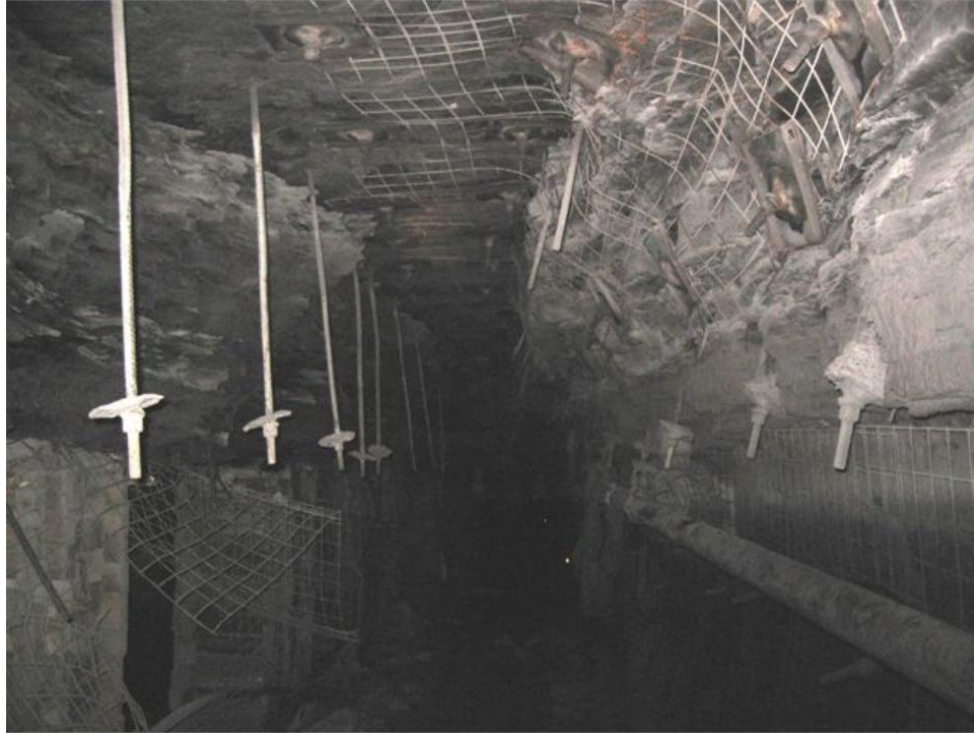
Figure 24: Rock disintegration between bolts extends nearly to bolt anchorage.

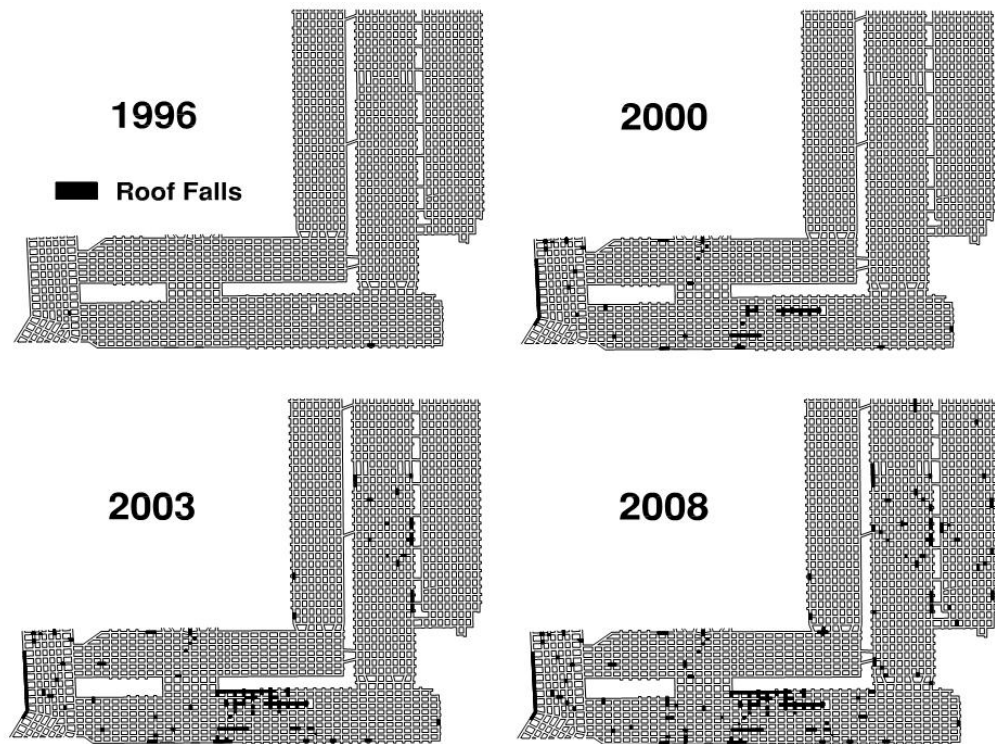
Figure 26: Time-dependent roof deterioration in an Illinois basin coal mine.
