Ground Failures in Coal Mines with Weak Roof

Greg Molinda, MS

Chris Mark, PhD

*Principal Research Engineer (cnm7@cdc.gov)
National Institute for Occupational Safety and Health (NIOSH)
P.O. Box 18070, Cochrans Mill Rd. Pgh., PA 15236*

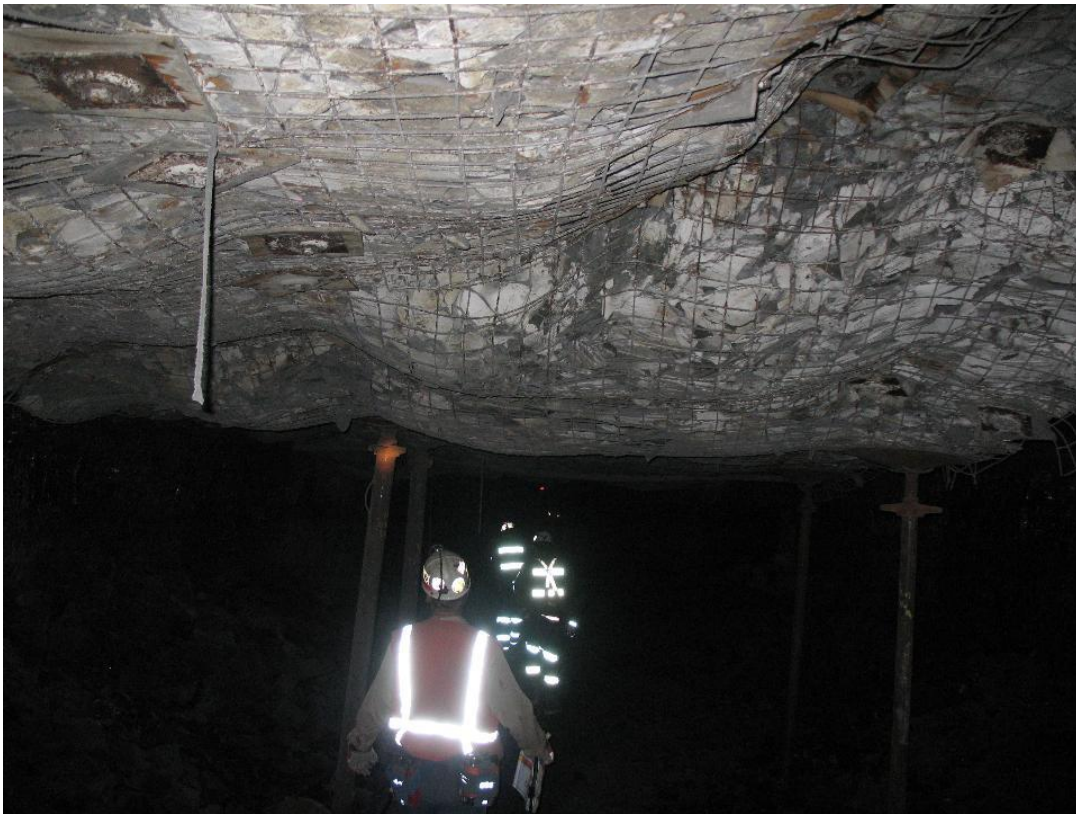
Figure 27: Roof screen holding a large amount of broken rock.

Both of the rock types are extremely weak (breakable by hand) and moisture-sensitive (complete disintegration within one hour of water immersion). There is a weak-moderate horizontal stress field, oriented E-W, attacking the roof. Roof falls are oriented N-S. The biaxial stress field is not overwhelming but strong enough to cut the weak roof shale (UCS = 1,200 psi). A small stress cutter develops on the ribline in entries oriented N-S and again on the box cut in the entry center. Once these cutters open up the roof, infiltrating moisture begins to deteriorate the roof. Weathering begins to occur within one month of roof exposure and is worst nearest the intake shaft and intake entries. Roof screens bag and are holding a large amount of broken rock (Fig. 27). Without the screen, much of the roof would likely be on the floor.

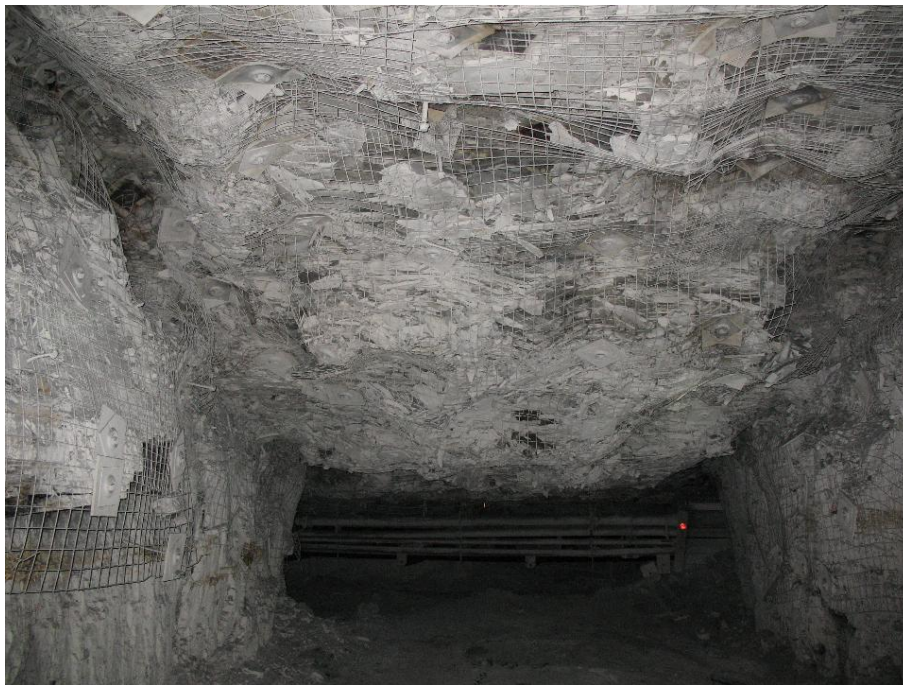
Such extreme weakness and moisture-sensitivity forced the mine to reduce entry width to 16 ft, and use a dense 6 bolts per row roof pattern to cut down the spacing between roof bolts. Each row consists of four, 9 ft, point anchored, resin-assisted bolts, with two 4 ft “cutter” bolts angled over the rib to support the corner. The entire roof was screened with welded steel wire. Even though the roof is essentially rubbleized, the roof screen, supported by the dense roof bolt pattern, is effectively controlling it (Fig. 29).

Figure 29: The rubbleized roof is effectively controlled by roof screen.

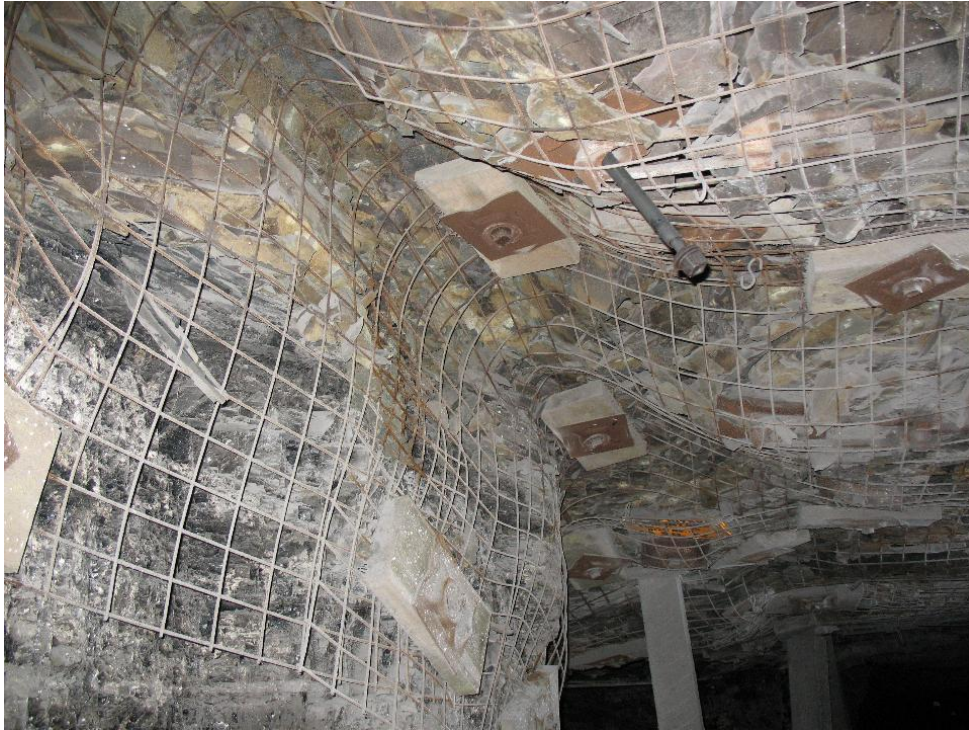
Figure 32: Rib and corner screening controls rib line guttering.

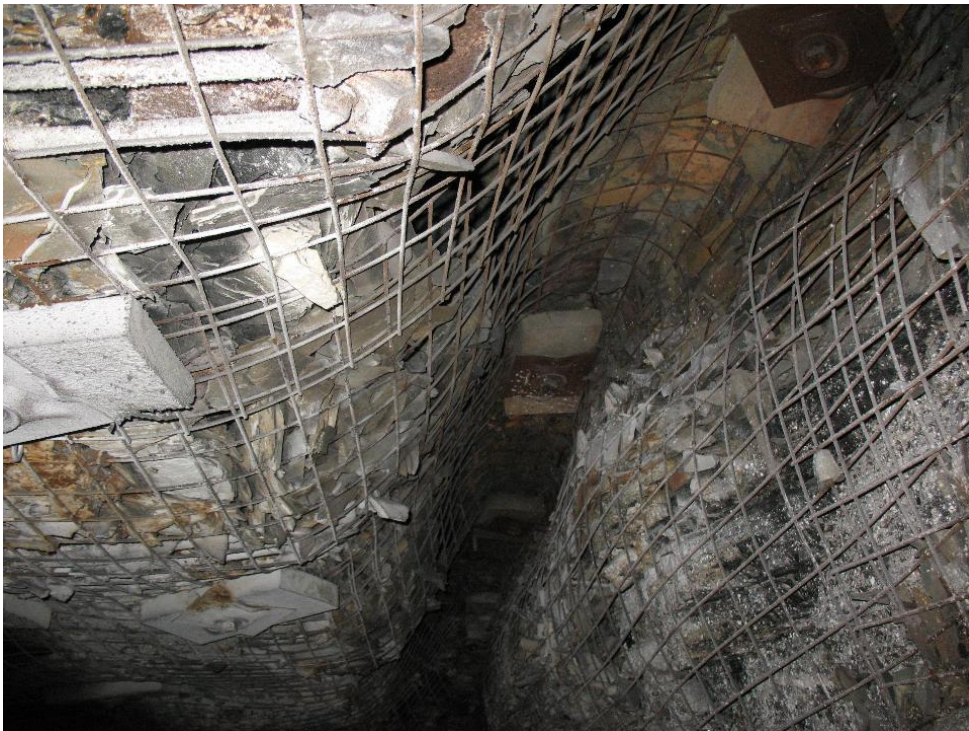
Figure 33: Screening of rib gutters can stop further deterioration.

special tool to push screen up into gutters to allow fallen rock piling up on the screen to confine the gutter (Fig. 33). After full roof and rib screening was introduced, roof falls were essentially eliminated.

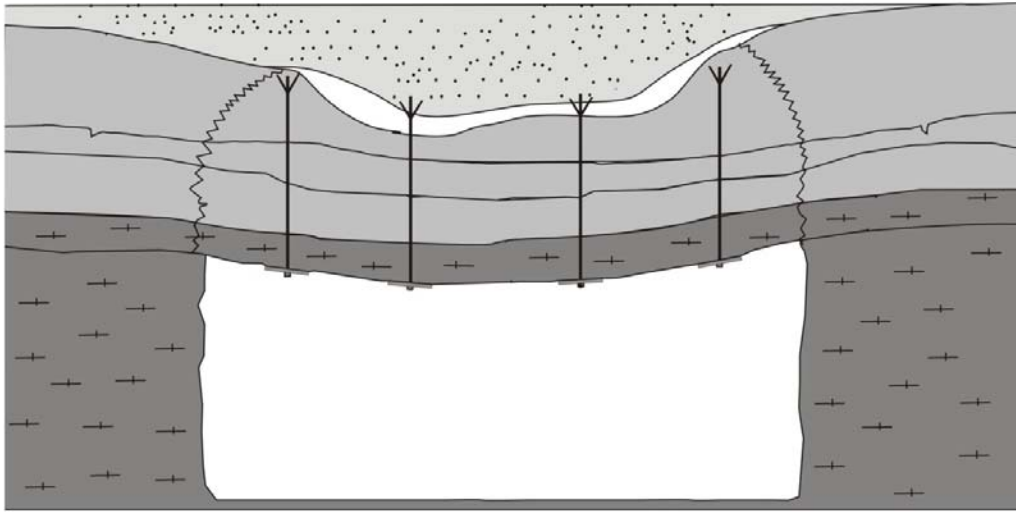
Figure 34: Failure to reach a stable anchorage with roof bolts can result in a roof fall.

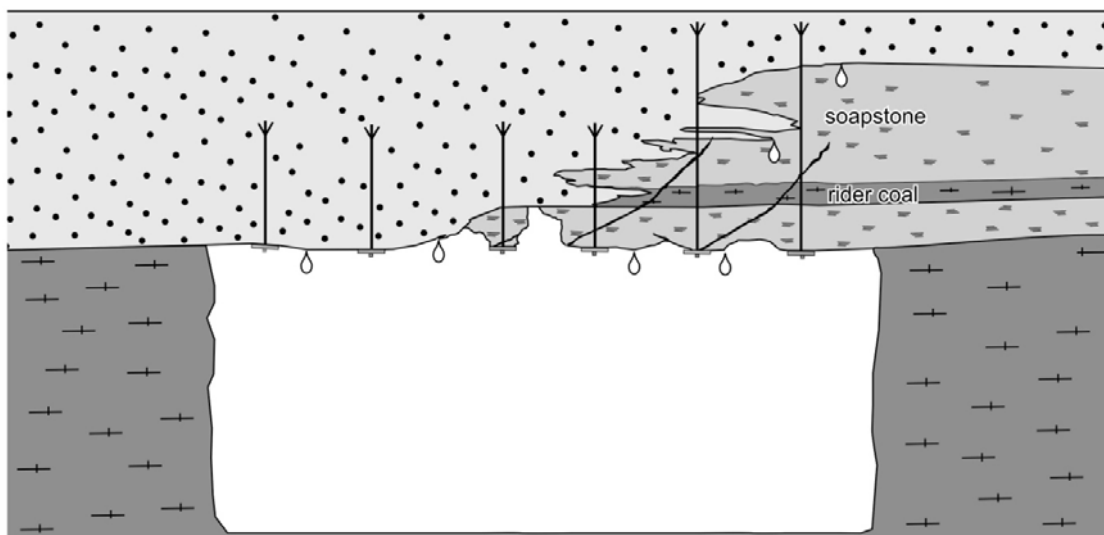
Figure 35: Hazardous roof conditions occur on the margins of a sandstone channel at a West Virginia mine.

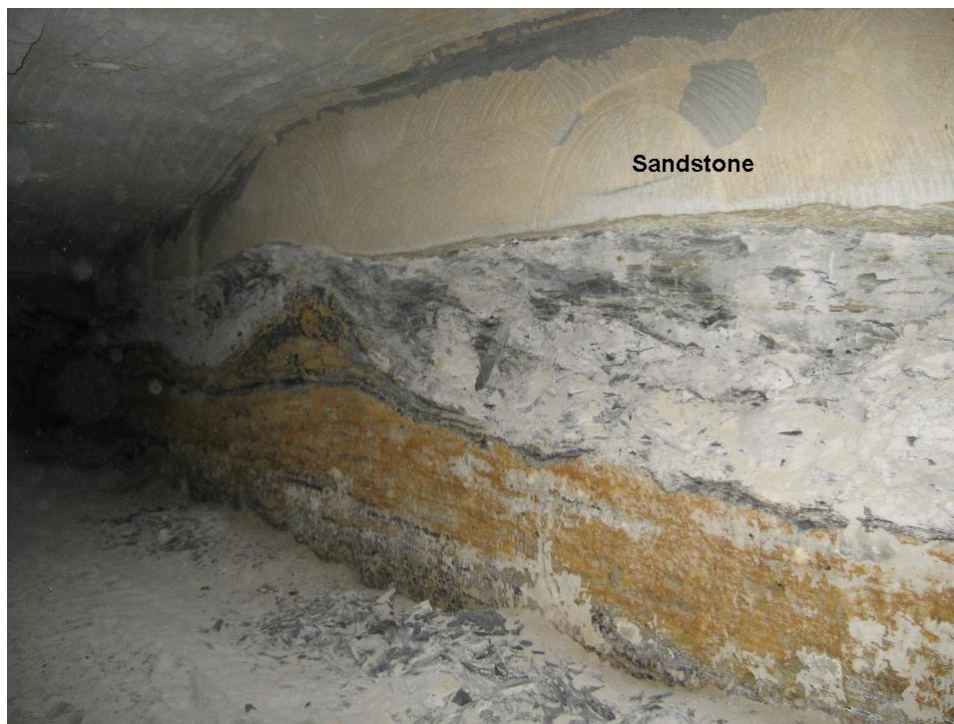
Figure 36: Sandstone layer is the roof bolt anchorage when close to the coalbed.

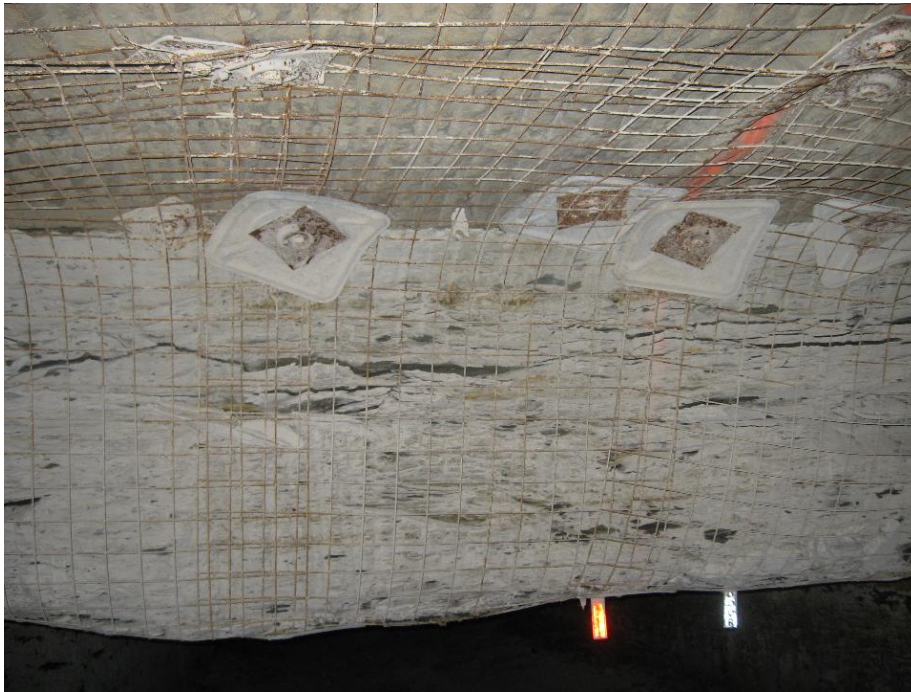
Figure 37: Bed separation in weak shale.

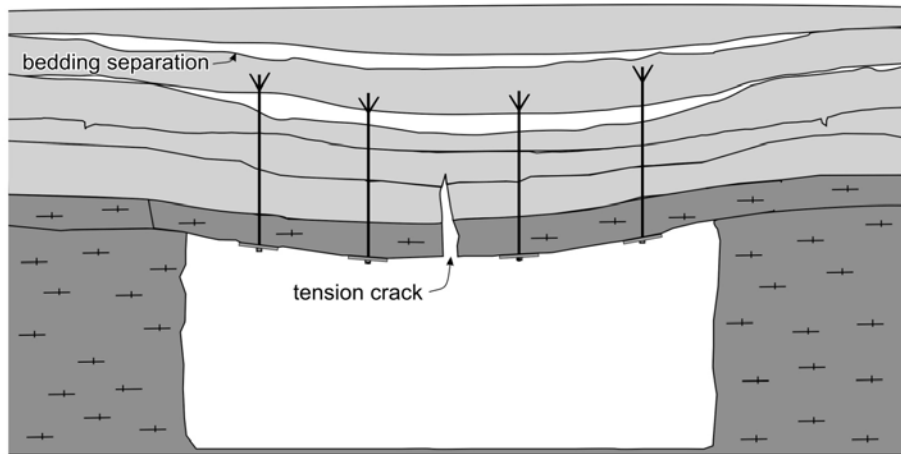
Figure 38: Tension cracks in the entry center develop as roof sags.

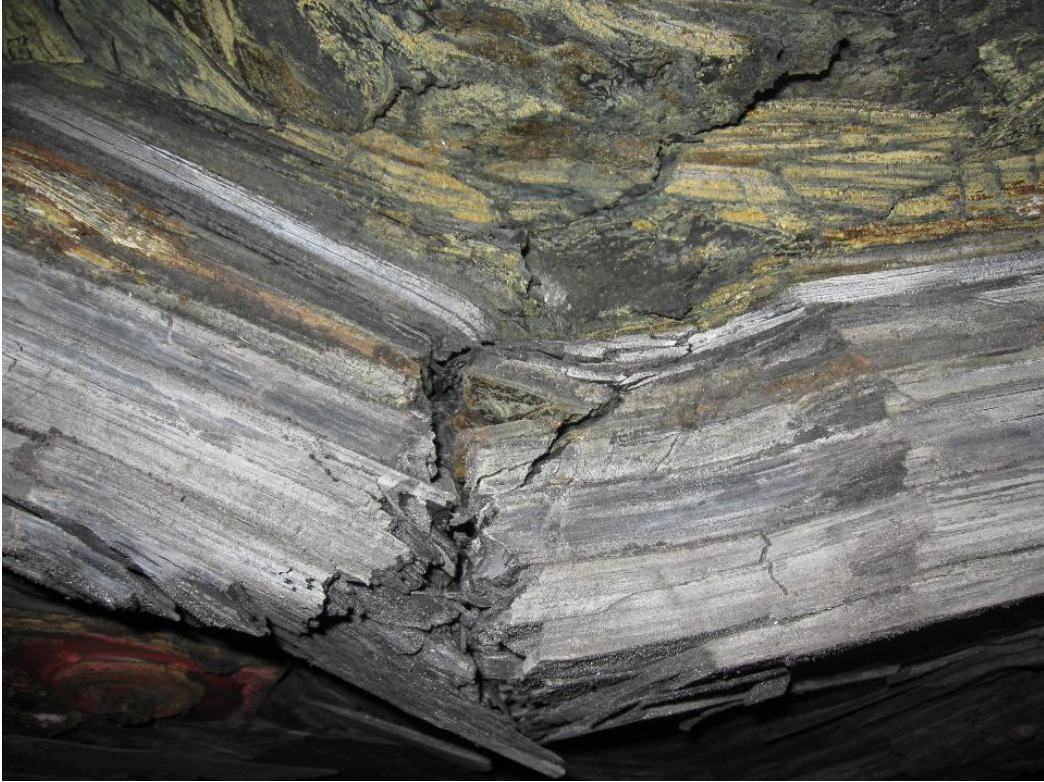
Figure 39: Tension crack develop in entry center as roof sags.

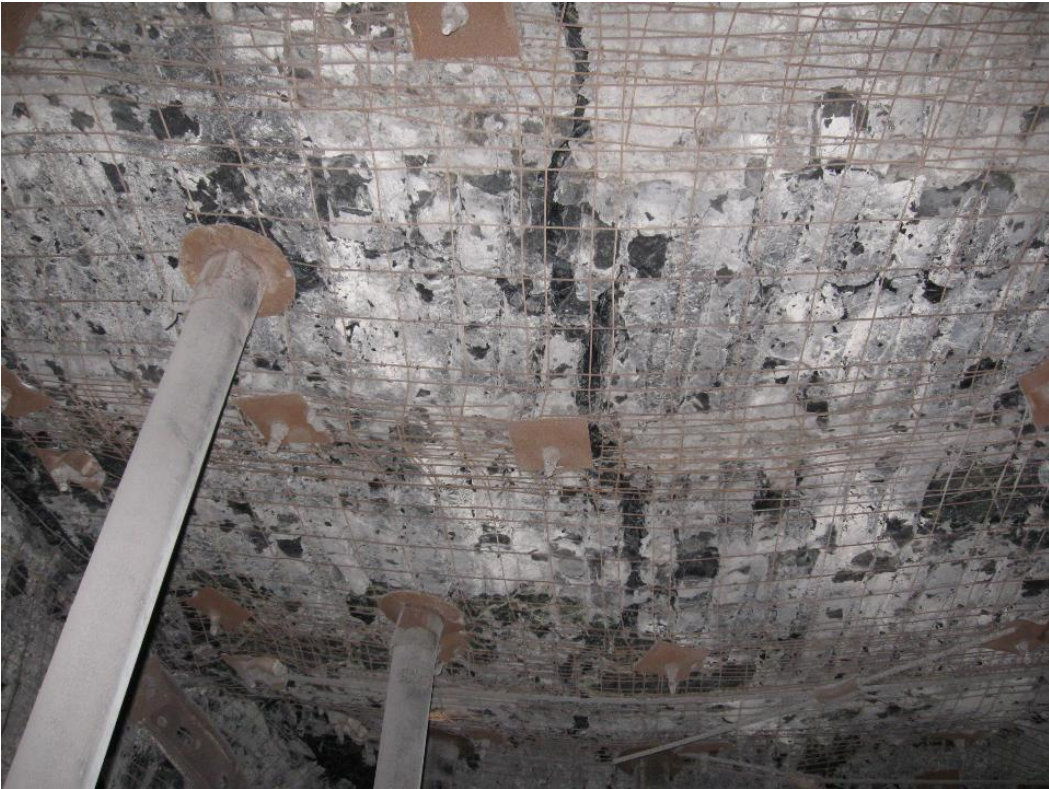
Figure 40: Tension crack in the entry center.

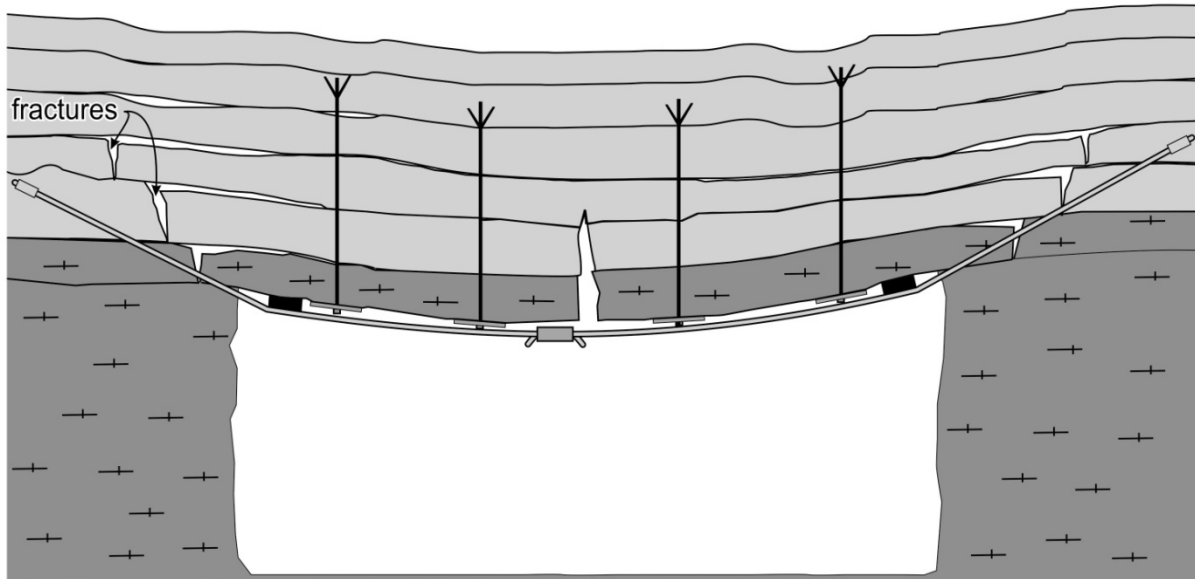
Figure 41: Stairstepping tension fractures begin at the rib abutment and extends over the pillar.

The roof coal has a Unit Rating of 36 and the overlying claystone has a Unit Rating of 32 for an overall ground water-adjusted Coal Mine Roof Rating of 30. The swelling claystone causes significant loading on the roof coal and causes damage to the roof when the roof coal is thinner than 2 ft. A large tension crack, often (3-4 in wide), can open in the entry center as the roof sags (Fig. 40). The roof beam also fails in tension and stair stepping tension fractures occur out and over the rib (Fig. 41). A similar failure was observed at another mine (Fig. 42).

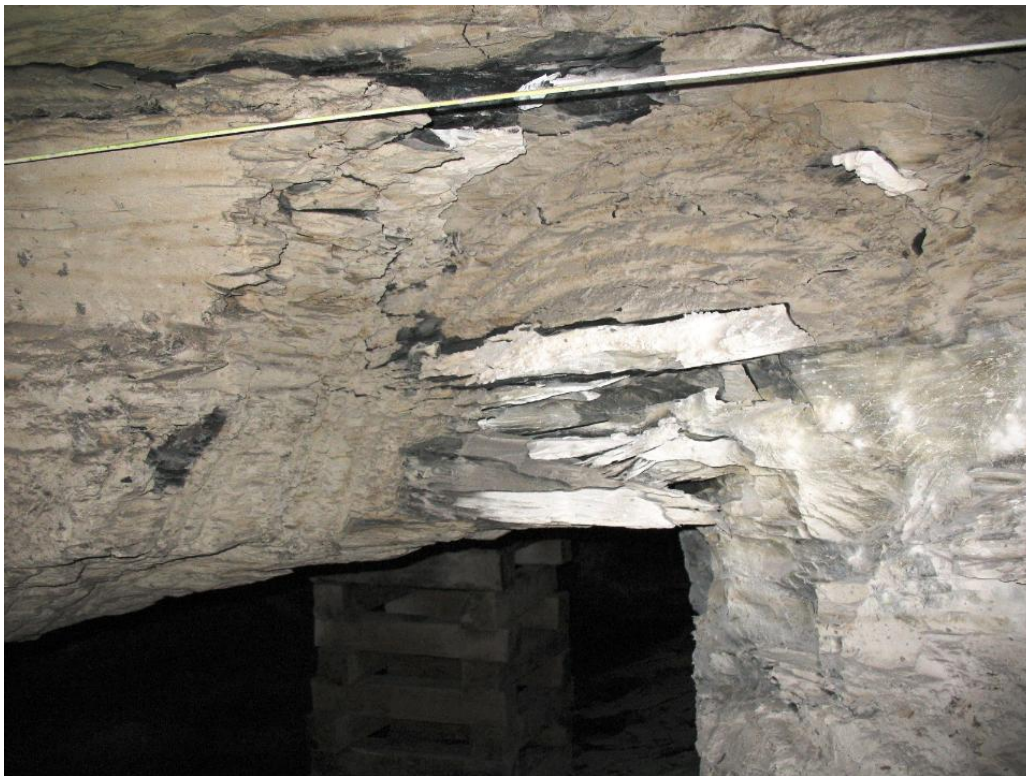
Figure 42: Stairstepping fractures extend over the pillar.
