Determination of volumetric changes at an underground stone mine: a photogrammetry case study

Slaker Brent^{a,*}, Westman Erik^a, Ellenberger John^b, Murphy Michael^b

^b Office of Mine Safety and Health Research, NIOSH, Pittsburgh, PA 15236, USA

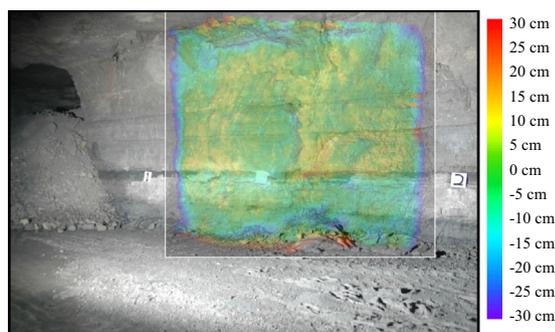
Fig. 2. Change at pillar 1 between Sep. 16th and Sep. 26th.

The change observed at pillar 1, in Fig. 2, is likely to be artifacts of the photogrammetry. The Sep. 16th pictures were both blurry and in very low light, resulting in a questionable point cloud. The presence of localized expansion of the magnitude being shown

should result in visible tension cracks when comparing the photos, but no such cracks exist.

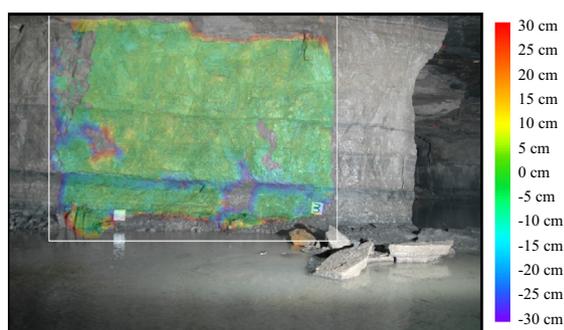
Fig. 3. Change at pillar 2 between Sep. 16th and Sep. 26th.

The change in pillar 2, on the side shown in Fig. 3, is confined to the weak shale band nearest to the base of the pillar. The uniform absence of deformation elsewhere, combined with the spalling of material from this band, follows the behavior suggested by Murphy et al. [7]. The holes in the overlay at the left-center and bottom-center do not indicate that large portions of the rib changed between photographs, but were merely areas that were unable to be reconstructed.

A weak shale band near the base of the pillar showed distinct spalling on one side of pillar 2. Large displacements were confined to this band. The short sides of the pillar did not show the same displacement in this band. No other pillars showed widespread failure of this shale band.

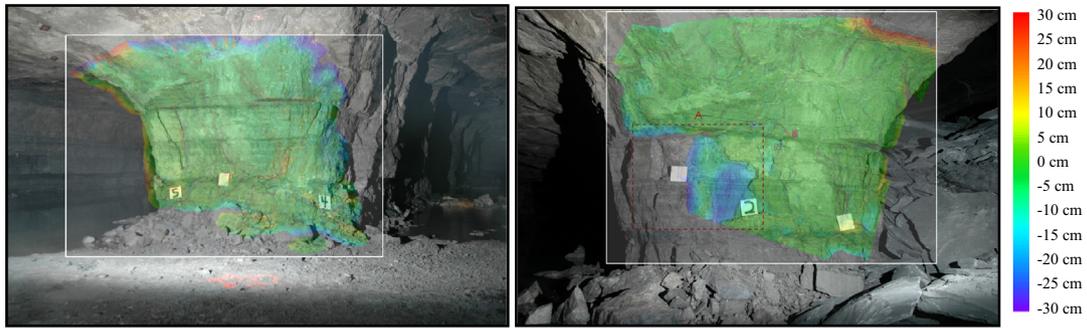
Fig. 4. Change at pillar 2 from Sep. 16th to Sep. 26th (top) and Sep. 26th to Oct. 28th (bottom).

The other visible side of pillar 2, shown in Fig. 4, exhibited little to no deformation between Sep. 16th and Sep. 26th, with the exception of the references placed on the rib, however, a large change in the rib was detected sometime between September 26th and October 28th. The area highlighted in Box A showed 0.36 m³ of change between the time periods. The change was likely larger than this, but the reconstructed area of pillar 2 for the second time period was smaller than the first due to insufficient overlap between pictures.

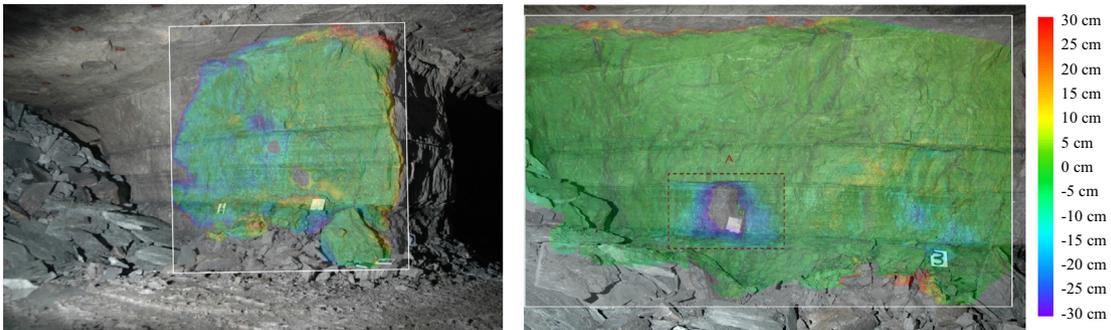
Fig. 5. Change at pillar 3 from Aug. 26th to Sep. 26th (top) and Sep. 26th to Oct. 28th (bottom).

Three sides of pillar 3 were photographed. The first side, Fig. 5, shows widespread removal of material along the left side in the Aug. 26th to Sep. 26th time frame, however, there were only two photographs in the first set (Aug. 26th), and both were blurry. The widespread change cannot be verified in the pictures due to the image quality, with the exception of the dark blue area near the center where a change does appear to have occurred. A clear change is visible in the Sep. 26th to Oct. 28th time frame, with the area enclosed by Box A showing a displacement of 0.52 m³.

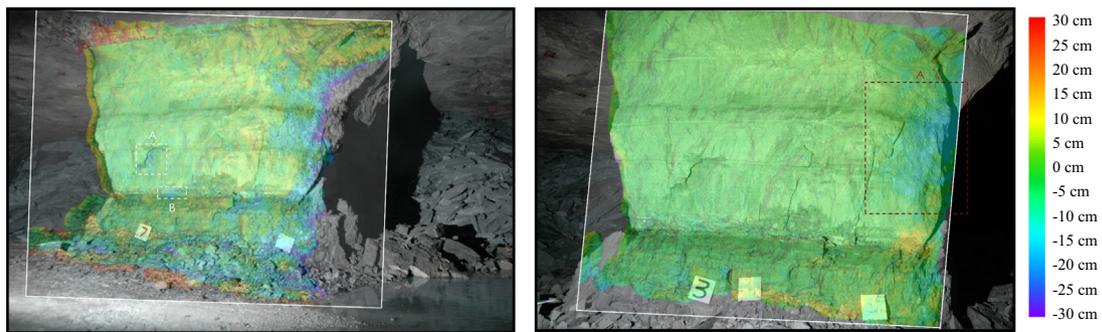
Fig. 6. Change at pillar 3 from Aug. 26th to Sep. 26th (top) and Sep. 26th to Oct. 28th (bottom).

Both time periods at pillar 3 in Fig. 6 shows a small amount of movement on the right side of the pillar, with a crack clearly visible by Sep. 26th, which separates the moving region of the rib from the stationary region. The areas inside Box A and Box B also show rather small, but distinct displacement. The change shown in Box A for the Sep. 26th to Oct. 28th time period shows 0.29 m³ of change, however, this occurs in an area with pronounced shadows which may be affecting the results. The rest of the pillar face is free of shadows and shows no significant change.

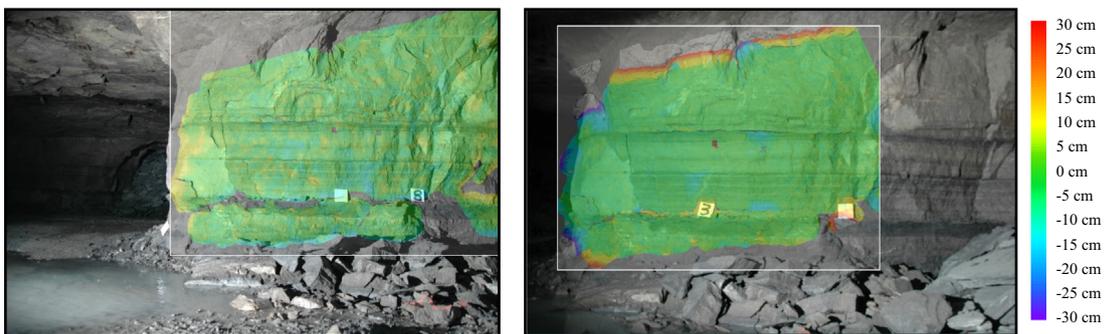
Fig. 7. Change at pillar 3 from Sep. 16th to Sep. 26th (top) and Sep. 26th to Oct. 28th (bottom).

Fig. 7 shows the last side of pillar 3, which includes numerous pockets of change between Sep. 16th and Sep. 26th. This is most likely due to shadows, which were significantly pronounced in one of the two photos from September 16th. The Sep. 26th to Oct. 28th time period does not include the shadowed photographs and shows far fewer, but verifiable, pockets of change, although no large rib movements.

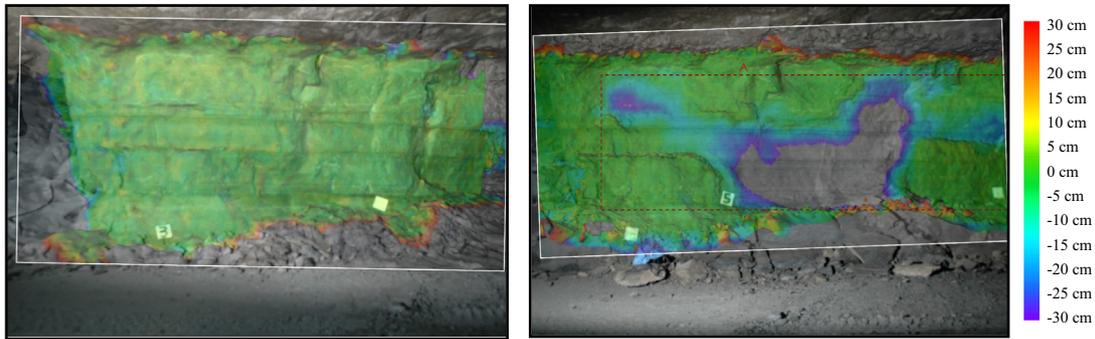
Fig. 8. Change at pillar 5 from Sep. 16th to Sep. 26th (top) and Sep. 26th to Oct. 28th (bottom).

The first time period, from Sep. 16th to Sep. 26th, in Fig. 8, shows no significant movement, with the small color variations likely due to the poor quality of the photographs used. The second time period, from Sep. 26th to Oct. 26th, a large displacement of rib material was detected. In the area enclosed by Box A, 4.03 m³ was displaced. The other sides of this pillar were inaccessible when the next visit occurred on Oct. 28th.

although the 4.03 m³ displaced on pillar 5 was the largest by far. This spalling did not appear preferentially located at certain parts of the rib.

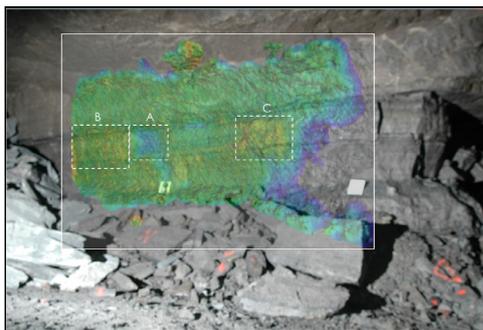
Fig. 9. Change at pillar 6 from Aug. 26th to Sep. 16th.

It is difficult to verify the change present in Fig. 9, due to the blurriness of the photographs. Change does appear to have occurred in the area enclosed by Box A, however Box B and Box C are inconclusive. A photograph of this area was taken on Sept. 26th, and it showed significant damage across the rib face, possibly a result of the movement shown taking place between Aug. 26th and Sep. 16th. In addition to the pillars shown, observations at the remaining photographed pillars are summarized in Table 3.

indicative of a poorly aligned or reconstructed point cloud. Considering the photographic quality at each site, pillar 6 is the only likely candidate for showing actual expansion of the rib. A photograph that was taken on the visit following the observed expansion shows significant damage in one of the expanding areas. That photograph showed no change in the area that had already shed material. With the uncertainty associated with the photographs, this is not conclusive, but is potentially predictive of areas that would experience failure.
