# LINE OF DUTY DEATH REPORT

REPORT F2023-12 • March 2025

## ***Career Firefighter Dies After Falling into a Light/Air Shaft during a Fire in a Four-Story Mixed Occupancy Structure – Illinois***

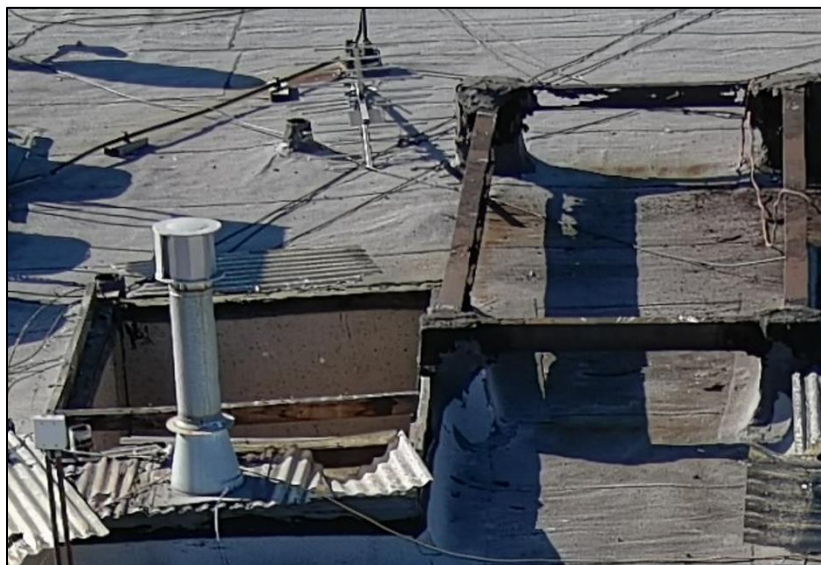
The overall roof structure appeared to be in good stable condition at the time of the incident (**See Photo 3**). There were two square covered sky lights located in the center at the front of the roof. The roof also maintained 12 HVAC systems along with several vent pipes, an assortment of wires, cables, and satellite dishes. Additionally, two five (5') feet by nine and a half feet (9'5") light/air shafts, covered with corrugated plastic panels, were present towards the center area of the roof. The two sky lights were separated by a rectangular shaped steel I beam in a framing configuration.

**Photo 3. Surface view of the South light/air shaft in which T44-3 firefighter fell**  
*(Photo courtesy of Fire Marshal's Office)*

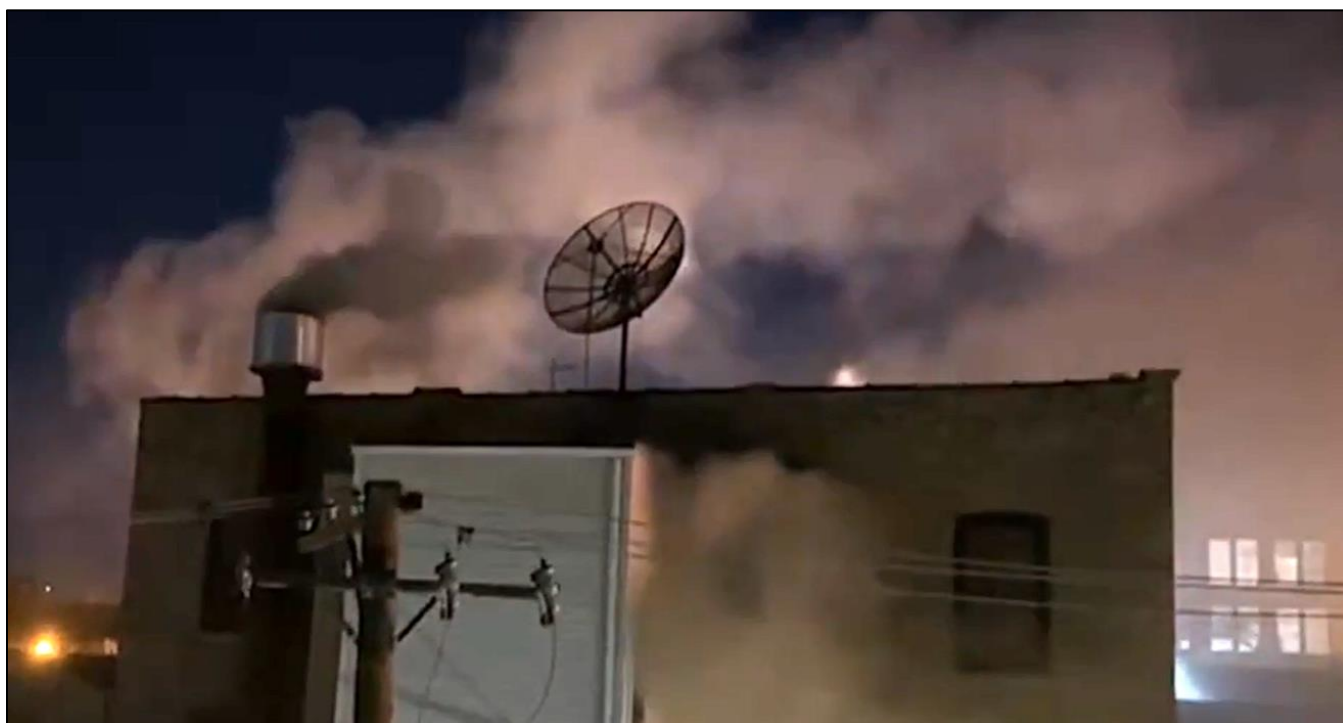
At 05:36 hours, multiple units were given assignments while en route to the scene. These units began to arrive on-scene between 05:38 and 05:51 hours. The second team from T44 ascended the aerial ladder and accessed the front of the roof. BC12 reported to dispatch that hose was stretched and a ladder was to the roof at 05:40:15 hours. As the T44 crew climbed onto the roof, smoke emanated from all vertical openings and smoke conditions increased as the T44 team started roof operations. As the smoke accumulated, it drifted and hovered over the roof, causing visibility to decrease. The smoke was failing to rise and dissipate, which was likely caused by temperature inversion (**see Photo 6**). The smoke conditions and darkness presented the T44 team with increased difficulty in identifying trip hazards and openings located on the roof.

**Photo 6. View of smoke over roof.**  
*(Photo courtesy of citizen app)*

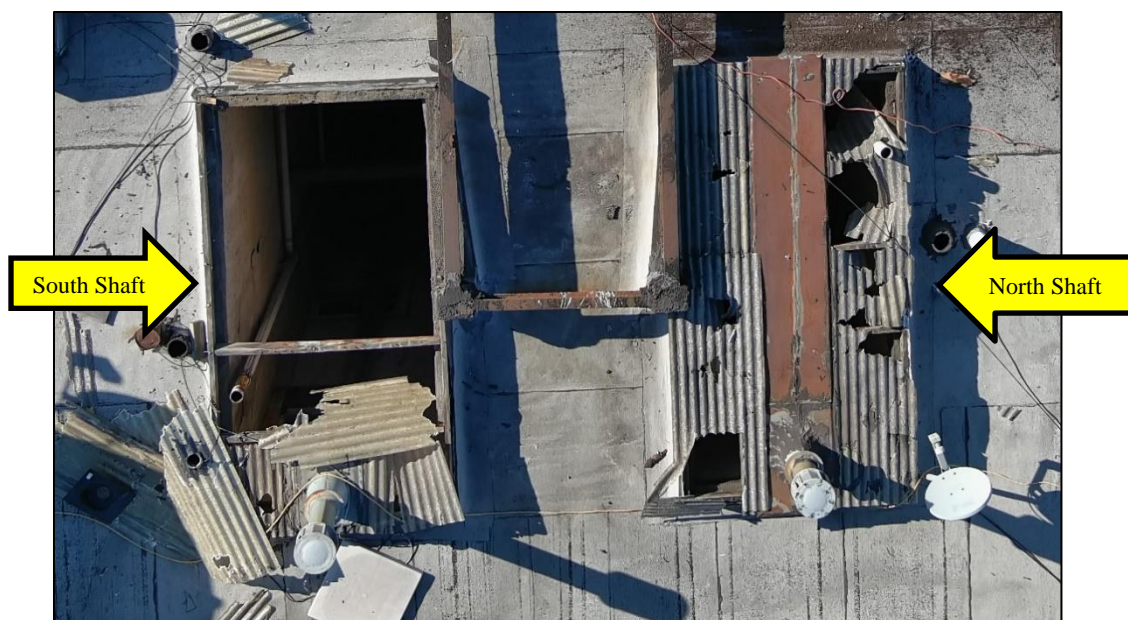
They observed two large light/air shafts covered with translucent corrugated panels (see **Photo 7**). They called out the hazard and proceeded with making several ventilation holes in the north light/air shaft covering.

**Photo 7. View of the two light/air shafts with removal of panel (south shaft) and ventilation holes (north shaft).**

***Recommendation #2: Ensure firefighters immediately notify the IC and all units operating on the fireground when the roof is ventilated and/or translucent corrugated roof panels are identified.***

Translucent corrugated roof panels can be difficult to identify and seldom have frames or other features that identify their location. Fire departments can identify structures within their jurisdiction that have translucent corrugated roof panels and include this information in pre-incident plans. ICs can consider conducting a risk benefit analysis of permitting rooftop operations on identified buildings as firefighters may not be aware of and may not fully appreciate the hazards and risks associated with these panels. It is the responsibility of firefighters to inform the IC and other firefighters when translucent corrugated roof panels are identified and not to walk or stand on them. Firefighters should constantly sound the roof to gauge structural integrity and changes in roof construction. Relevant information should be shared with mutual aid departments and added into the caution notes of Computer-Aided Dispatch systems where possible.

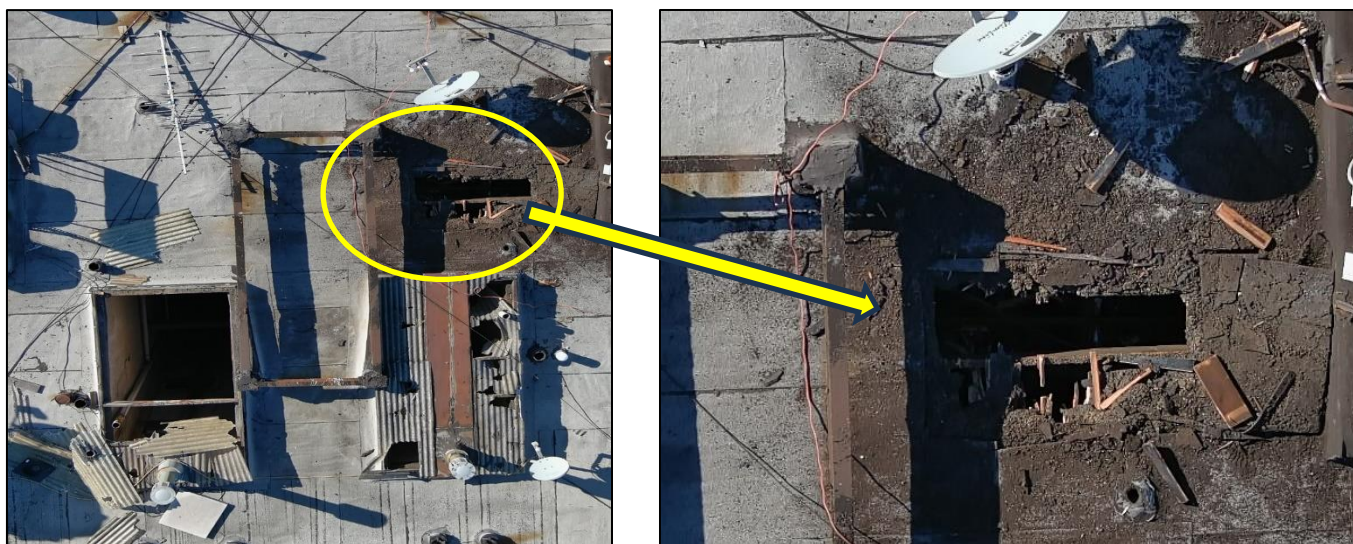
Two members of SQ1 proceeded to the roof to support T44. They began to assist in ventilating the vertical openings, removing the translucent corrugated panels from the South light/air shaft (see **Photo 8**). One of the members announced they were ventilating the shaft. SQ1-1 left his helmet near the shaft in an attempt to warn of the large opening hazard. At this time, T44-2 decided to return to the apparatus and retrieve a tool to probe the hole. T44-3 took a break from cutting the ventilation hole in the roof and put the saw down. A firefighter from SQ1 discussed a plan to widen the hole (see **Photo 9**). They then picked up the saw to expand the ventilation hole. During this time, T44-3 was observed on his knees, positioned west of the ventilation hole, adjusting his SCBA facepiece.

**Photo 8 and Photo 9. View of ventilation hole**  
*(Photo courtesy of Fire Marshal's Office)*

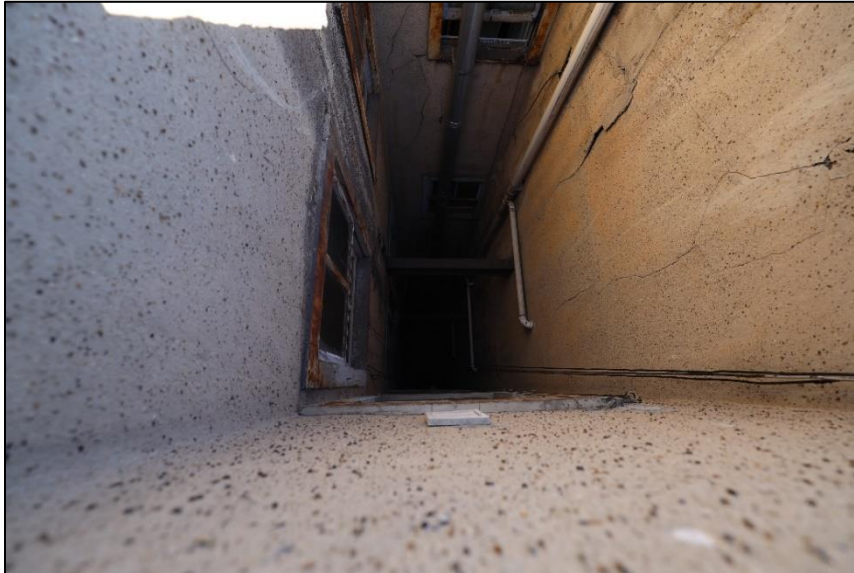
They then heard a PASS alarm sounding from the south light/air shaft (see **Photo 10 and Photo 11**). It was determined the alarm was from T44-3 and a Mayday was immediately issued at 05:53:51 hours. They were unable to get a visual on T44-3 due to the depth of the shaft as well as the lack of light. At 05:54:07 hours, "Still and Box" and EMS Plan 1 were dispatched.

**Photo 10. Roof view inside the light/air shaft.**  
*(Photo courtesy of Fire Marshal's Office)*

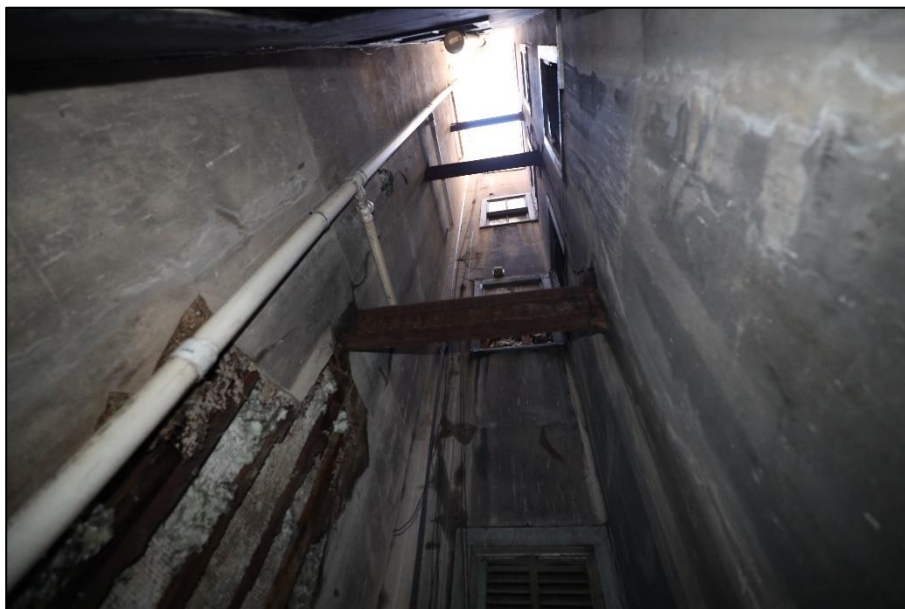
**Photo 11. Bottom view inside the light/air shaft.**  
*(Photo courtesy of Fire Marshal's Office)*

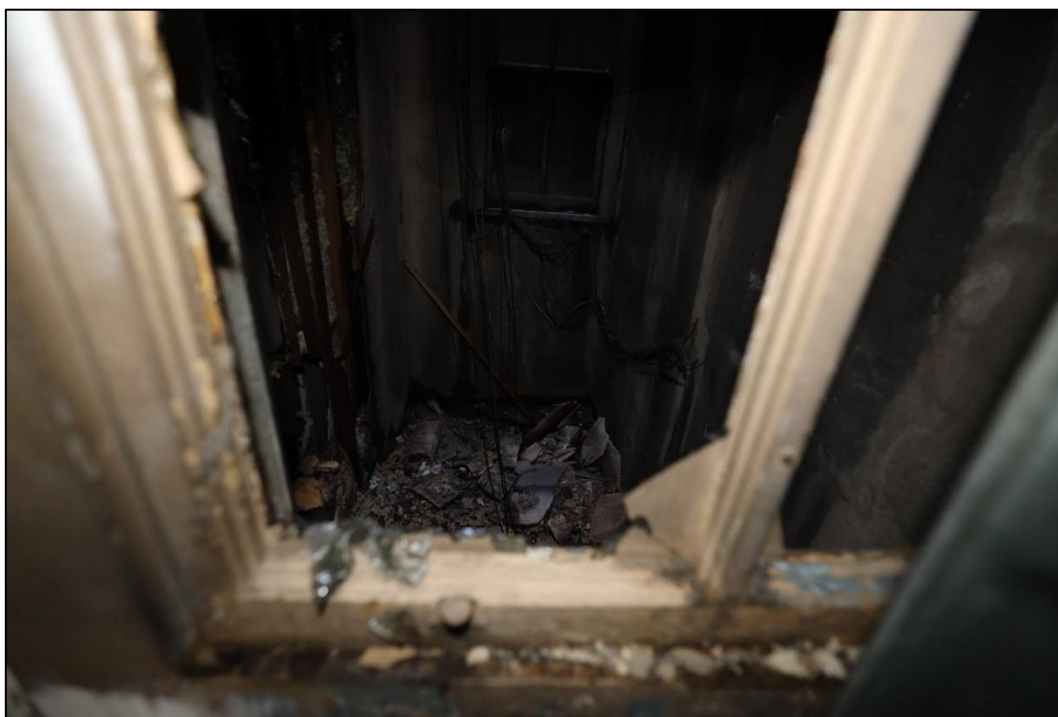
Once it was relayed that T44-3 fell down the shaft, rescue operations immediately commenced with units rapidly searching for access to the shaft at 06:11:04 hours. The officer of SQ1 directed personnel to gather equipment and proceed to the roof to assemble an artificial highpoint to lower personnel down the shaft. The plan was to make contact with T44-3 and to use a retrieval system if an access point was unavailable. As the rescue operation on the roof continued, other units searched for alternative access to the shaft. The RIT was operating on the 2<sup>nd</sup> floor and gained access through a window that was closed off and secured with a plywood and drywall covering (see **Photo 12**).

**Photo 12. View from window along wall of light/air shaft.**  
*(Photo courtesy of Fire Marshal's Office)*

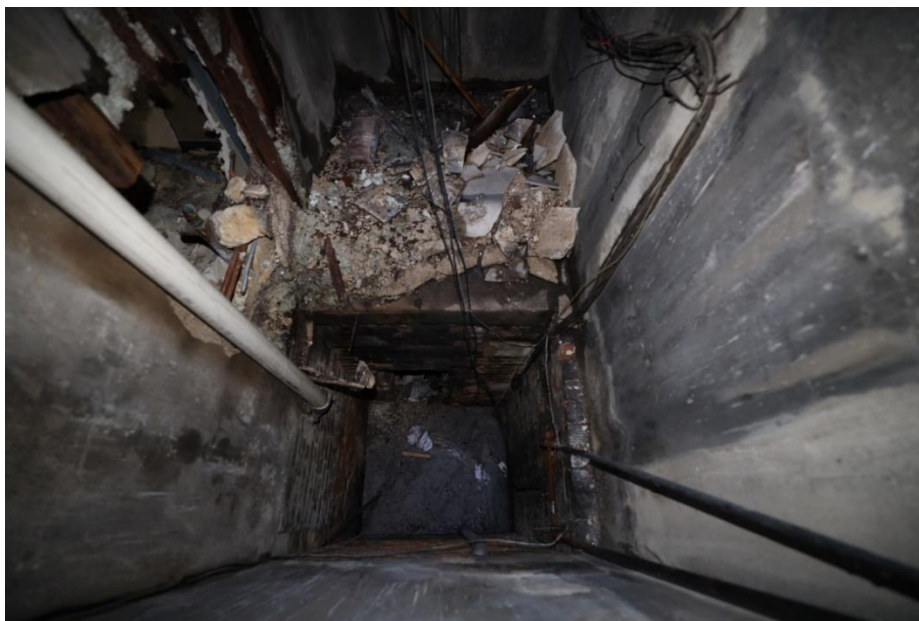
T44-3 was conscious, severely injured, and unable to feel his legs. He was lying in a fetal position covered with debris, with his SCBA facepiece off. At 06:23:06 hours, the SQ1 firefighter removed T44-3's SCBA to prepare him for extrication. A hasty harness was secured to him for extrication out of the shaft. Both firefighters were in a space with limited mobility which complicated extrication efforts (see **Photo 13**).

**Photo 13. View of area light/air shaft where T44-3 was trapped**  
*(Photo courtesy of Fire Marshal's Office)*

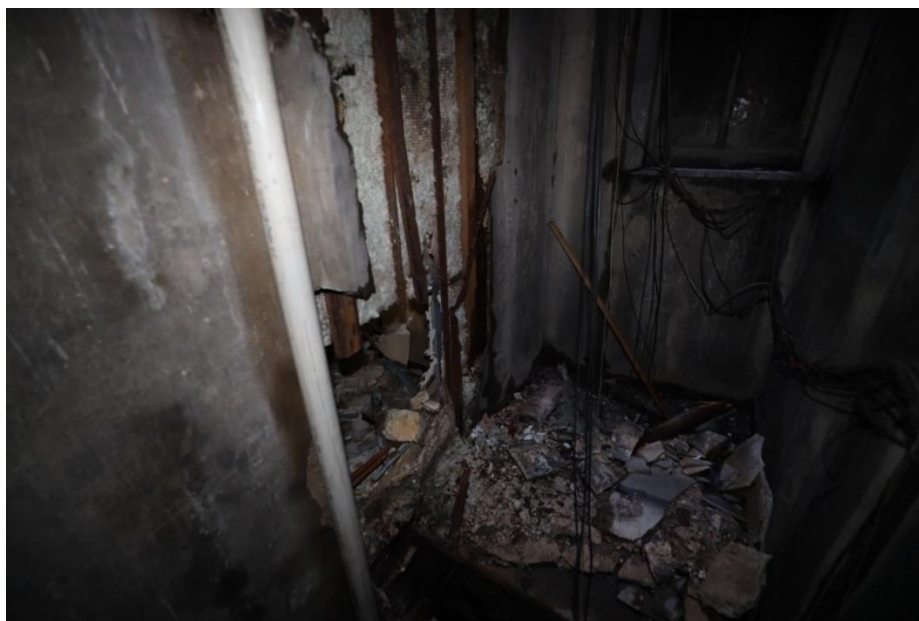
**Photo 14. View of extrication area.**  
*(Photo courtesy of Fire Marshal's Office)*

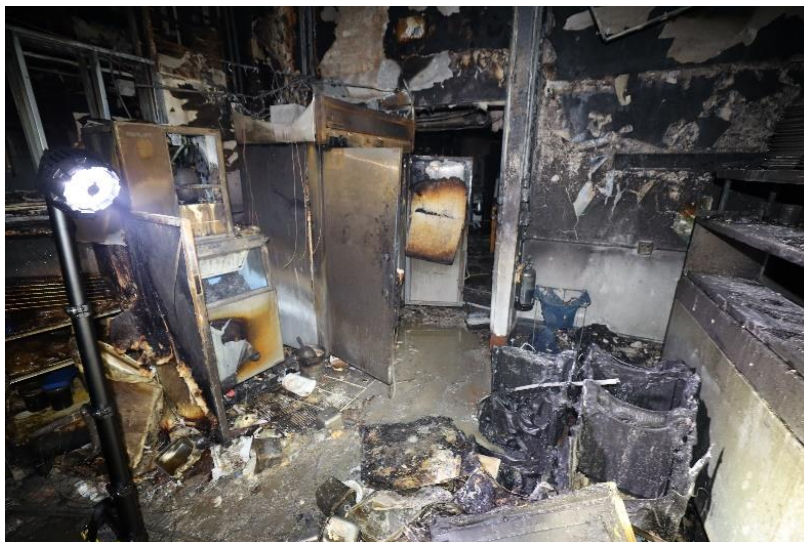
The fire was investigated by the fire department's Office of Fire Investigation, ATF, Office of the Fire Marshal, and the Local Police Arson Unit. The fire originated in the kitchen area of the first-floor restaurant (see **Photo 15**). There was a slight vertical extension of fire that traveled above the kitchen into a second-floor apartment. All logical ignition sources were investigated, and it was determined that the cause of the fire was accidental. The investigation was conducted using the principles of NFPA 921 *Guide for Fire and Explosion Investigations* (NFPA 921, 2024).

**Photo 15. Area of origin.**  
(Photo courtesy of Fire Marshal's Office)

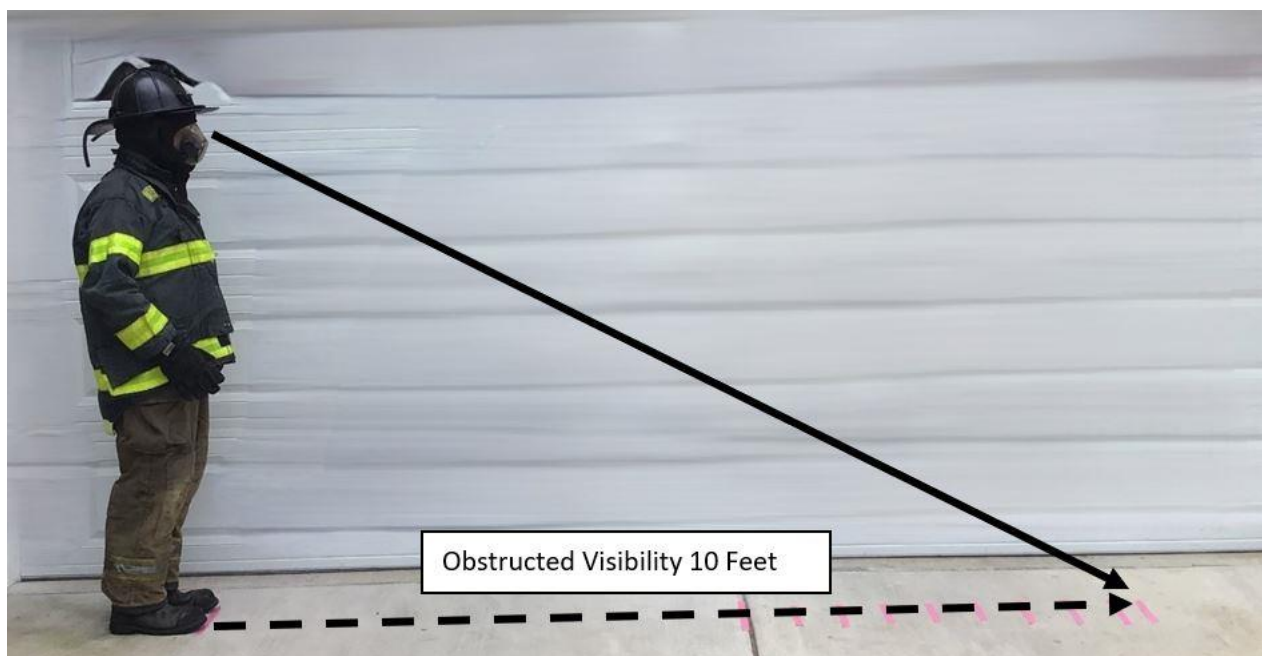
**Photo 16. Obstructed view of firefighter standing.**  
(Photo courtesy of NIOSH)

Generally, fire department training is already focused on the challenges firefighters face when confronted with poor visibility and disorientation. A firefighter's senses, such as hearing and sight, can help comprehend what is going on around them. However, PPE, including SCBAs, can decrease or obstruct hearing and visibility (**see Photo 16**). Further, while walking allows for rapid movement, walking erect can also cause firefighters in PPE to lose the visibility immediately in front of them when conditions are poor. This increases the risk of tripping and/or falling. One mitigation method is to train firefighters to crawl and walk while probing their immediate area with a tool to alert them of any hazards (**see Photo 17**). Additionally, when working in any high-risk area, operating at a reduced tempo can improve awareness.

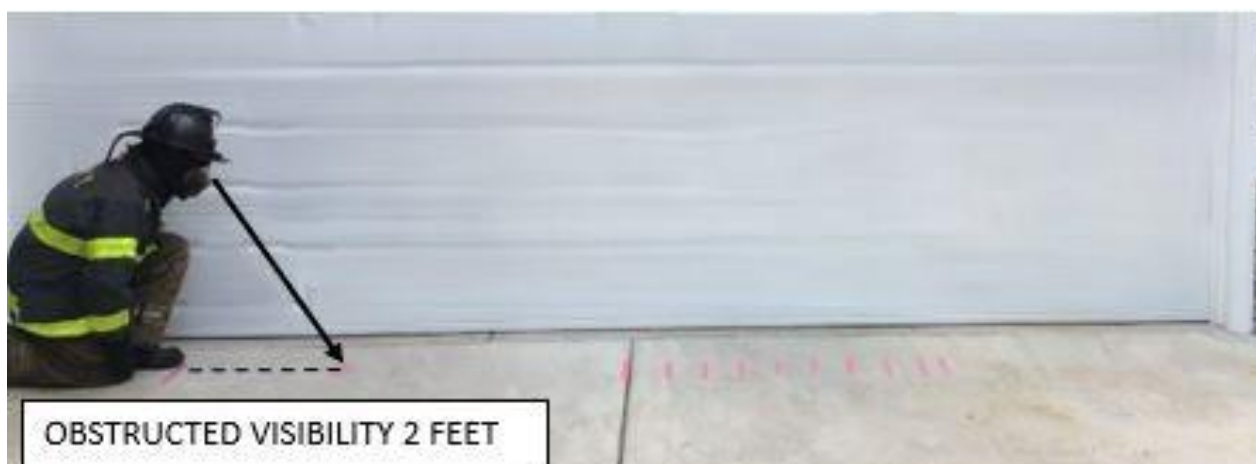
**Photo 17. Obstructed view of firefighter kneeling.**  
*(Photo courtesy of NIOSH)*

These conditions can also delay rescue efforts of firefighters and delay survival. If a life-threatening hazard present and there is no avenue to reduce or eliminate the hazard, the firefighter may opt to remove themselves from the area until the conditions improve, or the hazard is eliminated.
