**LINE OF DUTY
DEATH REPORT
REPORT SLIDES**

F2023-12

Career Firefighter Dies After Falling
into a Light/Air Shaft during a Fire in a
Four-Story Mixed Occupancy
Structure – Illinois

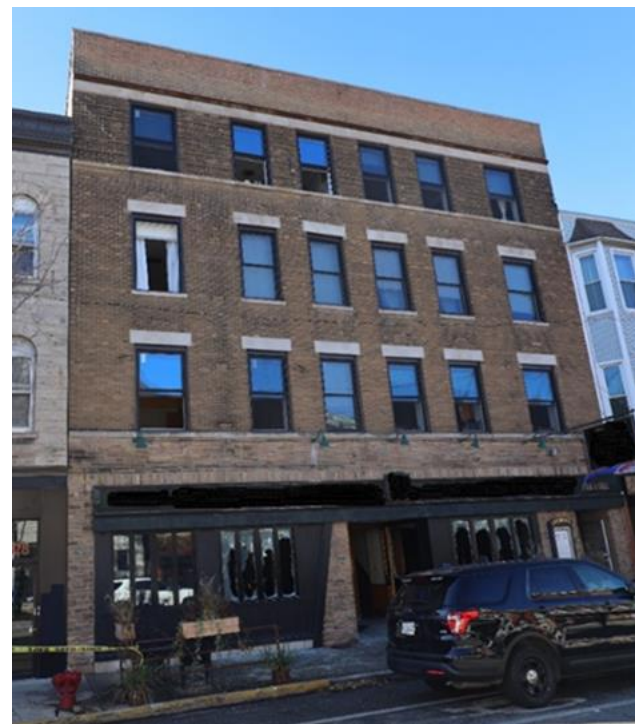
- On November 13, 2023, a 39-year-old career firefighter died after falling down a light/air shaft while performing roof operations.
- The Type III constructed building was a four-story mixed occupancy built in 1894.
- The first floor was occupied by a full-service restaurant.
- Floors two through four contained 12 occupied apartments.
- The roof contained a mixture of exhaust vents, several large natural openings, two sky lights, and two light/air shafts measuring 9 ½ feet by 5 feet.

A view of the structure from side Alpha. (Photo courtesy of the Fire Marshal's Office)

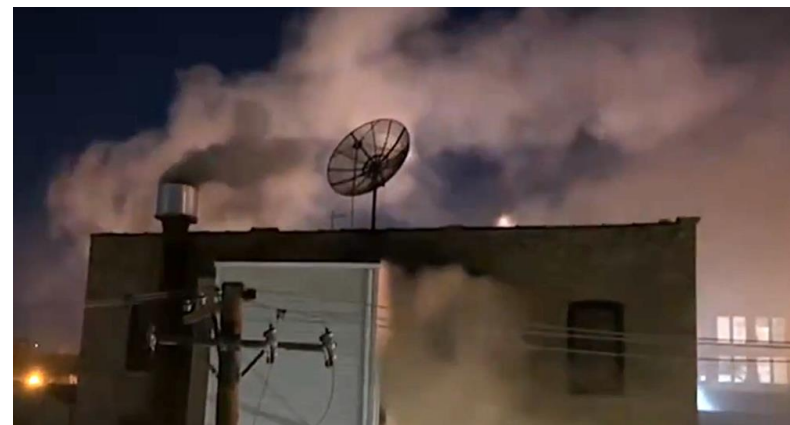
- Between 05:38 and 05:51 hours, the working fire units arrived.
- Squad 1 (SQ1) sent two personnel to the roof to assist with ventilation operations.
- They accessed the roof from T44's aerial ladder.
- Once on the roof, they assisted the two members from T44 with ventilating the vertical openings on the roof which were emanating smoke.
- They removed the translucent corrugated panels from the south light/air shaft.

View of smoke over roof. (Photo courtesy of citizen app)

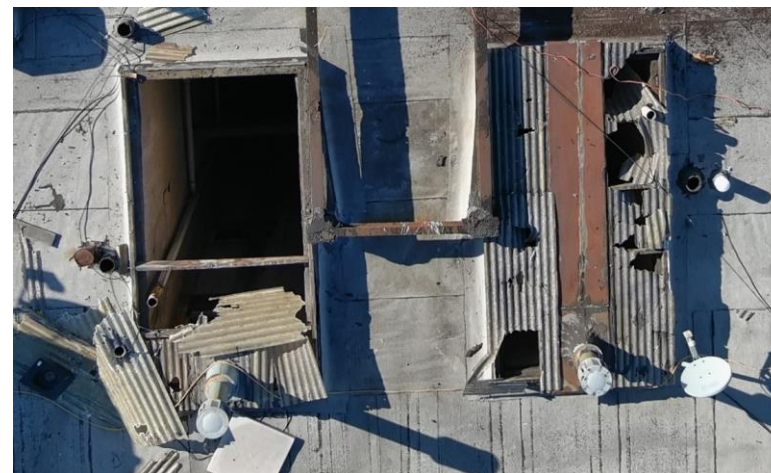
- The north side light/air shaft was ventilated by puncturing several holes in the translucent corrugated panels.
- There was a concern about the large open south light/airshaft so a firefighter from SQ1 (SQ1-1) removed his helmet and directed the helmet light on the shaft to alert firefighters operating nearby.
- Around this time, T44-2 left the roof to retrieve equipment to probe the roof openings.

View of the two light/air shafts with removal of panel (south shaft) and ventilation holes (north shaft). (Photo courtesy of Fire Marshal's Office)

- Ensure incident command implements the NIMS, including establishing functional and geographical assignments at the beginning and maintaining them throughout operations.
- Ensure firefighters immediately notify the IC and all units operating on the fireground when the roof is ventilated and/or translucent corrugated roof panels are identified.
- Ensure personnel maintain crew integrity at all times throughout an incident.

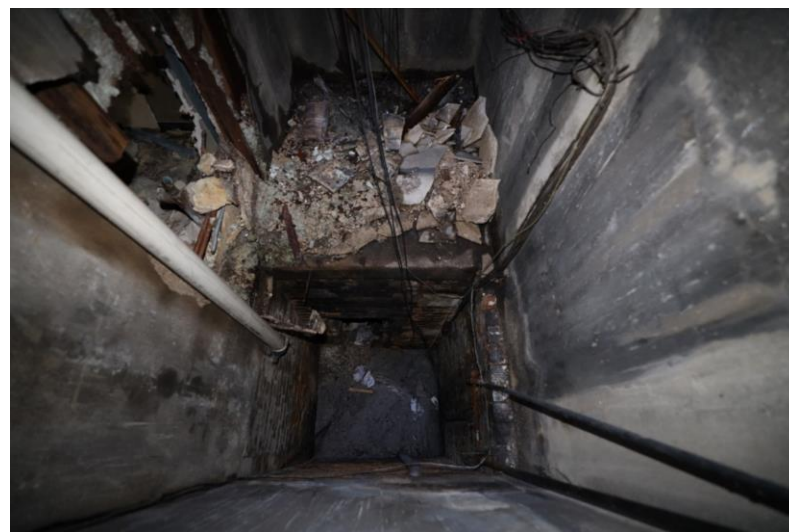
- It was determined that T44-3 fell 54 feet down the South open light/air shaft and was laying critically injured in a dry well below a platform adjacent to the first floor of the building.
- At 06:11:04 hours, rescue personnel begin extrication efforts.
- The officer of SQ1 directed his personnel to assemble equipment to execute a vertical rescue operation into the shaft from the roof.
- As the equipment was being retrieved, additional units were searching for other areas to quickly access T44-3.

View of area light/air shaft where T44-3 was trapped
(Photo courtesy of Fire Marshal's Office)
