**LINE OF DUTY  
DEATH REPORT  
REPORT SLIDES**

**F2021-20**

Career Candidate Firefighter  
Found Unresponsive at a  
Residential Structure Fire and  
Dies 5 Days Later–Illinois

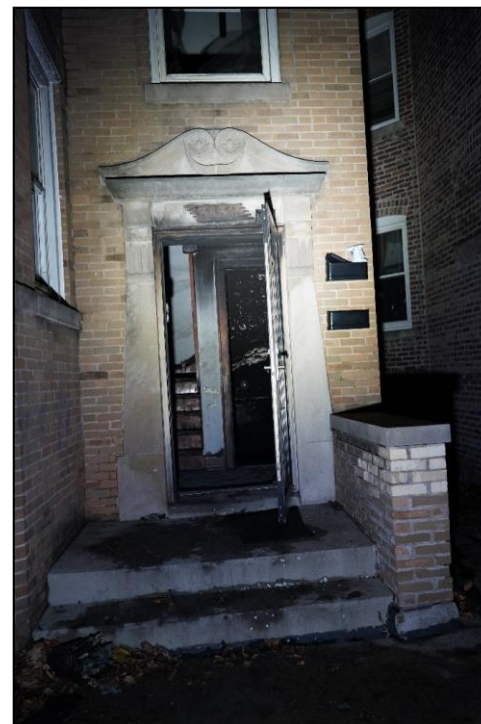
The front entrance to the apartment building. The basement entrance is to the right and the entrance to the 1<sup>st</sup> floor apartment is the set of stairs to the left.  
(Photograph courtesy of the fire department)

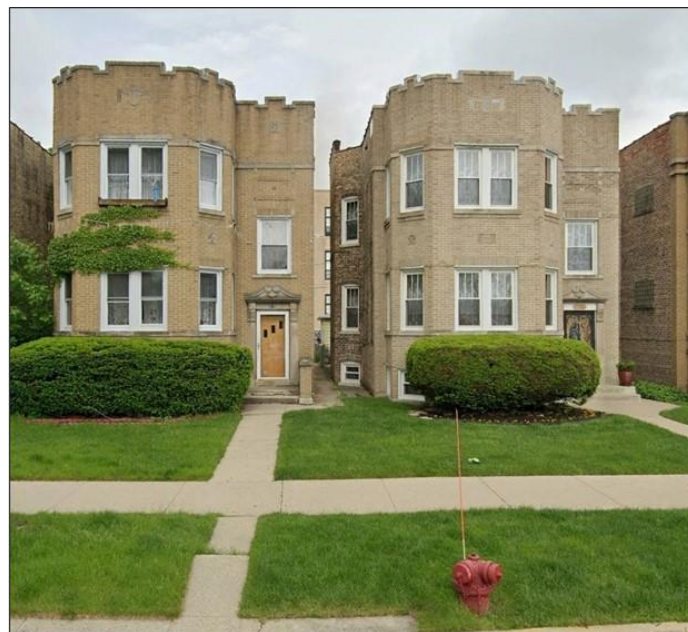
“Brick-2-Flat” apartment building. The front entrance is at the Side Alpha/Side Delta corner. The small casement windows near the ground indicate a basement.  
(Photograph courtesy of the fire department)

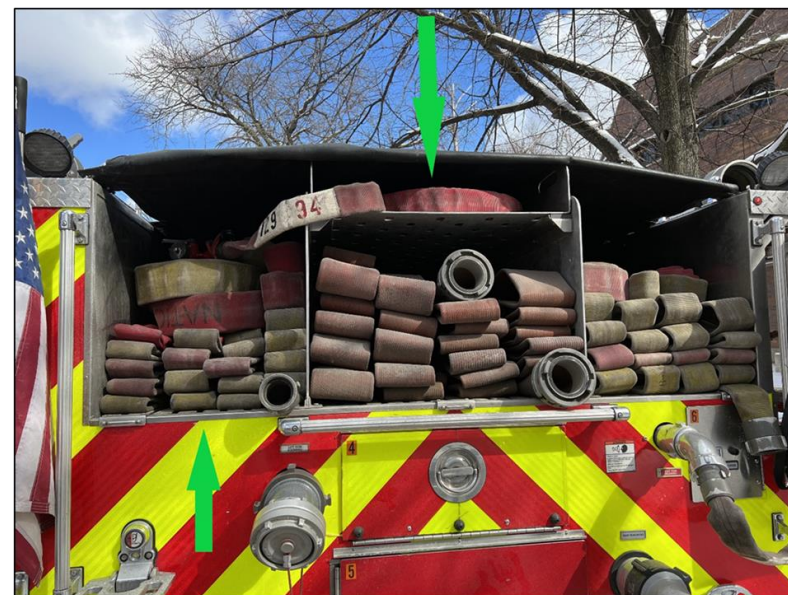
- He ordered the Engine 94 Nozzle and the Engine 94 Backup to stretch an attack line from the engineer's side and lead out.
- Engine 94 Nozzle pulled one horseshoe load of 2½-inch to 1¾-inch hose towards Side Alpha and the front door.

Hose bed on Engine 94. The horseshoe hose load that Engine 94 Nozzle pulled from the engineer's side of Engine 94. The green arrows indicate the hoselines that were pulled. (NIOSH Photograph)

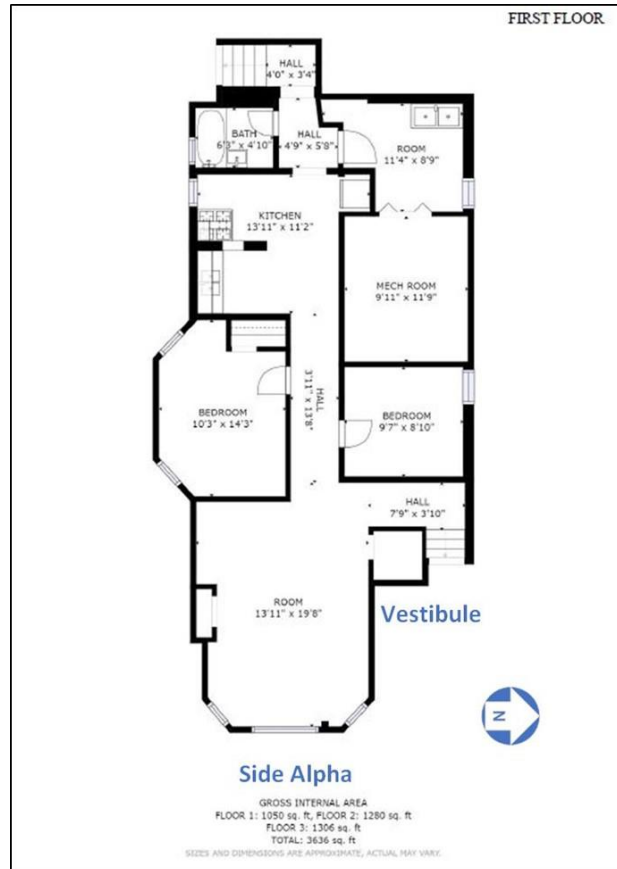
- The Lieutenant went into the basement to wait for Engine 94 Nozzle.
- Both Engine 94 Nozzle and Engine 94 Backup had gone on air at this time.
- Engine 94 Backup left the building to straighten out the hose with the engineer from Engine 94.
- While the Lieutenant of Engine 94 was in the basement, Truck 58 opened the Side Bravo near the corner of Side Charlie door and then forced open the basement apartment door.
- This created a flow path due to the opening of the door on Side Bravo and the open door on Side Alpha.

The floor plan of the basement apartment identified as Floor 1. The rear door entrance is on Side Bravo near the Side Bravo/Side Charlie corner and accesses the basement by the steps in the hallway.  
(Diagram courtesy of *Rayburn Fire Scene Investigations, Inc.*)

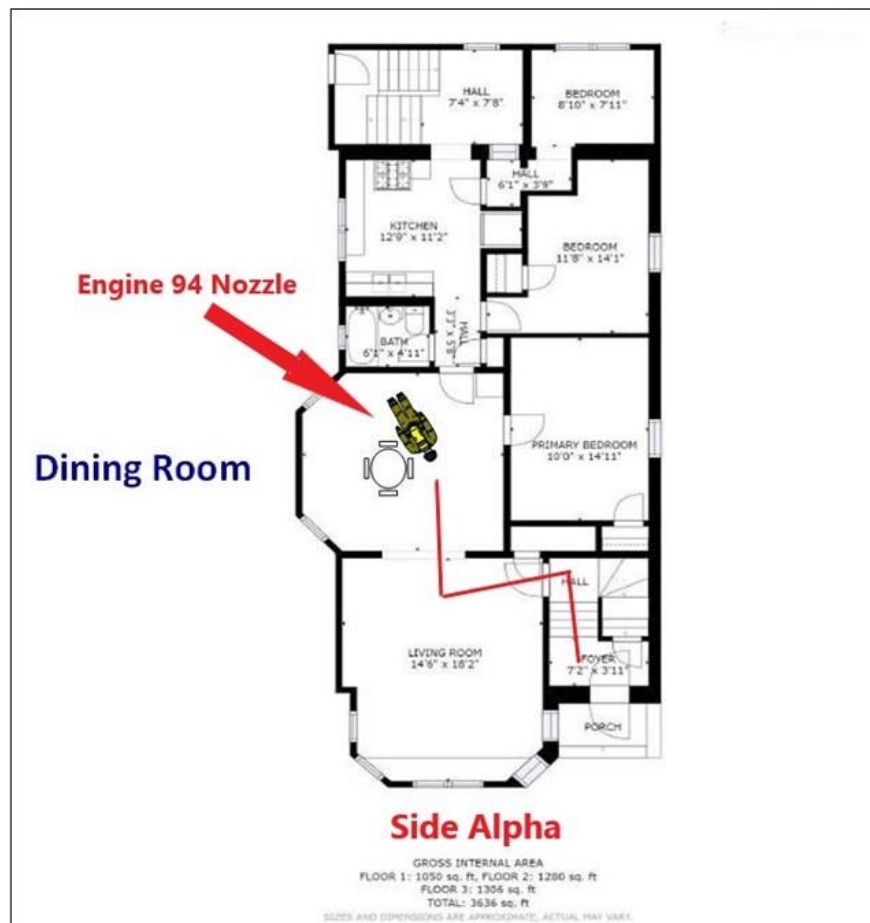
- Additionally, 3 civilians were located in the basement and removed by various companies at 02:15 hours, 02:21 hours, and 02:25 hours respectively.
- One of the civilians died and 2 were severely injured.
- Command initiated a RIT response.
- Command sent Truck 53 to the 1<sup>st</sup> floor apartment and Truck 57 and Battalion 7 into the basement apartment to search for Engine 94 Nozzle.
- The captain and a firefighter from Truck 53 entered the building through the front door and went up to the 1<sup>st</sup> floor apartment.
- While searching the 1<sup>st</sup> floor, they heard a PASS alarm sounding.
- They found Engine 94 Nozzle in a prone position in the dining room near the dining room table of the 1<sup>st</sup> floor apartment.

The location of Engine 94 Nozzle in the 1<sup>st</sup> floor apartment dining room when he was located by the captain of Truck 53 at approximately 02:25 hours. The red line indicates his path of travel from the vestibule to the dining room in the 1<sup>st</sup> floor apartment.

- His facepiece was on but was ajar on his face and the Mask-Mounted Regulator (MMR) was attached to the facepiece.
- There was no air flowing from the facepiece and he was unresponsive.
- The officer and firefighter from Truck 53 with the Lieutenant and a firefighter from Truck 57 removed Engine 94 Nozzle from the structure at 02:27 hours.
- Once outside, cardiopulmonary resuscitation (CPR) was started on Engine 94 Nozzle, and he was transported to a local hospital.
- While in the emergency room of the hospital, he regained a pulse and was eventually moved to a trauma center in the city.
- Engine 94 Nozzle was pronounced deceased five days later on December 21, 2021.
