# LINE OF DUTY DEATH REPORT

REPORT F2024-02 • March 2025

## ***Career Engine Company Officer Dies in Abandoned, Single-Family Structure Fire – North Carolina***

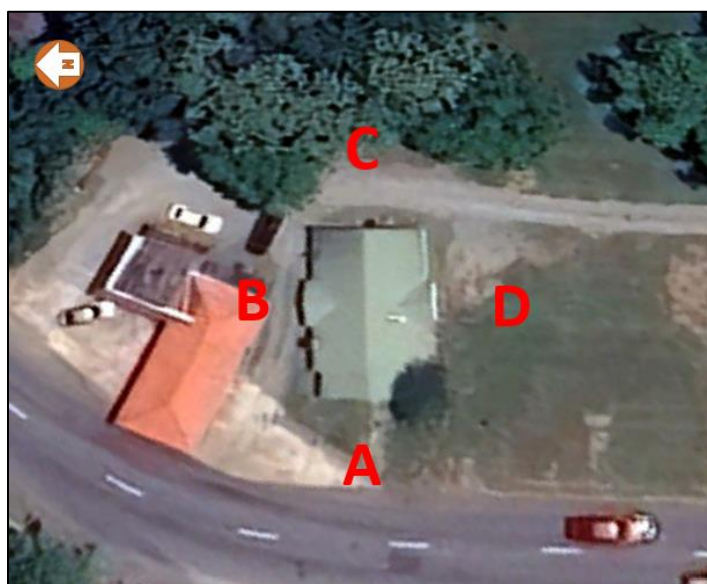
**Photo: 1 Aerial view of structure with sides of the structure labeled A (Alpha), B (Bravo), C (Charlie), and D (Delta)**  
*(Courtesy of Google Earth)*

This structure had four-bedrooms and two-bathrooms. It was built in 1930 and was wood frame construction with a vinyl siding exterior. It contained 2x4 interior stud walls that were covered with both common drywall as well as lath and plaster interior finishings. The sloping roof structure was constructed of wood roof rafters covered in a metal roof exterior finishing. For this report, side Bravo is orientated to the north followed by side Charlie to the east, side Delta to the south, and side Alpha to the west (see **Photo 1**). NIOSH investigators were able to gain access to the structure to take photographs and measurements.

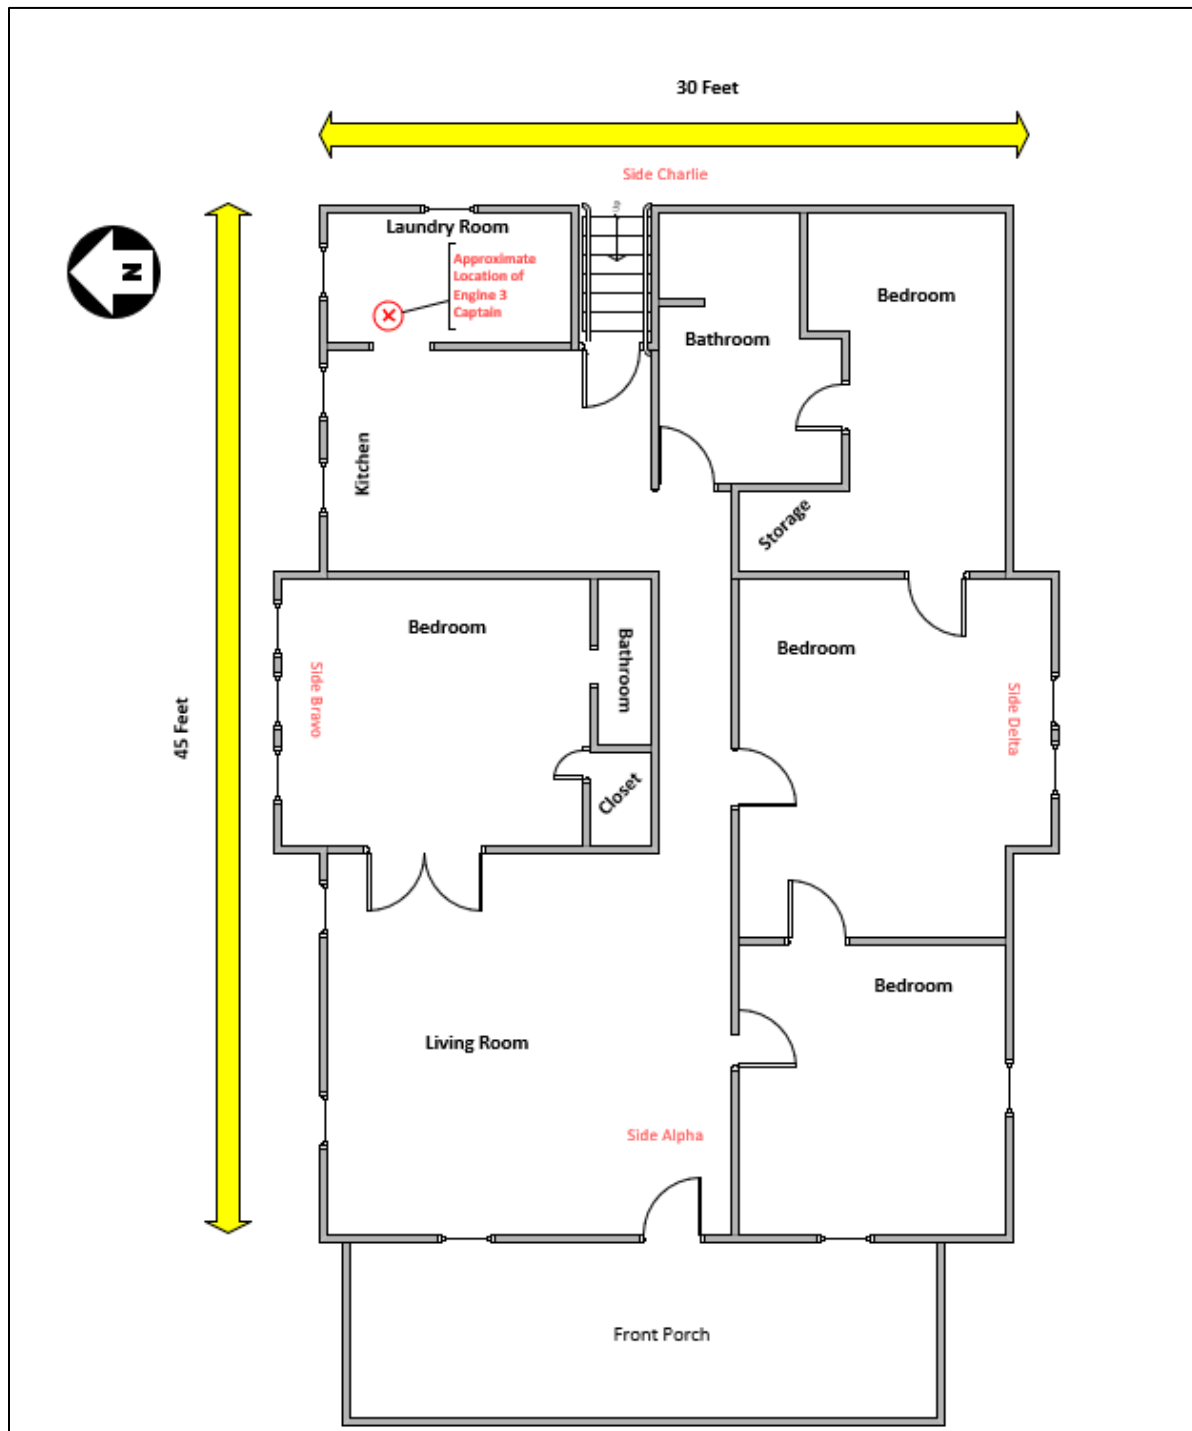
**Diagram 2: First floor diagram and approximate location E3 captain was found.**

after a Mayday had been declared by L1 on behalf of E3 captain. It is unknown what actions E3 captain performed to self-rescue. However, two smaller windows were present in the laundry room where he was found by RIC. It can be concluded from interviews and photographs that E3 captain assumed a prone position on the floor and experienced most of the thermal assault to his left side.

***Recommendation #7: Develop training initiatives that focus on the knowledge, skill, and ability of firefighter safety/survival self-rescue training to include emergency egress and low-profile clearance.***

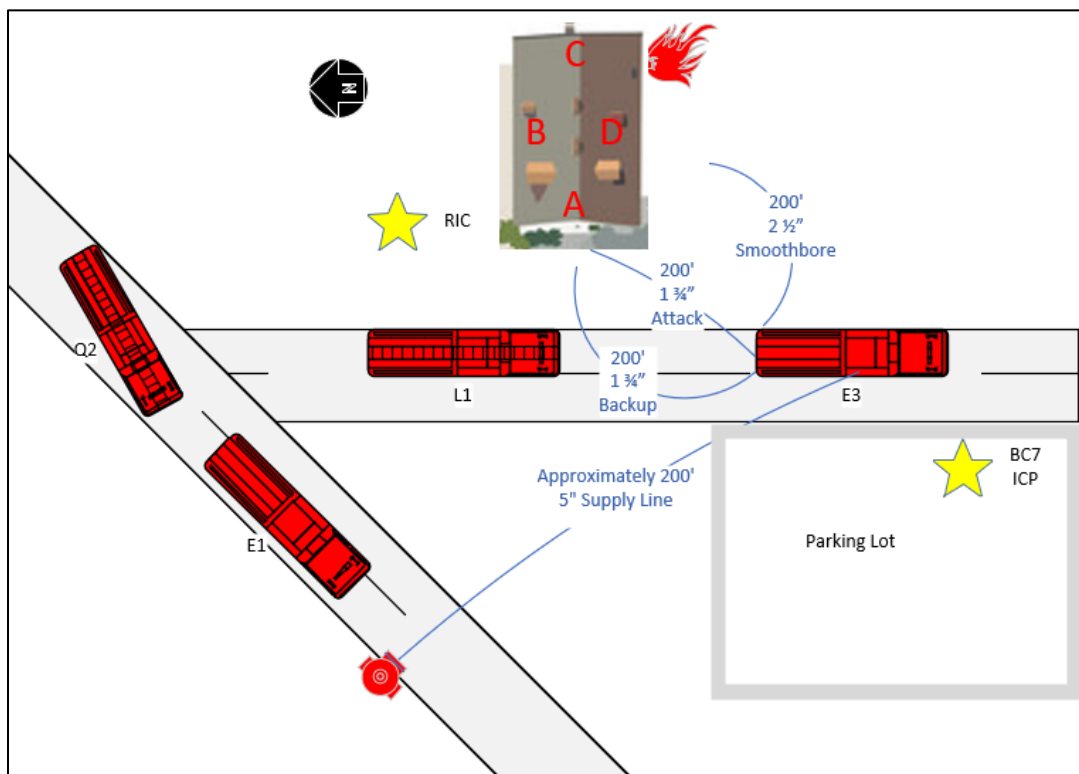
**Diagram 3: Apparatus, attack, supply line placement.**

The E3 crew (company officer and firefighter) and L1 crew (company officer and firefighter) made entry into the structure from side Alpha at approximately 0009 hours and observed brown smoke with limited visibility throughout the structure. No visible fire was observed upon entry as L1 proceeded to conduct a left-hand search while E3 pushed forward into the structure. E1 advised the IC that a backup 1 ¾ -inch attack line had been stretched and charged to side Alpha. L1 exterior crew advised IC that live wires were down at the service drop to the structure at the side Bravo/Charlie corner. IC acknowledged this message and requested utility services to the scene.

At 0012 hours, the company officer from E1 advised IC that heavy fire was venting out the side Alpha door. IC acknowledged the message and observed a middle room in the structure on side Delta flashover through the windows. The IC announced a change in strategy on the radio to a defensive operation. This message was acknowledged by the apparatus operator of E3 who began to sound the airhorns to indicate to interior crews that they needed to withdraw from the structure. A 200' 2 ½"-inch smoothbore attack line was then stretched to side Delta. At 0013:01, IC inquired if all companies had exited the structure when he was informed that L1 and E3 interior crews were still inside the structure. IC called both L1 and E3 captains on the radio and instructed them to evacuate the house. However, this message was never acknowledged by E3 captain. As noted in interviews conducted by NIOSH, the fire conditions at this point began to rapidly deteriorate both on the interior and exterior.
