**LINE OF DUTY
DEATH REPORT
REPORT SLIDES**

F2024-02

Career Engine Company Officer
Dies in Abandoned, Single-
Family Structure Fire – North
Carolina

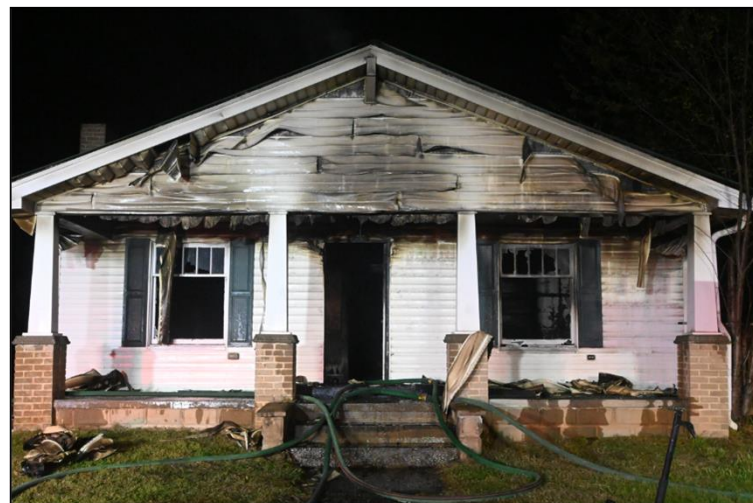
Side Alpha post fire event (Courtesy of: Fire Marshal Office)

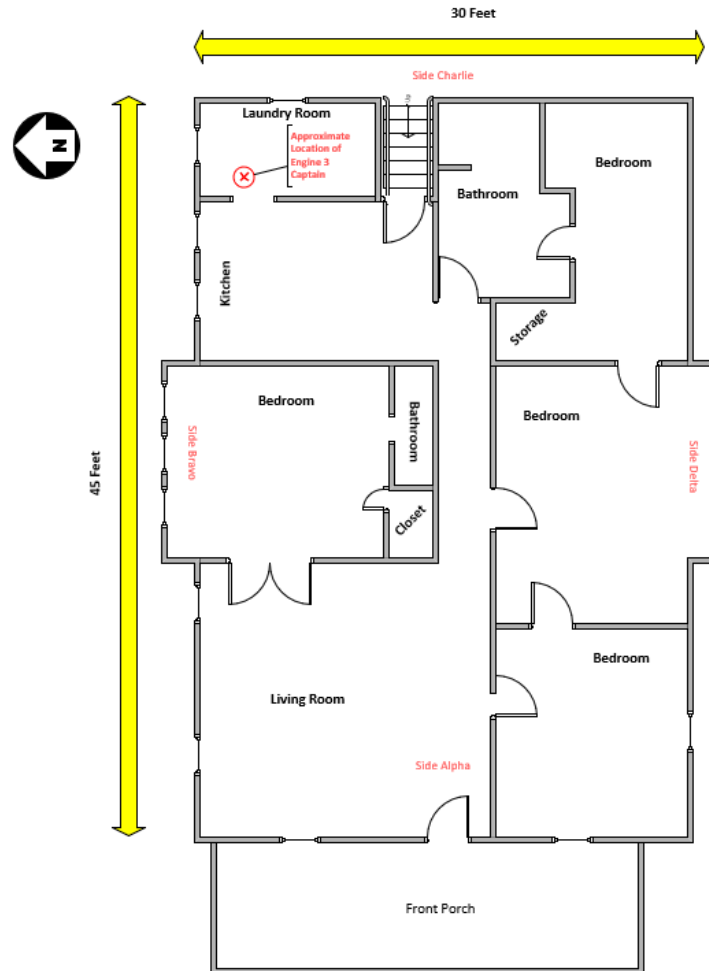
- RIC informed the IC that E3 captain was not located on the exterior of the structure and RIC was deployed to the interior at 0017:24 hours.
- Approximately two minutes after the RIC deployment to the interior, the RIC could hear an audible personal alert safety system (PASS) device towards the rear of the structure (side Charlie).
- RIC located the E3 captain in the rear of the kitchen on side Charlie at the Bravo corner at approximately 0021 hours.
- E3 captain was removed by being drug to the front door on side Alpha.
- E3 captain was awake and alert upon removal from the structure with personal protective equipment (PPE) and self-contained breathing apparatus (SCBA) still intact.
- He was airlifted from the scene to a local burn center where he succumbed to his injuries three days later.

First floor diagram and approximate location E3 captain was found.
Note: Diagram not to scale. (Courtesy of: NIOSH)
