**LINE OF DUTY
DEATH REPORT
REPORT SLIDES**

F2023-11

Lieutenant and Probationary
Firefighter Die after experiencing
Thermal Degradation of Self-
Contained Breathing Apparatus
Facepiece Lenses - Maryland

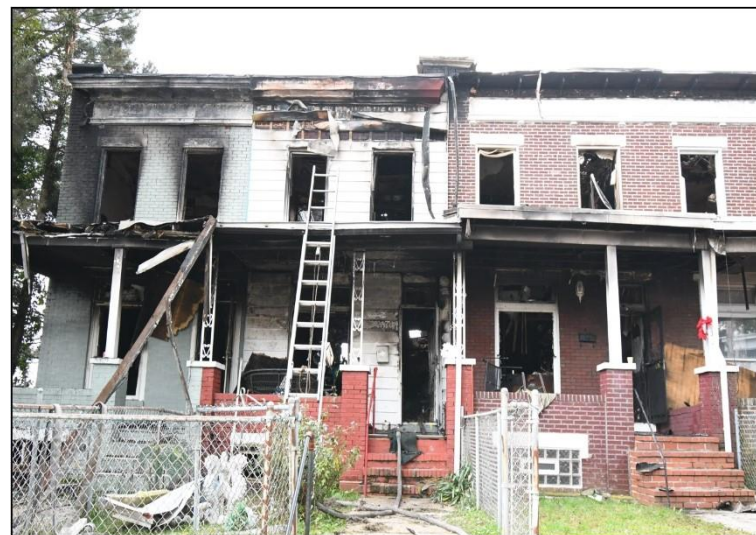
Side Alpha post fire event.
(Courtesy of Fire Marshal Office)

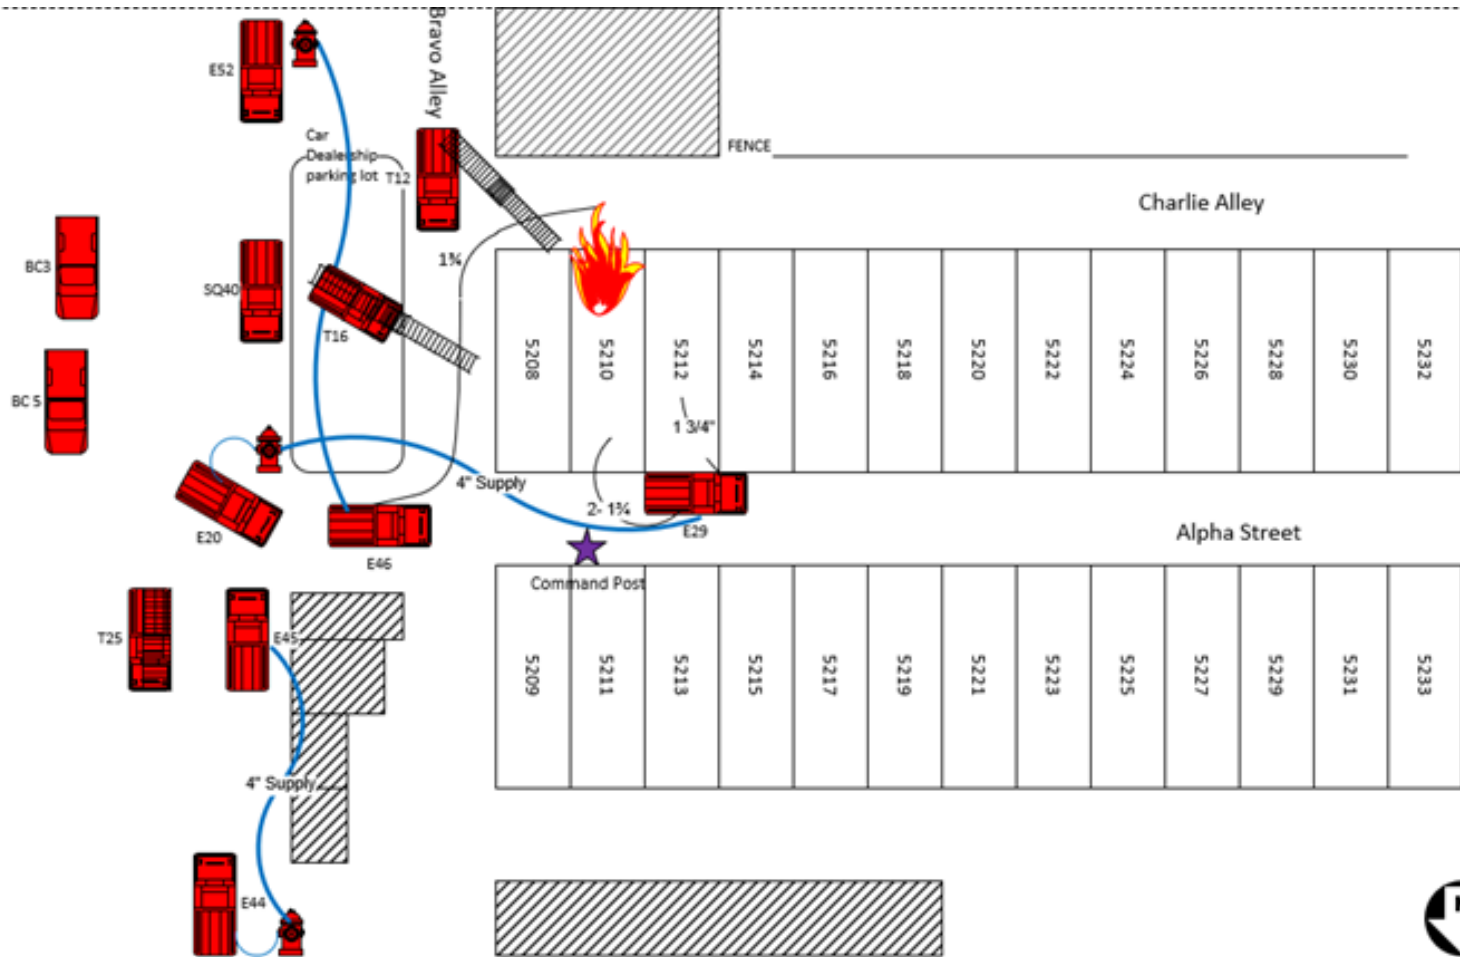
Apparatus and initial attack and supply line placement. (Courtesy of NIOSH)

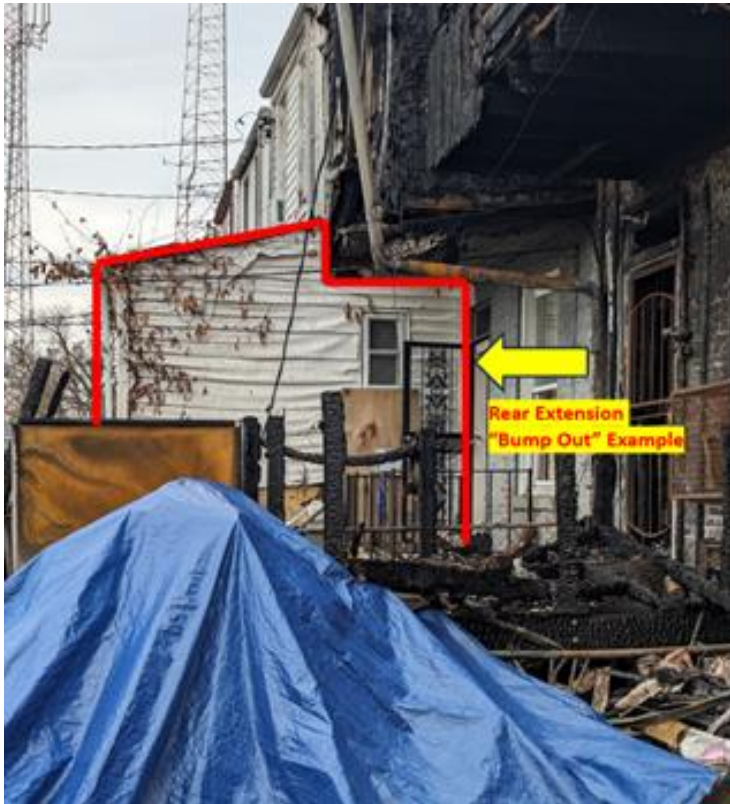
Side Charlie exterior porch.
(Courtesy of NIOSH)

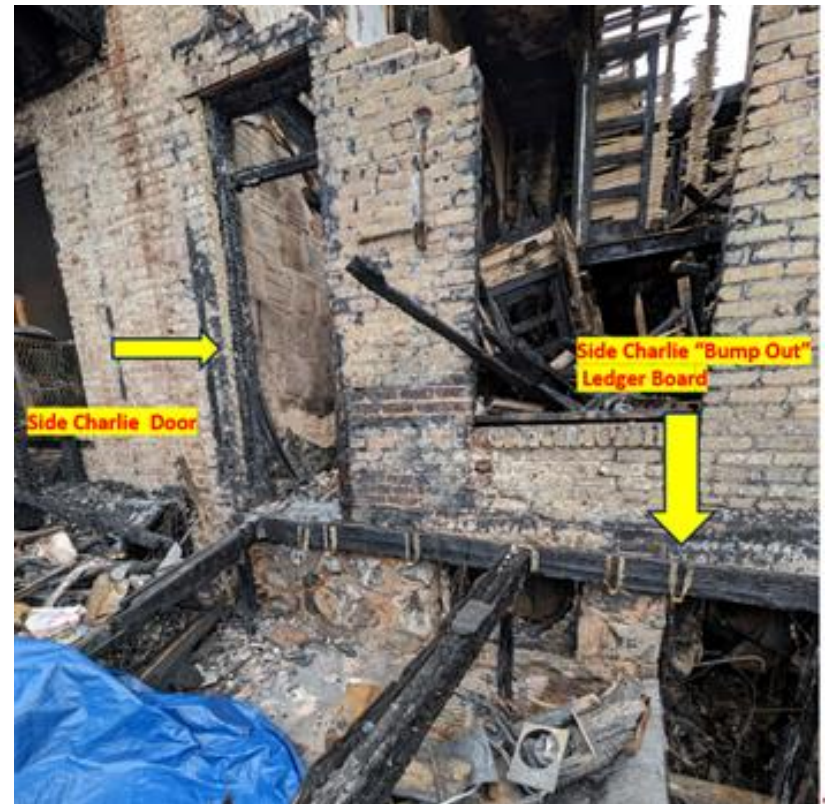
Side Charlie exterior porch frame.
(Courtesy of NIOSH)

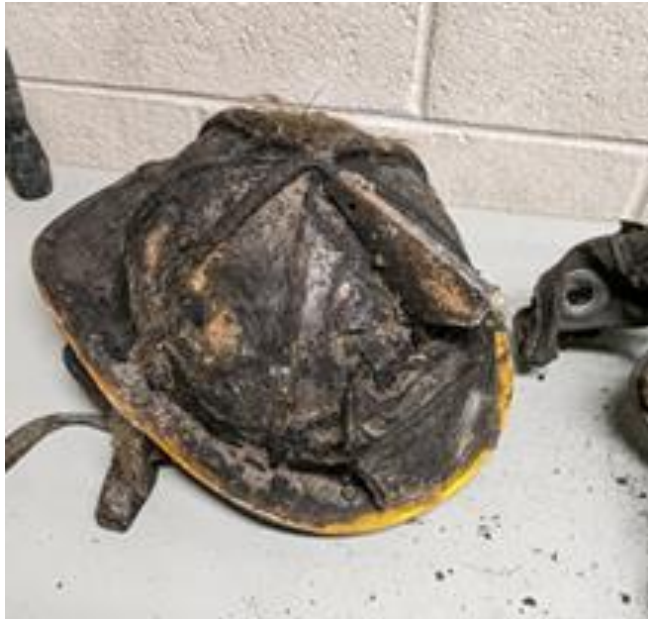
E29 Probationary firefighter's helmet. (Courtesy of NIOSH)

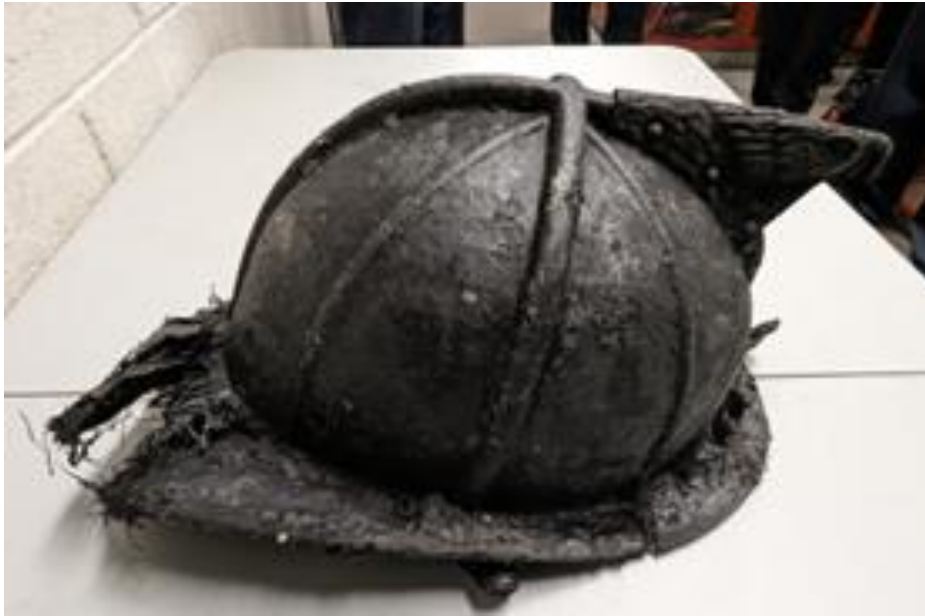
E29 Lieutenant's helmet (Courtesy of NIOSH)

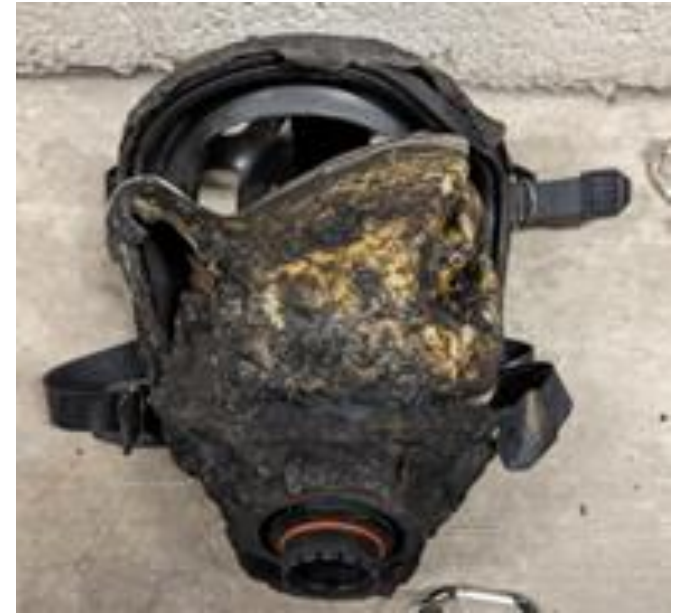
E29 Lieutenant's SCBA facepiece
lens (Courtesy of NIOSH)

- Strategy and tactics for exterior fires extending into the interior of a structure
- Thermal degradation and failure of Self-Contained Breathing Apparatus (SCBA) facepiece lenses and EBSS (Buddy Breather Whip)
- Recognition of fire dynamics
- Use of thermal imaging (TI) camera to observe changing fire conditions and escape routes
- Interior structural firefighting experience

- Develop policies that address both strategy and tactics as they relate to exterior fires, vertical fire spread, and horizontal extension into a structure.
- Consider upgrading or replacing current SCBAs to meet the 2013 or more recent edition of the NFPA 1981 or NFPA 1970 (1981) standard.
- Train firefighters in fire dynamics, recognition of flow paths, and tactics to reduce the potential of working in the exhaust portion of a flow path.
- Ensure proper training for firefighters on the use and limitations of TI devices as they relate to interpreting fire dynamics.
- Consider level of experience, tacit knowledge, skill familiarity, and the need for close supervision when assigning tasks with higher potential of injury to probationary firefighters.
