LINE OF DUTY DEATH REPORT

REPORT F2021-21 • March 2025

Firefighter dies from head injury during tire inflation – Louisiana

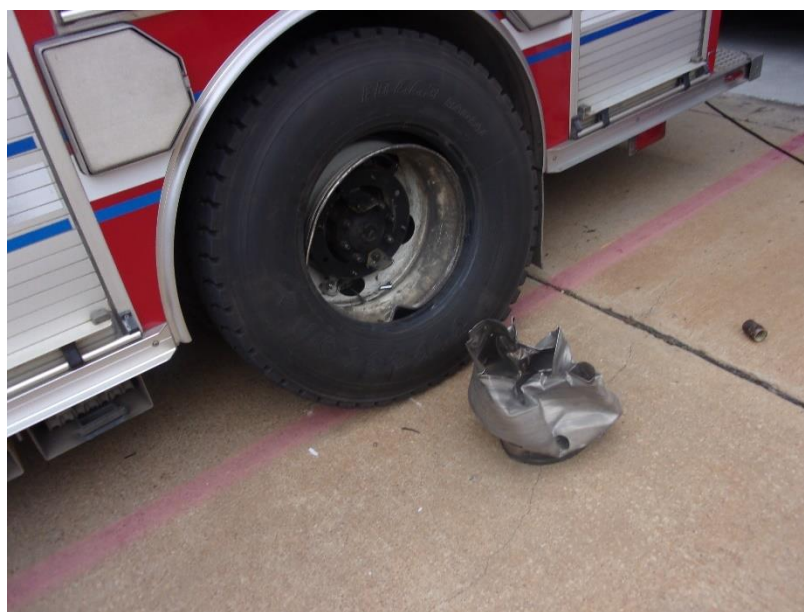
Photo 1: Apparatus tire that came off the wheel rim while being refilled with air.
(Courtesy of the fire department)

The tire that came off the rim in this incident was the outer dual configuration wheel on the driver's side rear of Engine 4 (**See Photos 1 and 3**). This wheel had a single piece rim with a decorative aluminum simulator/hubcap that covered the entirety of the rim over where the tire beads are seated (**See Photo 4**). After the tire incident, it was discovered that the wheel had sustained damage believed to be from either running over a curb or an object on a roadway. Specifically, the rubber of the tire had multiple scuff marks, and the metal rim had a significant deformation. The latter is believed to be what caused the tire pressure to leak. The simulator/hubcap would have covered and hidden the rim deformation from being discovered during a visual inspection. When firefighter 4 attempted to inflate the tire, the rim deformation allowed the tire bead to slip past the wheel rim, causing a zipper effect where the entire bead let go. Some combination of the outward motion of the tire and the sudden outburst of air from the tire, launched the wheel simulator/hubcap as a projectile.

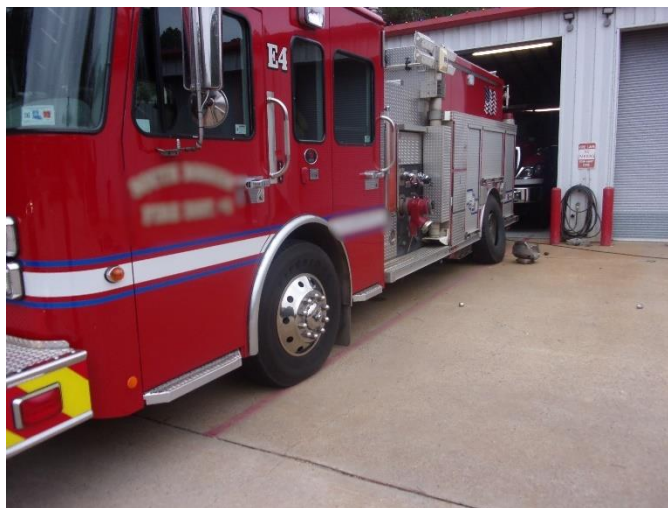
Photo 2. Engine 4 with tire off the rim.
(Courtesy of the fire department)

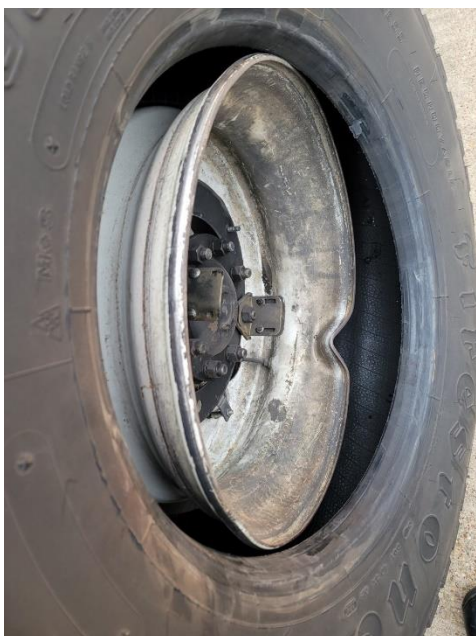
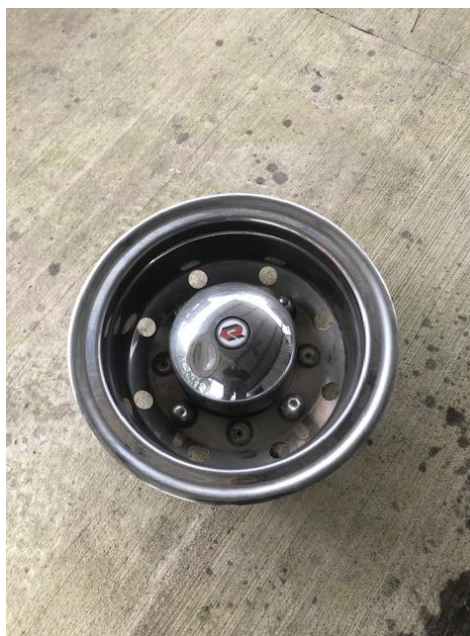
Photos 3 and 4. Apparatus tire that came off showing rim deformation and simulator/hubcap from passenger side of Engine 4.

The fire department has removed all wheel simulators/hubcaps from all apparatus in their fleet. They have purchased and provided firefighters at stations 1 and 4 with tire inflators with gauges that have a six ft hose with a locking valve stem connection. Their updated procedures mandate firefighters to report any abnormal strike of apparatus tire (e.g. curb or object in the road) to the fire department mechanic or chief officer. The procedures also include a mandate that if apparatus tires are lower than 90% of the desired pressure, the apparatus shall be pulled from service with the fire department mechanic or chief officer being notified to resolve the issue.
