REPORT #:
71-171-2018

REPORT DATE:
5/10/2018

INDUSTRY:
Bottled water manufacturing

Warehouse Worker Crushed by Forks of Laser Guided Vehicle

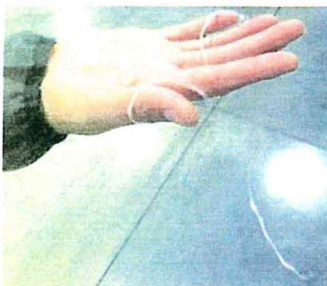
Example of a plastic "stringer" torn from pallet wrapping that often obstructed LGV sensors.

Investigators believe that the victim attempted to remove a piece of plastic from under the elevated forks of the LGV without first initiating an emergency stop. Long strips of plastic wrap often tore off of pallets during loading and unloading and stuck to the forks of the LGVs. If the plastic entered the safety detection field of the LGV, it would be recognized as an obstacle. Other employees said that these plastic "stringers" frequently triggered LGV alarms. The victim was likely bending or kneeling under the forks outside of the safety sensor field to reach the plastic stringer. Because the LGV was not in emergency stop mode, the system reset when the obstacle was removed, bringing the elevated forks down, crushing him against the wheel cover of the vehicle.

- Train workers about the specific hazards associated with automated guided industrial vehicles, like LGVs. Emphasize that workers are expected to follow required safety procedures every time, and ensure compliance through periodic refresher training and spot checks.

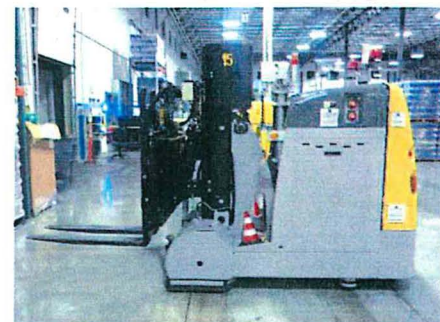
The victim was working in the warehouse when an LGV alarm was activated. Shortly after, another worker heard noises over the radio and looked into the warehouse to investigate. He saw the victim slumped over one of the LGVs. The LGV then started moving again, and the other worker hurried to it and initiated an emergency stop. He could see that the victim had severe injuries to his chest and jaw. He called for help and called 911. Emergency responders arrived within minutes and transported the victim to a local hospital where he was pronounced dead.

There were warning signs affixed to the vehicle indicating that workers should avoid standing beneath the elevated forks.

Photo of LGV involved in the incident.

- Employers must protect workers around PITs (powered industrial trucks), and not allow them under the elevated part of any PIT, whether it is loaded or empty. See [WAC 296-863-4005\(2\)\(a\)](#).
