71-201-2020

Roof deck of three-story  
college building under  
construction

## Ironworker Falls 42 Feet through Hole when Cover Fails

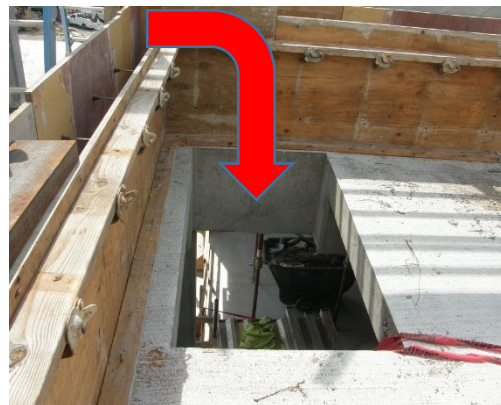
Plywood cover that failed. Circles indicate the two nails that secured the cover to the stem wall sill.

Investigators determined that the general contractor had installed the cover. The 32-inch by 62-inch hole was covered by a 5/8-inch thick piece of 10-year-old worn plywood. The plywood was 48 inches by 60 inches and was secured on one side with two nails to the stem wall sill. This placement left a gap of one inch on each end and only two sides of the plywood supported. When the ironworker landed on the plywood, it buckled in the center.

Incident scene on building roof deck showing the hole that the ironworker fell through when a plywood cover failed.

- Subcontractors should check hole covers to verify that the covers are adequate in strength and placement and report potential problems to the general contractor.
- Employers on multi-employer sites should use contract language that clearly defines the safety responsibilities of each contractor prior to initiation of work.
