# **Occupational Fatalities in Oregon Annual Report 2016**

***Oregon Fatality Assessment & Control Evaluation  
(OR-FACE)***

## Oregon Fatality Assessment and Control Evaluation

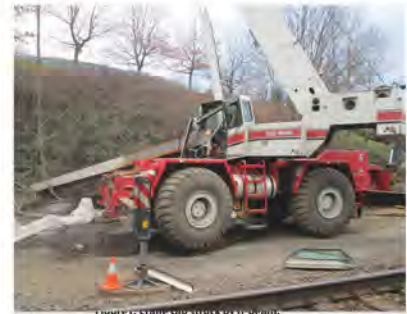
*The crew was not aware of the manufacturer instructions warning of clamp failure if the hydraulic clamp cylinder was not bled of entrained air. Pile lifting instructions in the manual required a shackle and short line attached to the hole in the pile clamp housing with the shackle fastened into the lifting hole in the pile.*

A 40-year old crane operator was killed when a 35-foot (5600 lb) H-beam fell crushing the crane cab and striking him in the head. During a pile driving operation, the H-beam pile had been placed in a drilled 25-foot hole. While using a vibratory hammer to force the pile further into the hole, the pile shifted. After several failed attempts to correctly position the pile it was extracted using the hydraulic clamp of the vibratory hammer and moved 12 feet from the hole. It was held in a vertical position with the bottom of the pile resting on the ground. The clamp holding the top of the pile unexpectedly released. The pile was not rigged to the clamp housing or attached to the whipline. The 5600 lb pile fell, struck and crushed the crane cab, and killed the operator.

Figure 1: Crane cab struck by H-beam.

- Employers should ensure that pile driving operations include measures to prevent inadvertent release of piles from lifting and pile driving equipment.
- Employers should ensure that workers are trained on the hazards of equipment and follow manufacturer's operating manual.
