FATALITY INVESTIGATION REPORT

REPORT #: 52-47-2021

REPORT DATE: 03/04/2021

Chip Truck Driver Struck by Passing Truck

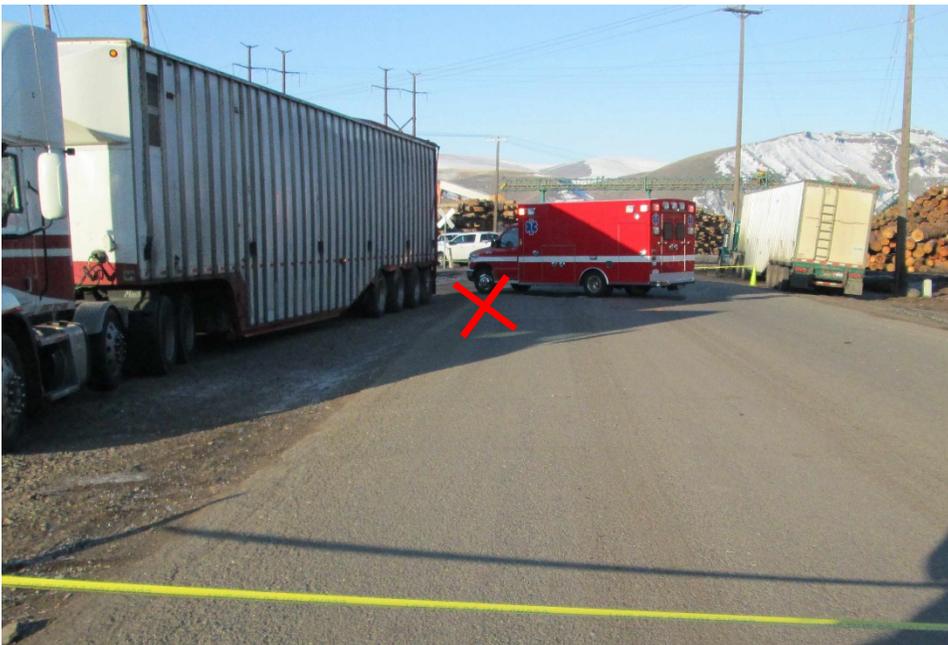
Photo 1: Incident Scene – driver’s tractor-trailer in turnout in left side of photo with ambulance parked across the roadway. Green witness tractor-trailer parked on shoulder in the right side of the photo. The “X” indicates approximate location driver was found following incident.

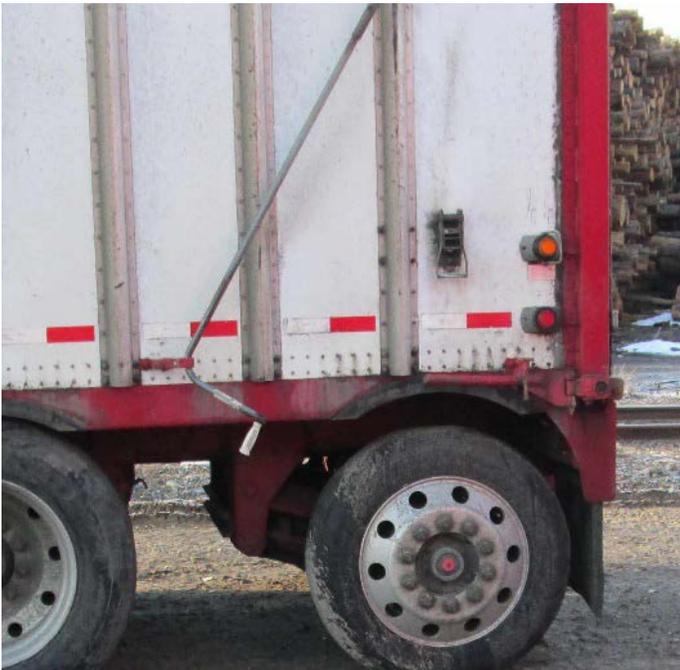
The trailer was loaded with piles of wood chips extending beyond the height of the trailer in several places. The piles could be seen over the top of the trailer. Typically if a trailer is filled with piles above the height of the trailer, the wood chips settle down into the trailer flattening the piles as the truck drives from the mill to the tarping area. However, the chip piles did not settle this time. One employee interviewed said that sometimes drivers will hit their brakes a few times to settle the wood chips down if the piles are still too high. It is unknown if the driver of the truck did this. Others interviewed indicated that the piles appeared higher than usual. This could have caused difficulty in cranking the tarp roll bar over the piles and closing the tarp over the trailer.

Photos 2 and 3: Photo 2 shows tarp system including tarp, roll bar, and strap on top rear of trailer. Note how wood chips are piled above the height of the trailer and strap is twisted on top of tarp. Photo 3 shows hand crank used to close tarp over the trailer.

Recommendation: Ensure trailers are loaded at the proper capacity so tarps can be safely closed and fastened.

Discussion: Employers should develop policies and train drivers to avoid loading trailers with material to a height that makes tarping difficult. This should include drivers working with mill workers and loader operators to not overfill trailers. If the employer had a policy to not overfill the trailer and the driver had instructed the mill workers accordingly, tarping the load may have been easier. Wood chip loading is done by visual assessment at the mill. The height of this load did exceed the height of the trailer and did not settle after driving to the turnout. While the trailer was loaded to the proper capacity for the weight limit, the height of the load likely made the trailer difficult to tarp. The proper load height should be considered. Even with automatic tarping systems or trailer arches, materials loaded too high inside the trailer would cause an equipment fault and require the driver to exit the vehicle to troubleshoot.

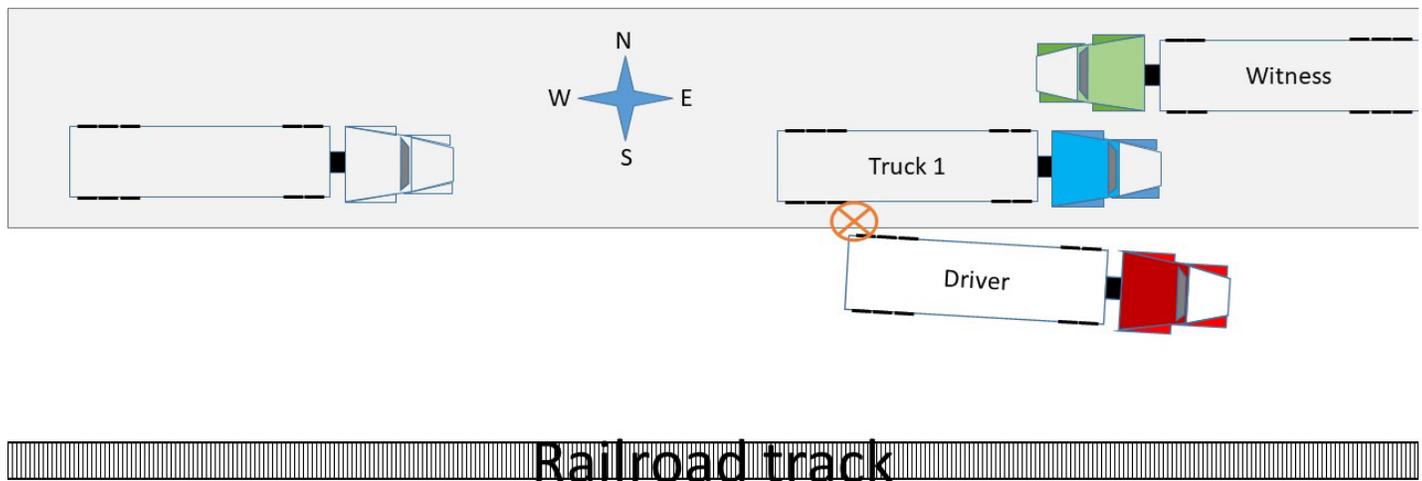
Diagram 1 (Not to scale): Approximate location of tractor-trailers at time of incident based on first responder report. Circle with “X” indicates approximate location chip truck driver was seen when tarping his trailer.

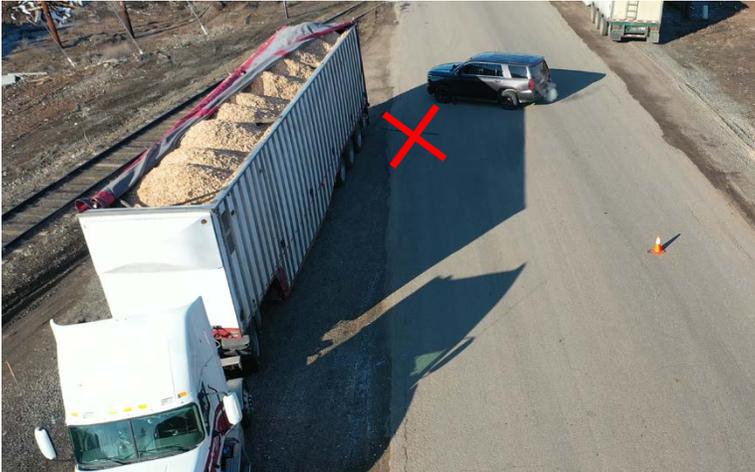
The tractor-trailer was parked in the turnout at a slight angle to the road with the trailer closer to the road. Photographs from the scene and drone footage show the rear tarp strap was twisted and on top of the tarp. The area where the driver appeared to be struggling to tarp the trailer was close to the road. The driver may have lost his balance while trying to reach the rear strap with the long reach tool and stumbled backwards just as the blue tractor-trailer was passing slowly on the road and was run over by its trailer.

Photo 4: Tractor-trailer with piles of wood chips, partially covered with tarp at rear but not at front.

Tractor is parked further away from the road, while rear of trailer is angled closer to roadway traffic. Long reach tool is seen at rear of trailer in road by tires.

The “X” indicates approximate location driver was found following incident.

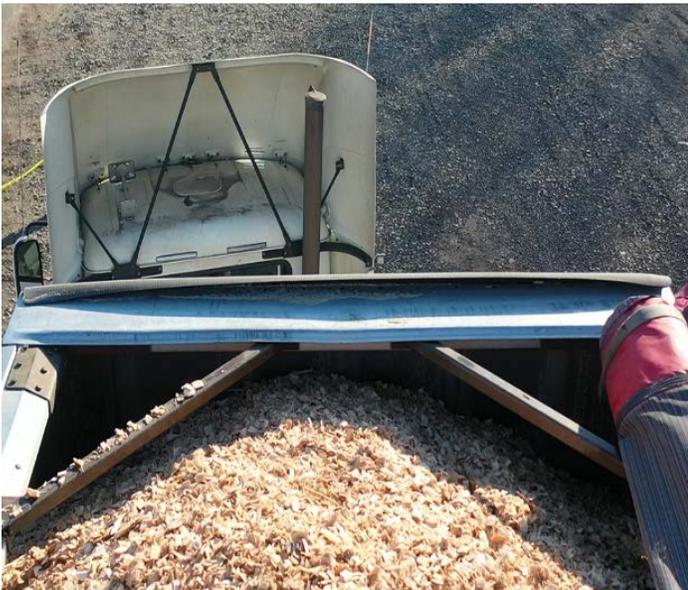
Another issue that may have caused the driver to struggle while covering the trailer with the tarp is the lack of an elastic stretch cord at the front of the trailer. Elastic stretch cords run across the front of the trailer and help guide and pull the front of the roll bar across the loaded trailer as the tarp is cranked in the rear. This cord is not required by law. Scene photographs show the tarp is positioned diagonally with the rear of the tarp closed and the front open. A guide cord may have helped the driver to fully close the tarp.

Photo 5: Driver’s trailer with manual tarping system missing the elastic stretch cord across the top end cap at front of trailer.

Discussion: The elastic stretch cord was missing from the front of the trailer’s tarp system. The cord helps guide and close the tarp as the driver operates the rear crank. If the tarp had closed as intended, the tarp straps should have hung down the side of the trailer. Scene examination shows the rear tarp strap tangled at the top of the trailer, which meant the driver needed to reach for and untangle it. While the incident was not witnessed, it is suspected that the driver may have stumbled backwards while trying to reach the tarp strap. The long reach tool was in the middle of the road, which he could have been tugging on forcefully when he stumbled backwards into the passing trailer. Automatic tarping systems are available for these trailers. These allow the trailer to be covered with a tarp by pressing a button inside the truck cab. The driver does not have to interact with traffic or struggle with tarp straps. This also reduces driver’s risk of falls and musculoskeletal injuries which are associated with manual tarping.

Recommendation: Maintain tarp systems and consider using an automatic tarping system that eliminates the need to manually close a tarp over a load.

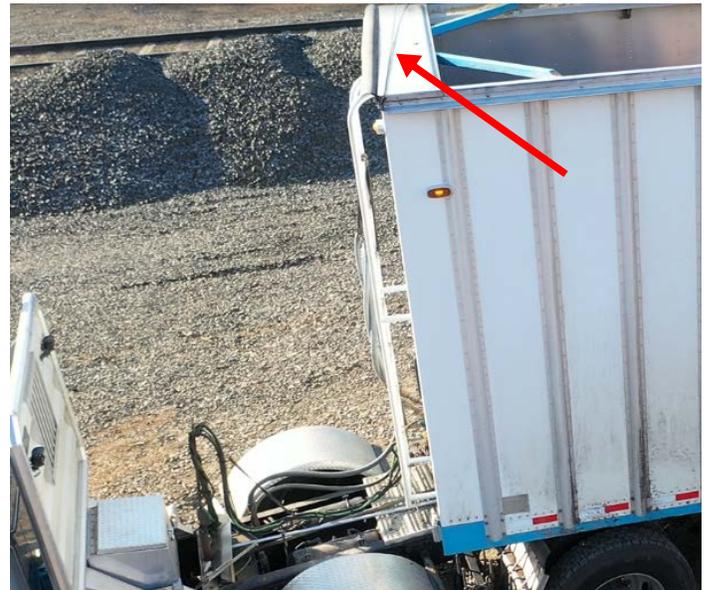
Photo 6: Tractor-trailer that stopped near the incident scene. Arrow points to intact elastic stretch cord across the top end cap at front of trailer.

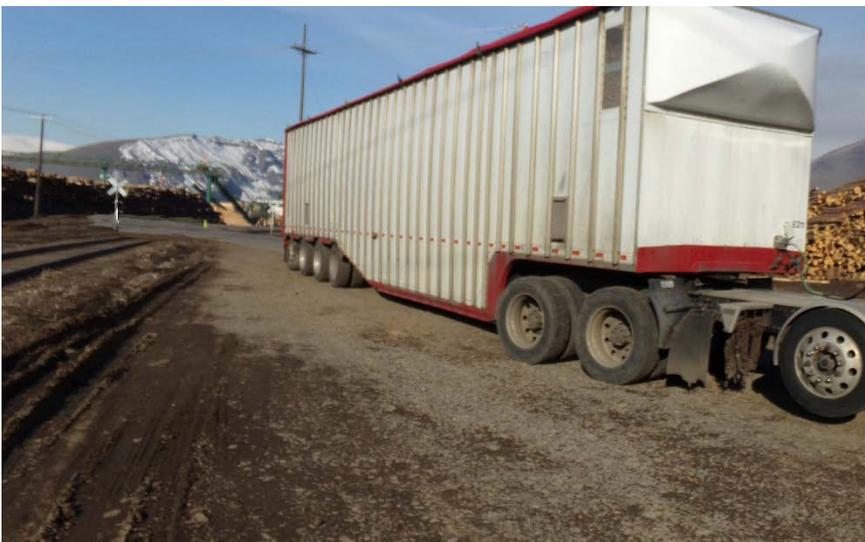
In this incident, the driver could have also parked his tractor-trailer further from the road, which would have allowed more room for working at the rear of the trailer.

Photo 7: Photo of location in turnout where the driver parked with more area toward the railroad track and in front that could have been used to park farther from the road.

Recommendation: Develop policies for how and where to safely park and tarp trailers.

Discussion: In this incident the customer did not have a tarping station available. Some customers do have them. Employers should develop policies that require drivers to use available tarping stations. When stations are unavailable, policies should be developed for drivers to safely park and work outside of their trucks. The area should be separate from the roadway and designated by signs, warning devices, or barriers such as concrete blocks, railings, or gates. This helps reduce the risk of drivers being hit by a moving vehicle. In Washington State, approximately 36% of motor vehicle fatalities occur to drivers outside of their vehicles. While personal protective equipment such as hi-visibility vests improve safety for drivers, reducing the interaction between drivers and vehicles is the best way to prevent these incidents.
