71-230-2022

November 21, 2022

## Carpenter Falls through Floor of Two-Story Garage

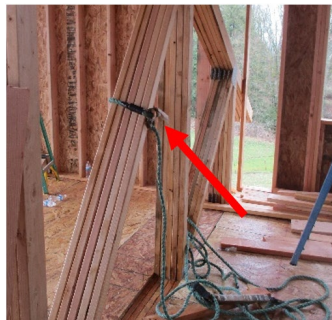
Example of how crew tied-off lifeline ropes to roof trusses.

After the incident, the brothers demonstrated to investigators how they tied-off their fall protection lifeline ropes by wrapping them around roof trusses. They did not have fixed or temporary anchors installed. Investigators determined their method of tying off was inadequate since diagonal truss braces are not rated for that. Investigators also found that the employer did not have an Accident Prevention Program (APP) and did not develop a fall protection work plan for the project.

- Frequently remind workers of the need to use fall protection 100% of the time they are at risk of falls.
- Develop policies and train workers to:
  - Tie-off to approved fixed or temporary anchors only. Wood beams of roof trusses are not designed to support fall protection systems.
  - Not store raw materials like OSB over floor joists or other areas where fall hazards exist.

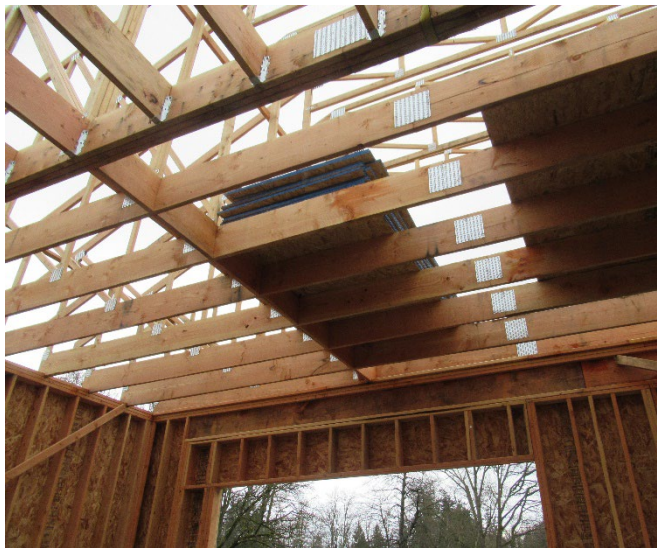
He went down a ladder to the ground floor to get some nails. After coming back up the ladder, he started nailing down a sheet. Shortly after, he fell through the joists of the unfinished floor along with a sheet of OSB to the concrete 14 feet below. Despite working close by, neither brother saw him fall. He was not wearing a personal fall protection harness when he fell. He died the next day at the hospital.

View through the unfinished floor of the room above the garage. The leading edge of the floor is on the right and the OSB sheathing is stacked on floor joists.
