LINE OF DUTY DEATH REPORT

REPORT F2022-02 • July 2025

Career Lieutenant Dies and Five Injured in Structural Collapse of Mixed-Use Occupancy during Cause and Origin Investigation - Pennsylvania

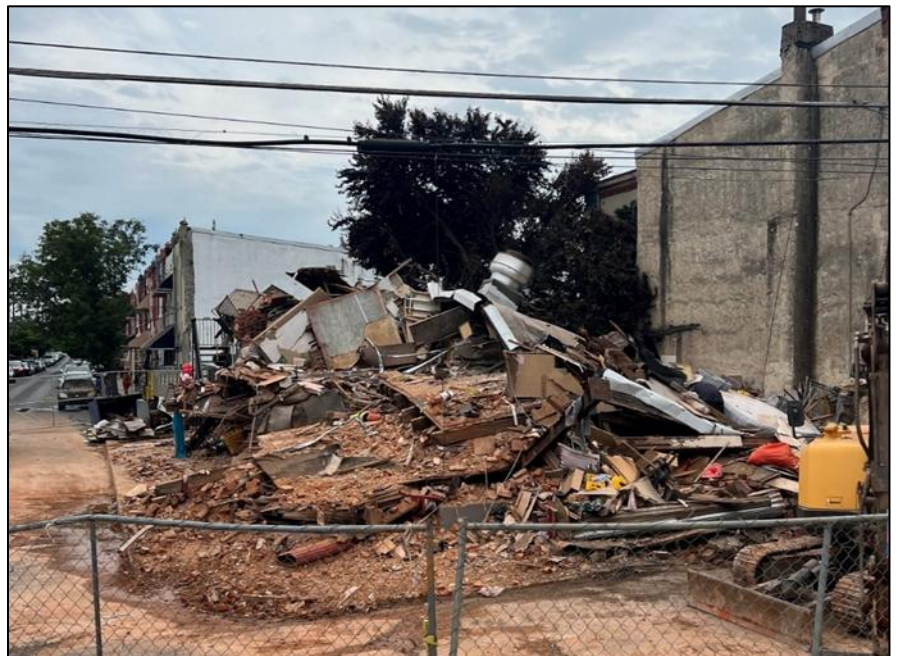
Photo 1: Aftermath of building collapse.
(Courtesy of fire department)

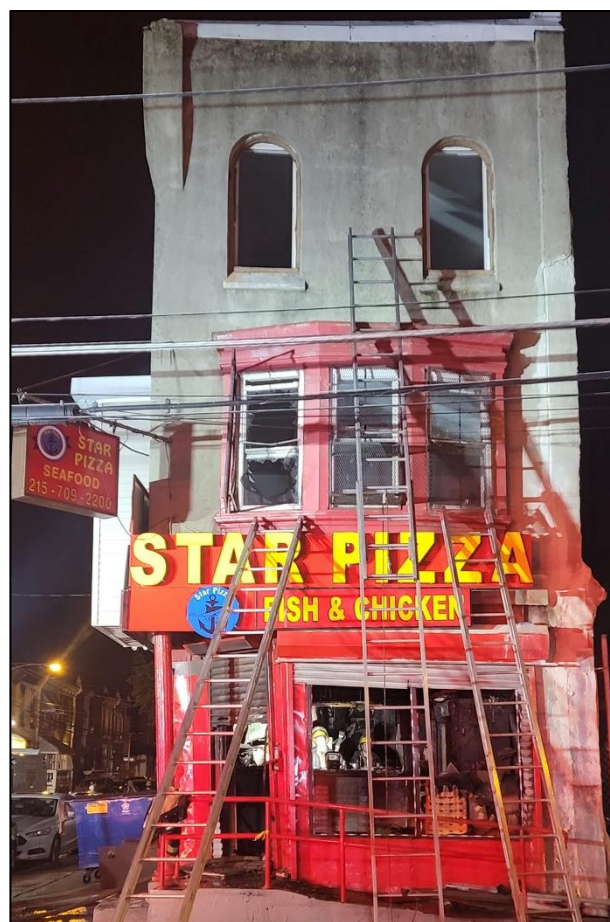
Photo 2: Scene photo of Side Alpha of the structure. (Courtesy fire department)

III, IV, and even V construction [Shady and Tobin 2020]. Typically, they are constructed in a row style with masonry bearing walls and combustible construction making up the floors, ceilings, and interior surfaces (see **Photos 4, 5, and 6**). The masonry exterior walls are exposed to the elements and can become weak as mortar between the stones and bricks is degraded or washed out entirely [Dunn 2010]. In this incident, all exterior walls of the building were covered with stucco-type material that masked any degradation of the bricks and mortar (see **Photo 2**).

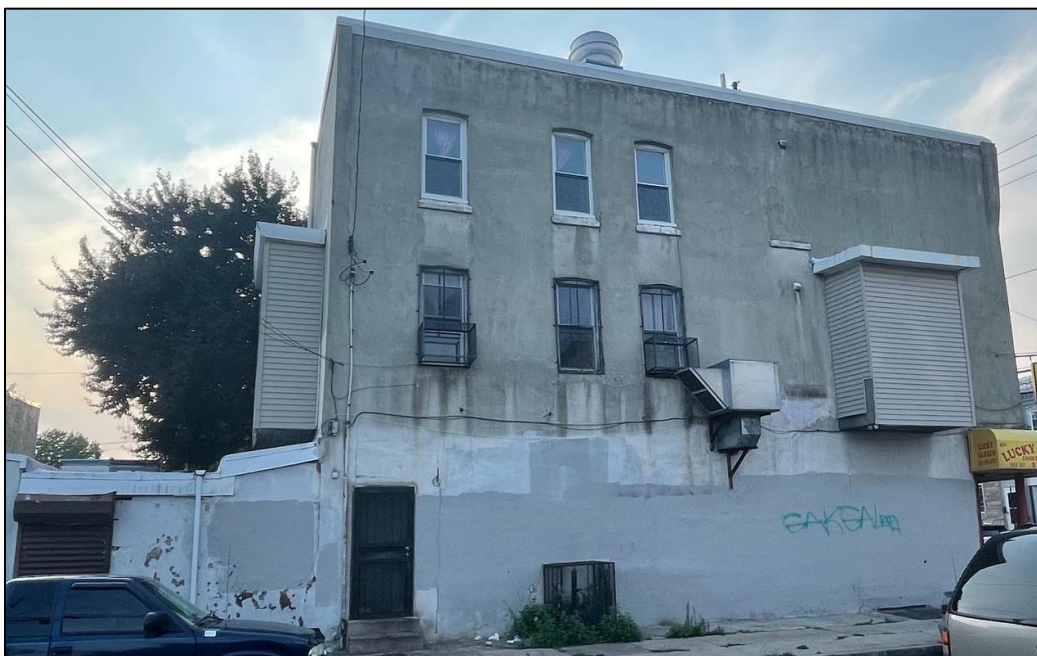
Photo 3: Bravo side of the structure. Note the bump out over the sidewalk and exposed windowsills where windows were covered over. (Courtesy of fire department)

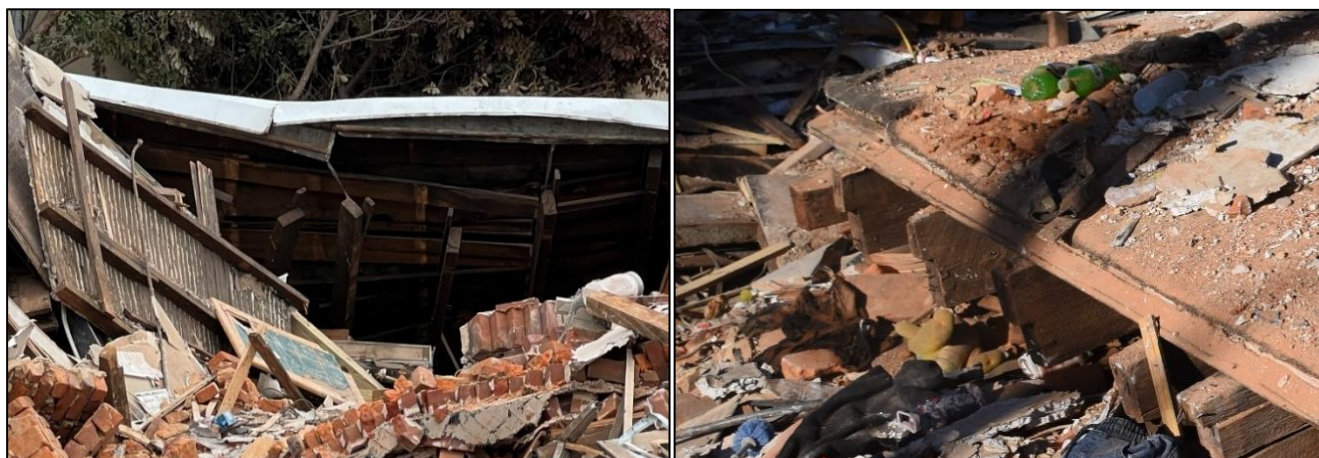
Photo 4 (Left) and 5 (Right): Legacy construction members common in type 3 "main street" buildings. (Courtesy fire department)

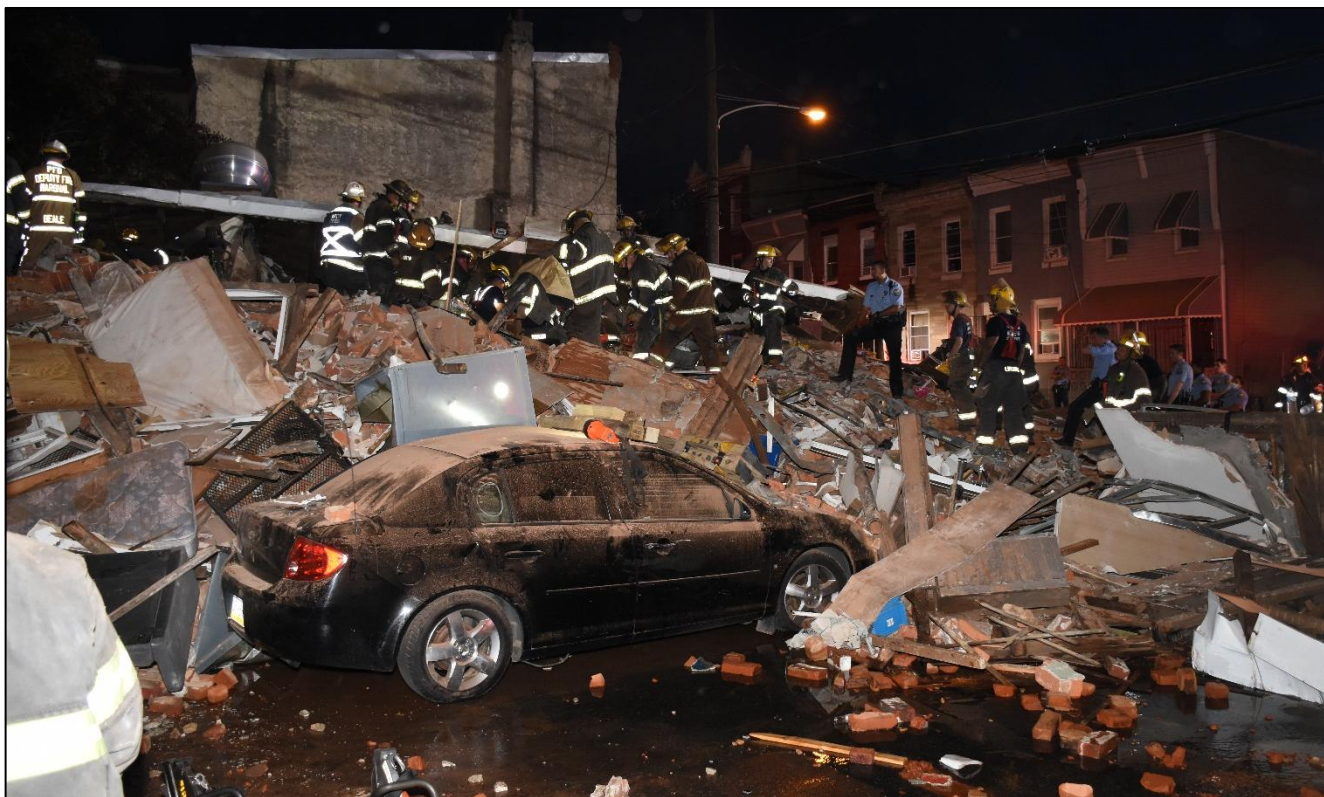
Photo 6: Incident scene of the Bravo side following the collapse. (Courtesy of fire department)
