Firefighter Dies After Becoming Lost in the Attic at a Residential Structure Fire – Illinois

Executive Summary

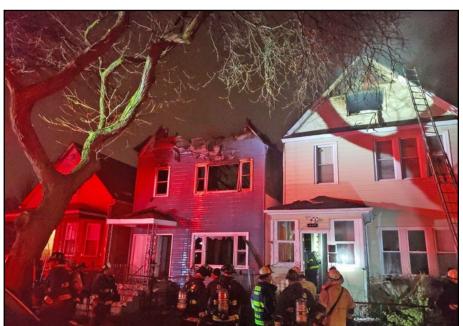
Photo 1: A firefighter was lost in the attic of the white residential structure (Delta 1 exposure).

feet of 2½-inch and 100-feet of 1¾-inch) to the fire building (middle building in **Photo 1**) but there was a delay in getting water due to a lack of water pressure. TL24 and BC22 arrived at 03:29 hours. A member of TL24 forced the door of the fire building for E75. The E75 nozzle and E75 officer were going up the stairs to the 2nd floor where the fire was located. The stairs were compromised, and they were ordered out of the building. The Incident Commander (IC) requested a Still and Box Alarm for Box 142016 at 03:31 hours and the OEMC dispatched several additional units. E75 hydrant (establishes water supply to the engine) (deceased firefighter) was assigned to take the hoseline from E75 nozzle to knock down the fire showing from the Delta 1 exposure (side of the structure shown on the right in photographs) (white building to the right in **Photo 1**). At approximately 03:37 hours, E75 hydrant and E75 officer went into the Delta 1 exposure and worked their way to the attic. The conditions in the attic were hot with heavy smoke, and there

E75 hydrant (deceased firefighter) took the hoseline from E75 nozzle to knock down the fire showing from the Delta 1 exposure (white building to the right in **Photo 1**). At approximately 03:37 hours, E75 hydrant and E75 officer went into the Delta 1 exposure and worked their way to the attic. When they reached the attic, E75 officer requested the roof be vented. The conditions in the attic were hot with heavy smoke, and there was fire in the side Alpha/side Bravo corner of the attic. E75 hydrant was attacking the fire, when E75 officer's EOSTI sounded. E75 was getting ready to leave the attic when IC ordered an evacuation of the Delta 1 exposure at 03:55 hours. The E75 officer told E75 hydrant that they were to leave the attic, which E75 hydrant acknowledged.

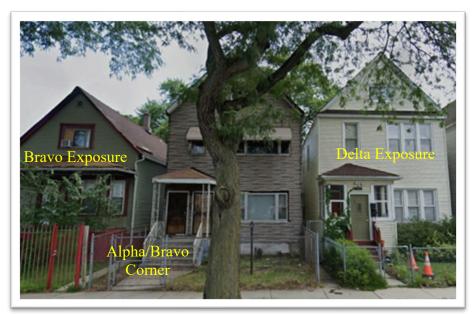
Photo 2. The fire building is the structure behind the tree. Bravo 1 exposure is to the left and Delta 1 exposure is to the right (with the traffic cones in the yard). The entrance and access to the 2nd floor on each structure is the door on the side Alpha/side Bravo corner.

The Delta 1 exposure had an entrance on side Alpha for the 1st floor apartment. The entrance and stairs to the 2nd floor apartment had separate entrance through the front foyer on side Alpha/side Bravo corner. The 2nd floor entrance door had a lock and deadbolt. The attic ran the length of the house from side Alpha to Side Charlie. There was a knee wall on side Bravo and side Delta. Most of the side Bravo roof burned through during the fire. It was reported that the 2nd floor and attic were cluttered.
