**LINE OF DUTY
DEATH REPORT
REPORT SLIDES**

F2023-05

Firefighter Dies After Becoming
Lost in the Attic at a Residential
Structure Fire – Illinois

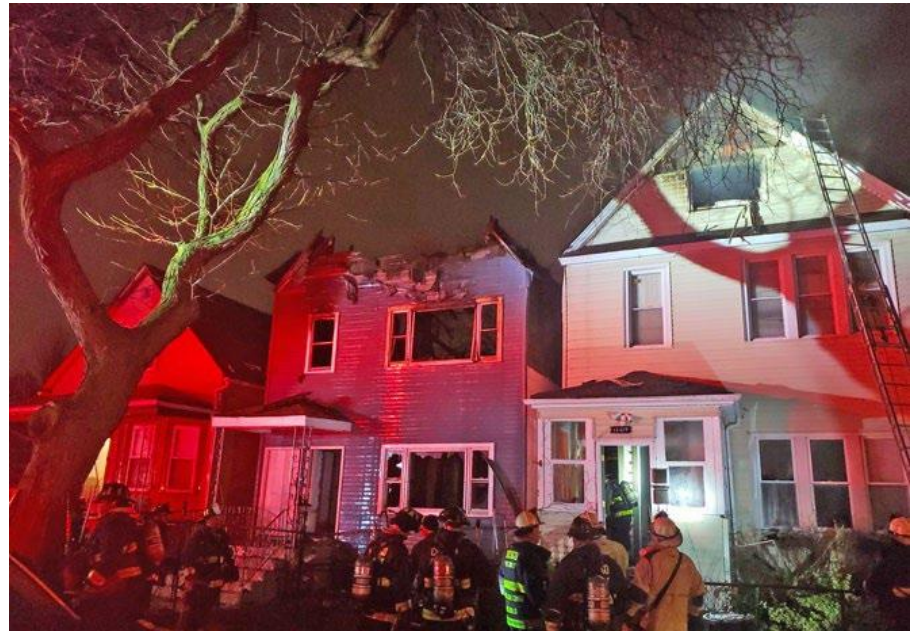
A firefighter was lost in the attic of the white residential structure (Delta 1 exposure). (Courtesy of the fire department)

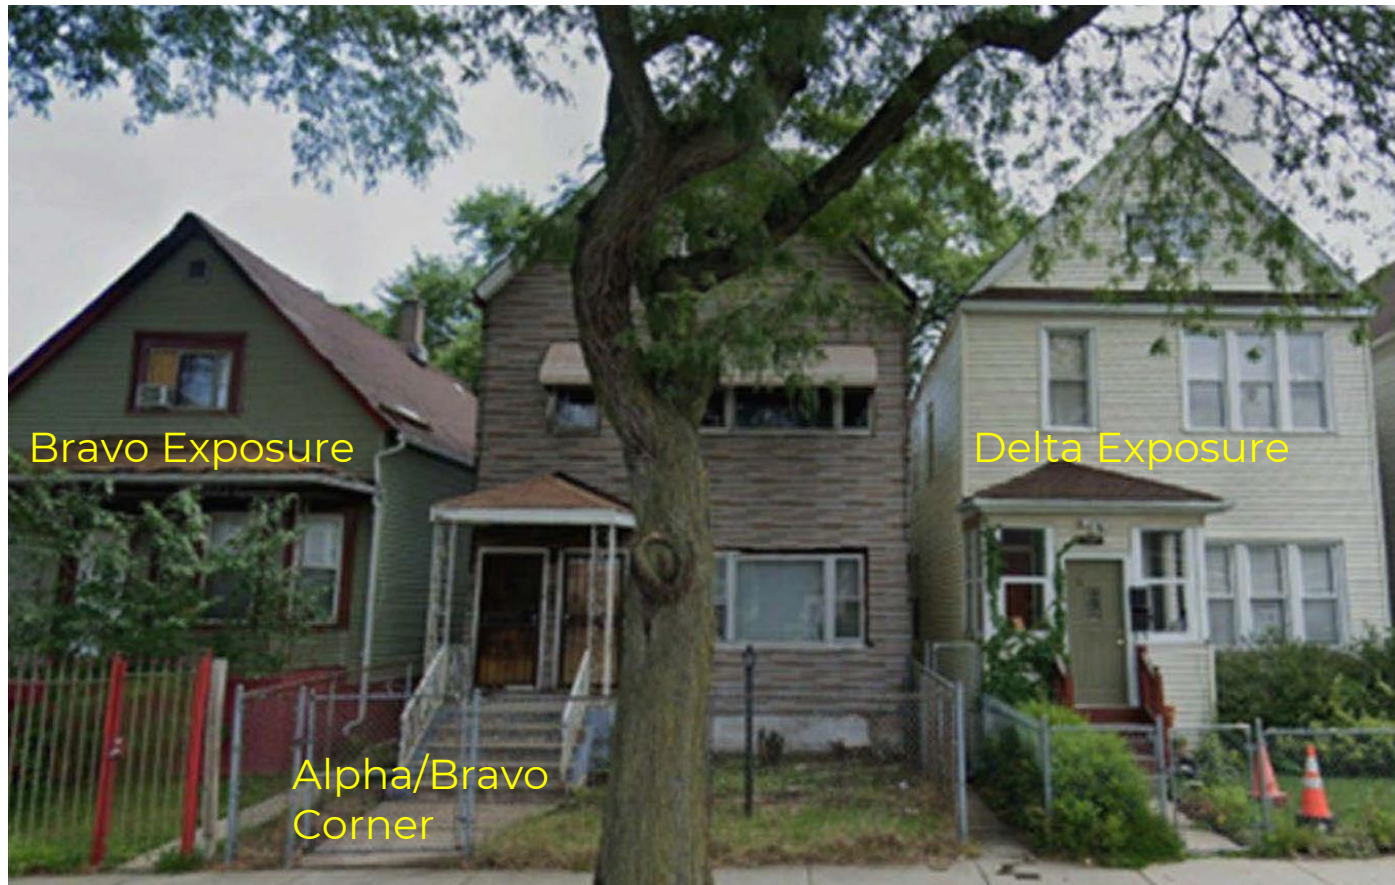
The fire building is the structure behind the tree. Bravo 1 exposure is to the left and Delta 1 exposure is to the right (with the traffic cones in the yard). The entrance and access to the 2nd floor on each structure is the door on the side Alpha/side Bravo corner. (Courtesy of the fire department)
