**LINE OF DUTY
DEATH REPORT
REPORT SLIDES**

F2024-01

Volunteer Firefighter Dies when
Propane from an Underground
Tank Leaked into a Residential
Home causing a Catastrophic
Explosion – Virginia

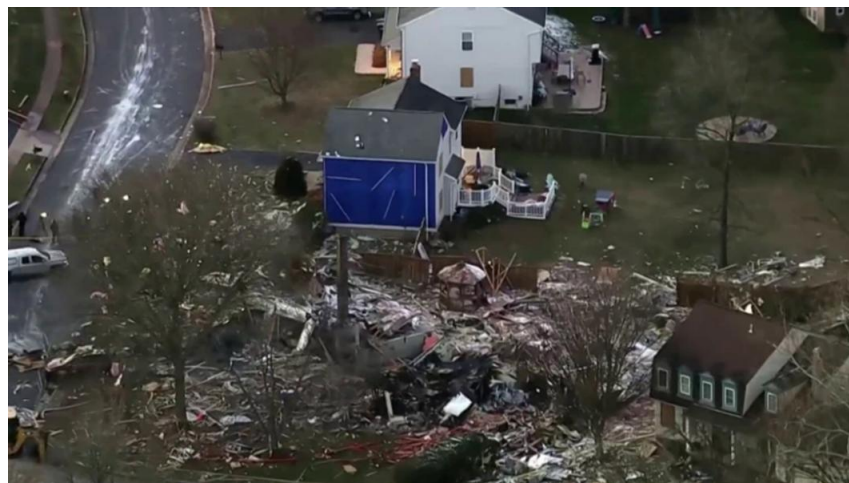
Aerial view of structure and surrounding area post explosion.
(Courtesy of fire department)

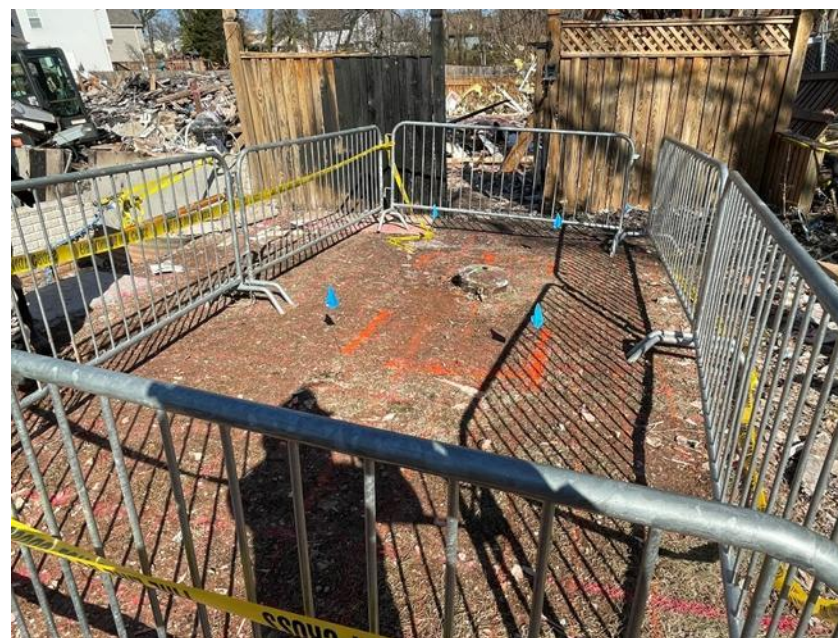
View of the area the propane tank was located. (Courtesy of Fire Marshal's Office)

- While the propane delivery driver was filling the tank, he noticed a leak.
- He deposited approximately 125 gallons of propane into the tank before he noticed the leak.
- He was unable to extract the delivered propane due to a concern with the tank's valves.
- Captain E618 updated the ECC with the information and the correct address.
- As the crews approached the area of the propane tank they noticed a strong odor of gas.
- They opened the tank dome and noticed visible vapors from the ground surrounding the tank.

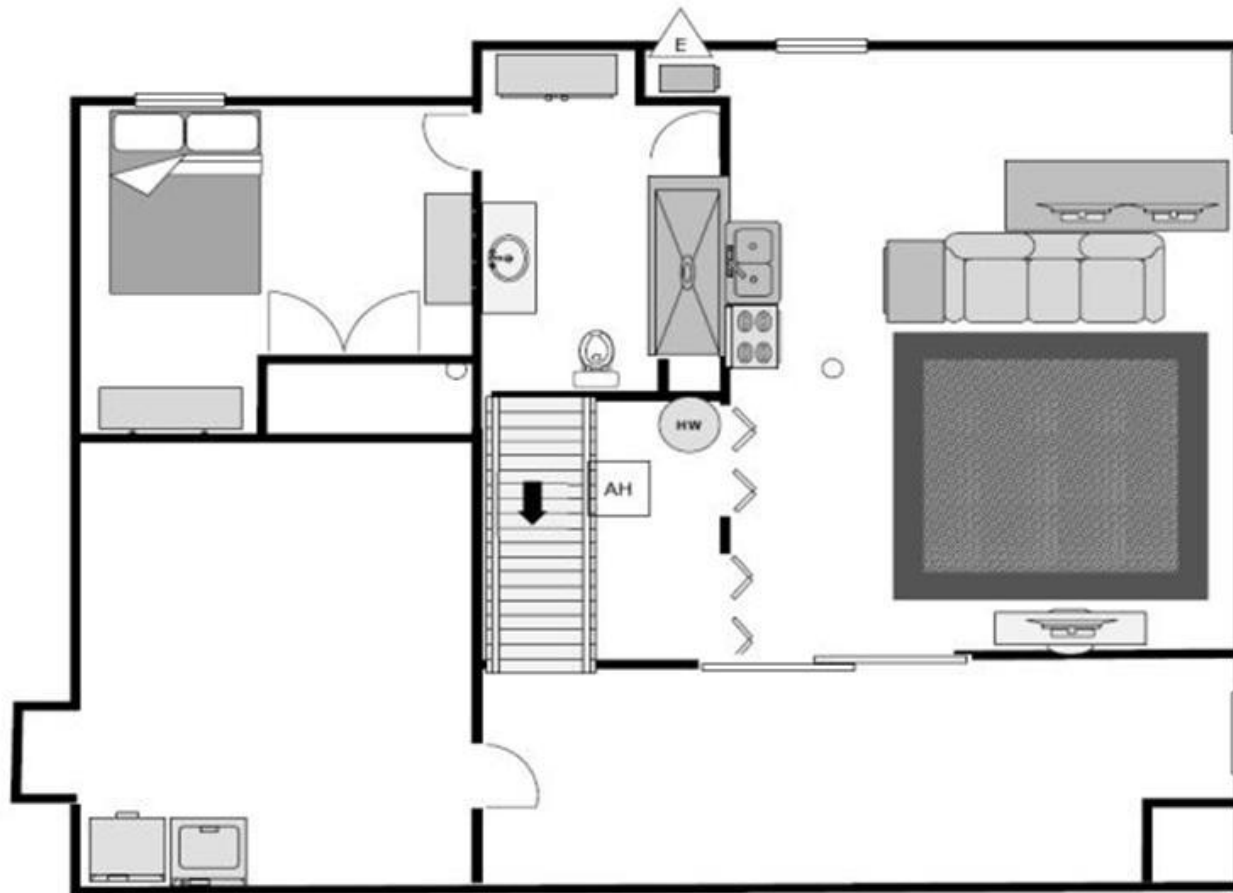
Basement of the structure.
(Courtesy of Fire Marshal's Office)

- They advanced down the basement steps, encountering the second occupant of the home.
- They directed her to immediately exit the house.
- A gas meter reading was taken in the basement.
- It went into alarm mode, giving an over range indication exceeding 10% of the Lower Explosive Limit (LEL).
- Once the occupant left the basement, Lieutenant T611 and E618FF1 began to manually open the basement windows.

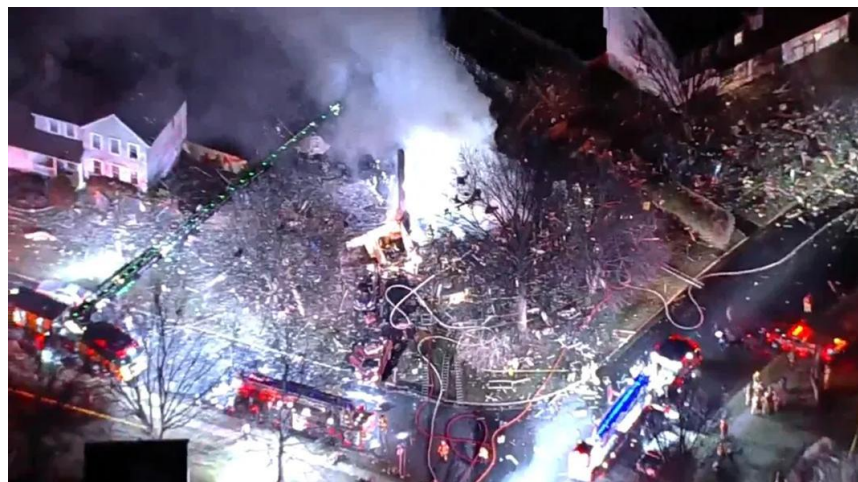
- Suddenly without warning, there was a catastrophic explosion.
- The force of the explosion raised the roof, and the walls collapsed propelling outward.
- The contents soared in all directions.
- All four walls of the foundation cracked, and heavy fire conditions consumed all the collapsed structural components, along with the home's contents.

Aerial view of area effected by explosion.
(Courtesy of NBC News)

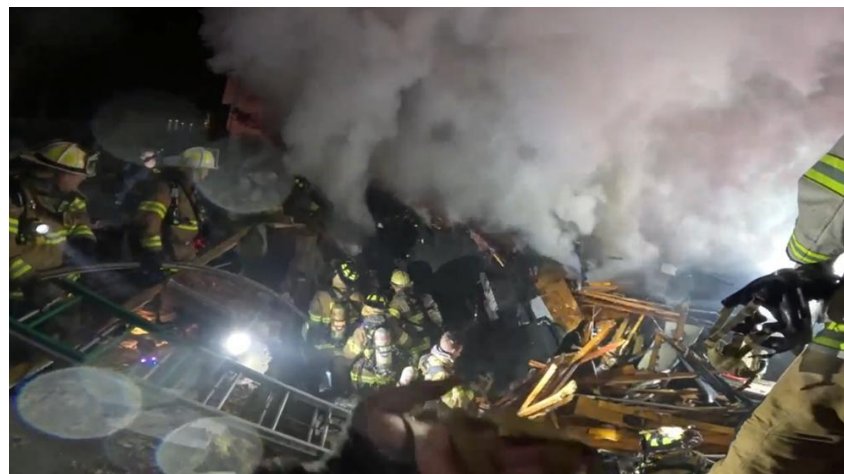
View of rescue operations.
(Courtesy of Fire Marshal's Office)
