# SERIOUS INJURY REPORT

REPORT F2024-03 • April 2025

## ***Career Firefighter Seriously Injured During Search Operations in a Residential Structure Fire – Oregon***

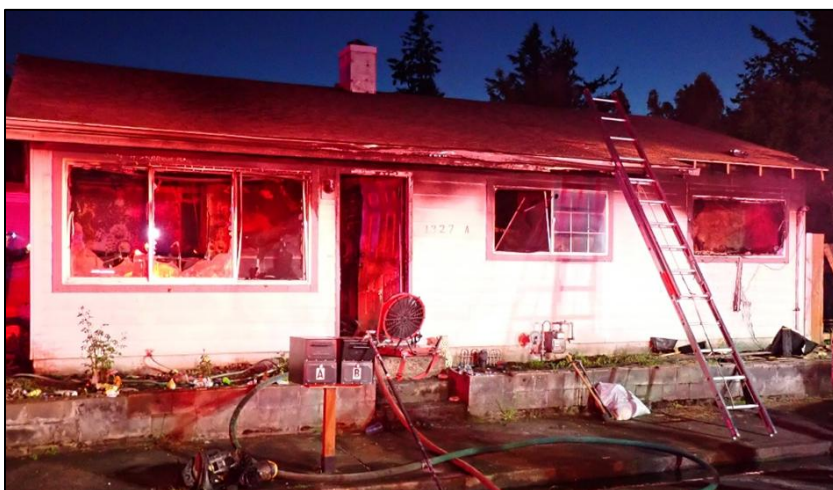
**Photo 1: Side Alpha of the structure post-fire.**  
(Courtesy of the fire department)

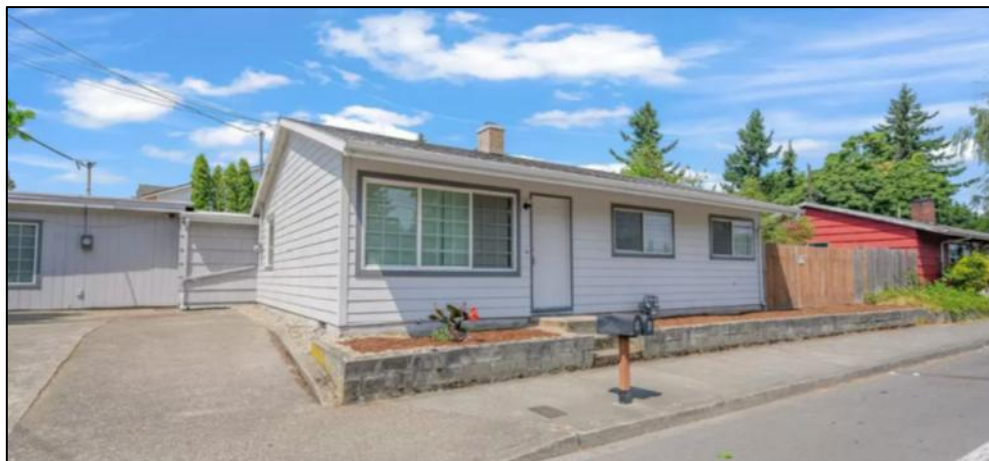
The one-story residential structure was a type V, wood-frame constructed building (see **Photos 2 and 3**). It was 936 sq ft and built in 1956. There was a 992 sq ft attached garage on the Bravo/Charlie corner of the building. In 2010, the garage was converted into a fully functional residence. There was no access from the main home to the converted garage. The fire building contained three bedrooms and one full bathroom. The living room, dining room, and kitchen were designed with an open floor plan. The interior finishes consisted of gypsum board walls and vinyl laminated flooring.

**Photo 2: Side Alpha of the structure pre-fire.**  
*(Courtesy of the fire department)*

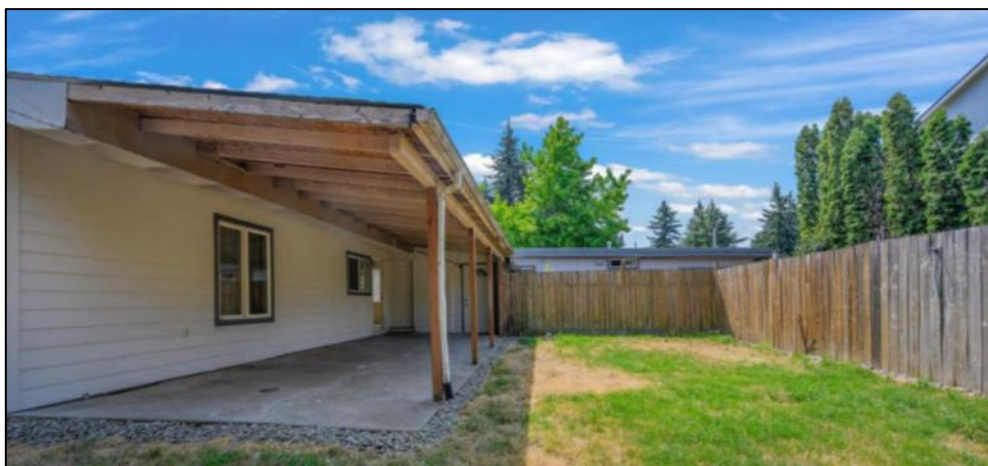
**Photo 3: Side Charlie of the structure pre-fire.**  
*(Courtesy of the fire department)*

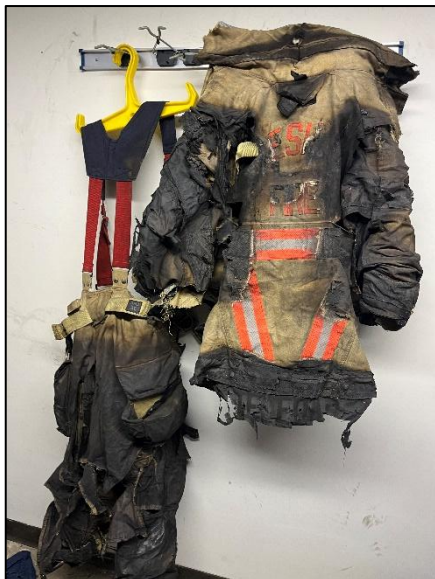
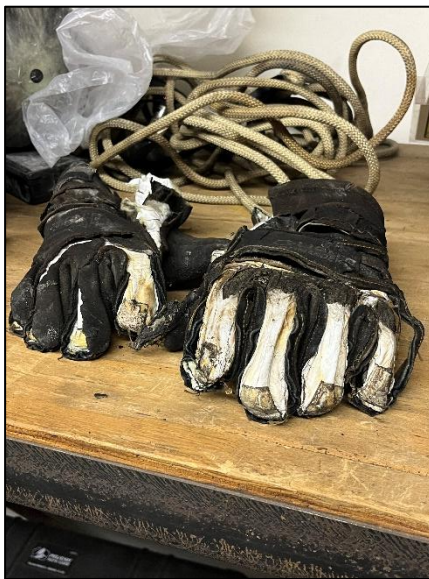
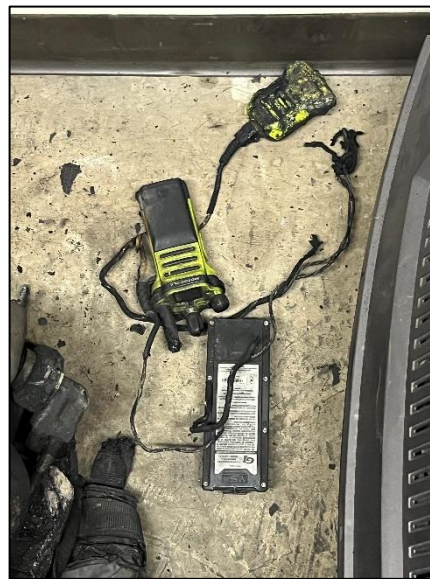
At the time of the SI incident, the seriously injured firefighter (E31FF1) was wearing full structural firefighting turnout gear and a NIOSH Approved® SCBA. The investigators examined and photographed the PPE (see **Photos 4a, 4b, and 4c**). Investigators noted that the portable radio worn by E31FF1 was worn in a radio pocket of the turnout coat with the remote speaker microphone (RSM) cable positioned around the firefighter's collar. This positioning first, directly exposed the cable to fire conditions and second, caused the radio to unintentionally transmit, which rendered the channel useless for fireground communications. Extensive thermal damage was noted to both the portable radio and RSM.

**Photos 4a, b, and c: E31FF1's structural turnout gear (4a), gloves (4b), and portable radio showing extent of damage (4c).**  
*(Courtesy of NIOSH)*

Discussion: In this incident, E31FF1 was able to self-rescue out of a window but sustained significant burn injuries. The portable radio he had was placed in a radio pocket of his turnout coat with the RSM cable positioned around his collar. This positioning directly exposed the cable to fire conditions, eventually causing the radio to unintentionally transmit, rendering the channel useless for fireground communications. Extensive thermal damage was noted to both the portable radio and RSM.

***Recommendation #6: Firefighters protect new and older radios and cables by wearing radio straps under their turnout coat, with the radio extended below the bottom of the coat, and with the antenna tilted away to protect the cable from damage.***

Based on other studies, the NFPA 1802 standard, and this SI incident, proper placement of portable radios entails wearing the radio on straps, under the turnout coat, and with the radio extended below the bottom of the coat with the antenna tilted away to protect the RSM cable from melting (**see Photo 6**). This placement of the portable radio allows the RSM cable to be protected from direct exposure. Additionally, this placement significantly reduces the possibility of an entanglement hazard involving the RSM cable and improves signal strength from the radio antenna. A 2013 [report](#) by the Fairfax County Fire & Rescue Department includes diagrams for proper wearing of a radio strap and portable radio for interior firefighting operations. Fire departments may consider equipping firefighters with radio straps and updating standard operating procedures or guidelines to include proper use during interior firefighting operations. Fire academies and fire instructors may opt to include radio strap use in both entry level and advanced firefighter training.

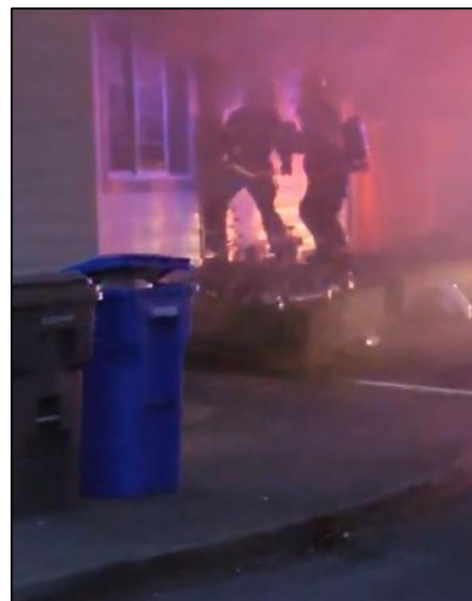
**Photo 5: E31FF1 and E31FF2 preparing to enter the structure.**  
*(Courtesy of the fire department)*

As E31FF1 and E31FF2 prepared to enter the structure (see **Photo 5**), R31 arrived on-scene. After hearing reports of a trapped child, a R31 firefighter (R31FF1) went to Side Charlie without notifying Command. Once he arrived on Side Charlie, a bystander stated there was a child in the bedroom that was hearing impaired. R31FF1 entered the structure on Side Charlie searching for the child. R31FF2 proceeded to E31 as E31's driver/operator (E31DO) pulled a 1¾ hoseline from the officer's side of the crosslay. The line was severely kinked due to failure of the webbing that secures the hose bed during travel releasing from the retention ring. As E31FF1 and E31FF2 entered the structure, Command realized the firefighters did not have a hoseline. Command made an announcement on the radio stating the E31 crew entered the structure without a handline and requested R31 to perform fire suppression on Side Alpha. At the same time, R31FF1 observed worsening conditions, exited Side Charlie, and returned to Side Alpha.

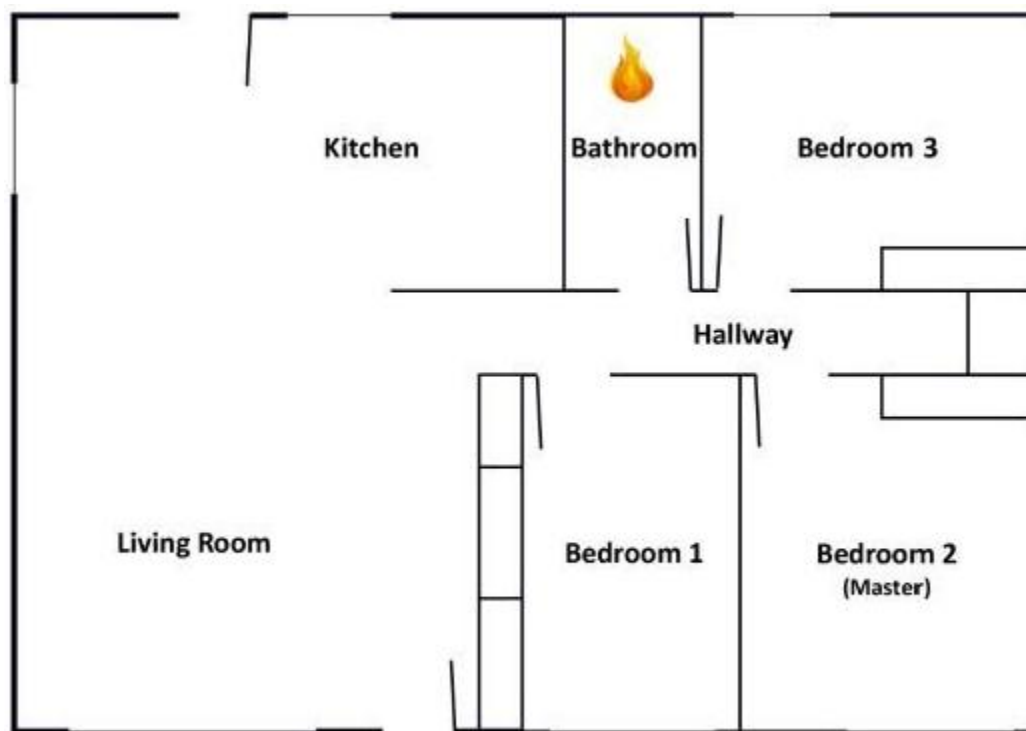
E31FF1 and E31FF2 proceed through the front door and made their way along the righthand wall of the open living room to reach a hallway (see **Diagram 1**). They made a right turn down the hallway. E31FF2 entered a bedroom on the right side of the hallway (Side Alpha) to conduct a search. While he was searching the bedroom, E31FF1 remained in the hallway but proceeded further down to look in the next bedroom (Alpha/Delta corner). He observed worsening conditions inside with a rapid increase in heat as firefighters on the outside observed the smoke coming from the Side Alpha door change from gray to black with a glow visible below the smoke layer. E31FF1 returned to the first bedroom and told E31FF2 that they need to exit the structure. E31FF1 led the way with E31FF2 following after exiting the bedroom. At the same time, E31DO charged the handline pulled from the crosslay. R31FF2 advised that there was no pressure in the line.

**Diagram 1: Floor plan, view from Side Alpha.**  
*(Courtesy of the fire department)*

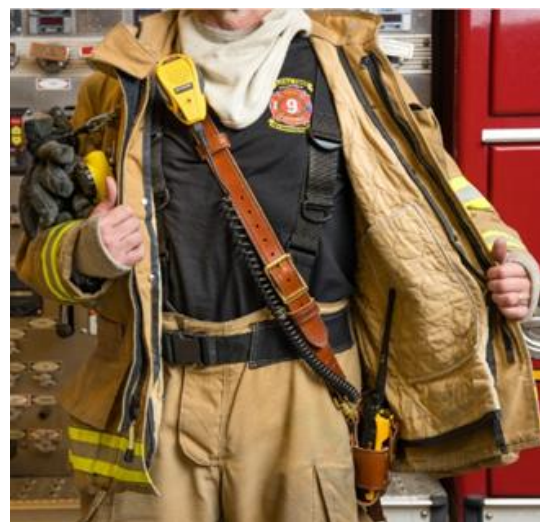
**Photo 6: Firefighter wearing portable radio on a strap under coat.**
