**SERIOUS INJURY
REPORT**
REPORT SLIDES

F2024-03

Career Firefighter Seriously
Injured During Search
Operations in a Residential
Structure Fire – Oregon

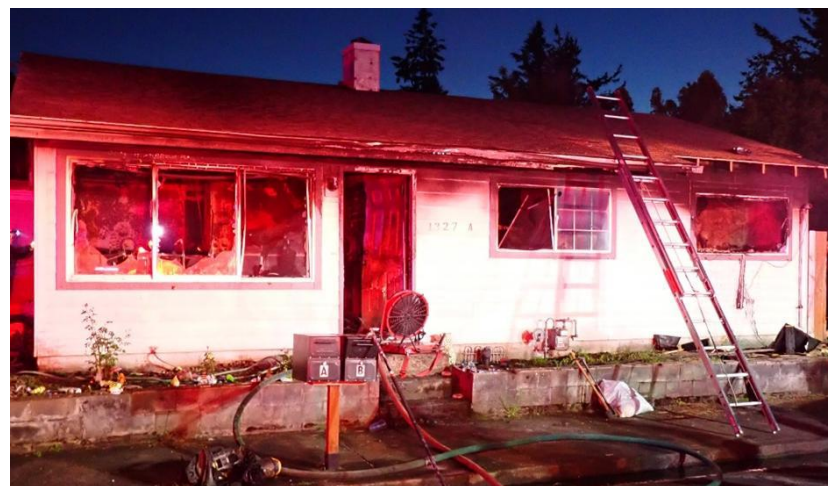
Side Alpha of the structure post-fire.
(Courtesy of the fire department)

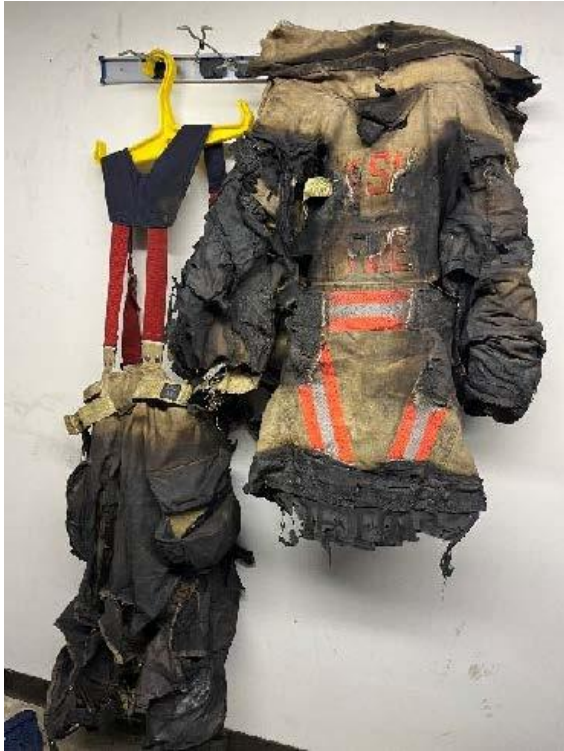
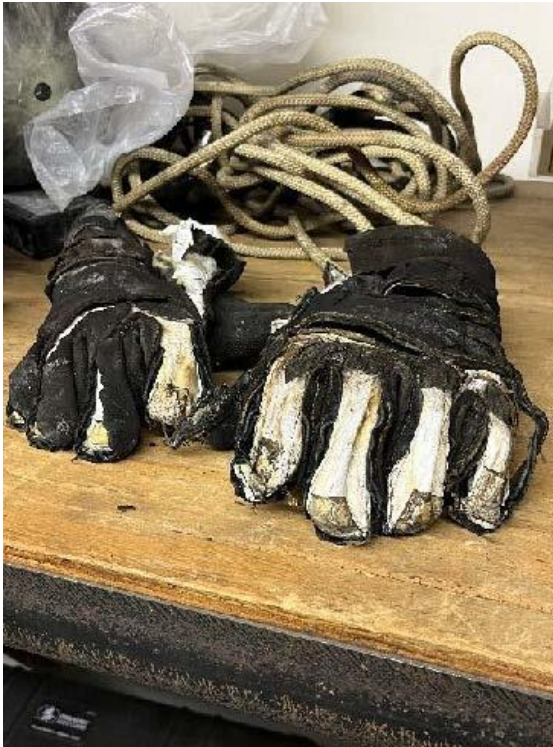
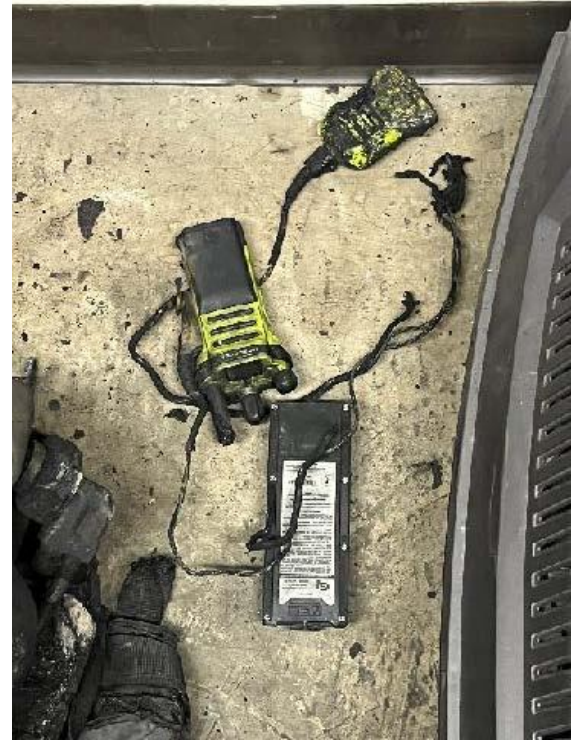
E31FF1's structural turnout gear (4a),
gloves (4b), and portable radio showing extent of damage (4c).
(Courtesy of NIOSH)

- Fire departments should ensure response plans include a dedicated and trained ISO.
- Fire departments should ensure firefighters protect new and older radios and cables by wearing radio straps under their turnout coat, with the radio extended below the bottom of the coat, and with the antenna tilted away to protect the cable from damage.
- Fire departments should ensure fire prevention efforts educate the community to help change knowledge, attitudes, and behaviors that can reduce risks, injuries, and fires within the community.
