# LINE OF DUTY DEATH REPORT

F2024-06

## ***Career firefighter dies and another injured while performing rapid intervention team tasks at vacant warehouse fire – Texas***

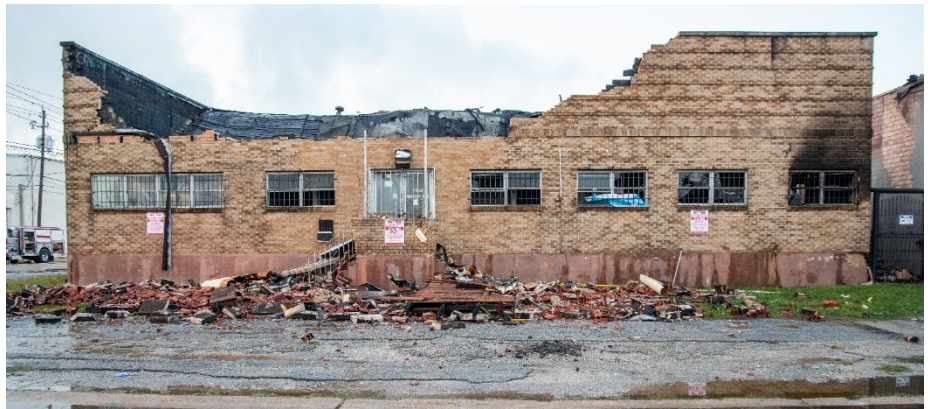
**Photo 1: Delta side of structure post-collapse.**  
*(Courtesy of the fire department)*

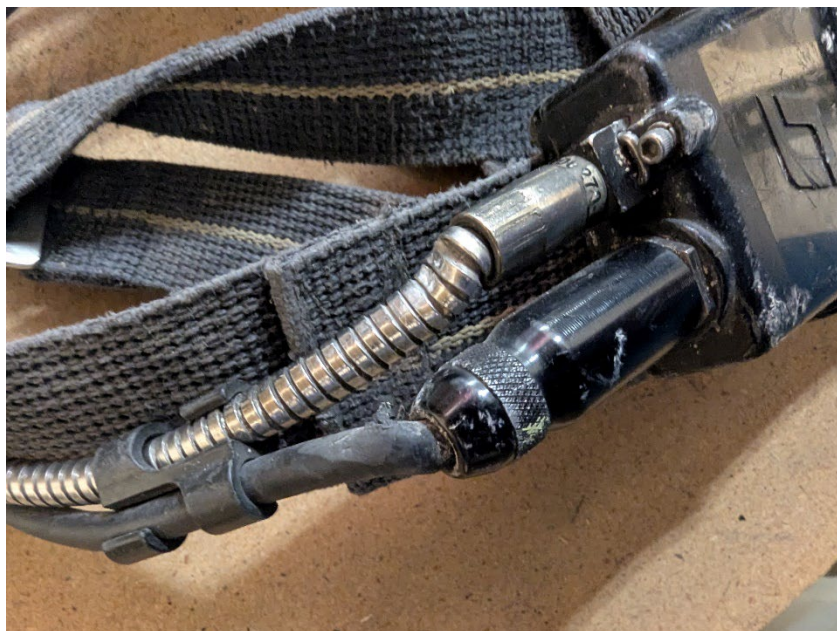
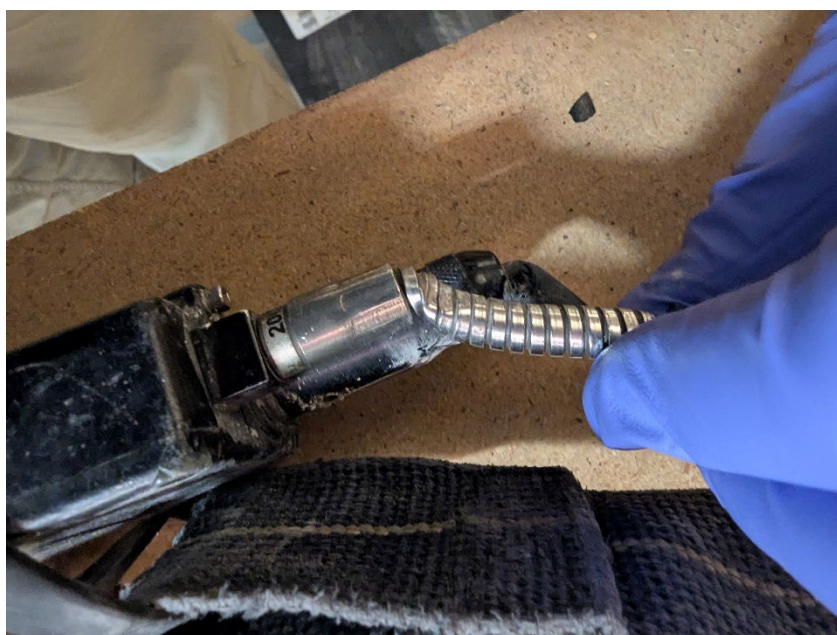
NIOSH investigators examined and photographed the PPE ensemble and SCBA of each firefighter at the arson evidence office. The SCBA of E23B had signs of crush damage to the high-pressure lines near the PASS device (See **Photos 2 and 3**). No evidence was identified to suggest that the SCBA units contributed to the fatality or injury.

**Photo 2 (top) & 3 (bottom): Show damage to the high-pressure hose near the PASS device of the deceased firefighter's SCBA. (Courtesy of NIOSH)**

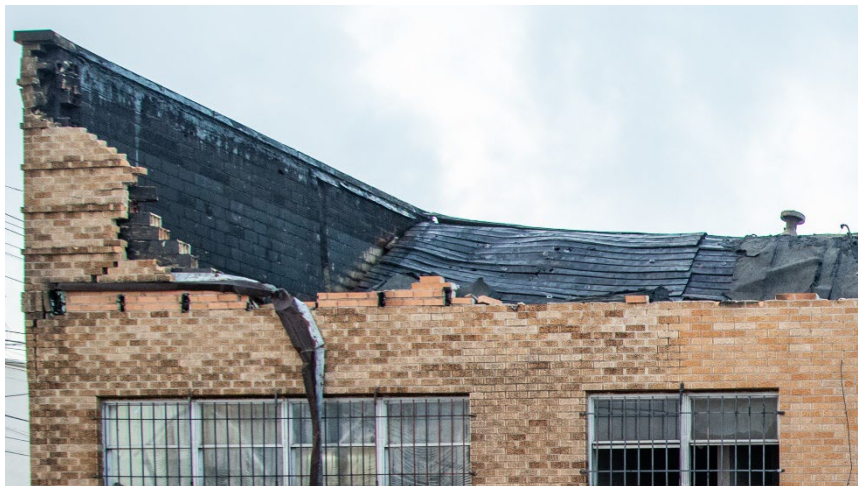
**Photo 4: Detail of Delta side wall showing the brick veneer over block wall, slots for previous canopy roof tie ins, roof surface covering. (Courtesy of the fire department)**

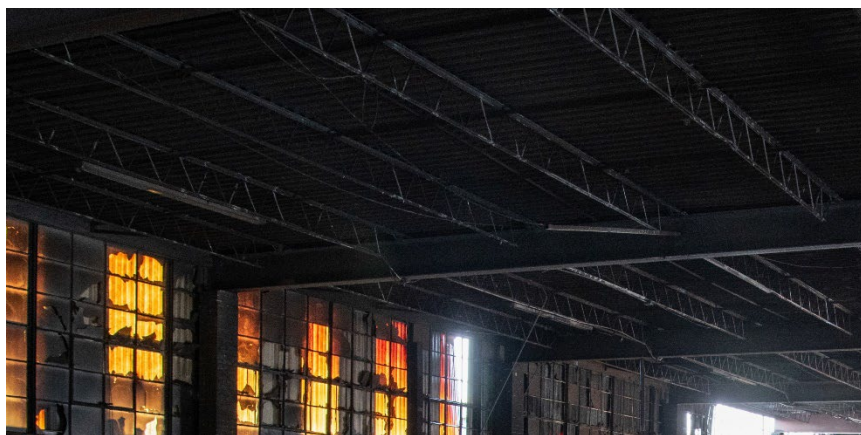
**Photo 5: Photo showing interior details of the building and roof construction. (Courtesy of the fire department)**

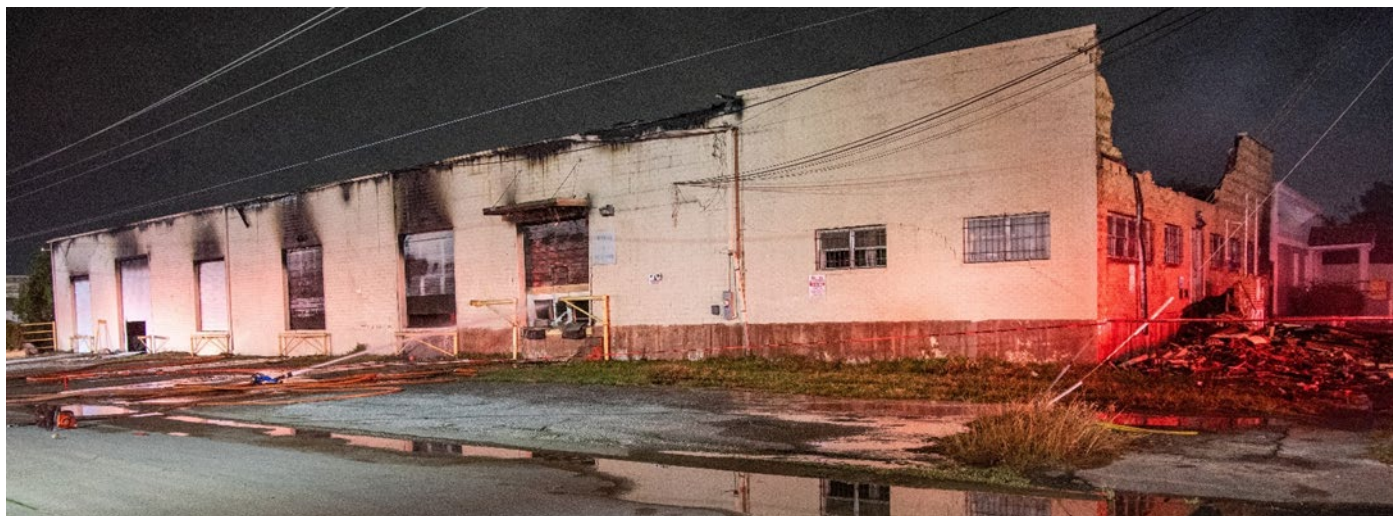
**Photo 6: View of the structure from the Alpha/Delta corner post collapse and during overhaul operations. (*Courtesy of the fire department*)**

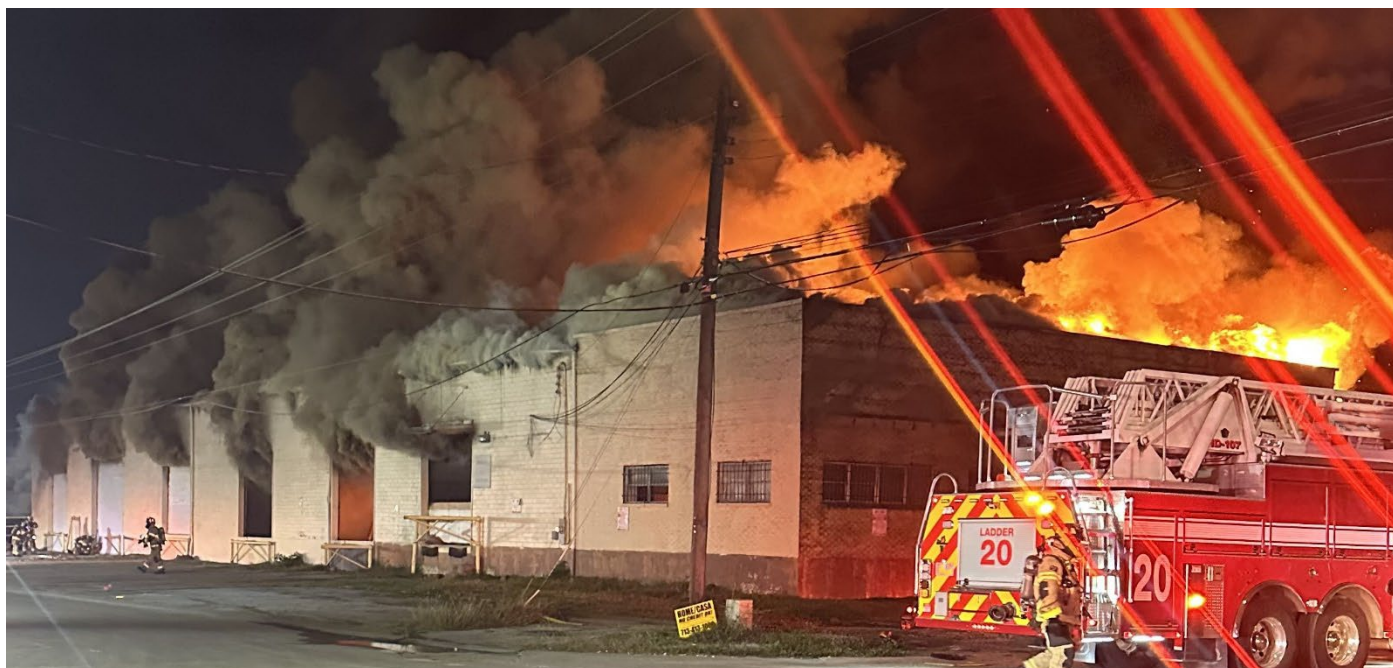
**Photo 7: Arrival conditions of L20 at the Alpha/Delta corner.**

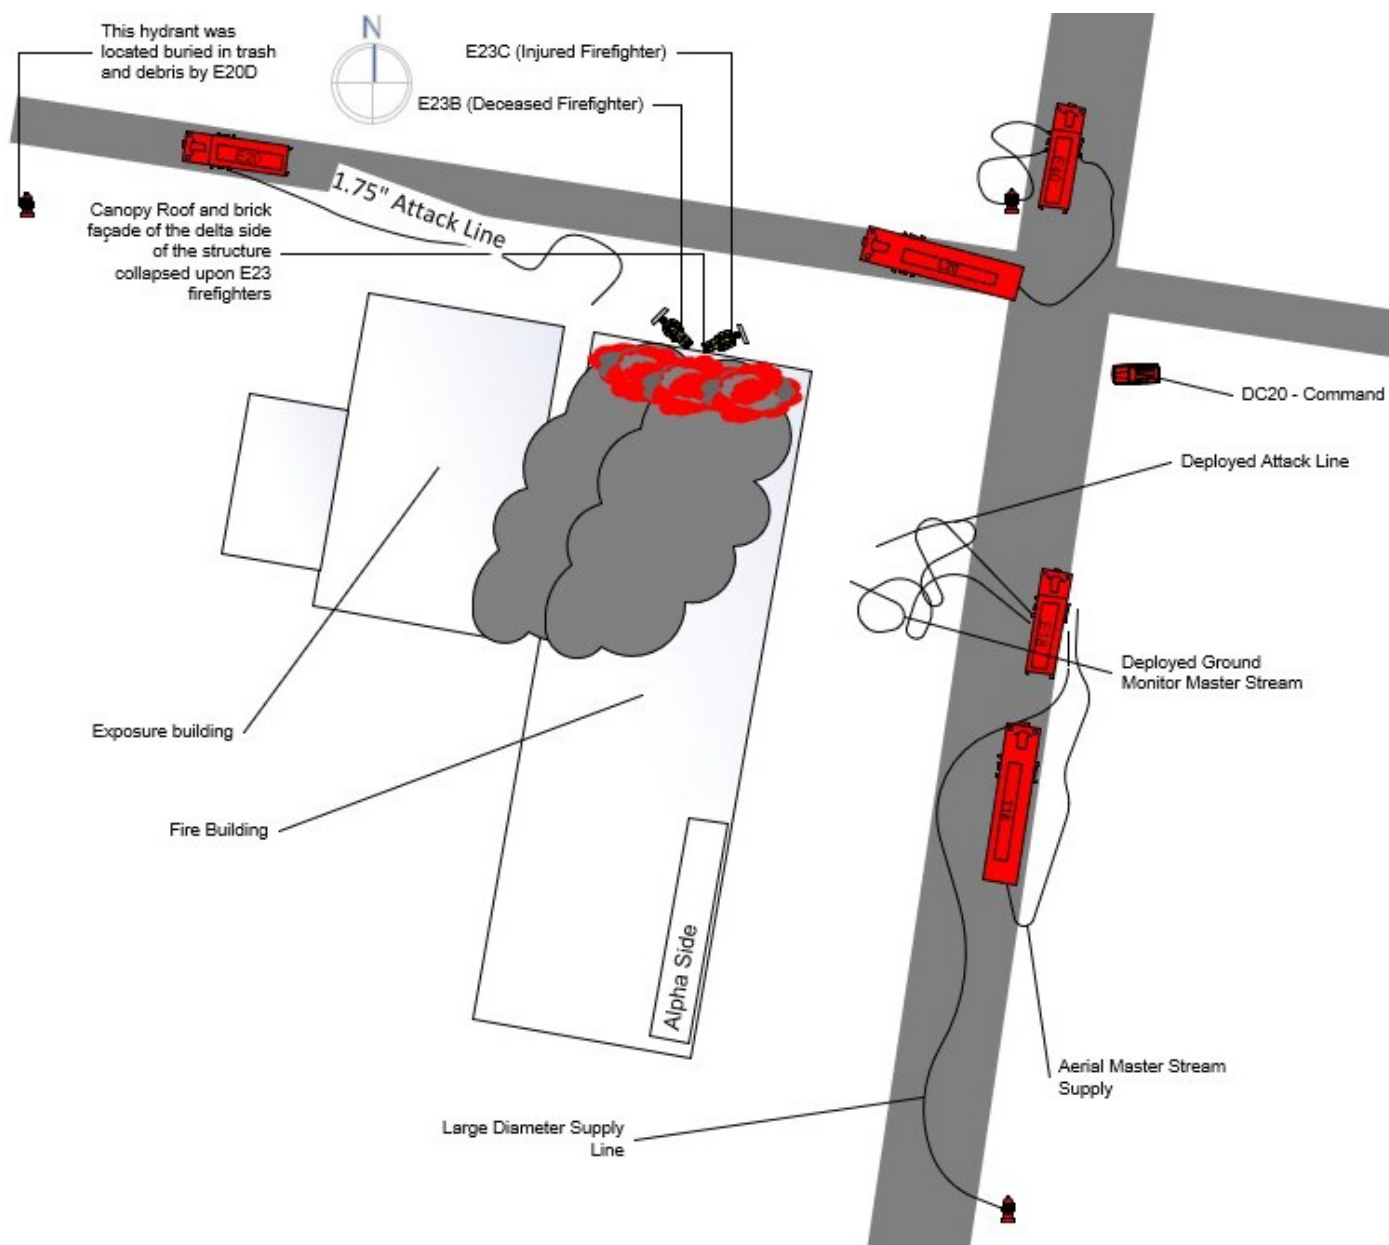
**Diagram 1: Scene layout from above at time of collapse. (Prepared by NIOSH)**
