Report of Investigations 8453

**Documentation and Analysis
of a Massive Rock Failure
at the Bautsch Mine, Galena, Ill.**

By Jack Touseull and Charles Rich, Jr.

**BUREAU OF MINES
Lindsay D. Norman, Acting Director**

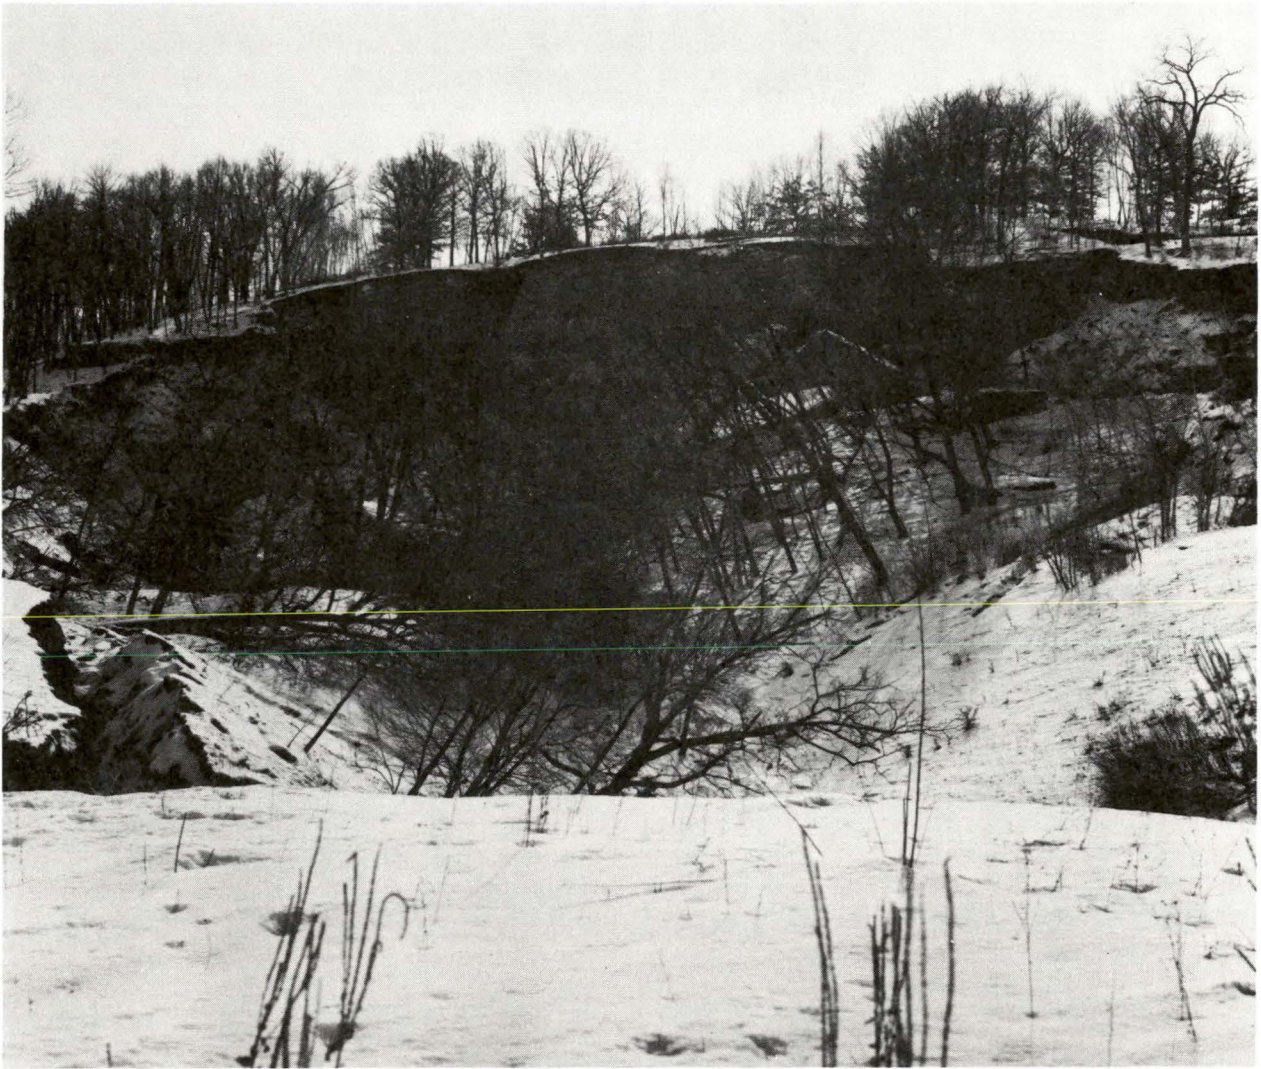
On November 15, 1972, the Bautsch mine—a lead-zinc mine in Paleozoic dolomites—experienced a massive rock failure³ (fig. 1) that led to the closure of the mine. A room-and-pillar mining system was being utilized at a depth between 160 and 400 feet (48.4 to 121.9 meters). Average extraction ratios were 81 percent in the failure area. Excessive extraction ratios was ruled out as a possible cause of the failure because many of these openings in the

FIGURE 1. - Surface failure over the Batsch mine looking south.

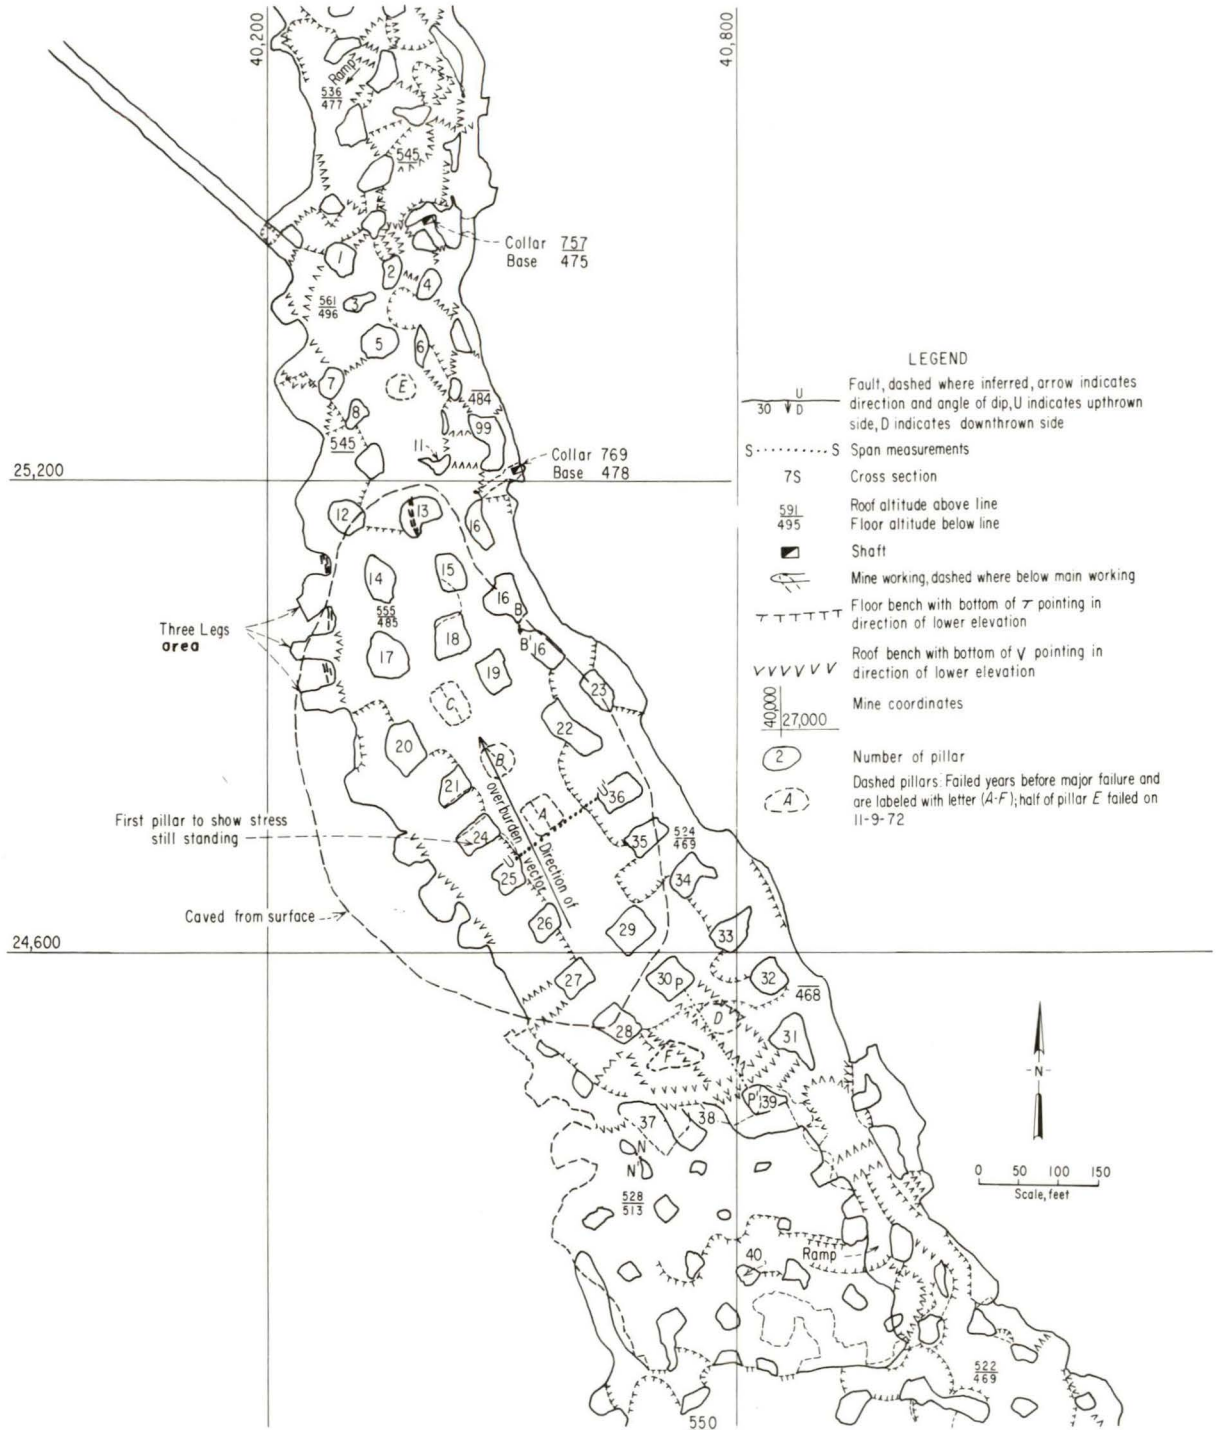
According to company information, the first signs of ground movement occurred underground in 1961 or 1962. Pillars A, B, and C failed near the center of the mine (fig. 4).

FIGURE 4. - Batsch mine failure area.

north of shaft 2. After dewatering in 1968, it was discovered that pillar D had failed during flooding by tipping over intact (private communication from Eagle-Picher Industries, Inc.).

In the area of failure (fig. 4), the pillars were generally rectangular and regularly spaced; however, at the southern and northern ends, the pillars were rectangular and irregular in shape (figs. 5-6), respectively. Average dimensions of pillars in the failure area were 92 feet (28 meters) vertically and 36.75 feet (11.2 meters) horizontally. Average spans in the area were 75 feet (25.5 meters), with the mine's maximum span of 130 feet (39.6 meters) along section line U-U' in figure 4.

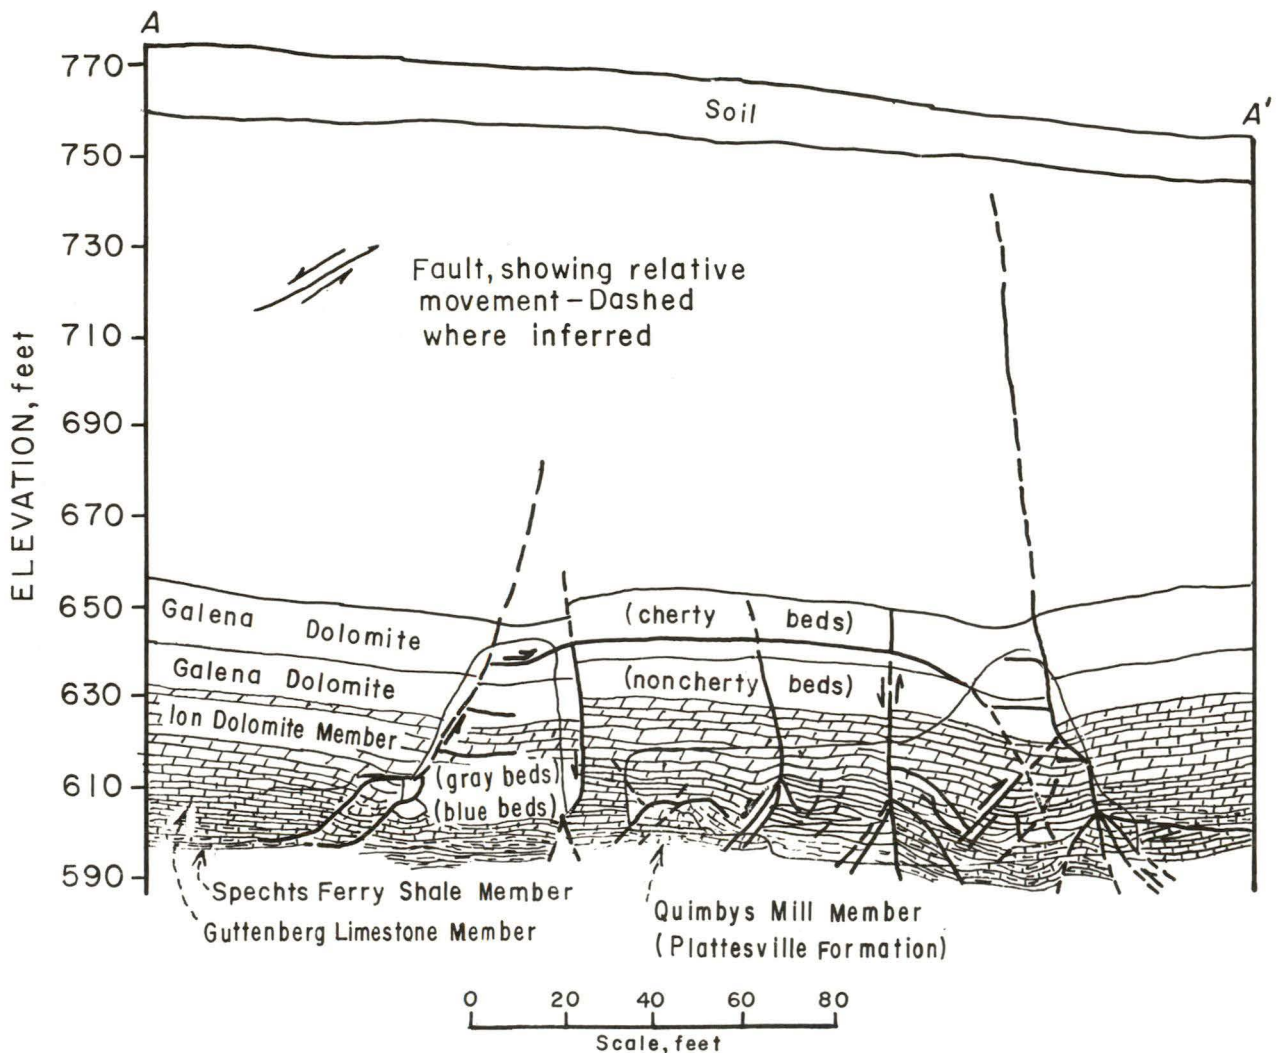
FIGURE 9. - Structural complexity and thinning in the incompetent beds of the Lower Decorah.

slope-- $\sim 79^\circ$ west--and appeared to be overhung. This slope is a result of the northeast limb of the fold containing steeper inclined joint sets and a more steplike fracture system (fig. 9).

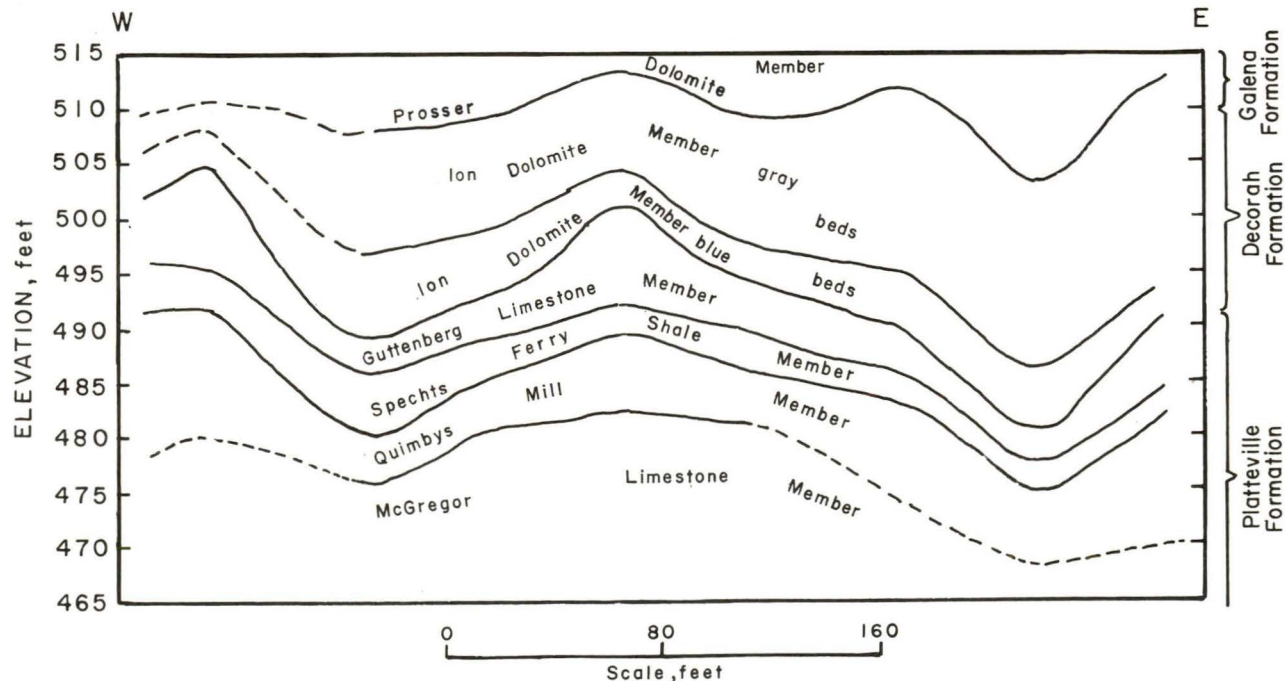
The Bautsch mine ore body is notable not only for its large size, but also for the unusually large amount of solution thinning that has led to marked accentuation of all the lithologic units (fig. 11). For example, two adjacent vertical drill holes obtained 13 and 7 feet (4 and 2.1 meters) of drill core for the Guttenberg Member, respectively.

FIGURE 11. - Cross section midway between shafts 1 and 2 of the Bautsch mine showing solution thinning of pre-Galena beds.

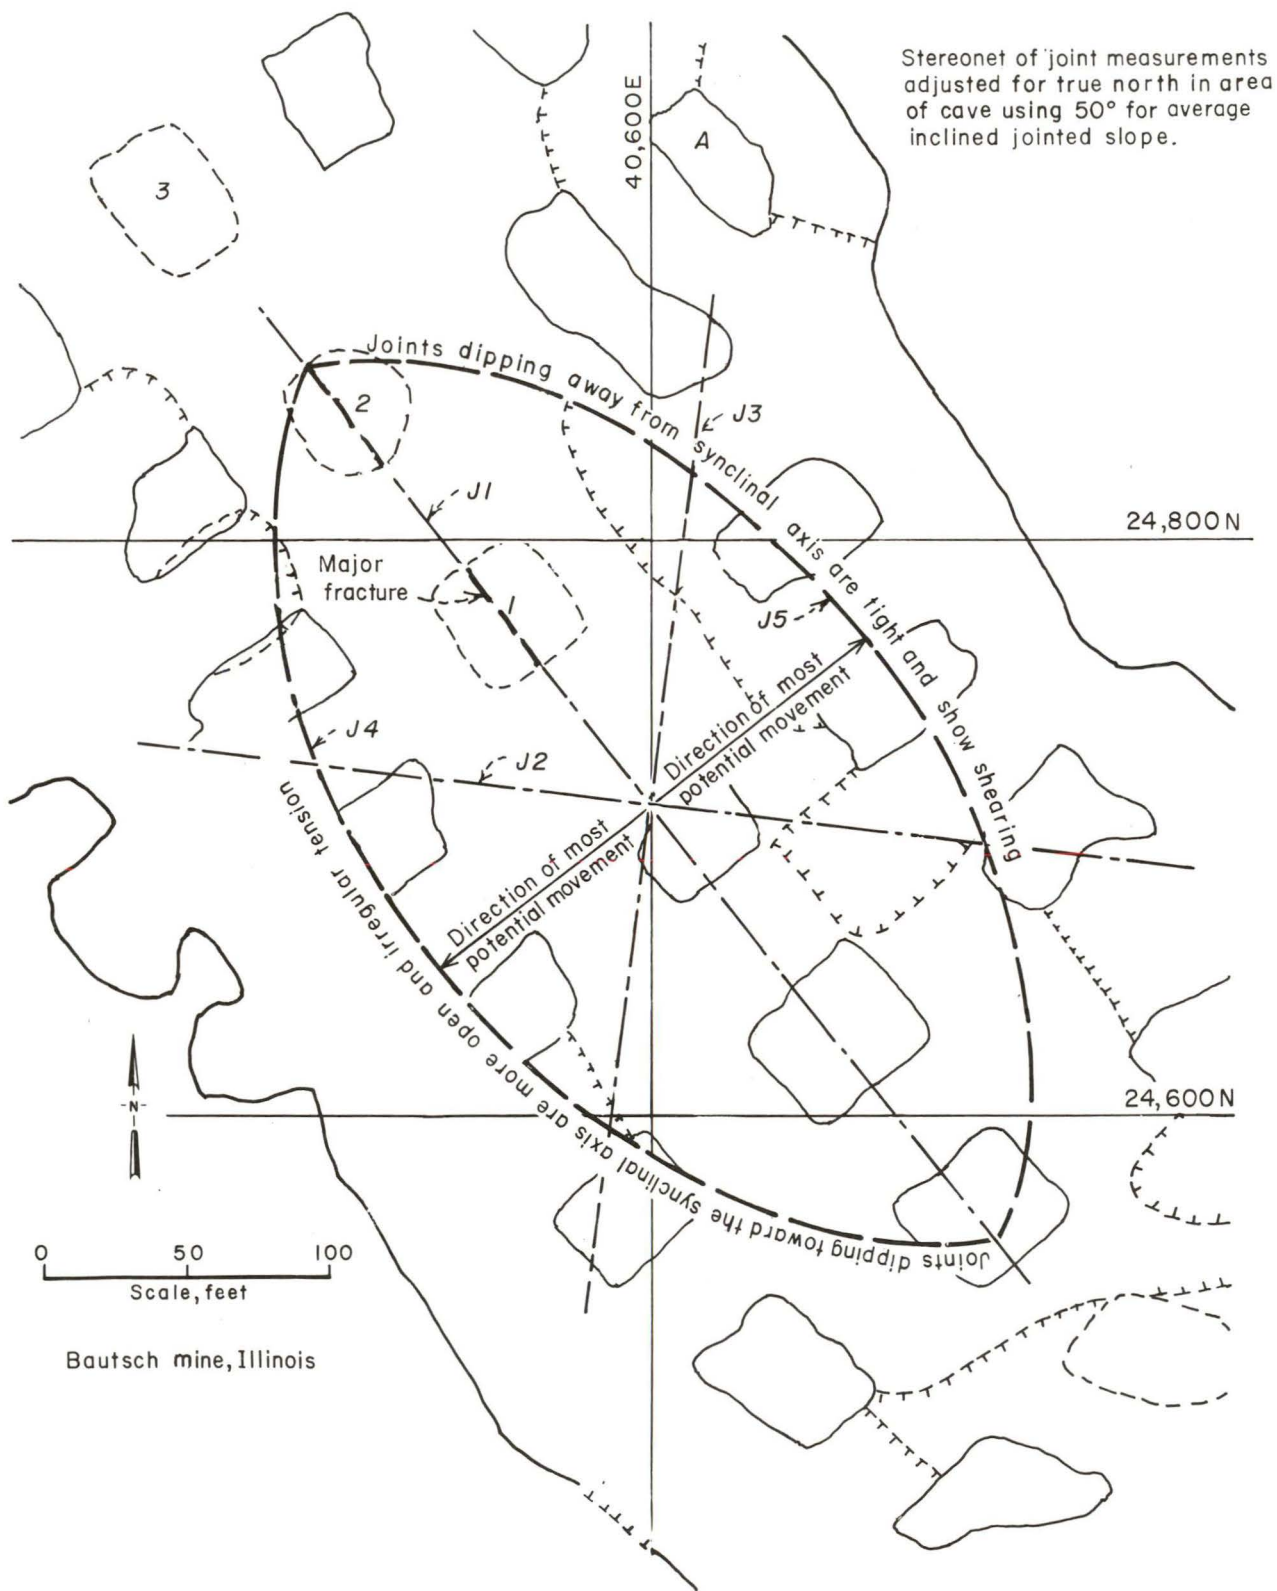
FIGURE 13. - Stereographic projection of joints in area of failure.

From an analysis of the fractures at the mine, it was evident that these features affected the mode of failure and the strength of supports. For example, a stereographic plot of joint set readings (including inclined sets) taken on the surface, in the area of failure, was made and corrected for true north. When the plot was overlaid on the area of failure (fig. 13), the following relationships were observed: (1) the direction of potential movement along sets J_4 and J_5 was approximately perpendicular to the long dimension of the mine; (2) vertical set J_1 projected directly along the major fractures underground; and (3) vertical sets J_2 and J_3 are orientated so that they can act as release surfaces for block movement.

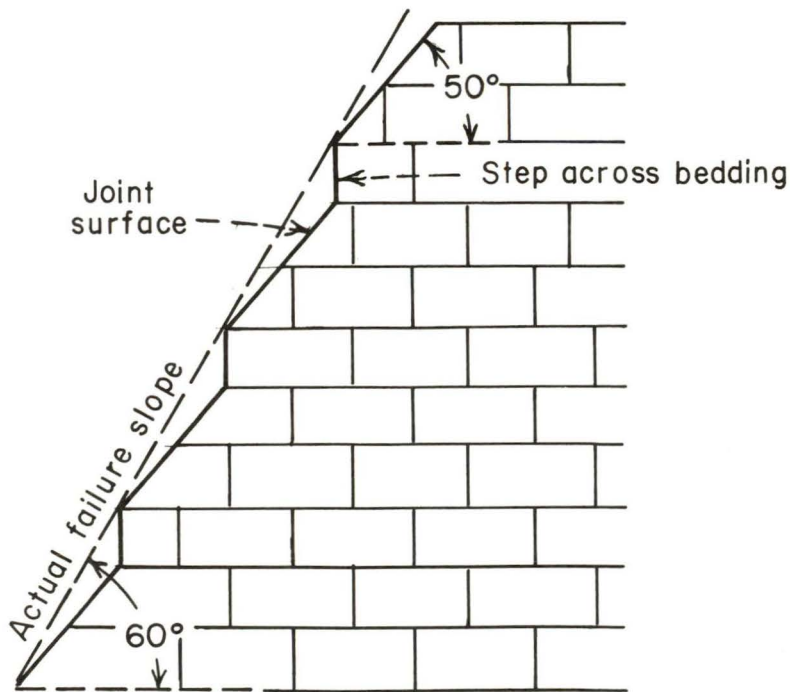
FIGURE 14. - Example of step failure along joint surfaces.

Calculation of the slope angle on the west side of the failure was about 60° east. The angle is slightly larger than the average dip of inclined joint sets in the district, but it is probably due to a steplike failure (fig. 14). This is a reasonable assumption because the inclined joints are not continuous, but zigzag across the bedding.

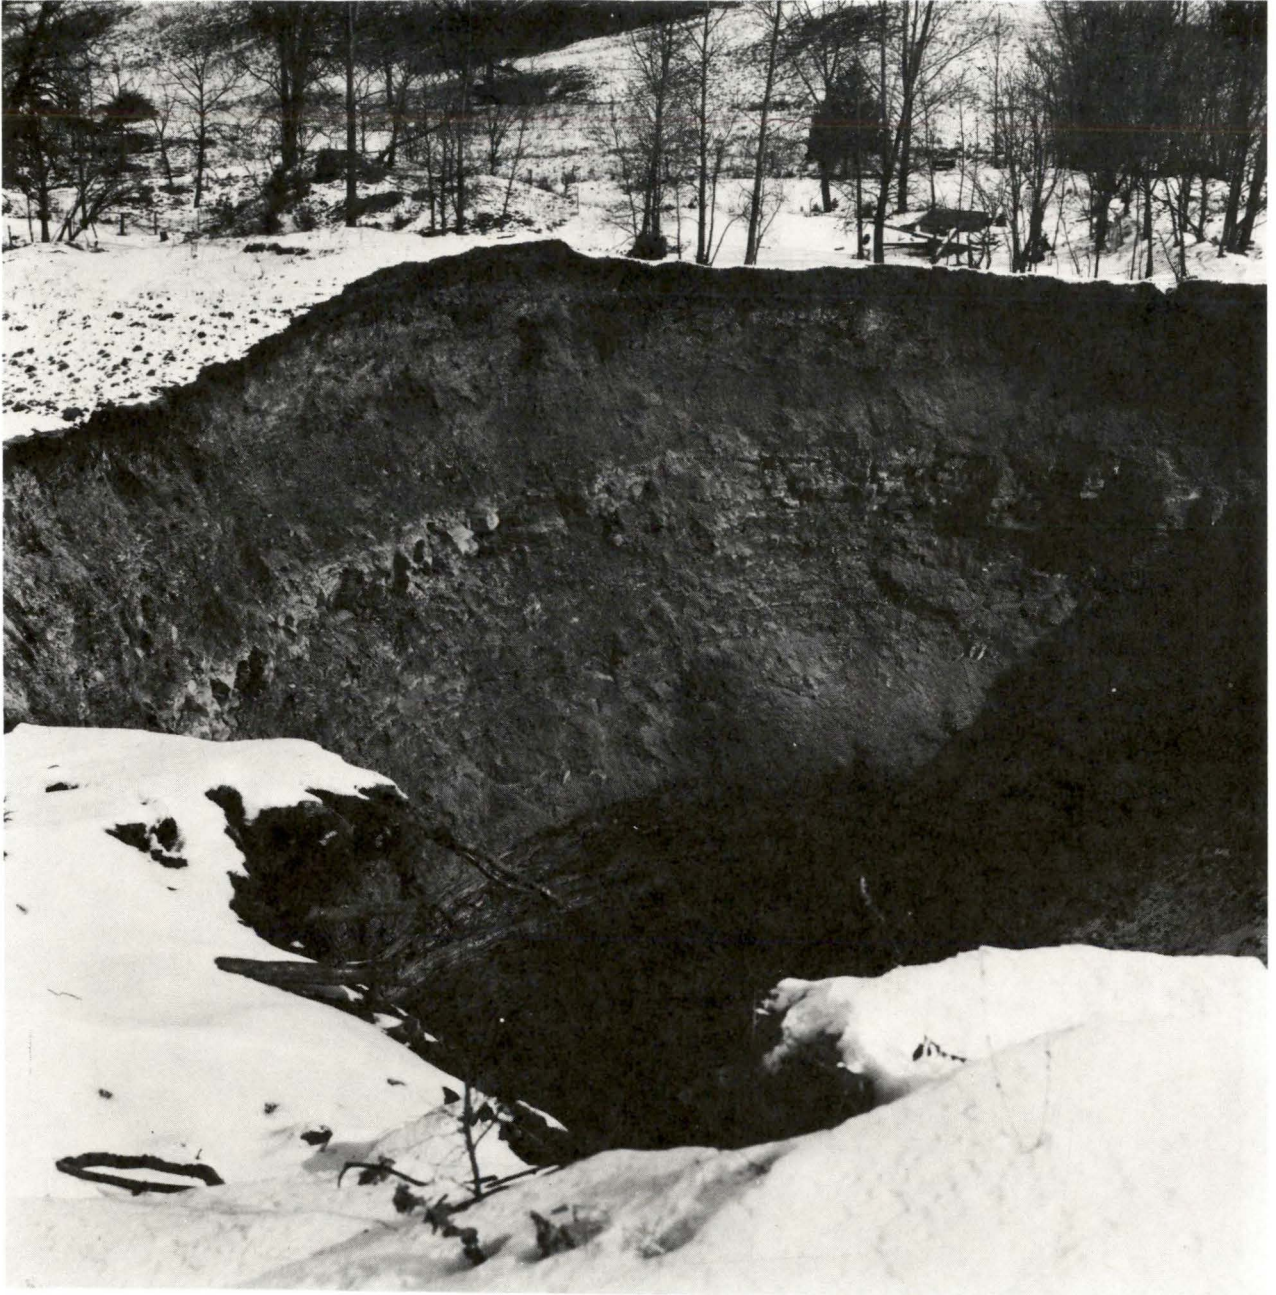
FIGURE 15. - Soil profile of weathered in situ rock at north end of Bautsch mine failure.

Evidence of inclined loading--resulting from the topography effect--consists of tensional cracks (fig. 17) that formed primarily around the southern end of the failure area. At the northern end (fig. 15), however, the failure was more sharp and showed less signs of tensional cracks.

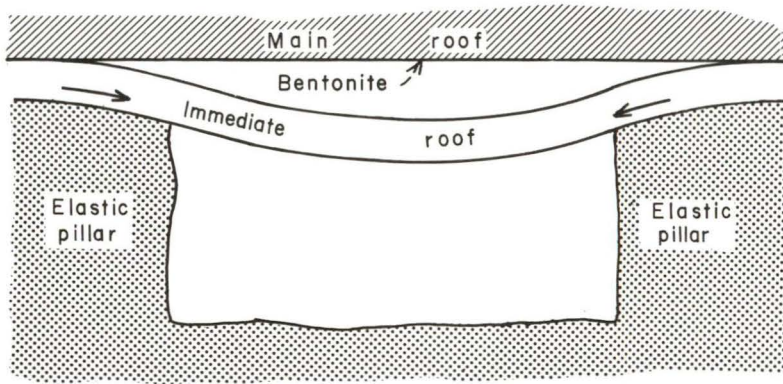
FIGURE 16. - Rotational forces on pillars produced by sagging roof.

It is possible that the sagging of the roof on one side of a pillar created rotational forces from a shifting of the center of gravity (fig. 16) in tall pillars and influenced failure. The existence of rotational forces is indicated in at least one instance when pillar D (fig. 4) failed by tipping over intact.

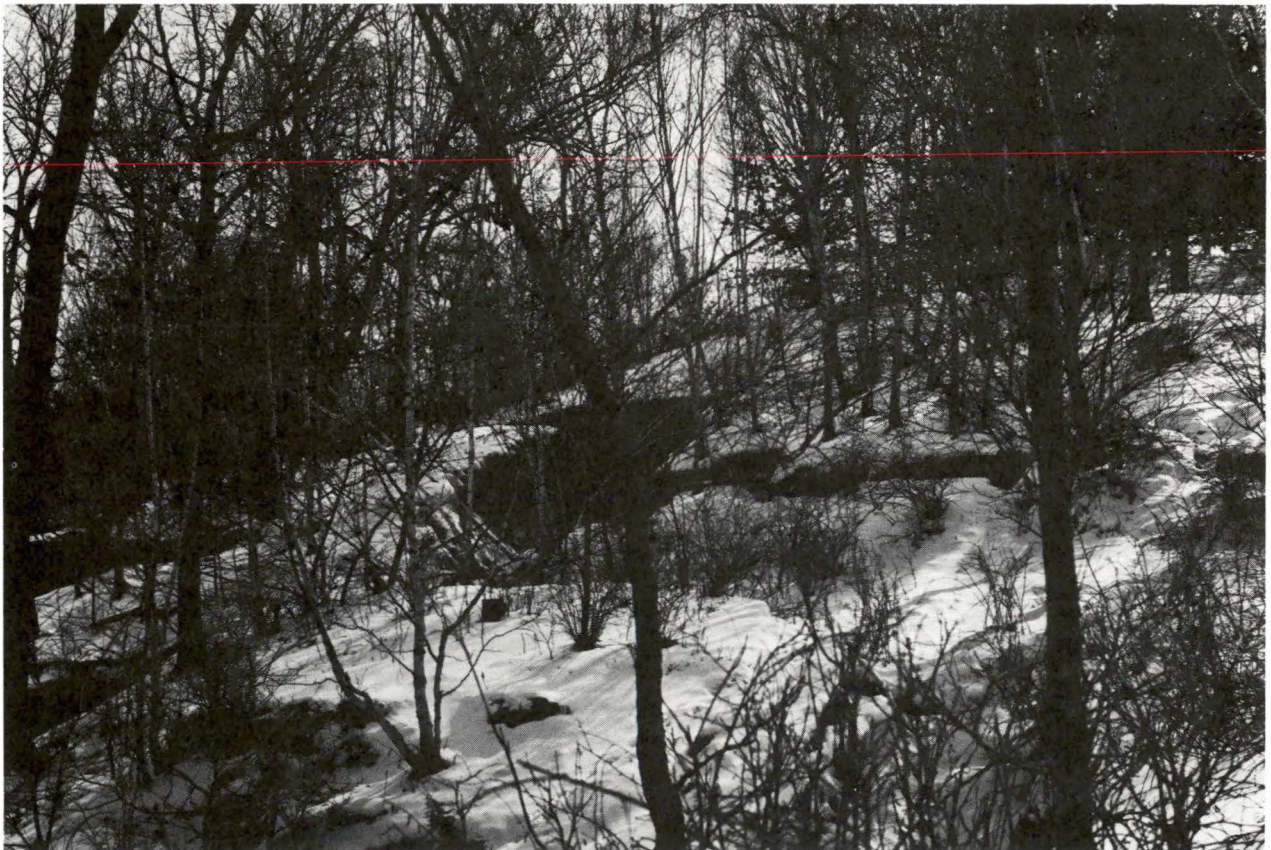
FIGURE 17. - Tensional cracks along southern end of Bautsch mine surface failure.

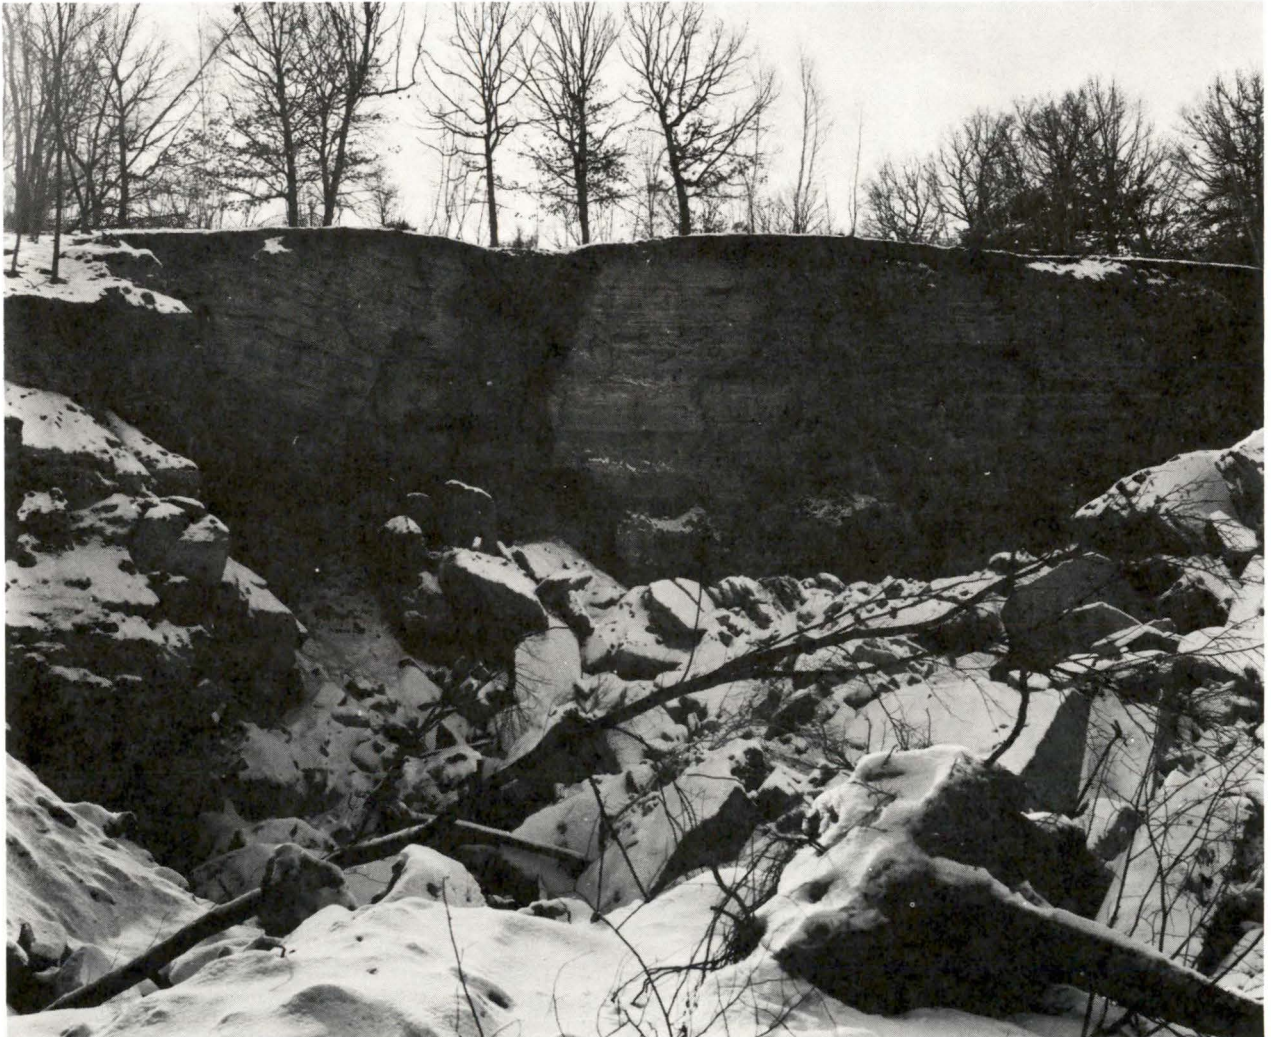
Ground troubles began as sporadic pillar slabbing and small roof falls along the western side of the mine. These events showed that pillars were taking on an added load and that bonding strength between thin slabs in the back was being exceeded. Initial failure activity concurs with previous events (that is, clay layer analysis) showing that the west side would be carrying a larger share of the load, therefore the west side would have a smaller safety factor and show the first signs of postfailure. Also, the initial activity at the northern end of the failure area occurred as a result of a lower time-lag for ground-water recharge through the thinner overburden (figs. 15 and 18) and location near the base of the hill.

FIGURE 18. - View of soil cover over south end of failure.

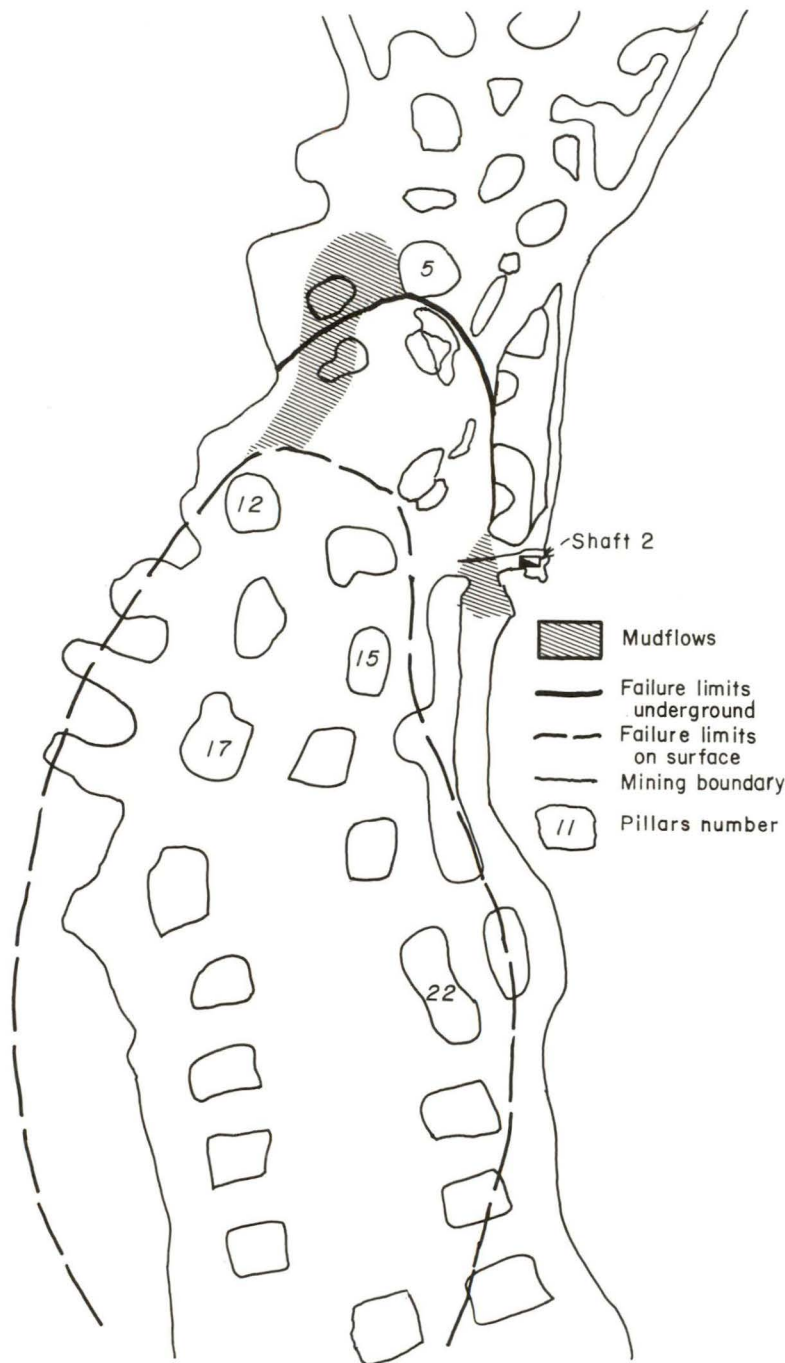
FIGURE 19. - Failure limits and mudflows underground.
