**Demonstrating the Noise Control
of a Coal Preparation Plant
Volume I. Initial Installation and Treatment Evaluation**

**Contract No. USBM H0155155
Demonstrating the Noise Control of a Coal Preparation Plant
Volume I.**

1. Report No.	2.	3. Recipient's Accession No.	
4. Title and Subtitle DEMONSTRATING THE NOISE CONTROL OF A COAL PREPARATION PLANT - VOLUME I. INITIAL INSTALLATION AND TREATMENT EVALUATION		5. Report Date September 1977

7. Author(s) Matthew N. Rubin		8. Performing Organization Report No. BBN Report No. 3631	
9. Performing Organization Name and Address Bolt Beranek and Newman Inc. 50 Moulton Street Cambridge, MA 02138		10. Project/Task/Work Unit No.

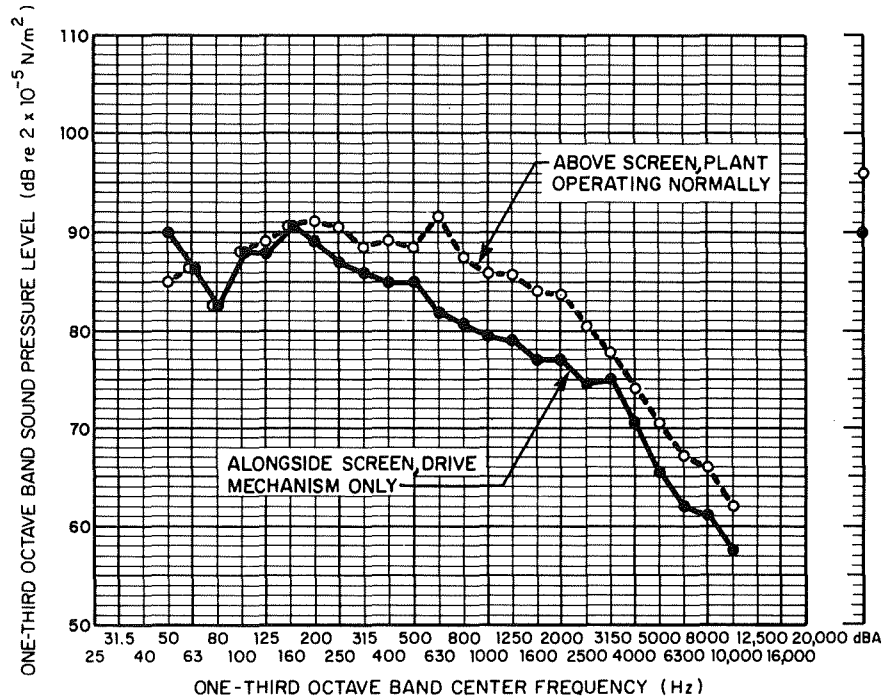
Level 2 contains the main section of the primary sizing screen. The sound level at Position A₂, alongside the screen, was 94 dB(A) during normal operation. The sound level with the primary screen running alone (without coal) was 90 dB(A); it represents the lowest noise level achievable with the installation of "quiet" screen decks. Figure 13 shows the 1/3-octave band sound spectra measured with the plant operating normally and with the shaker running alone without coal. It can be seen

FIG. 13. PRIMARY SCREEN AND DRIVE MECHANISM NOISE.

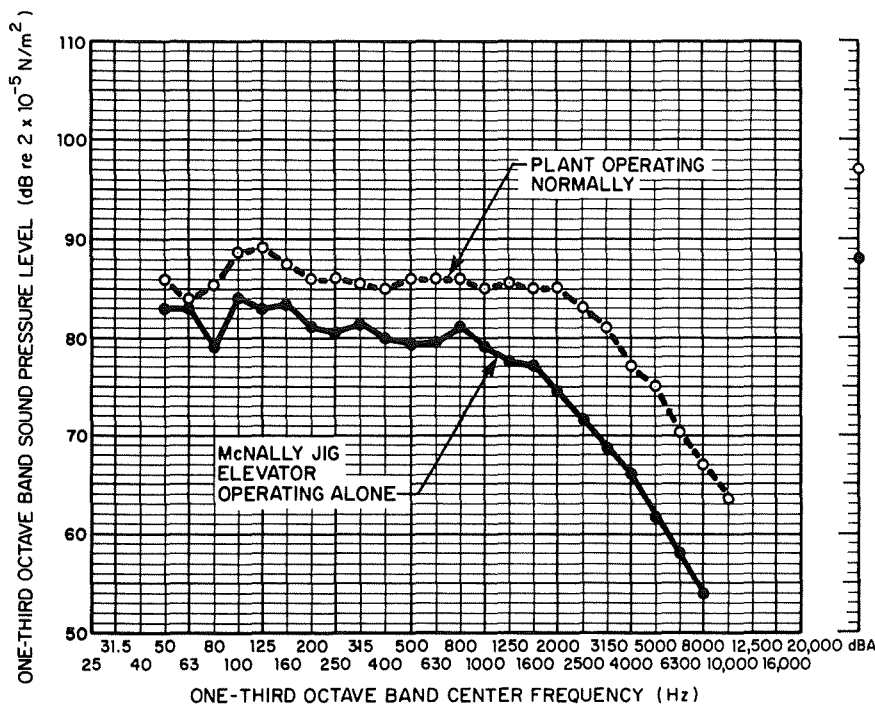
Figure 14 shows the A-weighted 1/3-octave band sound spectra measured at Position E₂, 6 ft behind the No. 2 jig refuse chute. The two conditions represented are the original sound levels with the plant operating normally [97 dB(A)] and the jig elevator operating alone without refuse [88 dB(A)]. The latter spectrum

FIG. 14. McNALLY JIG REFUSE ELEVATOR NOISE.

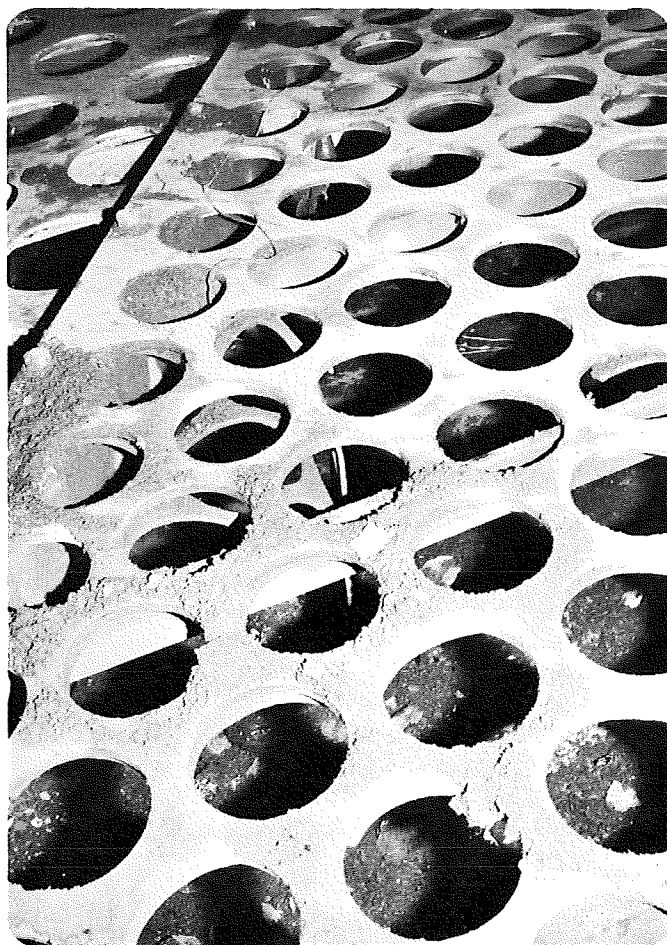
The screen was installed on 26 July 1976. After approximately 1 month of service, the damping material began to separate from the steel screen. After 2 months of service, approximately 50% of the EAR material was torn from the steel deck (see Fig. 22). Once the separation began, it progressed rapidly.

FIG. 22. EAR-DAMPING MATERIAL TORN FROM UNDERSIDE OF STEEL SCREEN (CENTER).

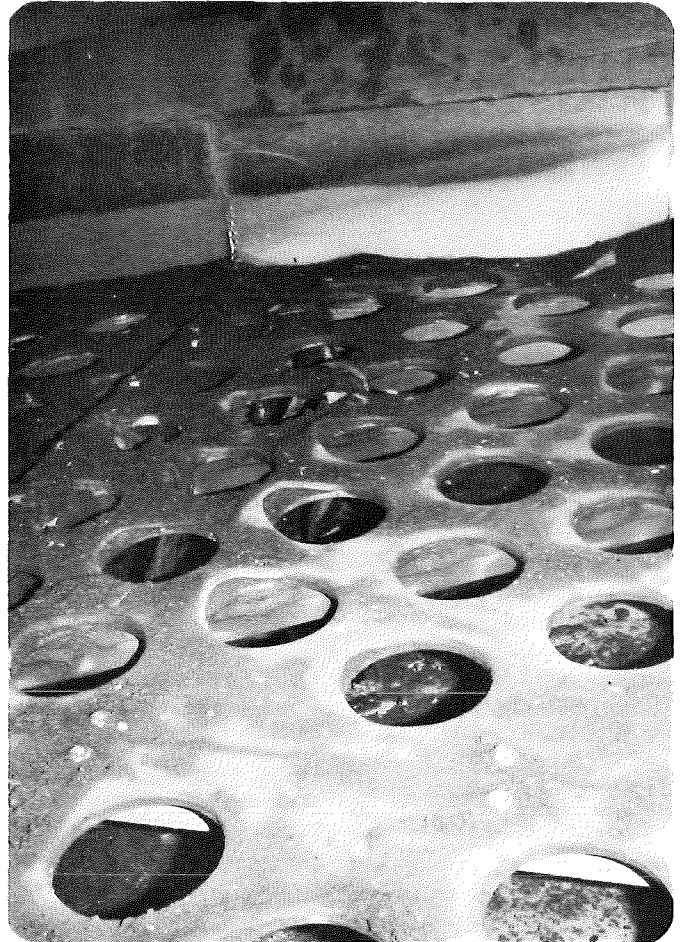
interfere with the product flow, the production was not affected by the use of the screens. Removal after 4 months of service was necessitated by separation of the layers, not by wear of the resilient top layer. The original steel screen life was about 2 years.

FIG. 23. SEPARATION OF TUFFGARD-80 DUROMETER LAYER FROM STEEL SCREEN AFTER 2 MONTHS OF USE.

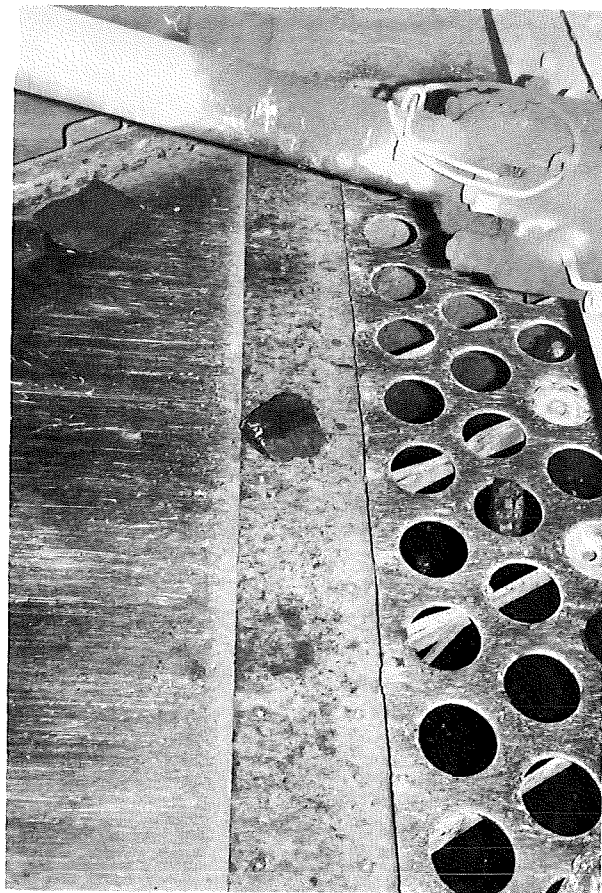
The noise reduction at the picking table was 3 to 4 dB(A); however, this result reflects the combined effect of this treatment and treatments of the McLanahan rock crusher infeed chute. The use of the Armaplate pad did not noticeably affect the flow of material over the picking table.

FIG. 29. GOODYEAR ARMAPLATE (1/2 in.) INSTALLED BETWEEN THE TAIL END OF PRIMARY SCREEN AND LEADING EDGE OF PICKING TABLE.

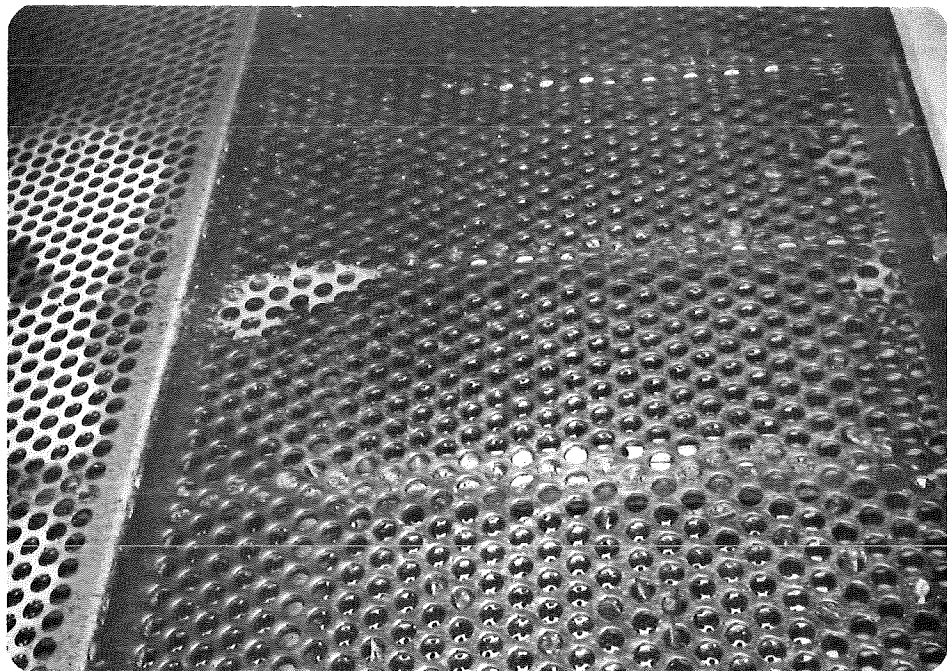
The two panels were installed on 22 January 1976. They performed reasonably well for approximately 5 months after installation, with the amount of blinding within the acceptable range for this shaker (10 to 15%). After approximately 5½ months of operation, the forward edge of the upper screen began to show some separation between the rubber and steel plate. In addition, one worn patch appeared on the upstream side of the screen. At the end of 6 months of service, the upper screen was reversed so that the worn areas were now on the downstream side (Fig. 36). This servicing required 2 men for 1½ hours. Over the next 6 months,

FIG. 36. HENDRICK RUBBER-CLAD SCREEN DECK ON SECONDARY SHAKER AFTER ROTATING AND REINSTALLATION.

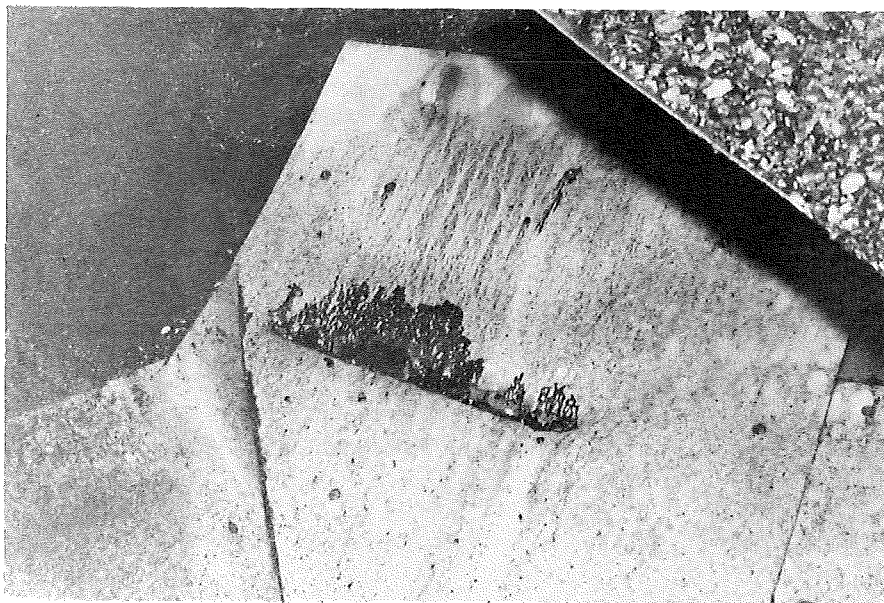
FIG. 59. WORN AREA IN MINALOY BIN LINERS AT DISCHARGE OF CLEAN-COAL DESANDING SHAKERS.

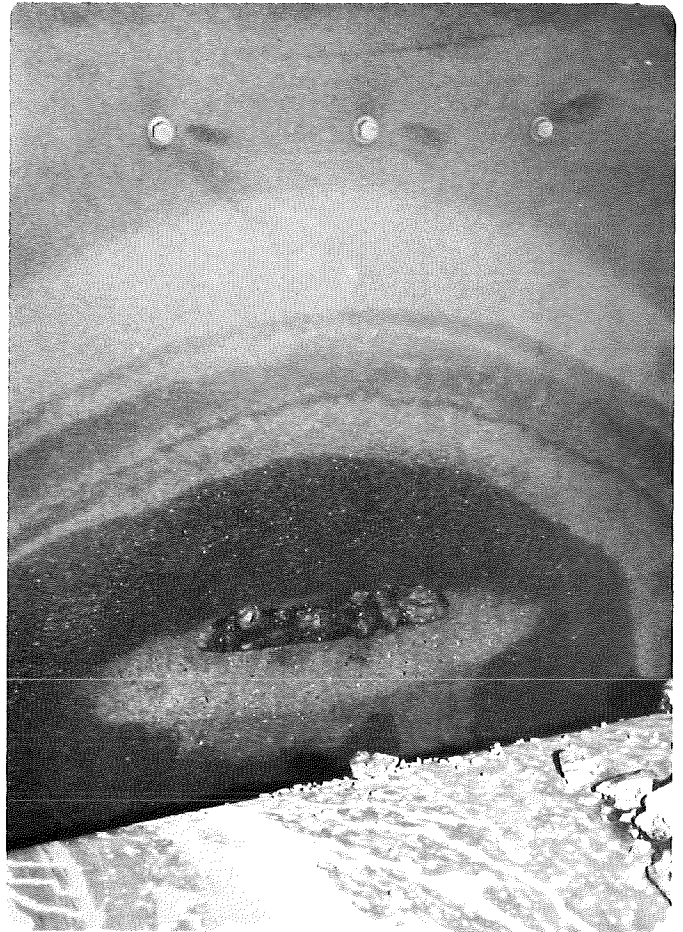
9.0	1-1/2-in.	\$33.00	6	Head end of 7xl-1/4 clean coal belt	12/17/75	9/4/76	Pad worn through at center; replaced with Trelleborg.
Trelleborg	VP plate profiled trellex 60	9.0	2-3/16-in.	\$66.00	4	Head end of 7xl-1/4 clean coal belt	9/4/76	6/23/77	Pad worn out at center.

FIG. 63. URETHANE PAD AT HEAD END OF $7 \times 1\frac{1}{4}$ CLEAN-COAL BELT AFTER 8 MONTHS OF USE. NOTE WORN AREA.

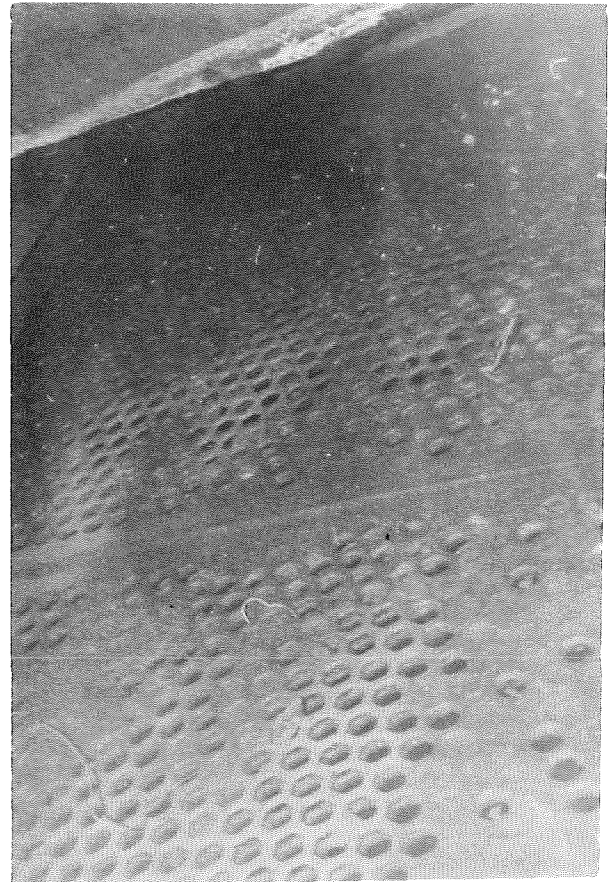
FIG. 65. SEPARATION AND BLINDING OF RESILIENT SCREEN DECKS OF RIPL-FLO VIBRATORS (AFTER 6 MONTHS OF USE).

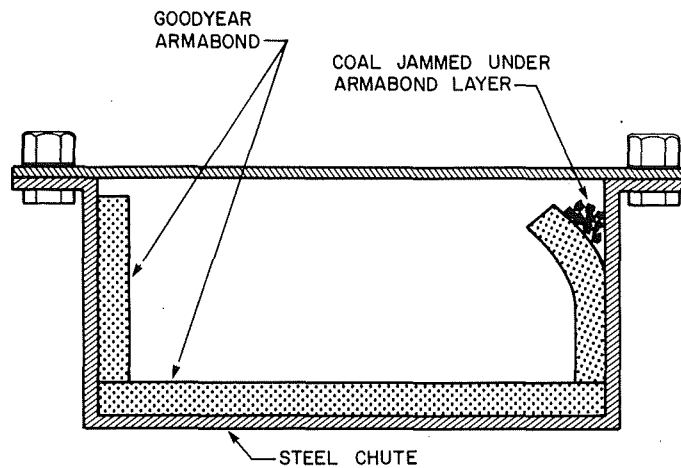
FIG. 69. CHUTE NO. 4 CROSS SECTION, SHOWING LOCATION OF ARMABOND SEPARATION.
