A mining research contract report  
December 1985

# GEOLOGIC CONDITIONS AFFECTING COAL MINE GROUND CONTROL IN THE WESTERN UNITED STATES

OFR 86-63

Contract J0145032  
Goodson & Associates, Inc.

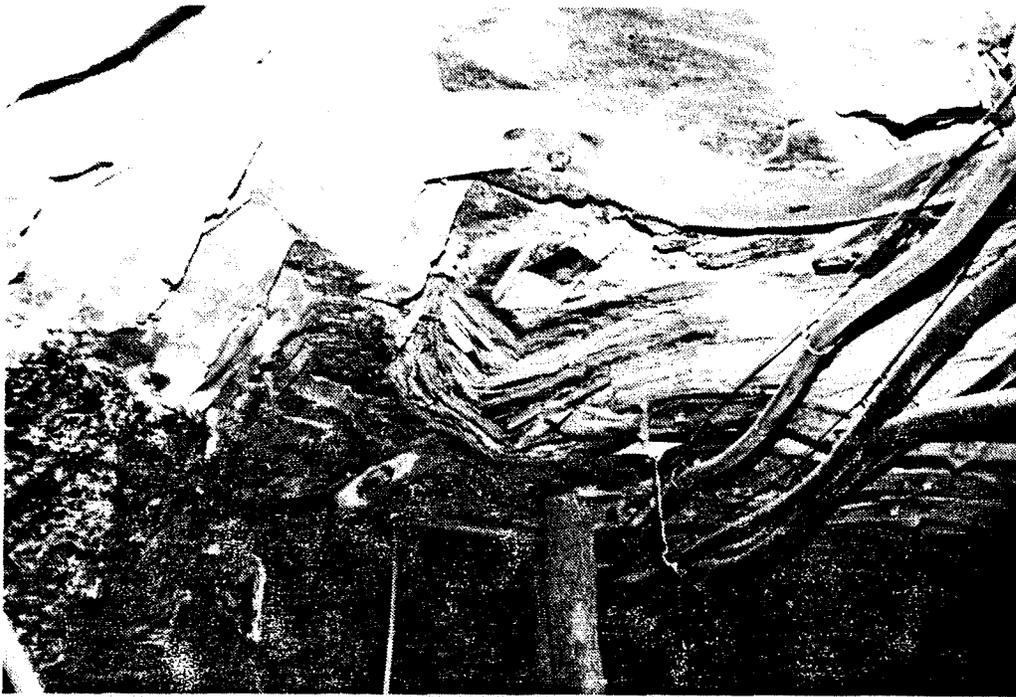
PLATE 14. - "Roof cutter" in crevasse-splay deposit, western Book Cliffs Coal Field, Utah. Brittle sandstone and siltstone laminations have fractured and delaminated adjacent to a pillar. Stress, produced by an overburden thickness of 1600 ft., is inferred to have contributed to this fracturing of the thin, brittle sandstone and siltstone laminae of a crevasse-splay deposit. Mats are 8 in. wide.

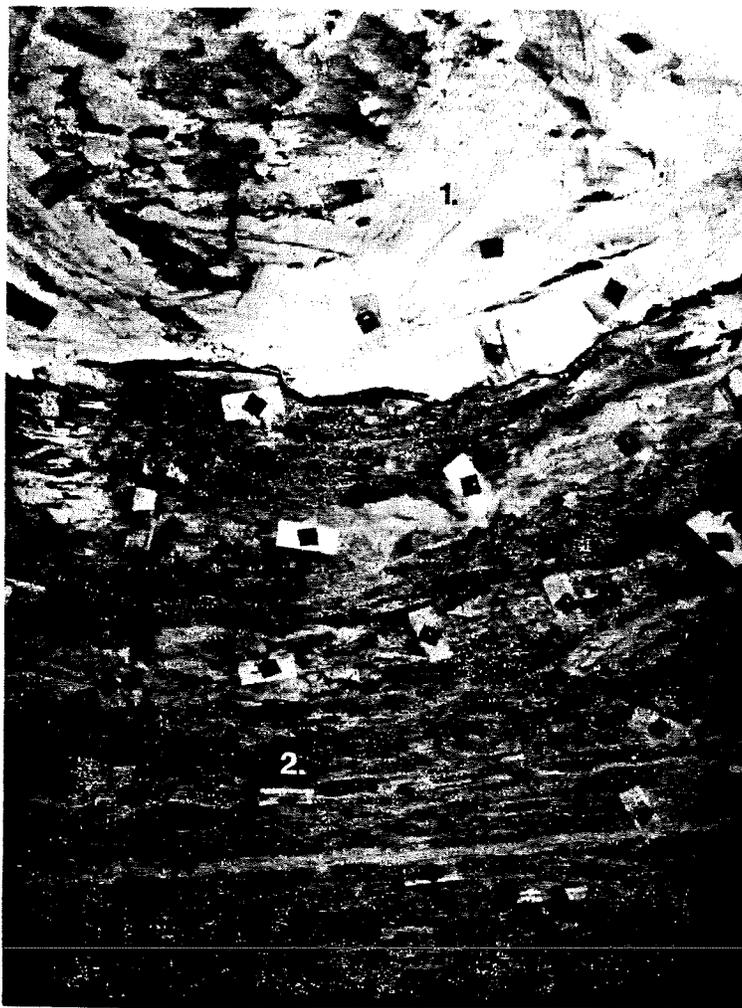
PLATE 15. - Photograph showing domed roof cave caused by overlying sandstone channel, western Book Cliffs Coal Field, Utah. Cave is approximately 25 ft. high and 30 ft. in diameter in an intersection. Unit 1. is the overlying sandstone channel and Unit 2. is delta-plain shale. Top of steel set is visible in the lower right corner of the plate. Cap blocks are 8 in. wide.

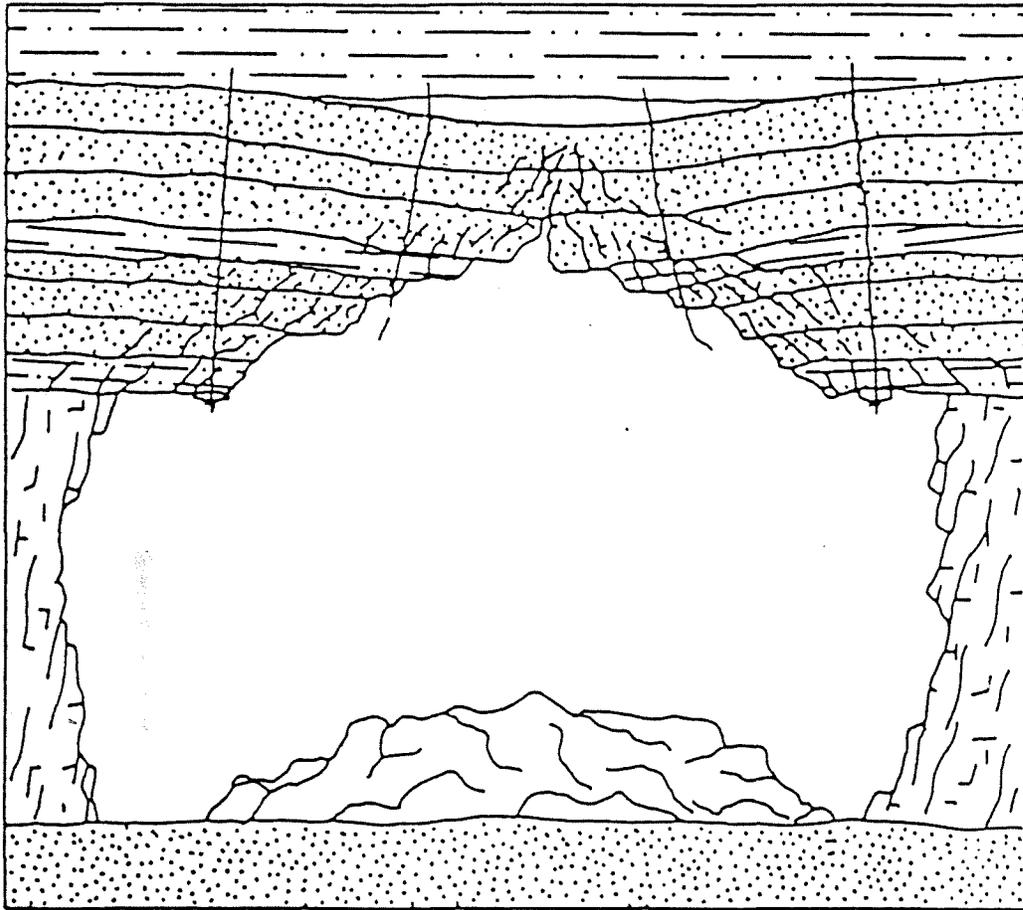
FIGURE 45. - Cross-section through a roof fall caused by an overlying sandstone channel. Roof rock above the coal seam and below the sandstone channel is approximately 5 ft. thick. The intervening strata between the coal and sandstone channel can cave up to 40 ft. in a thicker sequence (33).

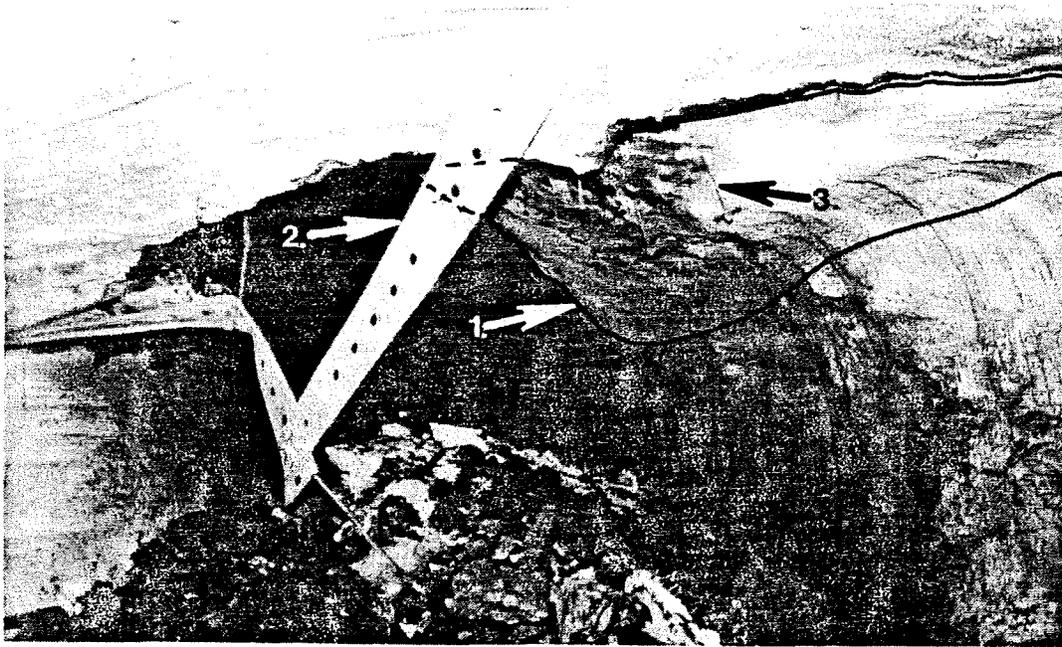
PLATE 17. - Roof fall adjacent to a coal cut-out produced by a fluvial sandstone channel, northern Wasatch Plateau Coal Field. The steep angle and density of the sandstone channel has caused differential stress, weak bonding, and fractured and disrupted rock adjacent to the channel to collapse. Arrow 1. points to outline of sandstone channel; arrow 2. points to roof mats torn away by the roof fall; arrow 3. points to remaining bolts anchored in competent sandstone. Roof fall measured 60 ft. long, 15 ft. wide, and 8 ft. high.

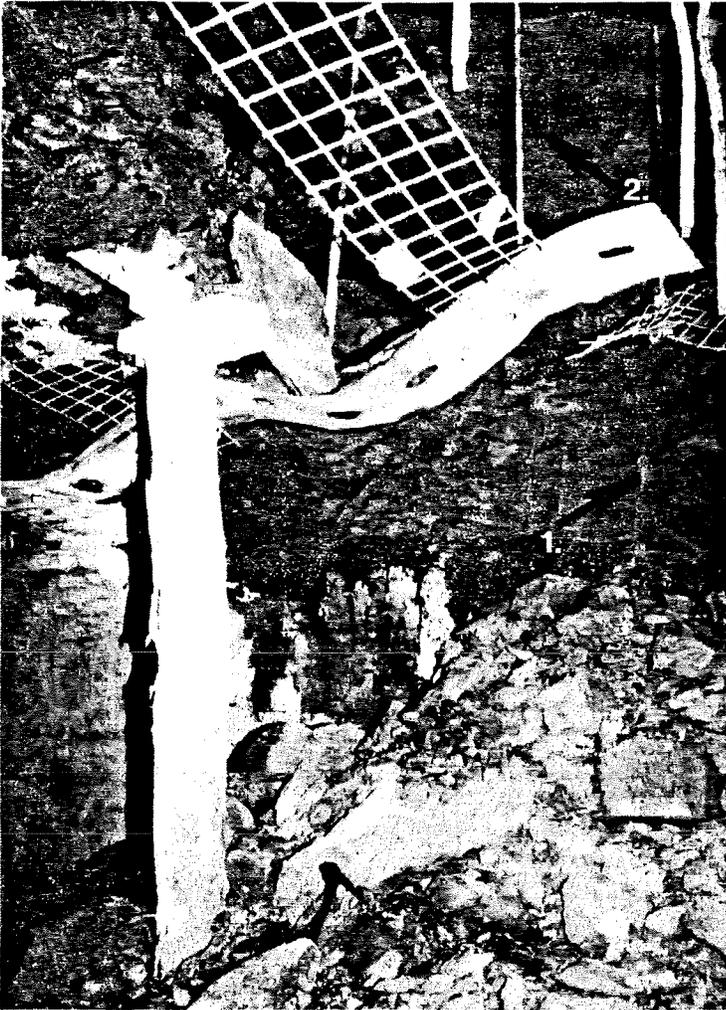
PLATE 23. - Typical roof fall within lithofacies change roof type, Somerset/Paonia Coal Field. Arrow 1. points to calcite precipitation; arrow 2. points to carbonaceous layer. Roof fall measures 8 ft. in diameter and 4 ft. to 5 ft. in height.

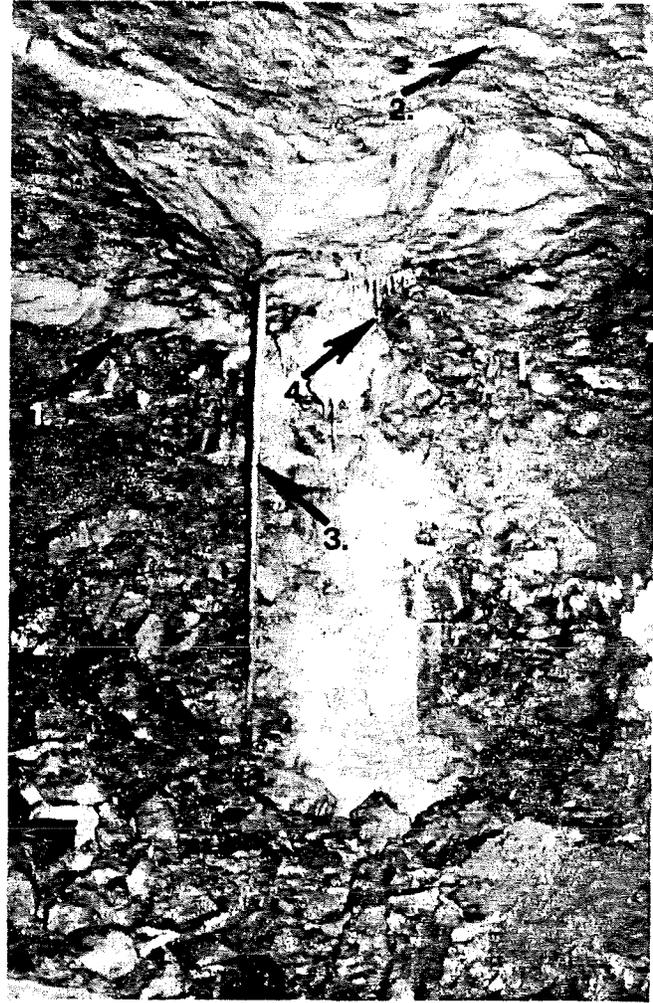
PLATE 24. - Roof fall within lithofacies change roof type, Somerset/Paonia Coal Field. Arrow 1. points to a concretion measuring 2 ft. long and 6 in. wide; arrow 2. points to droplets of water influxing from roof; arrows 3. and 4. point to mineral and ice stalagmites. This roof fall measured approximately 15 ft. in diameter and 10 ft. to 12 ft. in height.

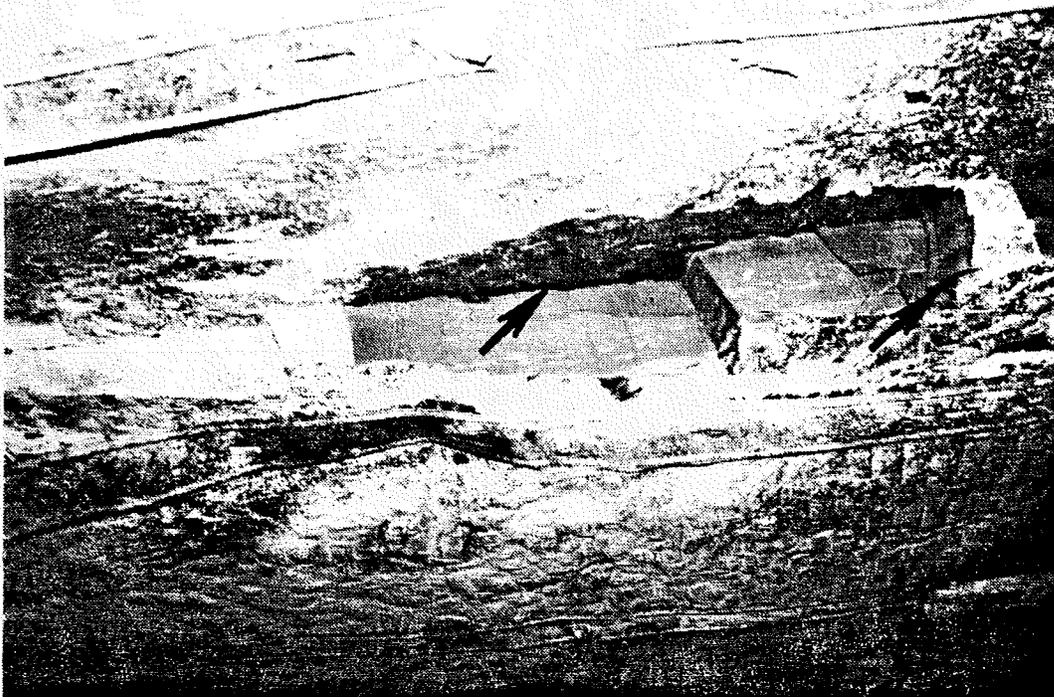
PLATE 26. - Photograph depicting weak bedding planes in shale, central Wasatch Plateau Coal Field. Arrows point to poorly bonded bedding planes in shale; bolted mats have stopped delamination. Mats are 8 in. wide.

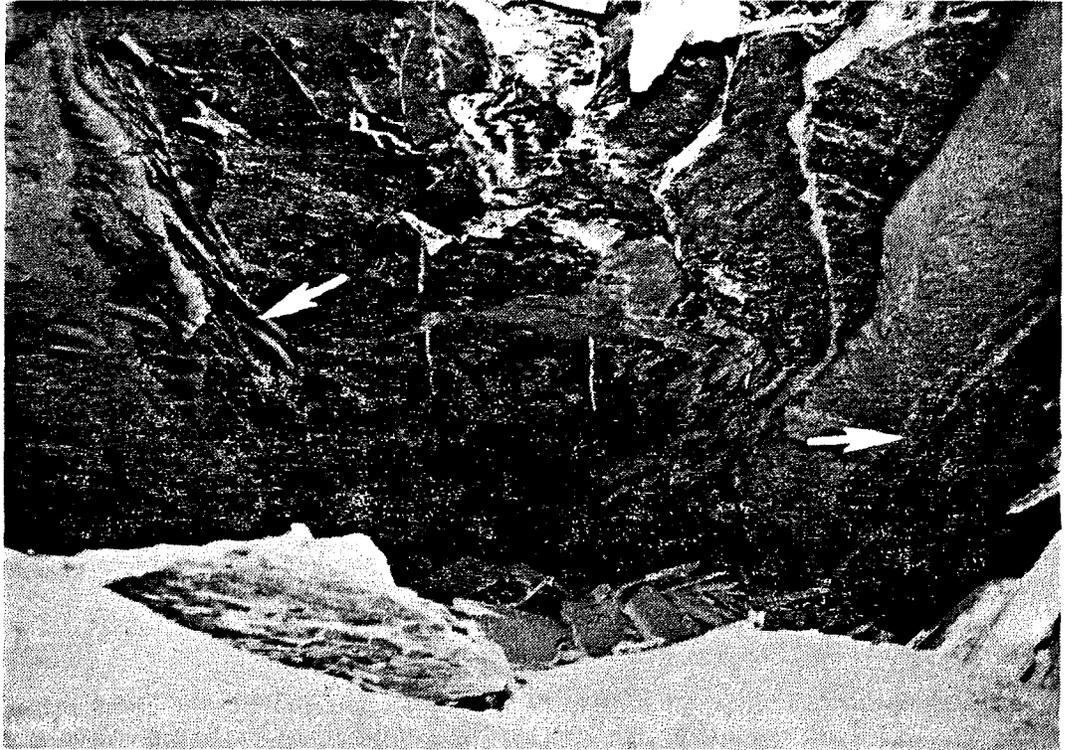
PLATE 27. - Photograph depicting bedding-plane failure in a crevasse-splay deposit, Book Cliffs Coal Field, Utah. Lateral and overlying pressure caused by sandstone channels has contributed to failure along already weak bonds between laminations of sandstone and siltstone. Continuous delamination has filled this entry with broken sheets that have extremely sharp edges. Arrows point to thin laminations of siltstone and sandstone.

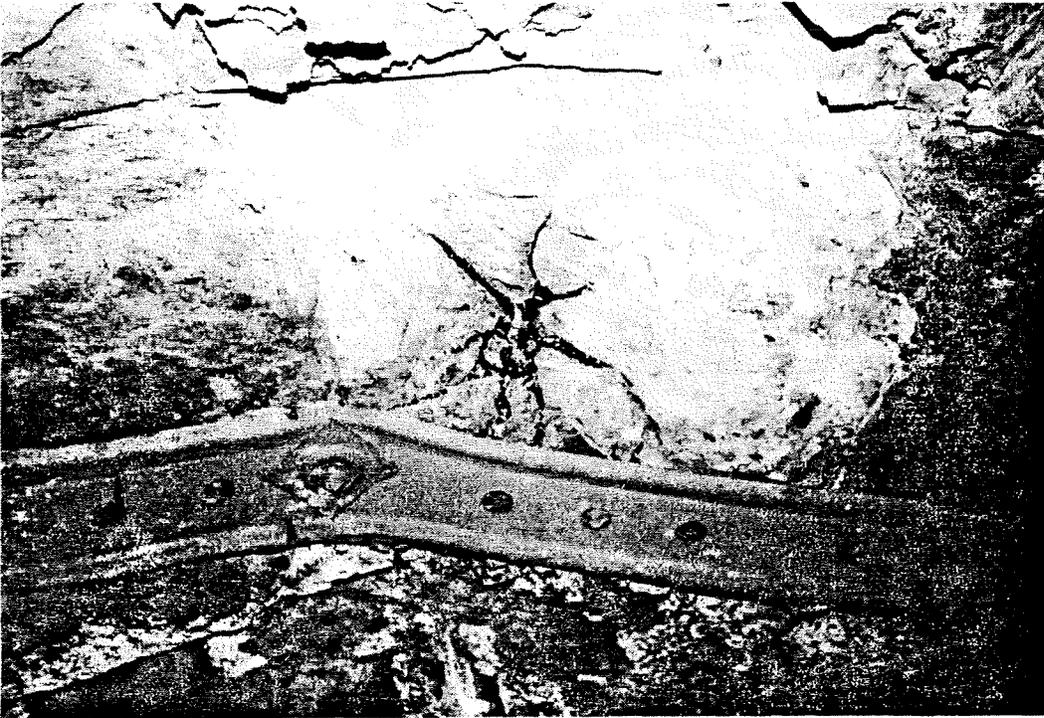
PLATE 28. - Coalified roots of small Cretaceous conifer in a mine roof, central Wasatch Plateau Coal Field. Mat is 8 in. wide. A 4 in. thick kettlebottom detached and fell from below these roots.

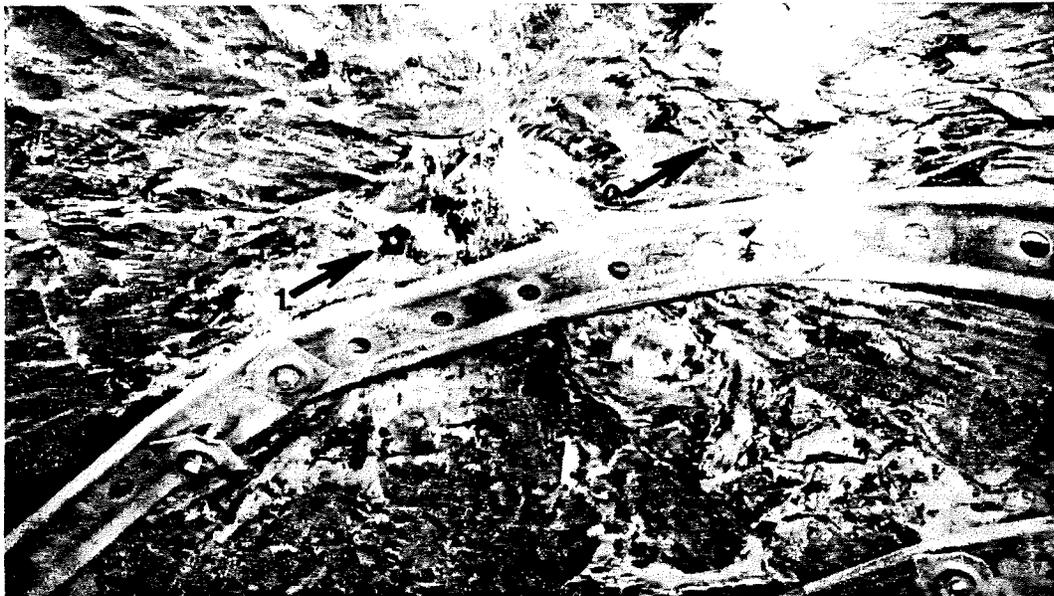
PLATE 30. - Top of large kettlebottom cave, Somerset Coal Field. This kettlebottom cave is 10 ft. in diameter and 4 ft. high. Mats are 8 in. wide. Arrow 1. points to coalified roots; arrow 2. points to imprints of root bark. Sides of cave are entirely slickensided.

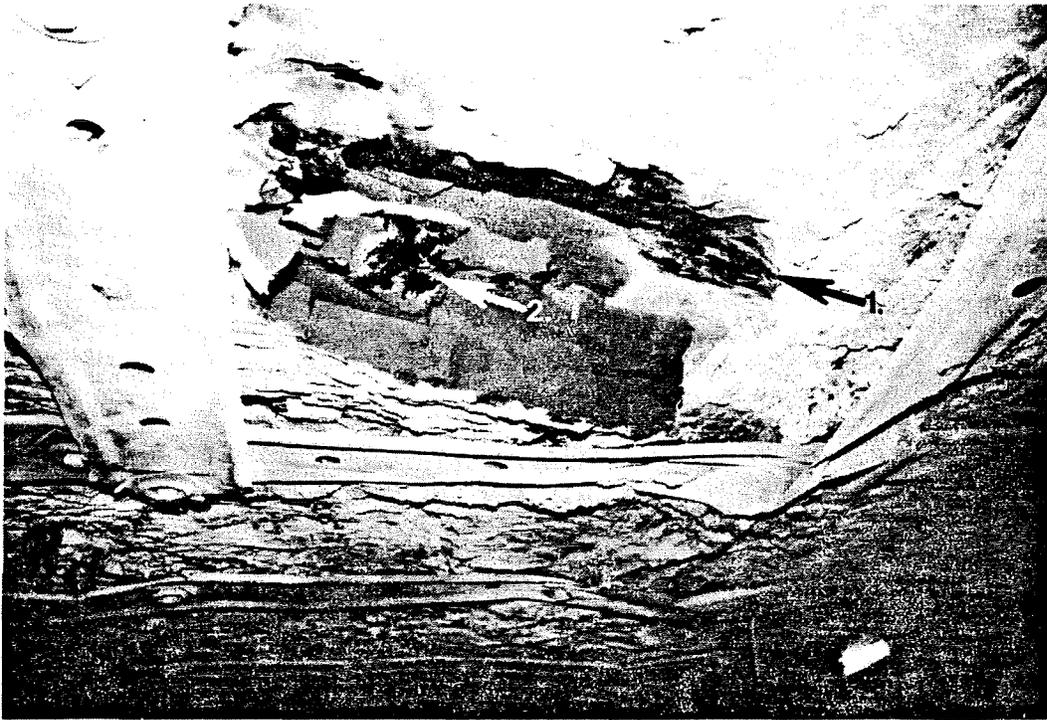
PLATE 31. - Kettlebottom beginning to detach, Somerset Coal Field. Mats are 8 in. wide. Arrow 1. points to slickensided edge of kettlebottom and arrow 2. points to slickensided root-bark imprint. Notice the similarity of the kettlebottom roof with the surrounding roof. Had the kettlebottom not been bolted and matted, it would have caved upward 4 ft. to 5 ft.

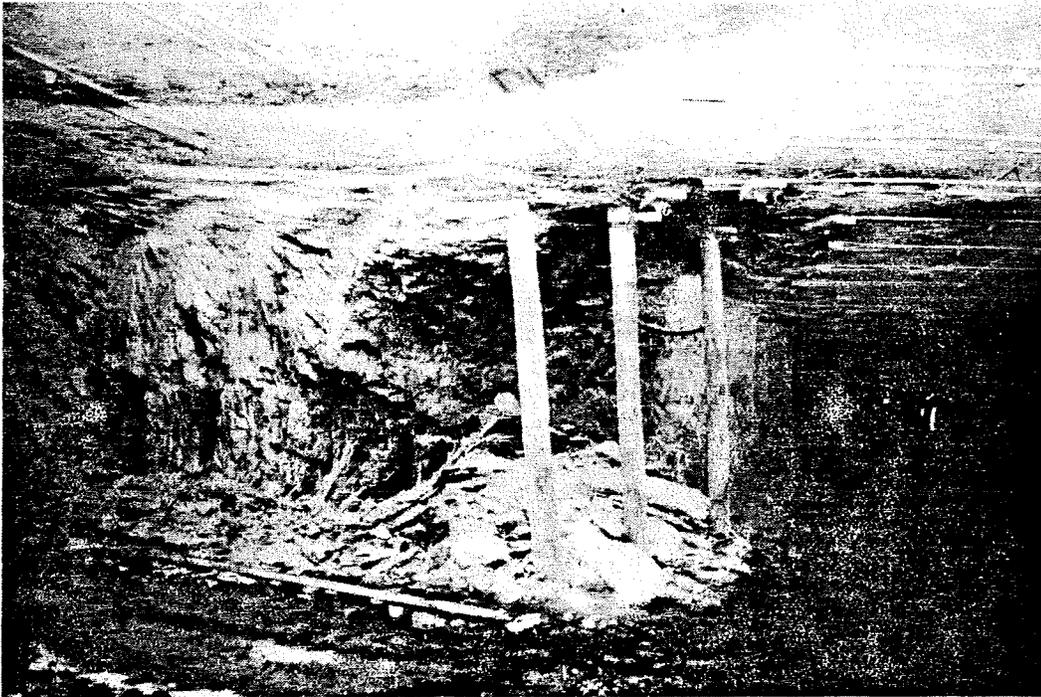
PLATE 35. - Effect of steeply dipping joint on pillar corner, Yampa Coal Field. Jointing is oriented at an obtuse angle to mine development. Seam is approximately 9 ft. thick. Timber supports have been installed to compensate for loss of roof support through slabbing of pillar corner.

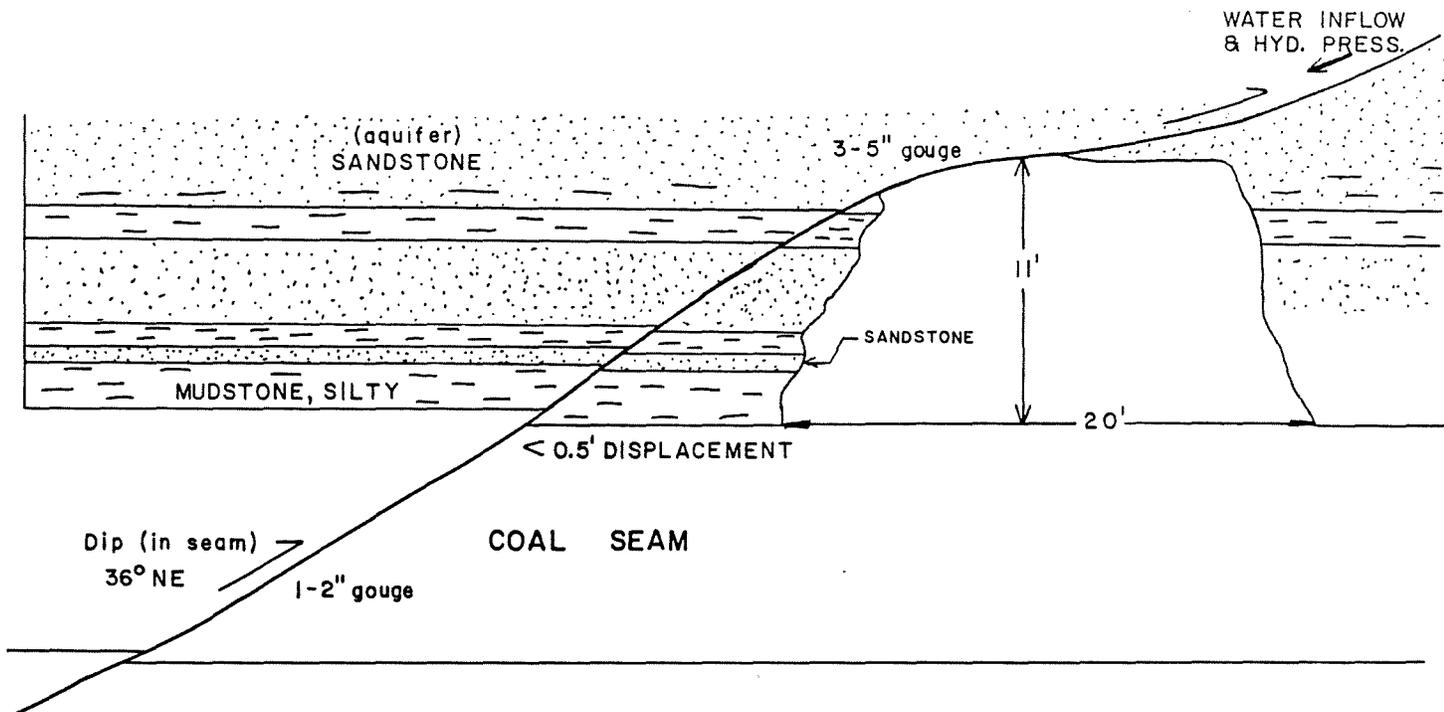
FIGURE 56. - Cross-section through roof fall caused by weak plane of low-angle thrust fault combined with water infiltration along fault plane, Yampa Coal Field.

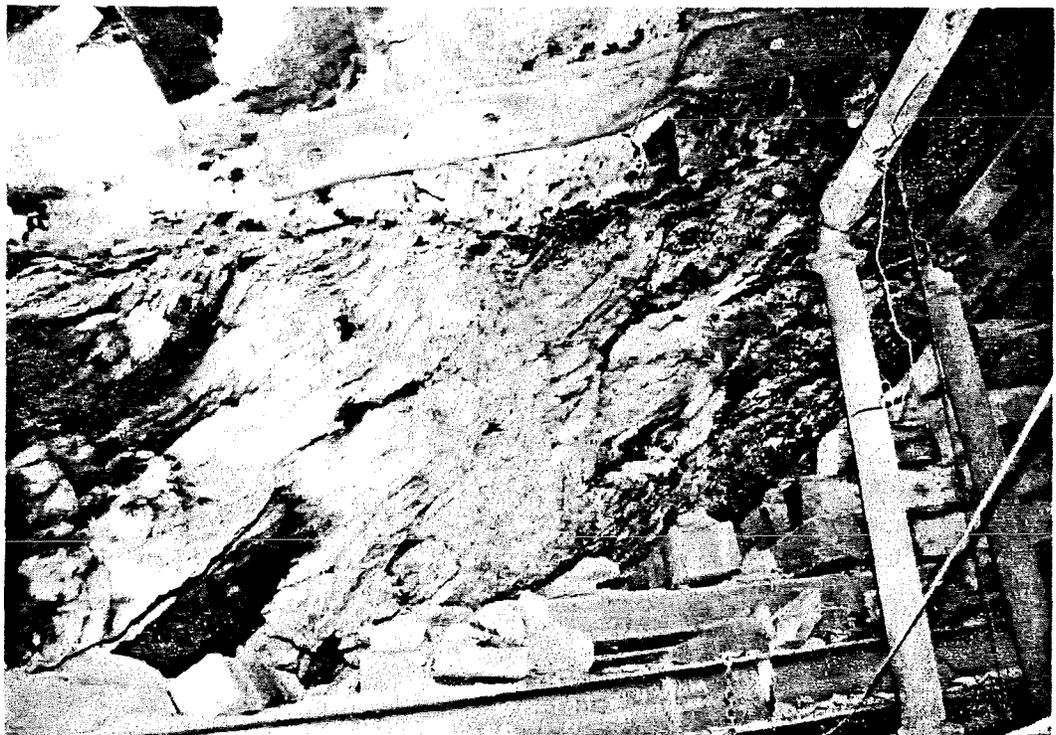
PLATE 40. - Photograph of sheared and distorted rock of major fault zone, Carbondale Coal Field. Mat is 8 in. wide. Note fractured and crumbling fault gouge onto extensive roof control support (timbers, I-beams).

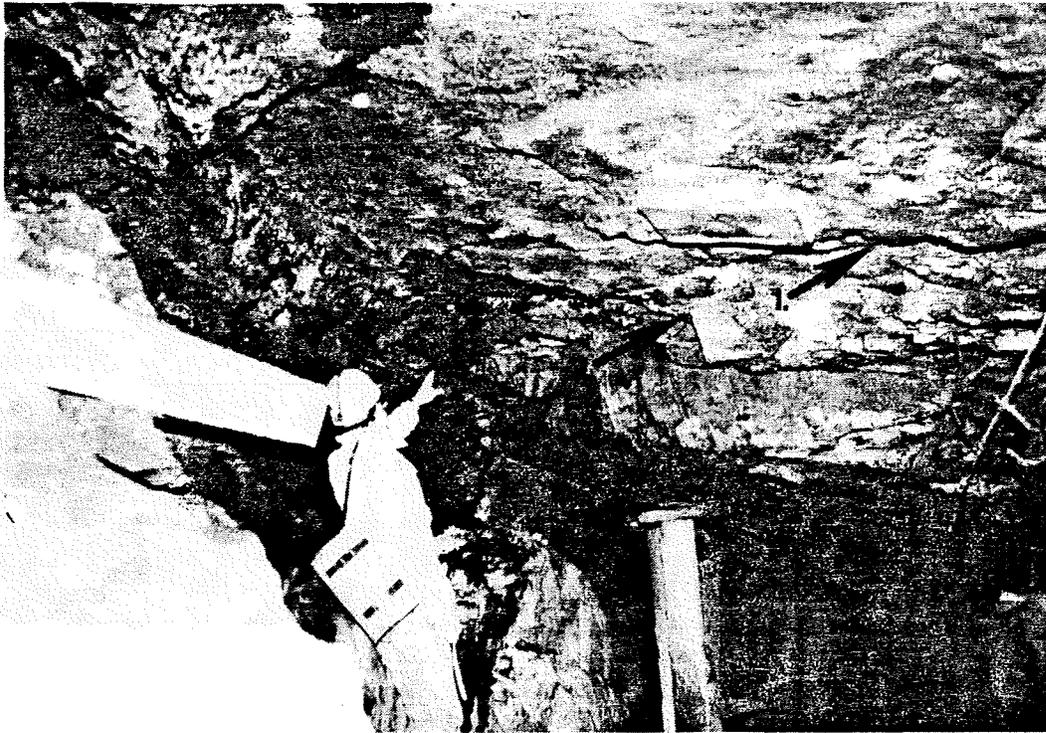
PLATE 41. - Photograph of fault set, Carbondale Coal Field. Observer is pointing to water infiltration along fault planes. Arrow 1. points to fault plane with approximately 2 ft. of displacement; arrow 2. points to second fault plane with 2 ft. of displacement. Note fractured rock separating two faults. Cap blocks are 8 in. wide.
