ORE HANDLING EQUIPMENT OPERATIONS SAFETY STUDY IN UNDERGROUND METAL AND NONMETAL MINES

THEODORE BARRY AND ASSOCIATES
USBM CONTRACT REPORT H0230004
MODIFICATION NO. ONE

JULY 1975

FINAL REPORT
USBM Contract No. HO230004 - MOD 1

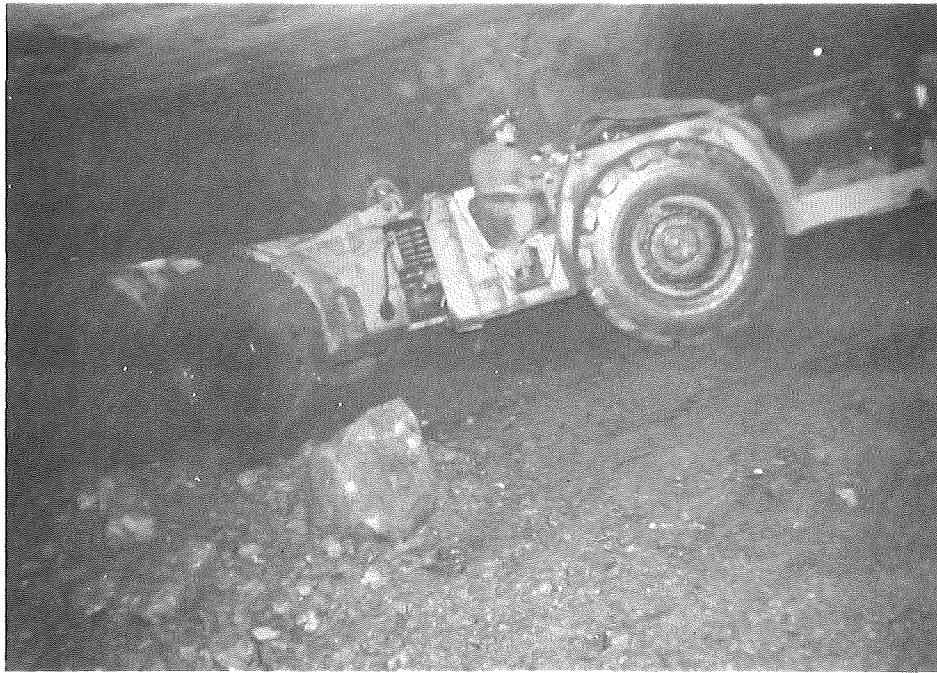
Exhibit II-3

No Falling Object Protection for LHD Operator

- Load-Haul-Dump equipment should require Falling Object Protective Structures (FOPS) in all underground applications. These protective structures should meet specified standards like those of the Society of Automotive Engineers. The design of these FOPS should not inhibit operator visibility and his ability to get on and off the LHD's with relative ease. Implementation of this solution would be through regulations requiring new LHD units to be equipped with FOPS. Additional research to develop the best program for retrofitting existing LHD's is recommended.

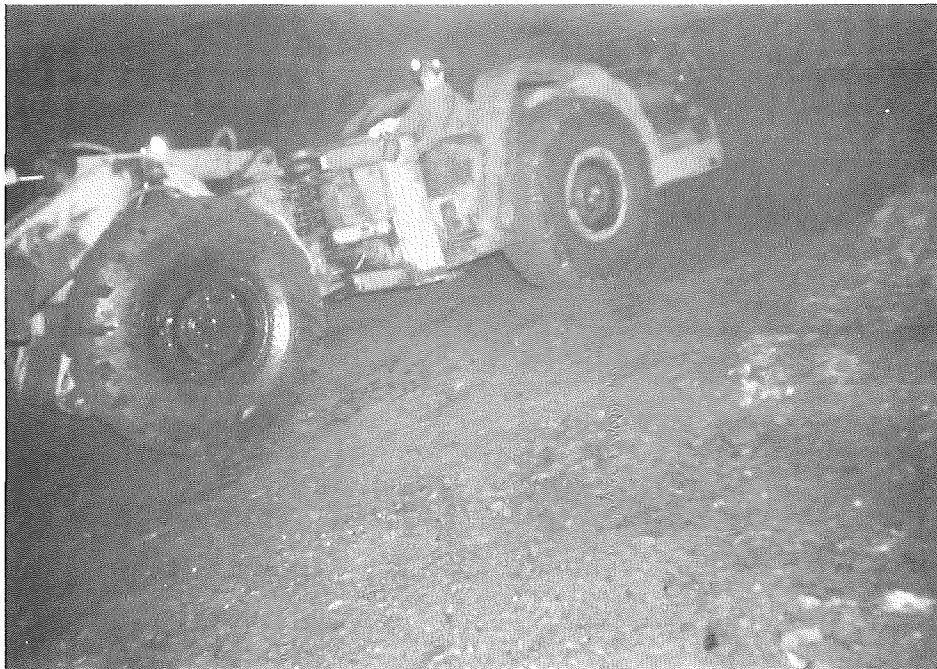
Exhibit II-4

Example of Steep Grade

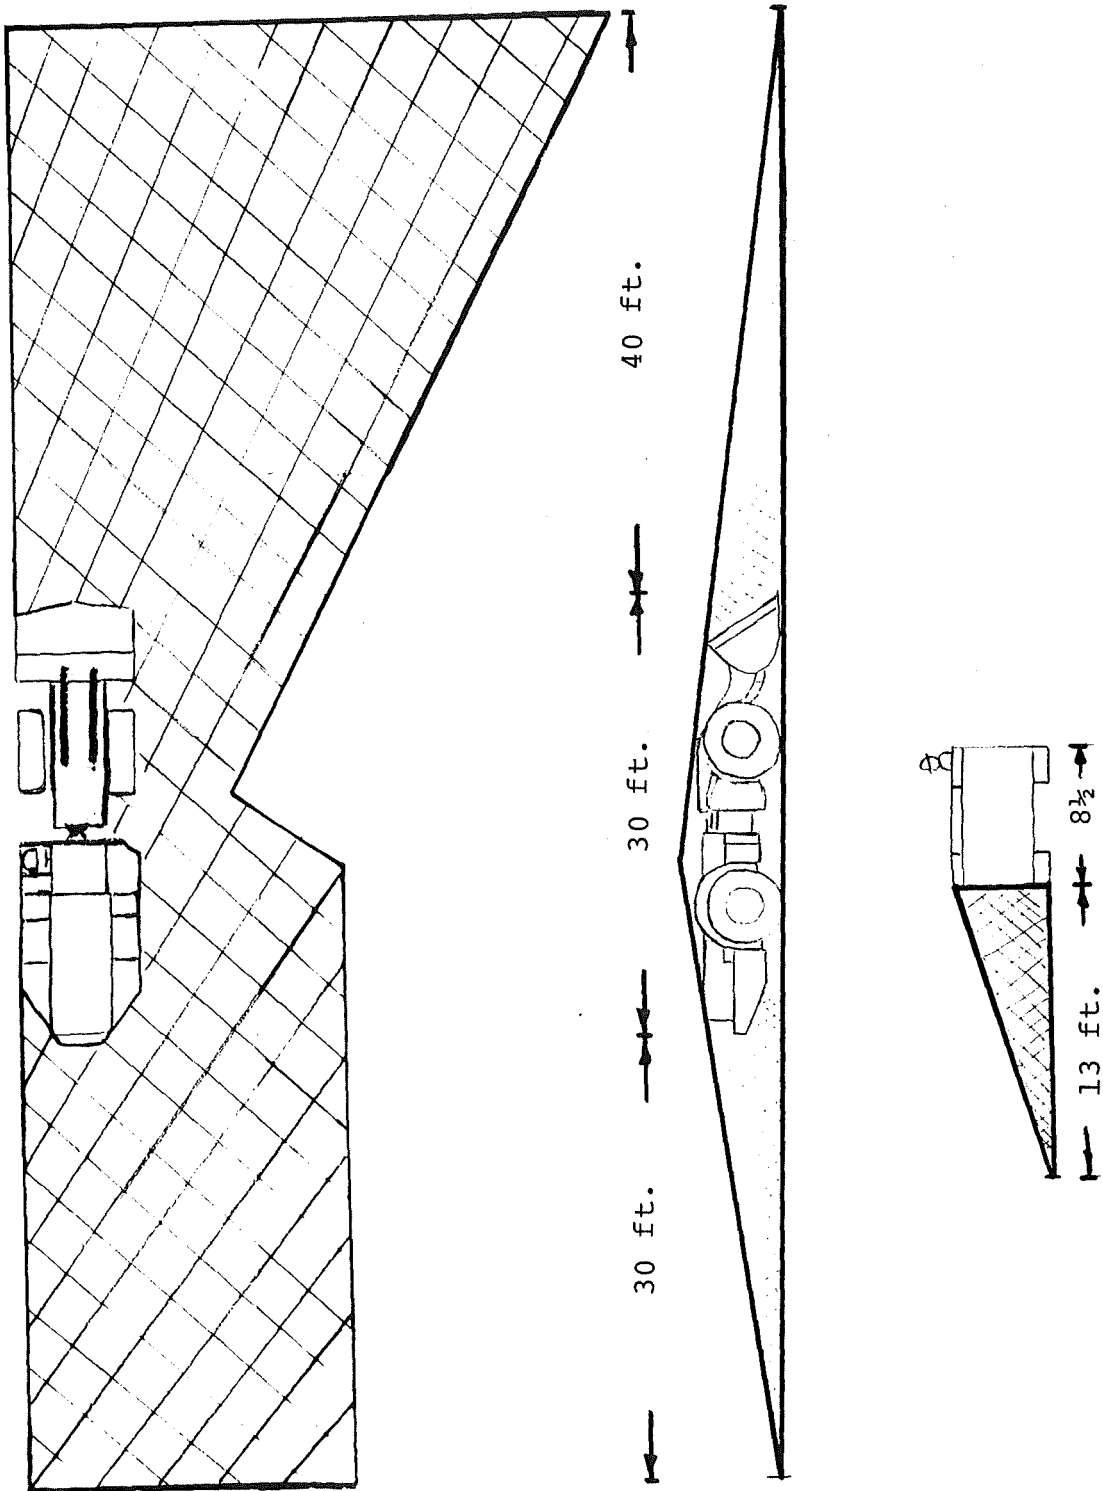
Typical blind areas associated with LHD equipment.

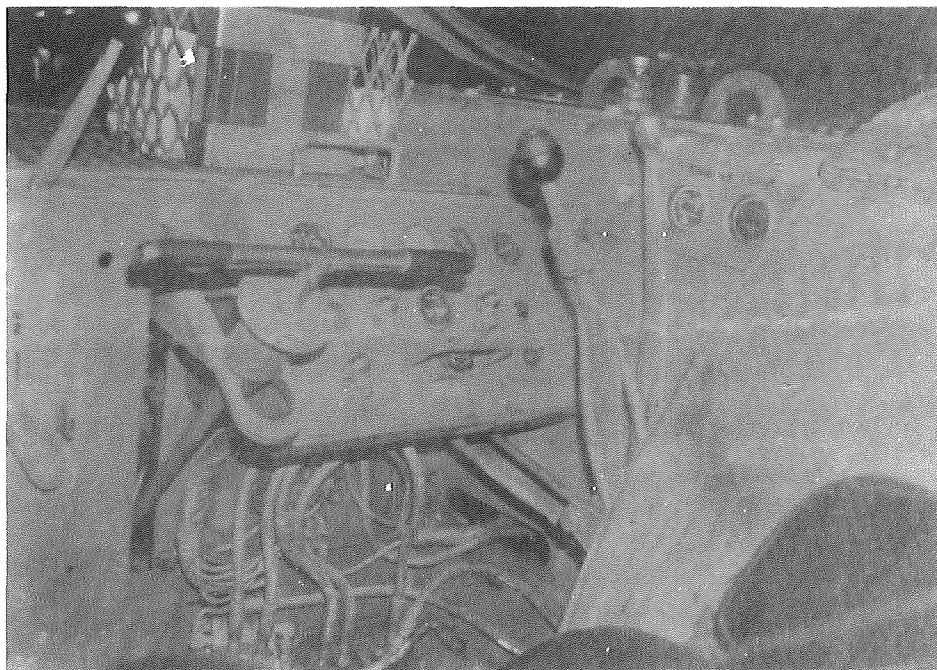
Exhibit II-7

Equipment Log Book on LHD

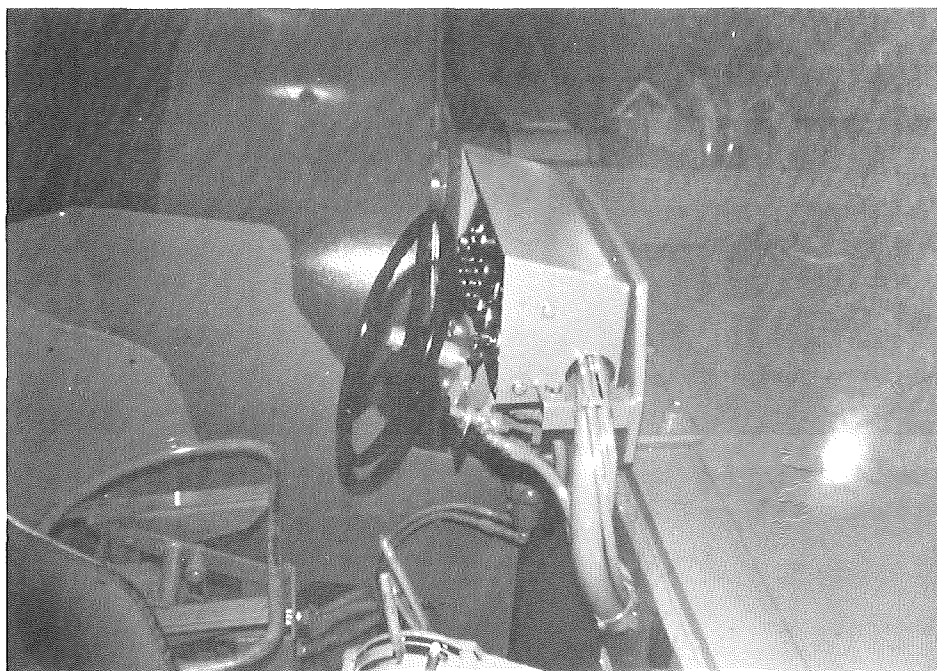
Exhibit II-8

Tight Clearance Between Gauges and
Steering Wheel

- Distance between steering wheel and control panels were restricted so that operator knuckles frequently hit edges and gauges, as shown in Exhibit II-8.
- Scrubber tanks are often located almost next to the operator seat, as shown in Exhibit II-9. These tanks radiate substantial heat as their temperature gets in excess of 180 degrees F.
- Operator's controls are not located in the best location. Exhibit II-9 shows a brake valve unit placed where the operator's ankle should be to push the brake pedal.
- Seats are not designed to allow for adequate space required by cap-light batteries and self-rescuers on operator's belt (Exhibit II-10). This results in substantial discomfort to the LHD operator.

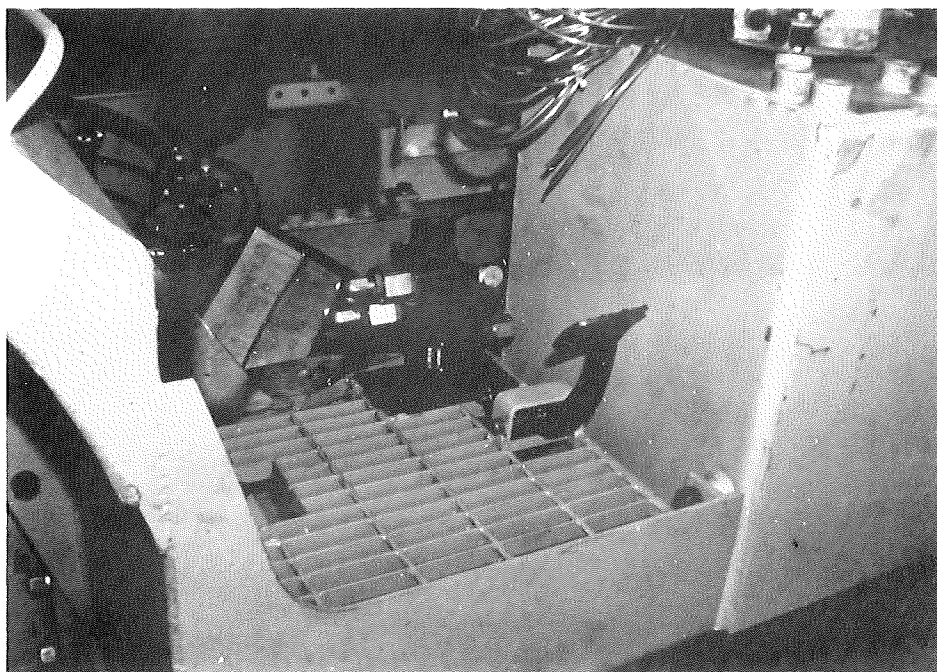
Exhibit II-9

Scrubber Tank Next to Operator's Seat
Poor Location of Brake Valve

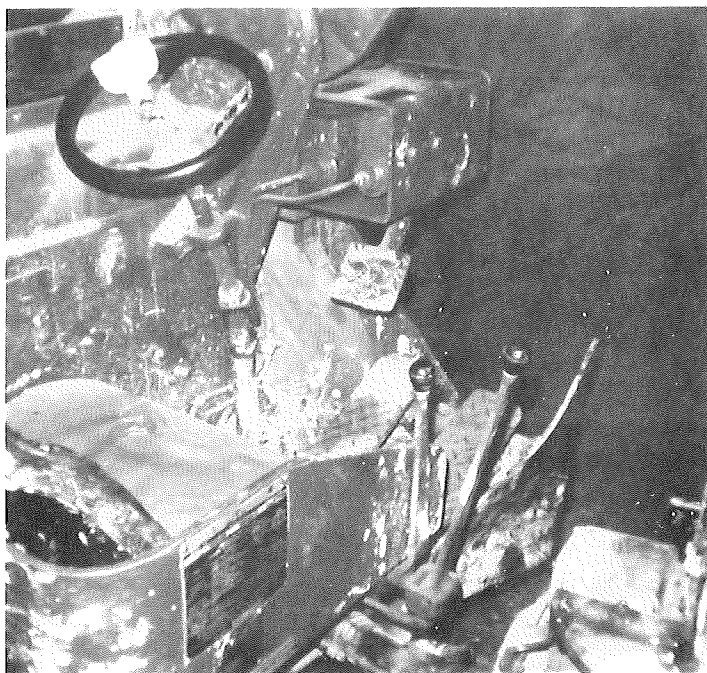
Exhibit II-10

Restricted Space Around LHD Operator's Seat

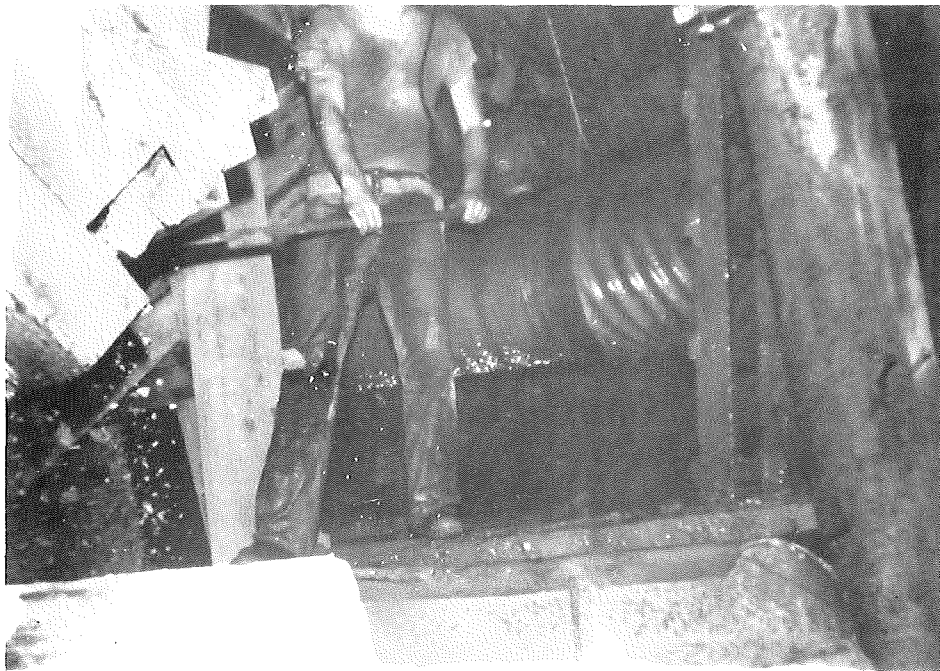
Exhibit III-2

Car Loading Platform Located in Front of Chute

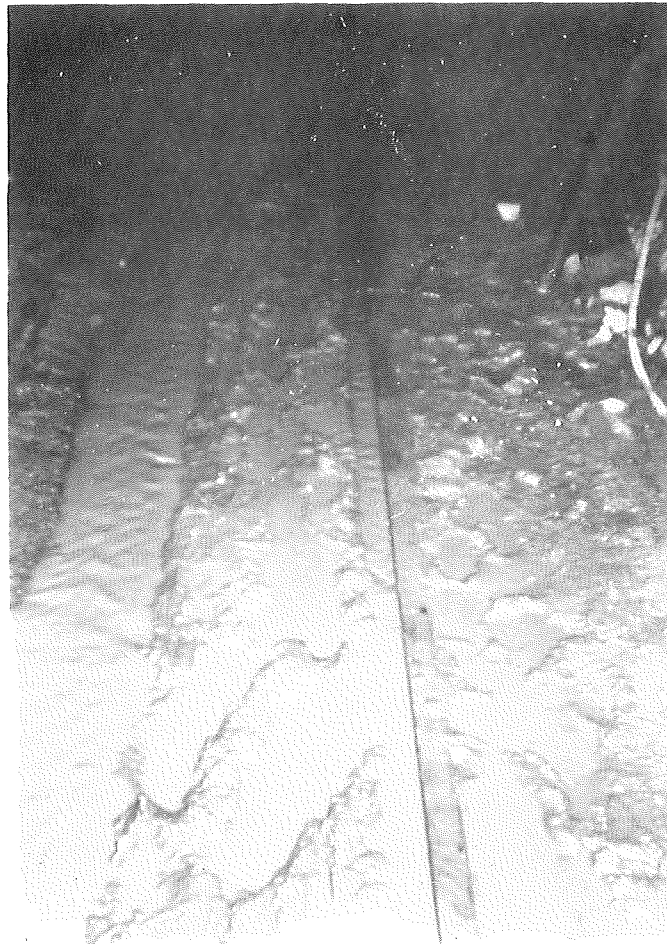
Exhibit III-3
Poor Track
Conditions

- Derailement: accounted for 16 percent of the rail system accidents. A derailment is often caused by a combination of items. Some of the main causal agencies are worn wheels, mis-matched switch blocks, and poor track conditions. Inadequate track conditions are often found to result from loose track ties and rails. Gauge variations, sharp corners, and muck spills can also cause a bad track condition, as shown in Exhibit III-3. Our field observations and interviews revealed that after a derailment occurs, the rails can be twisted and loosened even more. Seldom are adequate repairs done to sections of bad track. Field visits also revealed that not enough attention is paid to track maintenance throughout the underground mining industry. Although most of the mines visited did have full-time workers on track maintenance, the activities of the crews were usually spent on main line tracks and, occasionally, cleaning the muck off secondary tracks. Preventive maintenance of tracks, especially at secondary levels, is lacking.

- Track preventive maintenance programs should be required in underground metal and non-metal mines, and specific standards should be developed for acceptable and unacceptable track conditions. Improved track maintenance can be expected to reduce accidents by 10-20 percent.

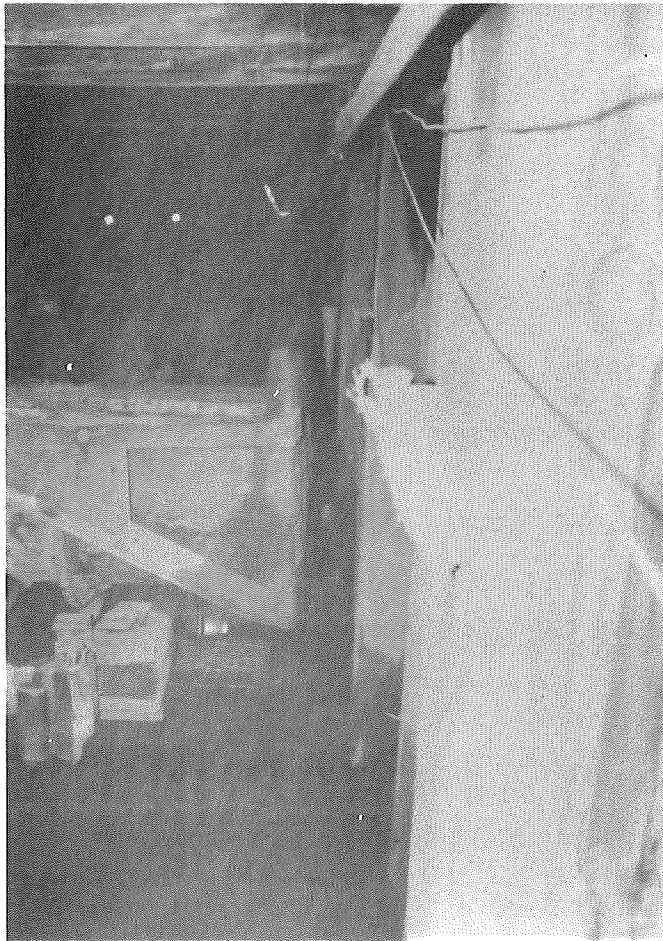
Exhibit III-4
Tight Clearance
in Haulage Drift

- Specific guidelines determining (a) the minimum required distance between shelter holes, and (b) minimum clearances in rail haulage drifts need to be developed. In addition, increased enforcement of regulation CFR 57.9-110, ensuring pedestrian safety in haulage drifts is recommended. These guidelines and increased enforcement would reduce rail accidents by 5-7 percent.

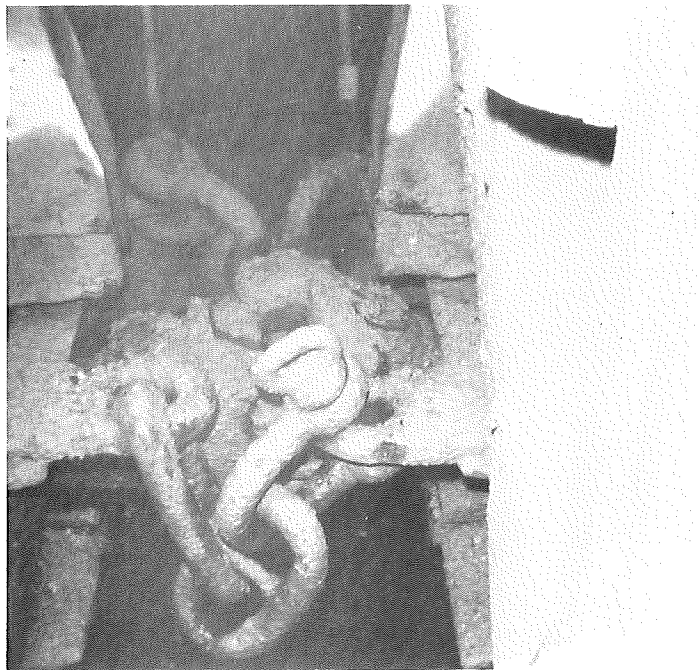
Exhibit III-5
Automatic Coupler and Safety Chain

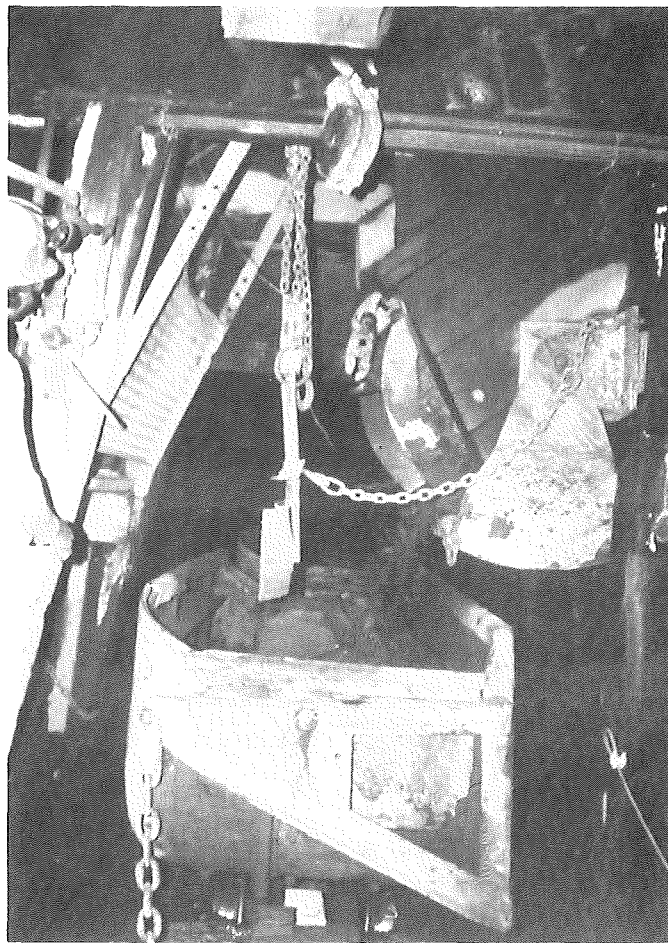
Exhibit III-6
Relocated Car
Loading Station

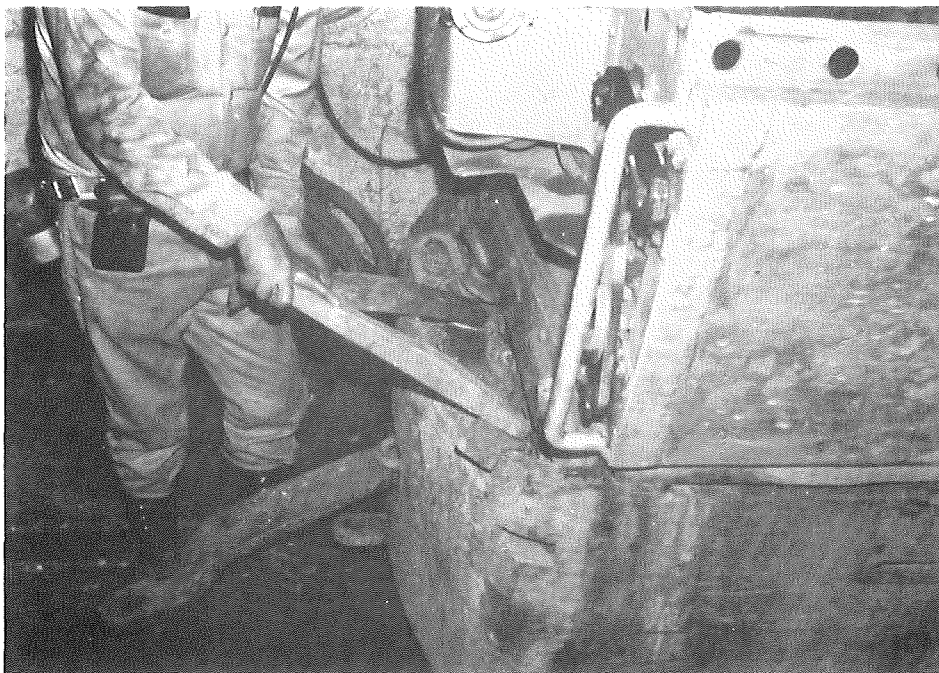
Exhibit III-7
Rerailers Carried on Locomotives

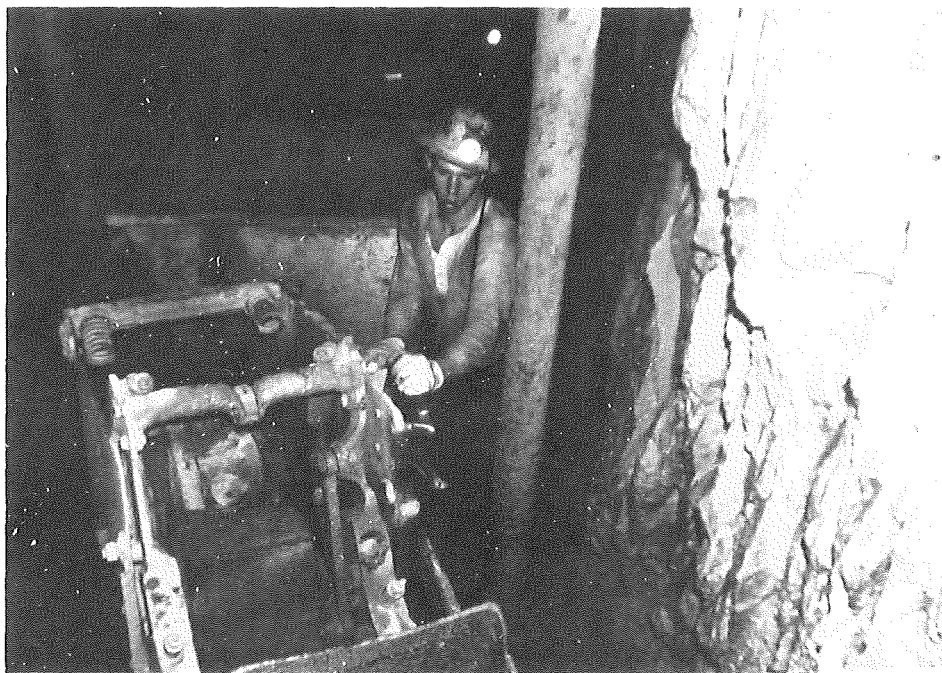
Exhibit IV-2

Mucker Operator Working in Tight Clearances

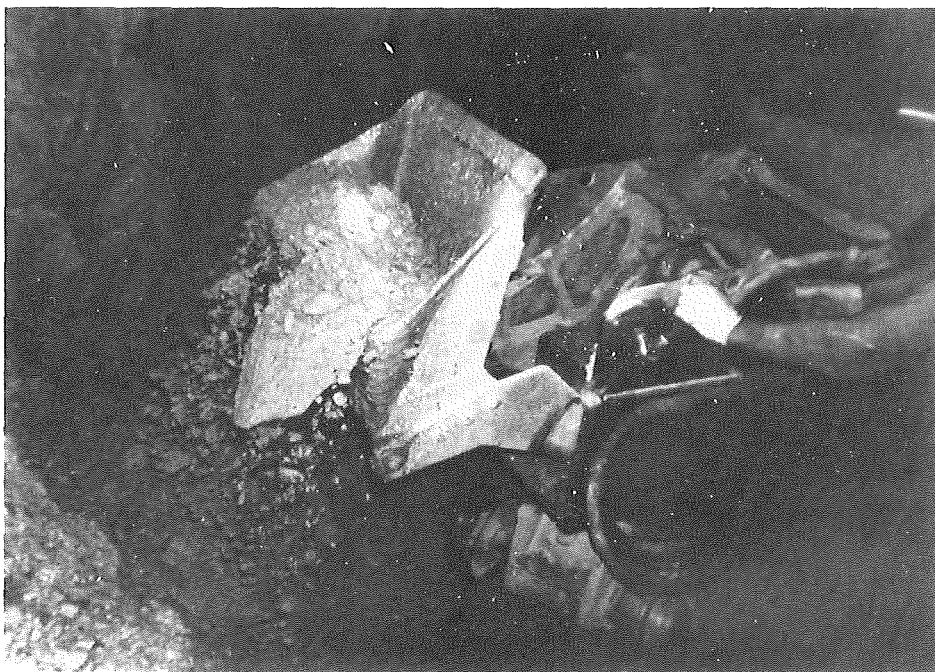
Exhibit IV-3

Operator Exposed to Rocks Rolling Off
the Bucket

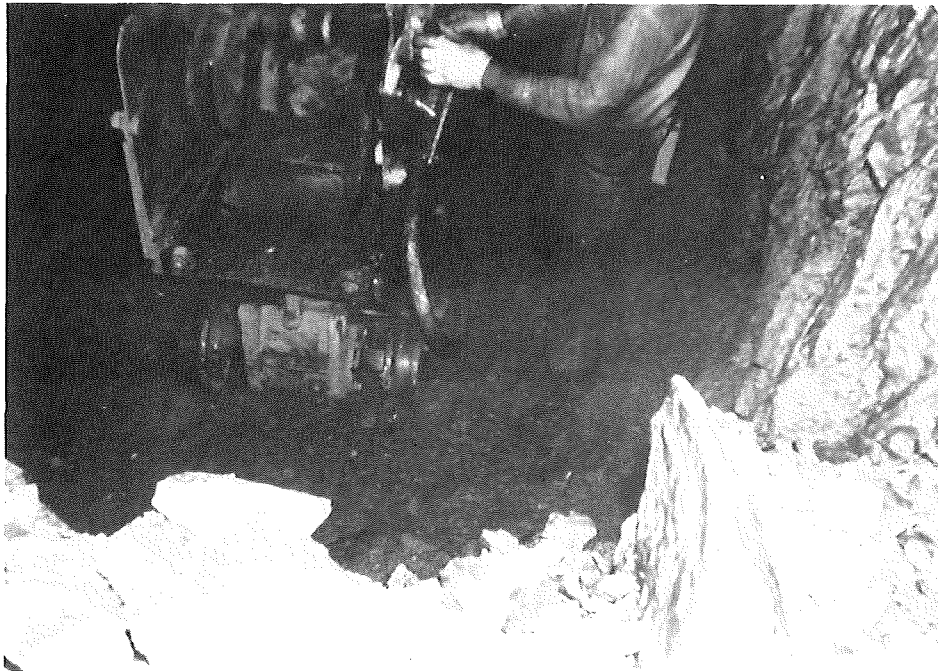
Exhibit IV-4

Muckers were occasionally observed where the operators had removed the step plates (which are normally part of the mucking machine), as shown in Exhibit IV-4. These step plates are removed especially while working in tight working areas. This contributes to run-over type accidents, and possibly more equipment tipovers. The step plate, when in position, can act as a deterrent to the equipment tipping completely over. Additionally, high noise levels were encountered at most mucking machine operations. The contribution of these high noise levels to the occurrence of accidents was not measurable from accident reports.

Mucker Operating with Step Plate Removed

- We recommend that existing step platforms on the mucking machines should be modified to improve operator protection. Some essential features for this modified platform would be (a) the ability to retract when equipment is to be transferred, (b) mucker would not operate without platform in position, (c) design characteristics that deter tip-overs and protect operator's feet. This recommendation can best be implemented through regulation immediately following the development and redesign of operator platforms. Expected reduction in mucker accidents would be 10-15 percent.

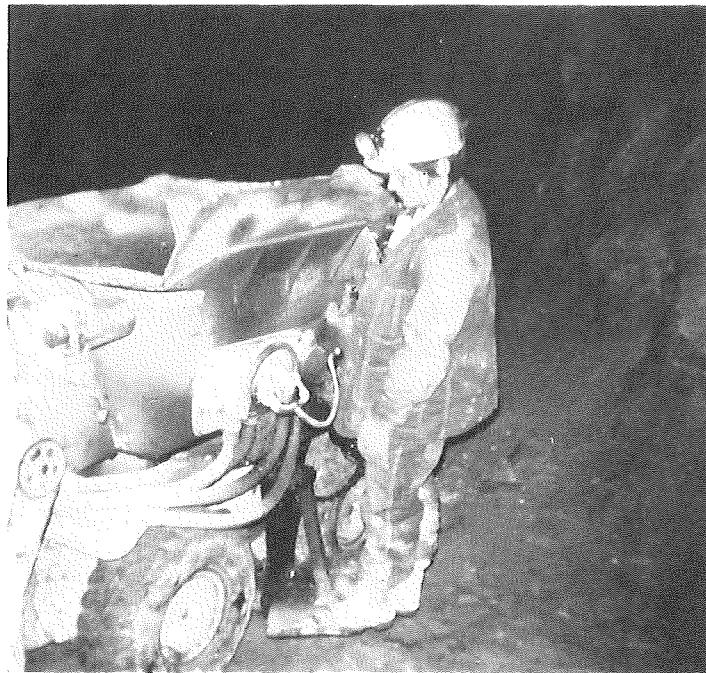
Exhibit IV-5

Example of Inadequate Step Plate

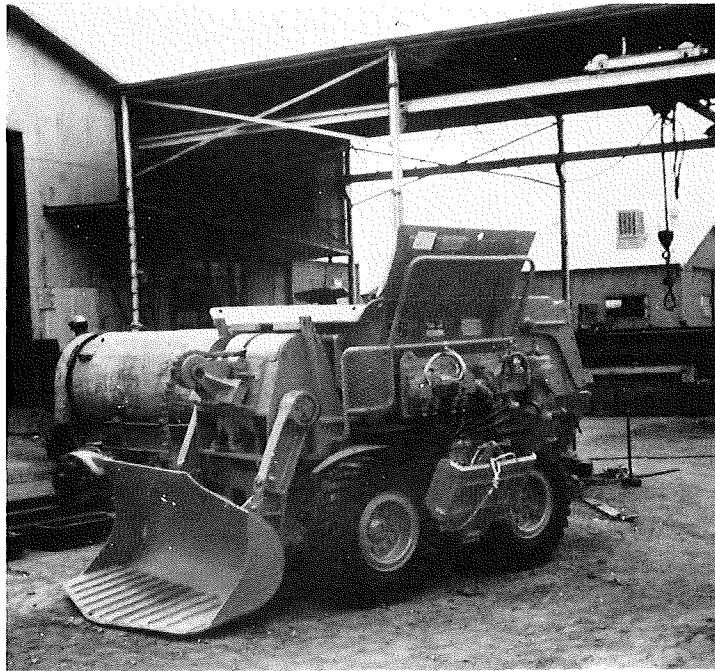
Exhibit IV-7

Example of Operator Protective Guards

- They should be so designed that operators' visibility is not inhibited. A screen material shield of adequate strength installed between the bucket trajectory and the operator controls, as shown in Exhibit IV-7, is a good example.
- These guards should be so constructed that they can be retracted to facilitate transfer of muckers from one work site to another in the mine. However, some kind of a lockout procedure should be incorporated that ensures that the machine will only operate when these guards are in position.

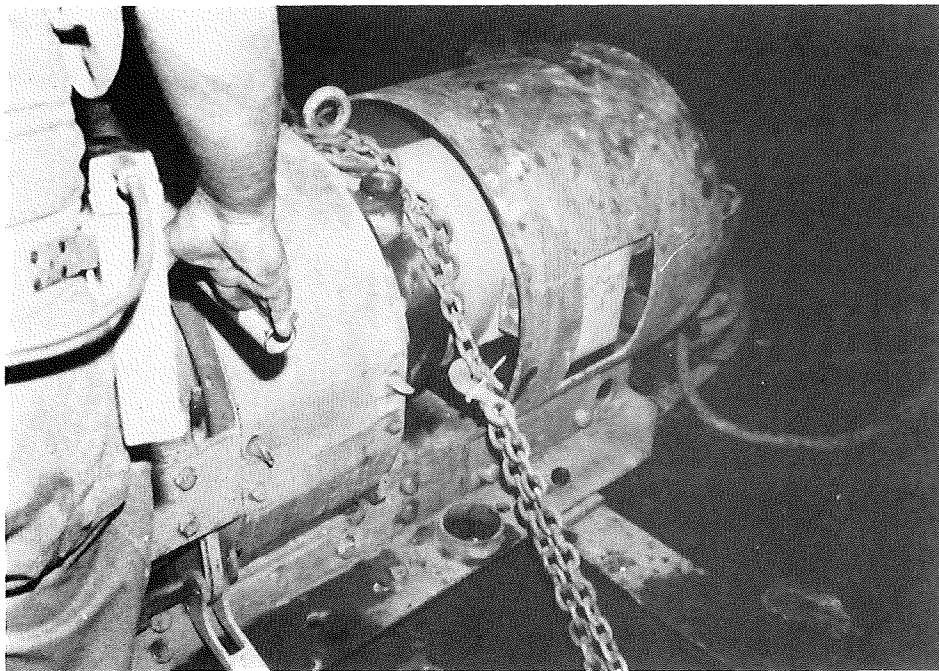
Exhibit V-2

Slusher Tied by Chain

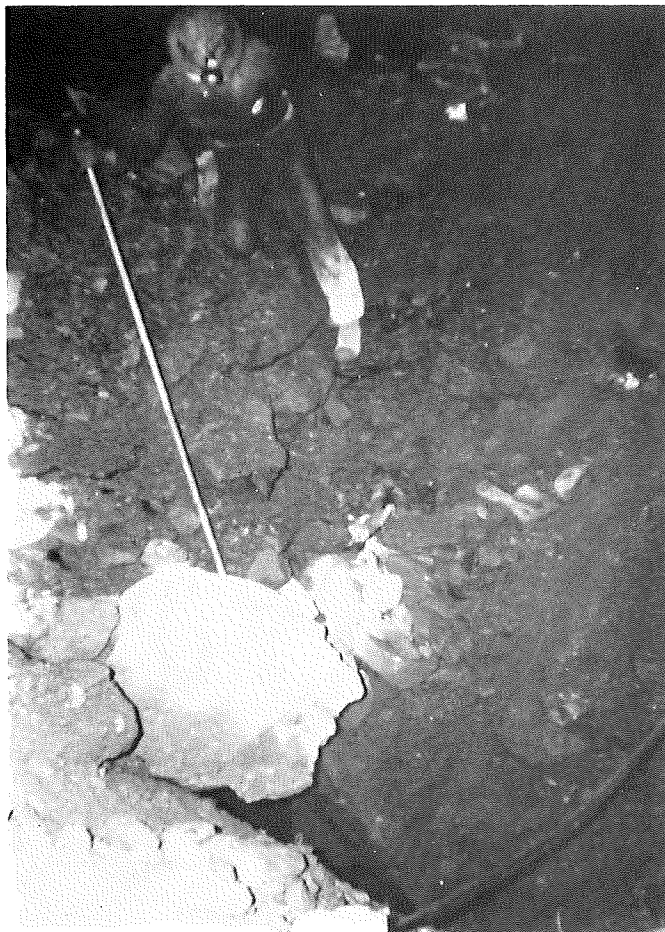
Exhibit V-3
Barring Oversize
Into Unprotected
Ore Pocket

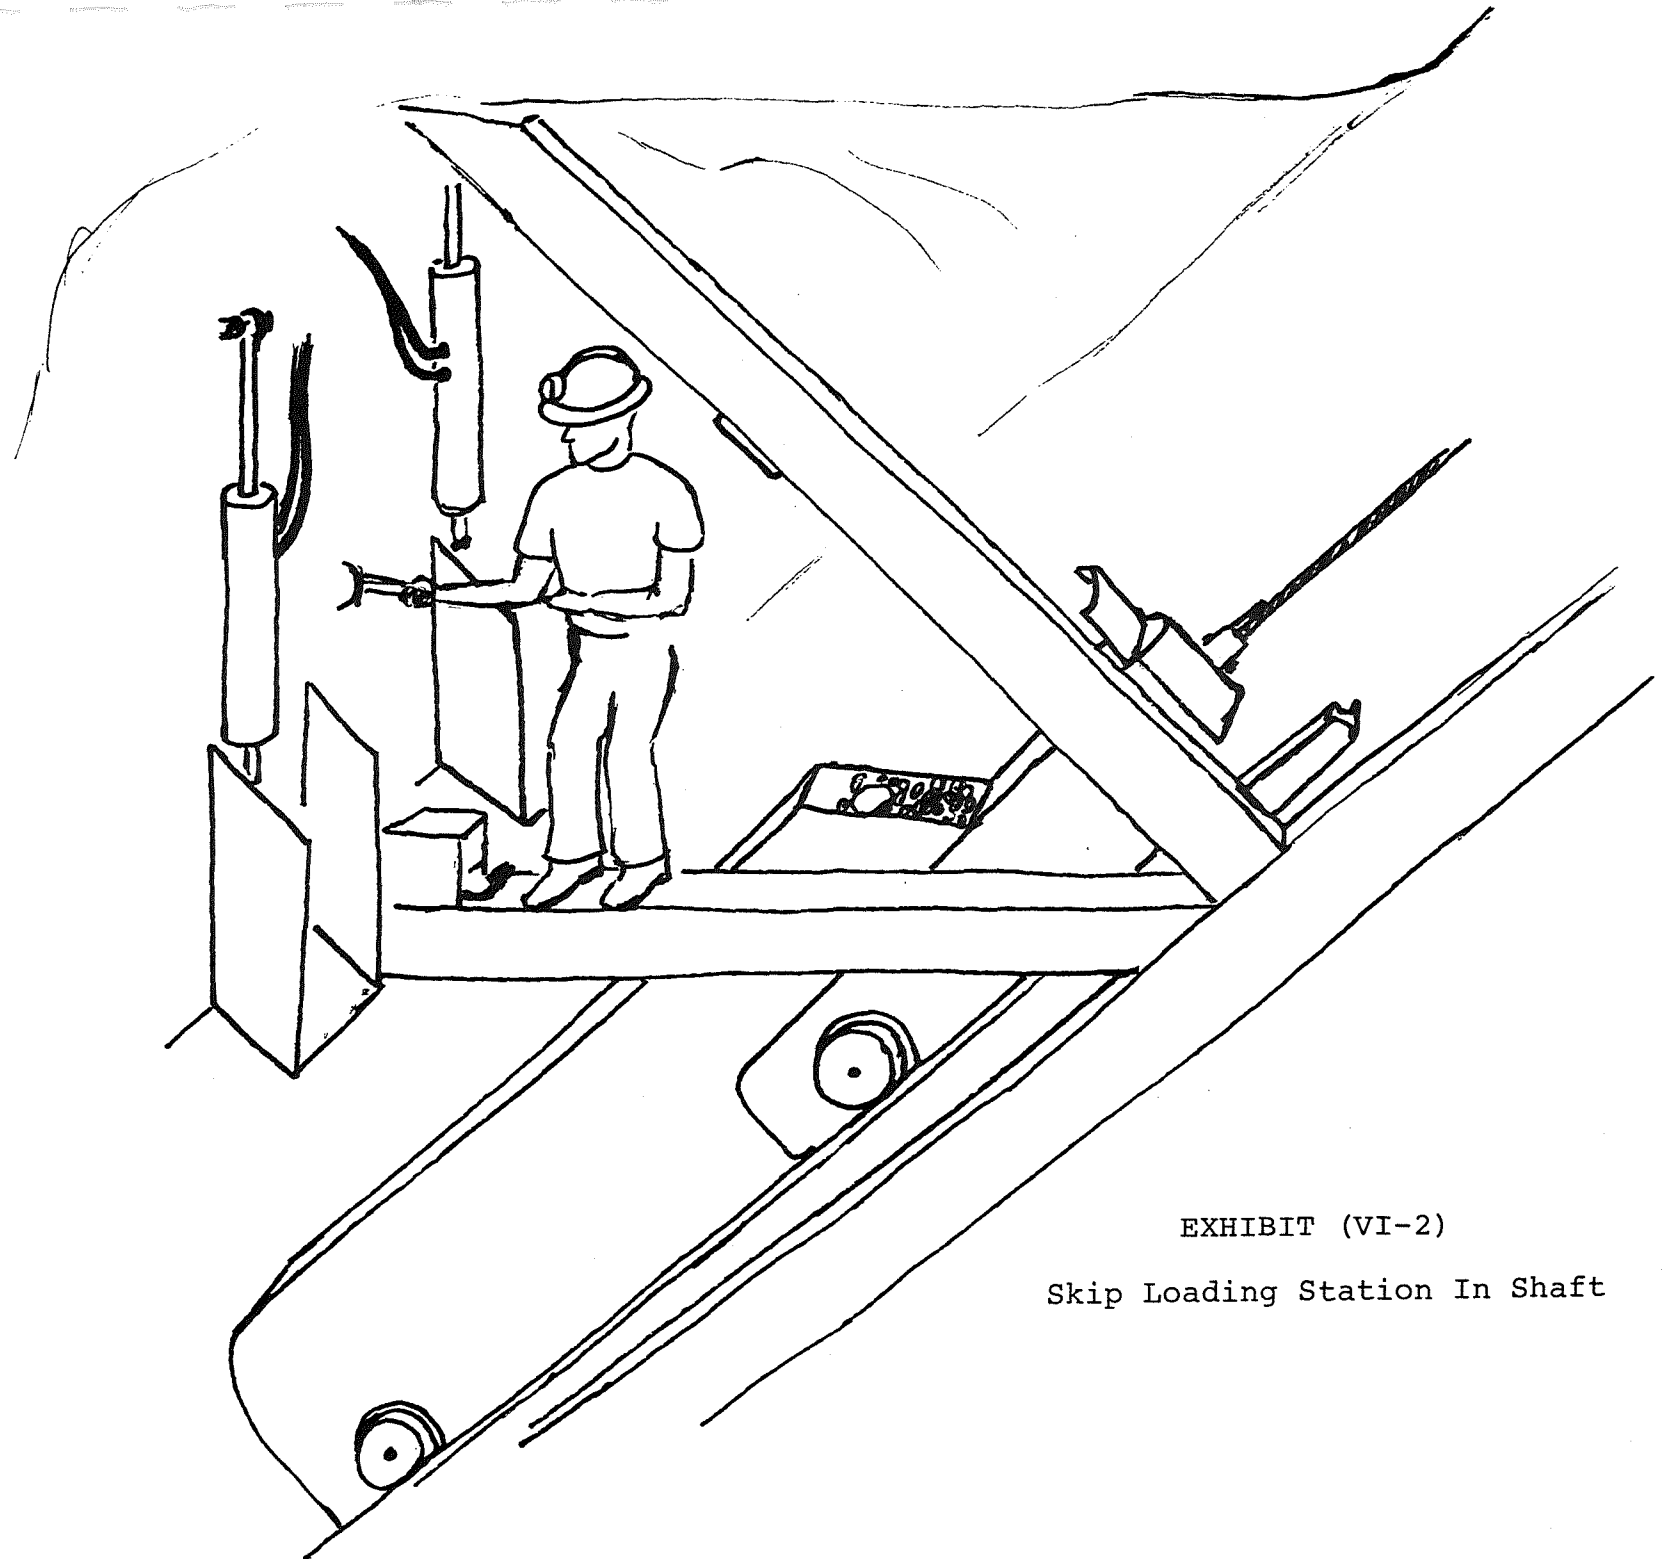
EXHIBIT (VI-2)

Skip Loading Station In Shaft

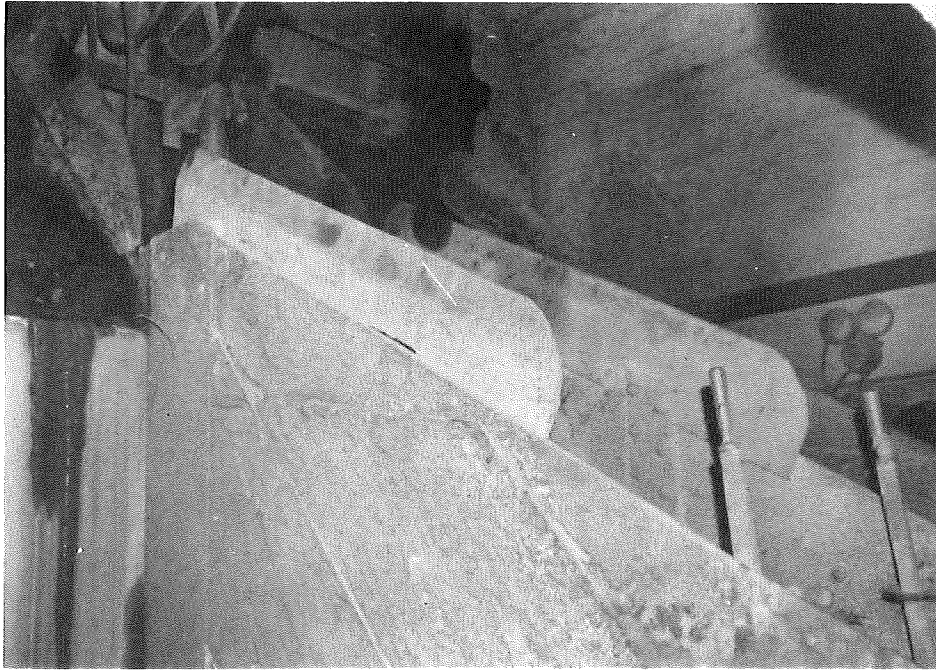
Exhibit VI-3

However, in many cases (Exhibit VI-3), relocation of the skip loader station may not be feasible or economical. In those cases, adequate operator protection (example

Skip Loader Station Without Overhead Protection

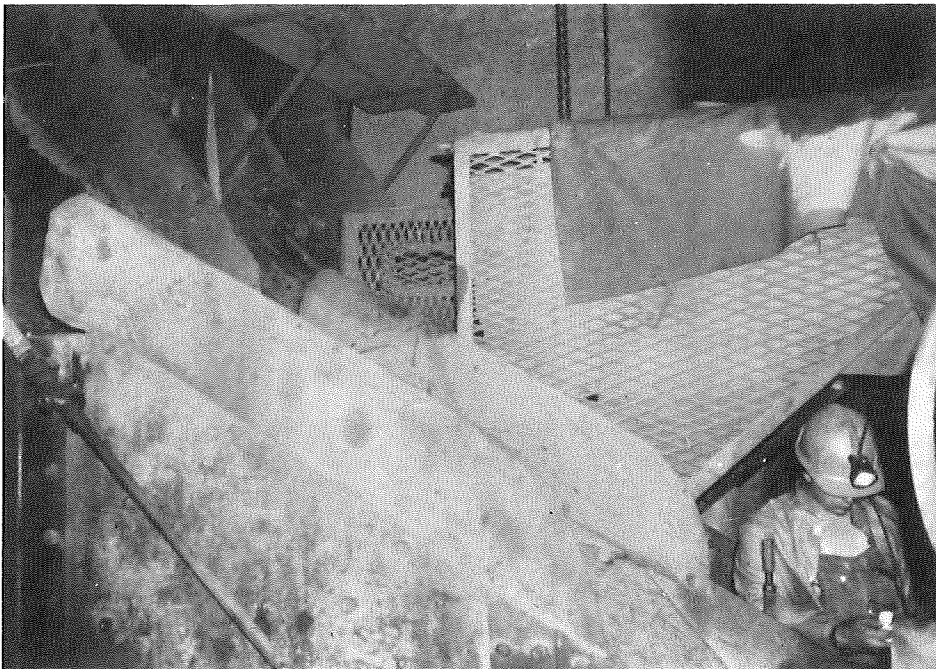
Exhibit VI-4

Skip Loader Station With Overhead Protection

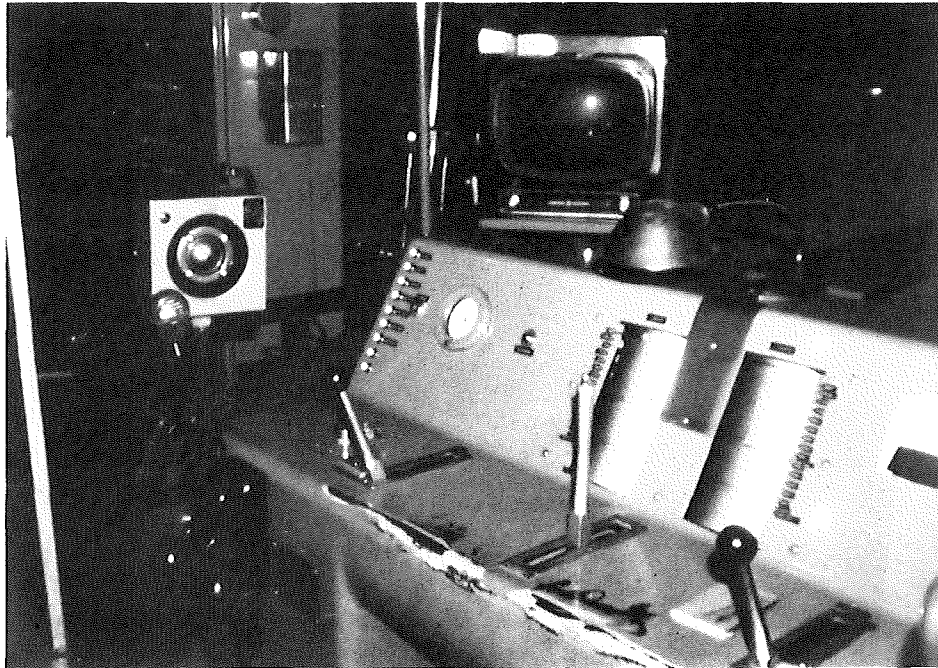
Exhibit VI-5

Hoistroom With Radio Communication

- Radio Systems: Radio communication systems were also observed in both shaft inspection activities, as well as personnel hoisting operations (Exhibit VI-5). Fixed units at hoisting controls on conveyances, or carried units, provided an information link whenever needed.

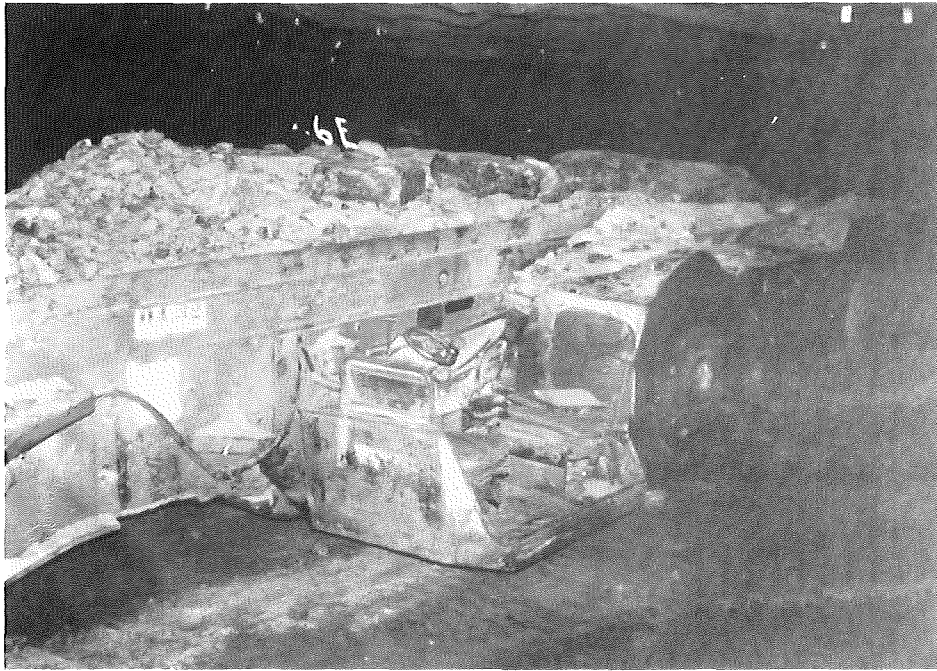
Exhibit VII-2

Operator Exposed to Rocks Off Haulage Bed and
Falling Objects

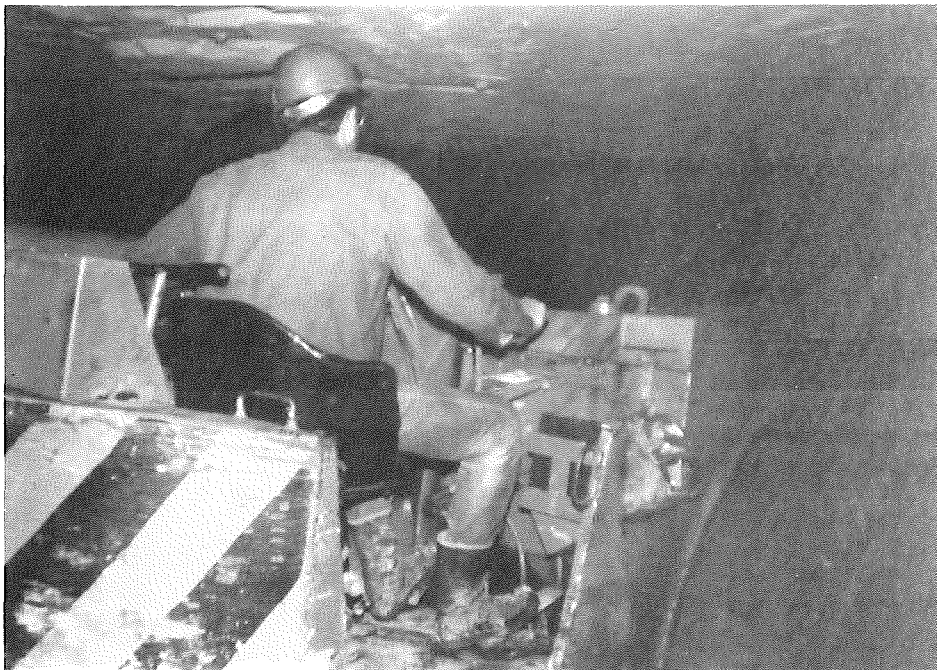
Exhibit VII-3

Low Head Clearance for Shuttle Car Operator

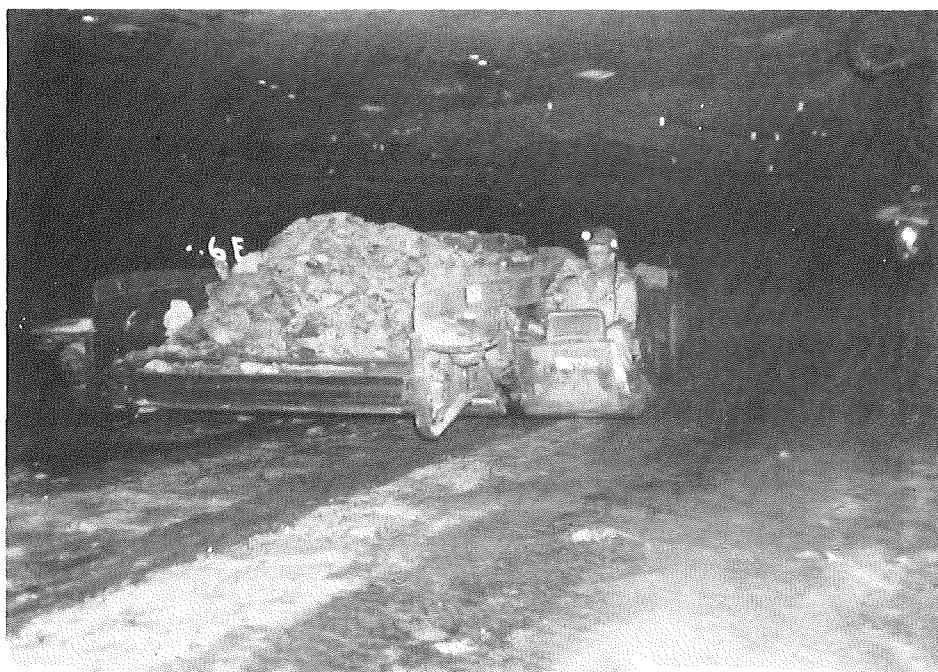
Exhibit VII-4

Corner Located Operator Compartment: Minimal
Operator Protection

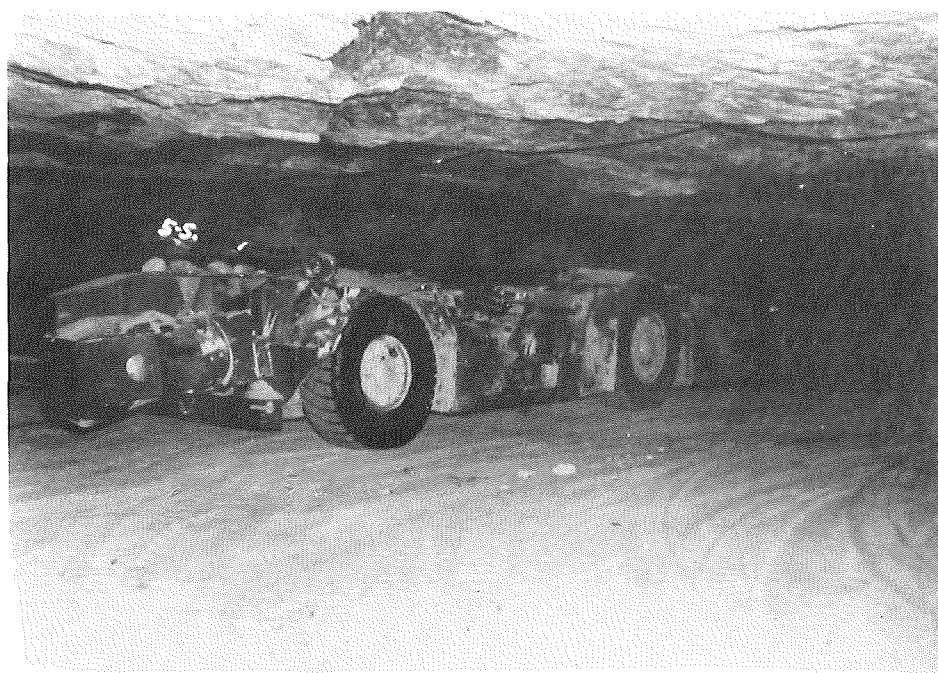
Exhibit VII-5

Center Placed Operator Compartment: Limited
Visibility But Improved Operator Protection

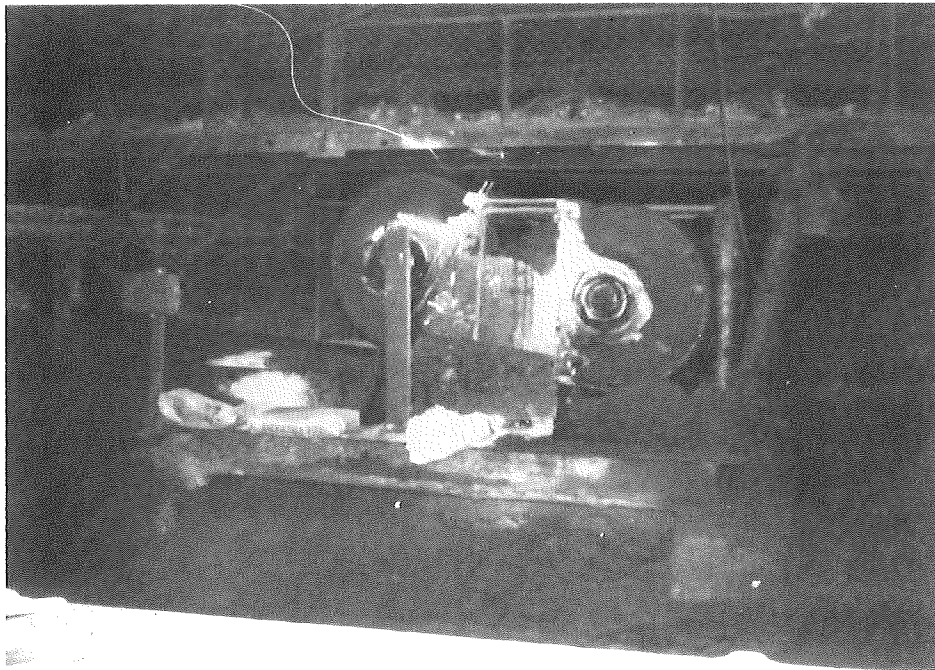
Exhibit VIII-1

Inadequate Conveyor Guards

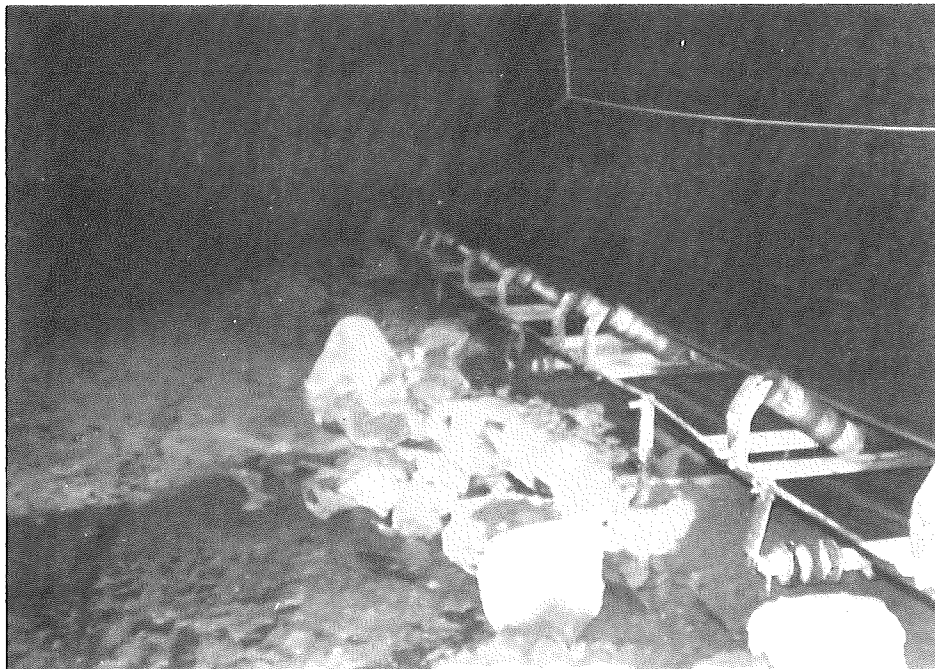
Exhibit VIII-2

Example of Rocks Off Moving Conveyors
