ORE HANDLING EQUIPMENT OPERATIONS SAFETY STUDY IN UNDERGROUND METAL AND NONMETAL MINES

THEODORE BARRY AND ASSOCIATES
USBM CONTRACT REPORT H0230004
MODIFICATION NO. ONE

JULY 1975

FINAL REPORT
USBM Contract No. HO230004 - MOD 1

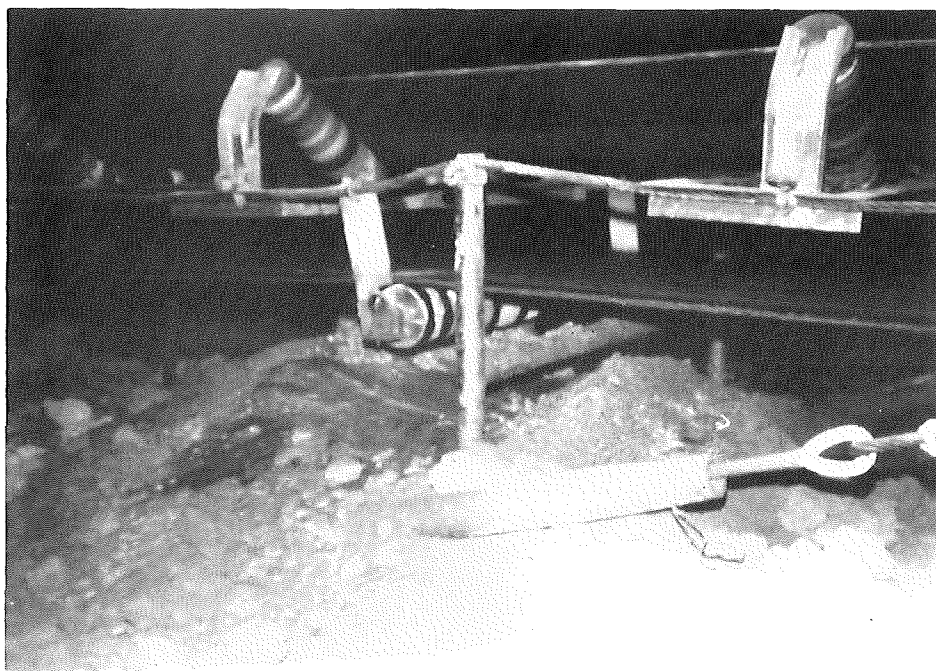
Exhibit VIII-3

Conveyor Wearing Out the Idler Hanger Bracket

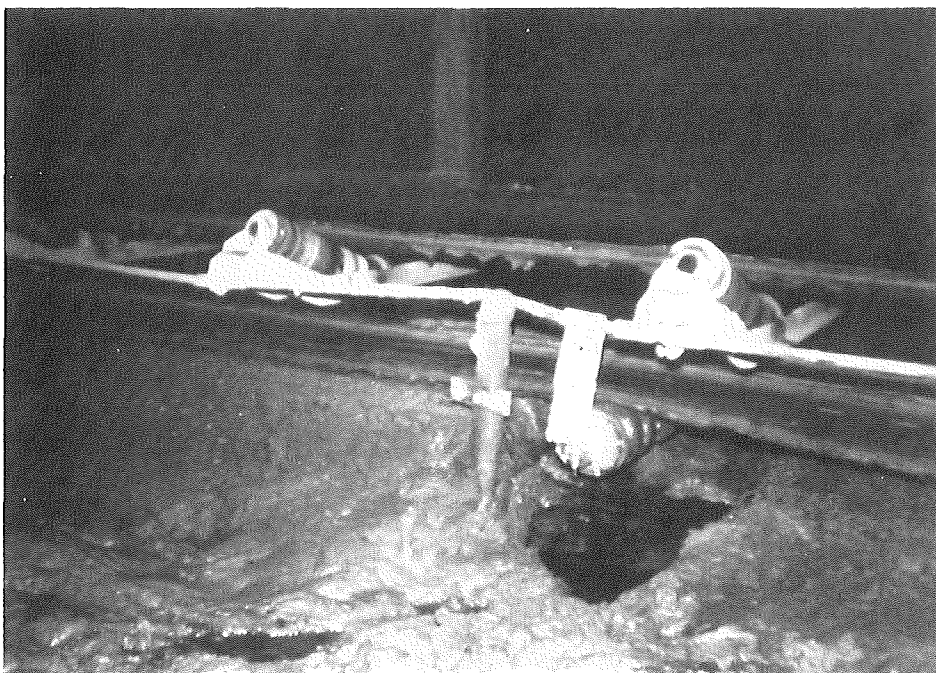
Exhibit VIII-4

Muck Buildup Under Conveyor

- Belt cleaners should be used on conveyors to eliminate build-up of material and carry-back of broken ore. These devices installed on appropriate conveyor systems would minimize the need for cleaning activities and can reduce accidents by 10 percent.
