THE DEVELOPMENT OF GUIDELINES FOR
CLOSING UNDERGROUND MINES:
MICHIGAN CASE HISTORIES

Institute of Mineral Research
C.W. Schultz, Director
Michigan Technological University
Houghton, Michigan 49931

Allan M. Johnson
Research Leader

Date prepared June 28, 1984

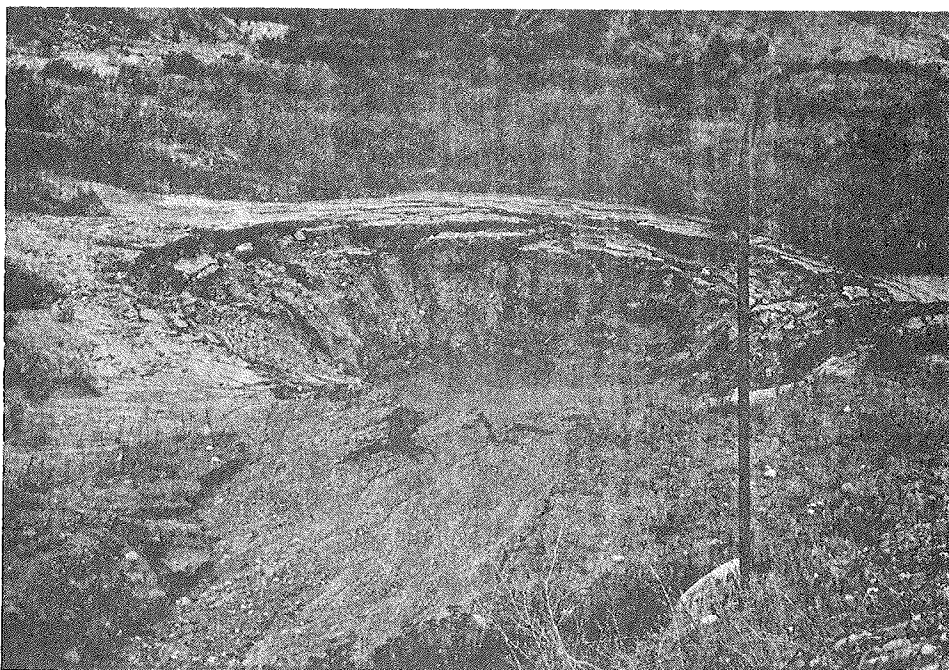
It is believed that following the rise of water in the overburden above the Sherwood Mine that water flow into the mine through the pit area washed sand into the incompletely filled stopes below. This loss of sand from the "plug" consisting of sands previously washed into the opening in the top of

Figure 11. Photograph of initial subsidence in West Pit area taken on September 7, 1979. The subsidence pit is about 30 feet in diameter and ten feet deep. The bent pipe in the foreground is an old well casing installed in the 1940's. Photograph taken with a 50 mm lens on a 35 mm camera, looking southeast. Cave first observed August 31, 1979.

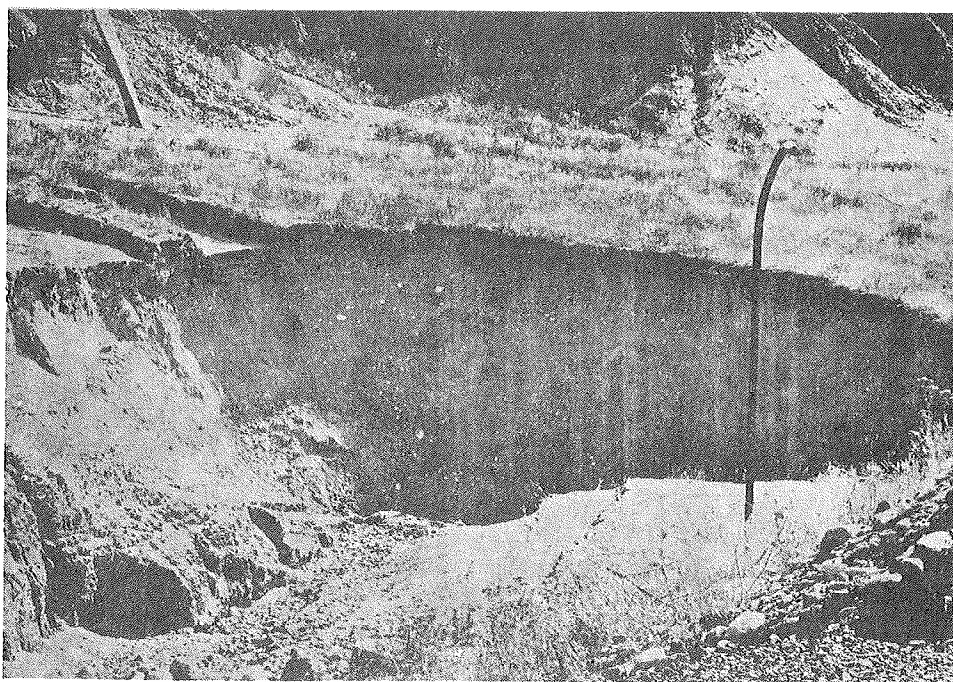
Figure 12. Photograph of enlarged subsidence pit which caved on October 14, 1979. The resulting pit is about 100 feet in diameter and 60 feet deep. Note old well casing pipe in foreground; also cribbing and bent over 30-inch pipe in background at upper left, formerly used for sand filling stopes under this area. Looking southeast, photo taken with 35 mm camera equipped with a 50 mm lens.

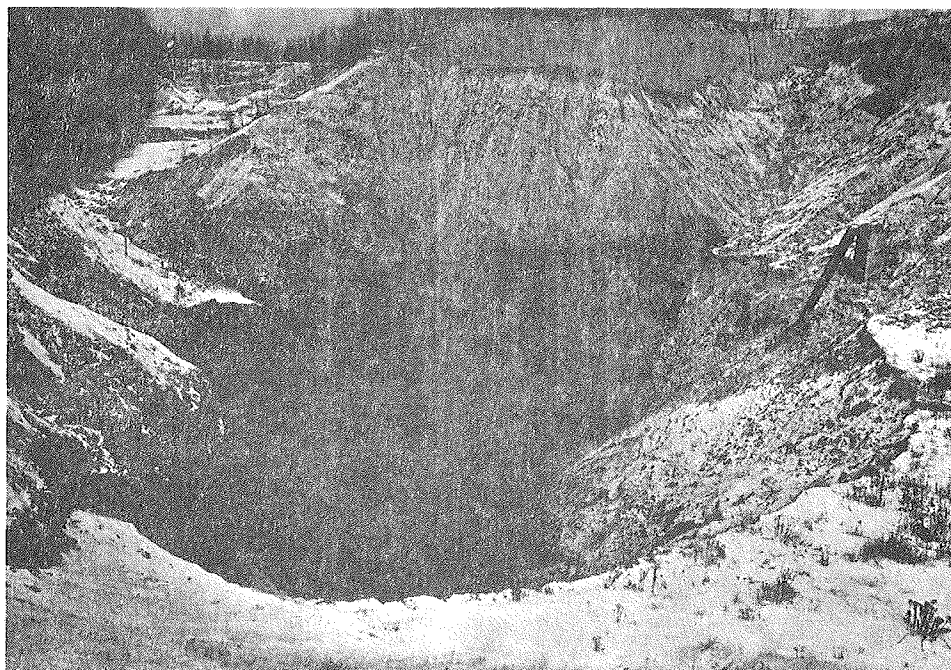
- a Greatly enlarged subsidence pit which caved on October 19, 1979. The pit is about 200 feet in diameter and 100 feet deep. Shear rock walls are exposed on the west and north walls of the pit. Note the old well casing on the far right and sand filling pipe and cribbing on the left. This cave occurred on October 19, 1979. View looking north. Photograph taken with a 28 mm wide angle lens on a 35 mm camera.

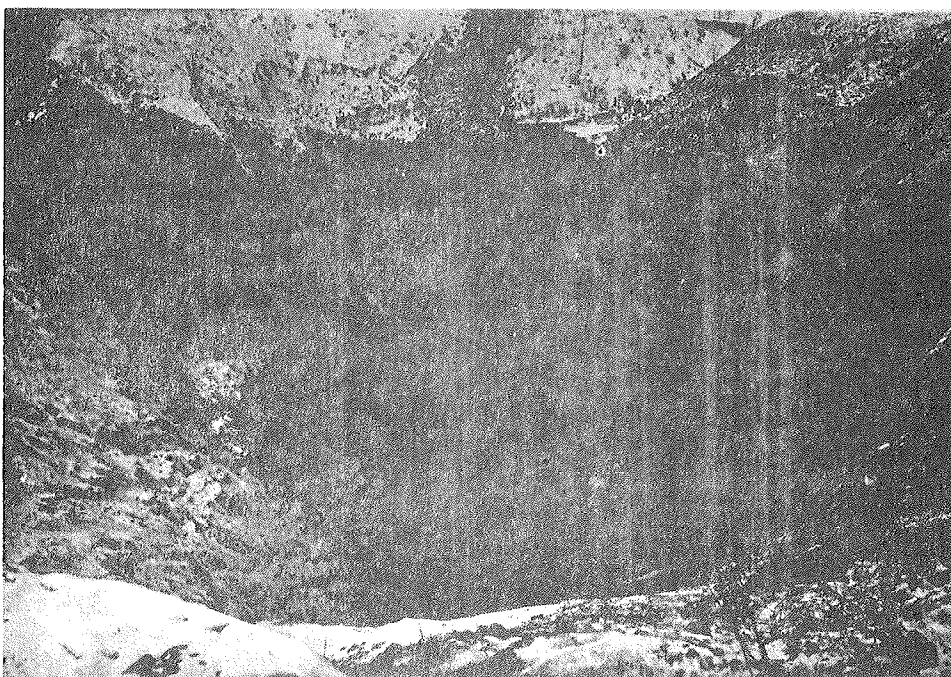
- b Close up of the October 19, 1979 cave. View is looking northwest. Note 30-inch diameter sand fill pipe in near foreground and old well casing in background. Photograph taken with a 28 mm wide angle lens, 35 mm camera.

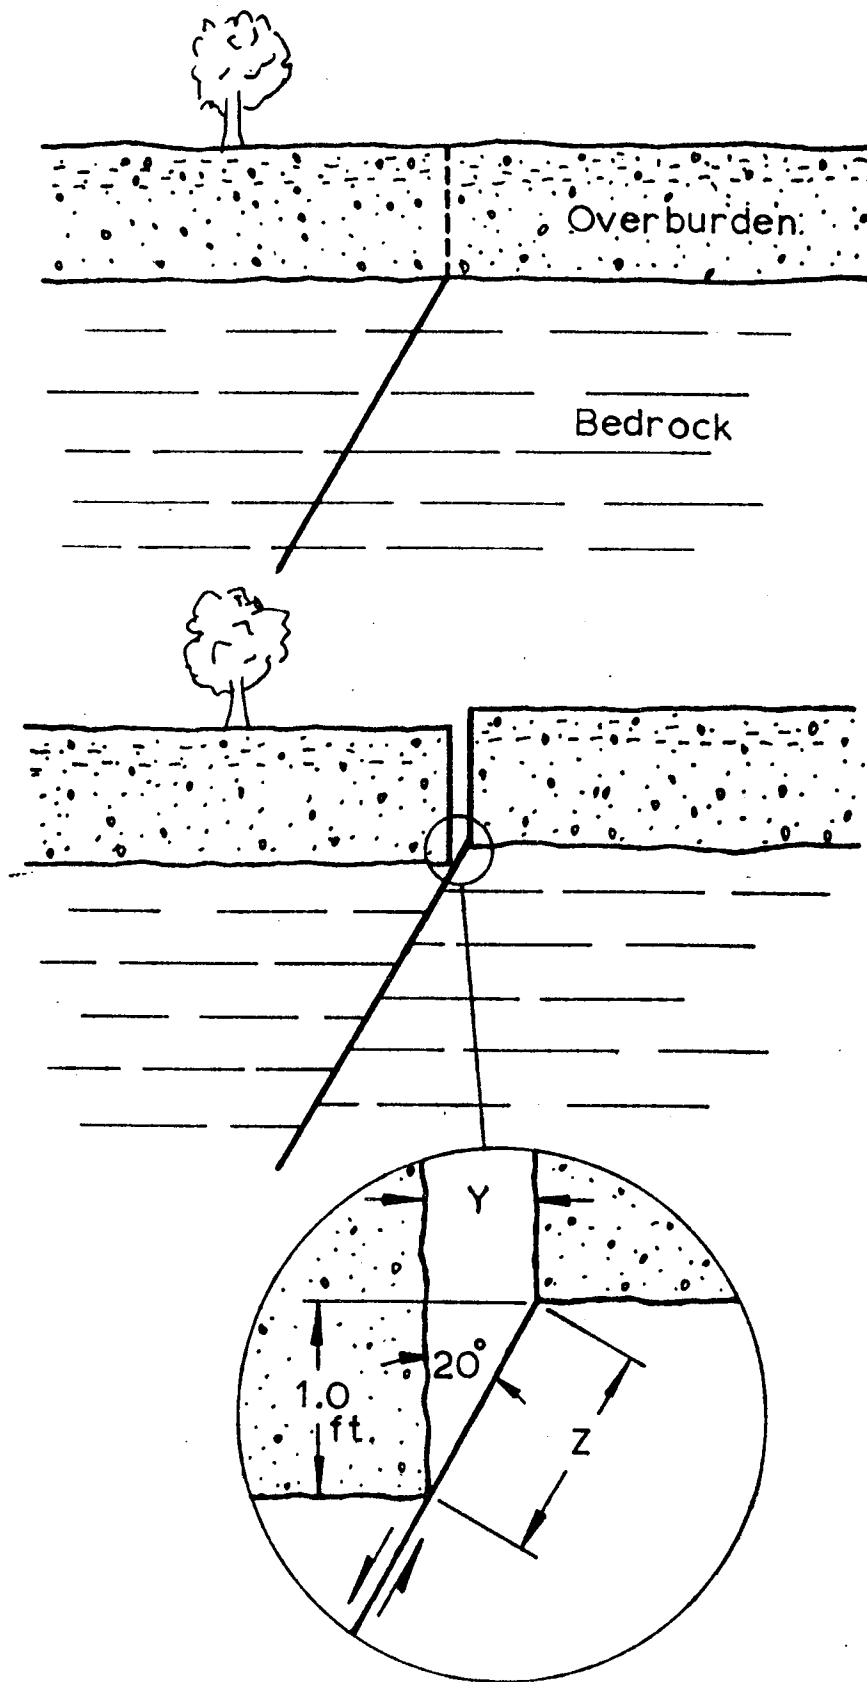
It is hypothesized that renewed movement of the massive south block of the mine occurred as a result of mine flooding. It is likely that groundwater inflow into the shear zone reduced the frictional forces holding the block in position and perhaps loading of the sealed stopes within the block with water may have helped this movement. It is also possible that movement on the shear plane may have been partly responsible for initiating

Figure 16. Suggested Mechanism to Explain Surface Pits on South Block of Surface Shear - Looking West.

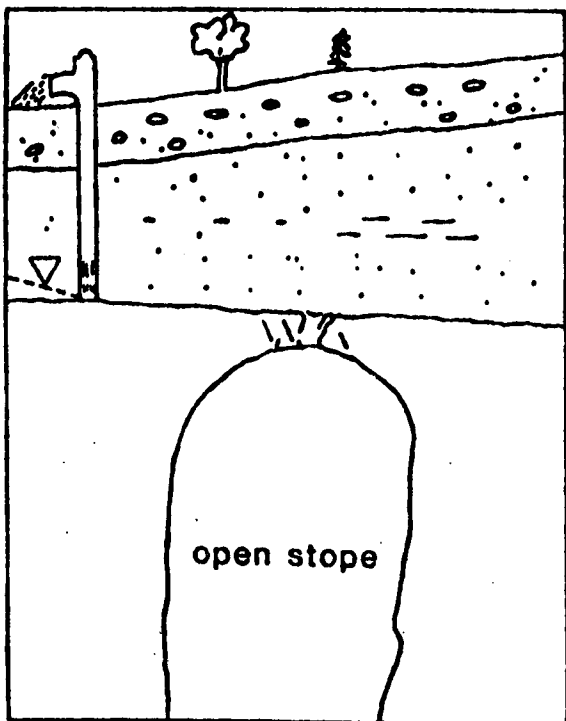
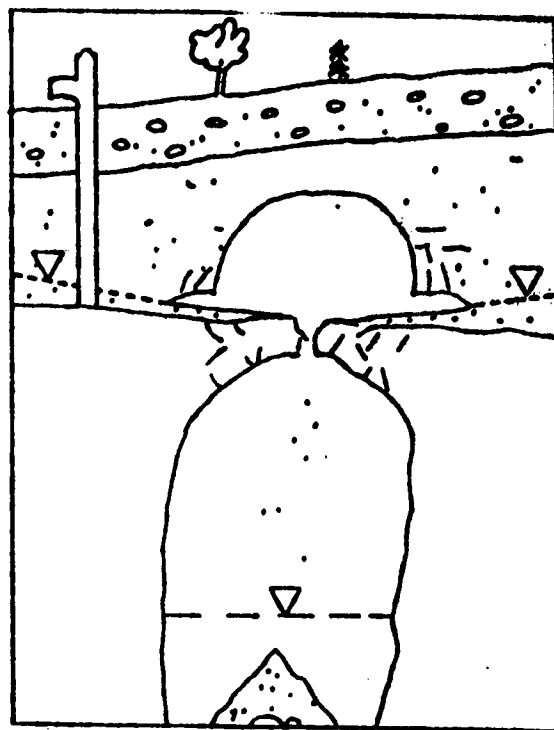
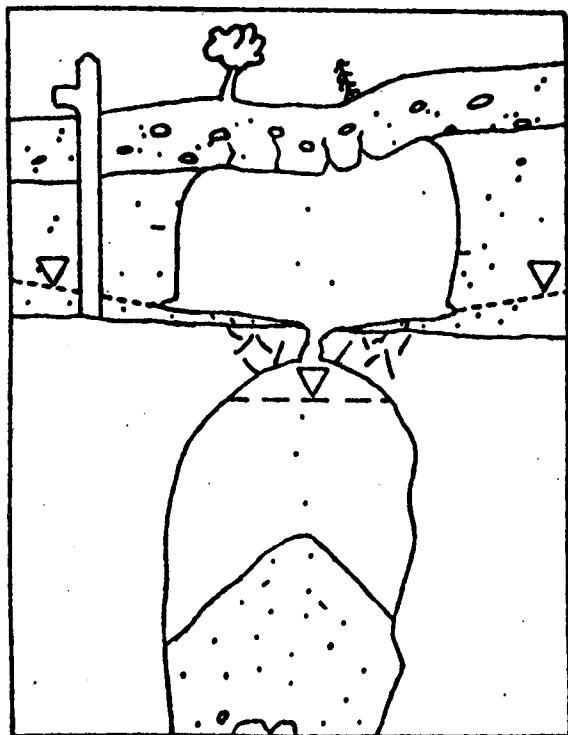
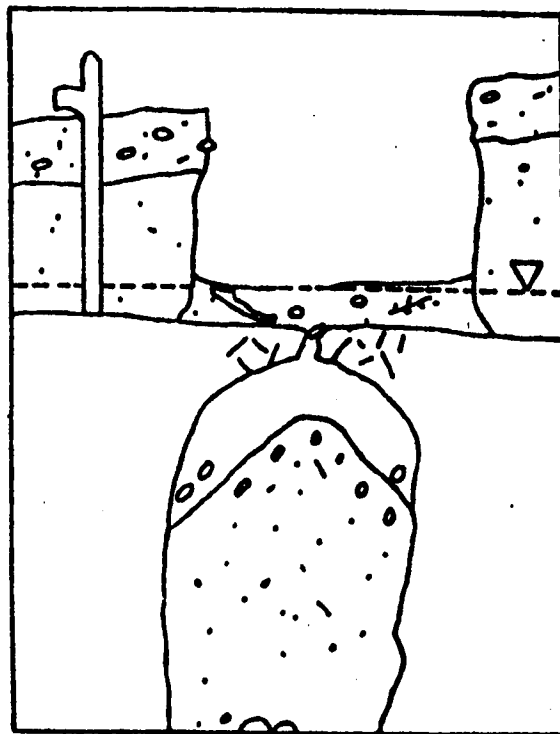
If the diameter of the hemispherical piping cavity exceeds the length that the surface capping will withstand, surface collapse will occur. The resulting pit will be straight-walled with a high depth to width ratio. This will serve to distinguish a piping-generated cavity from one formed by shear failure of running sands. These cavities may apparently exist for long periods without any surface expression to indicate their presence. Capping failures may be triggered by outside forces; i.e., explosions or hydraulic forces as occurred at the Sherwood Mine.

A. Mine operating, surface and underground pumping in progress. Stope underlies erodible sands and competent till capping.

B. Mine closed, pumping stopped. Groundwater rises in overburden and mine begins to flood. Cavity develops in sands above bedrock as sand/water mixture flows into the stope via open fractures.

C. Soil cavity enlarges as water inflow causes undercutting at periphery resulting in sand collapses from the roof. Soil is carried into mine by groundwater flow. Competent capping layer still intact.

D. Collapse of cap, subsidence is complete the mine is flooded and the groundwater table is at equilibrium. Resulting pit has near vertical walls and a flat bottom.

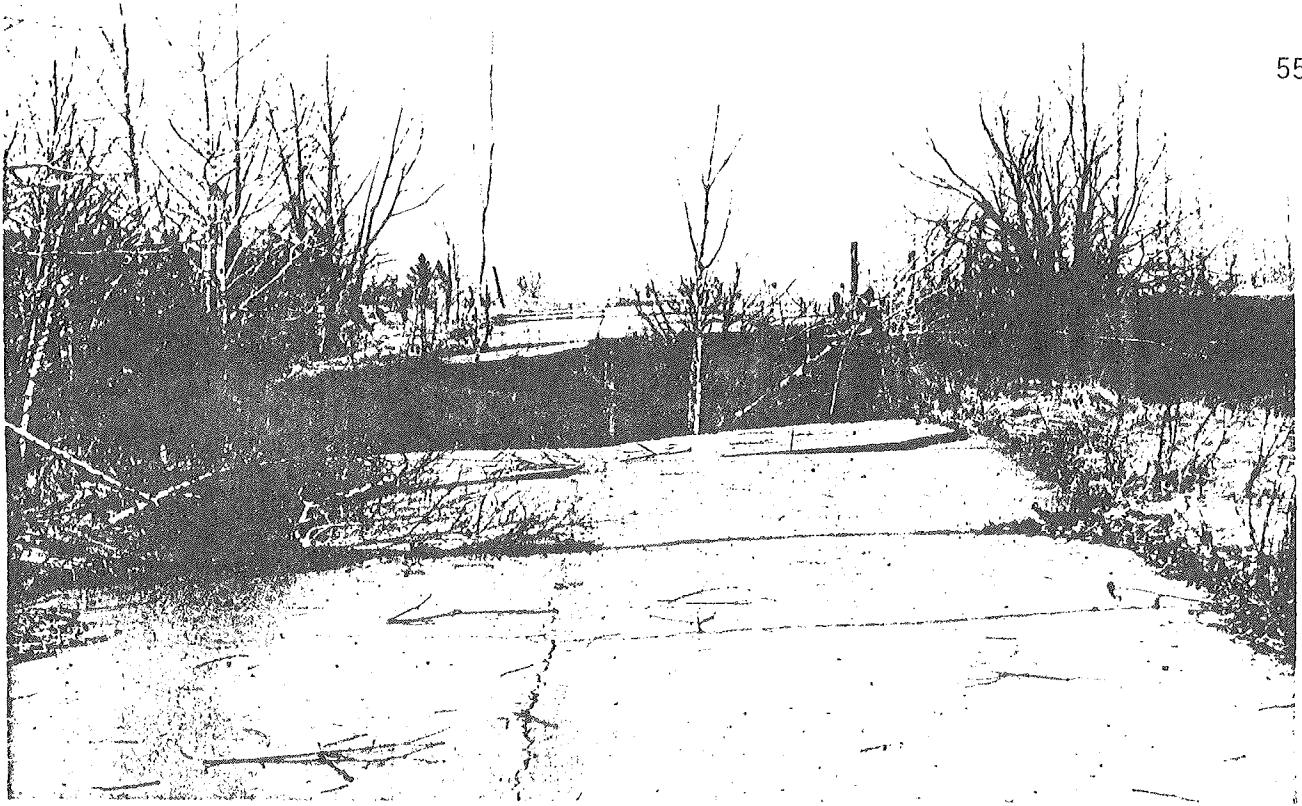
Figure 18. Smuggler Mine Cave-in on County Road 424: Looking East

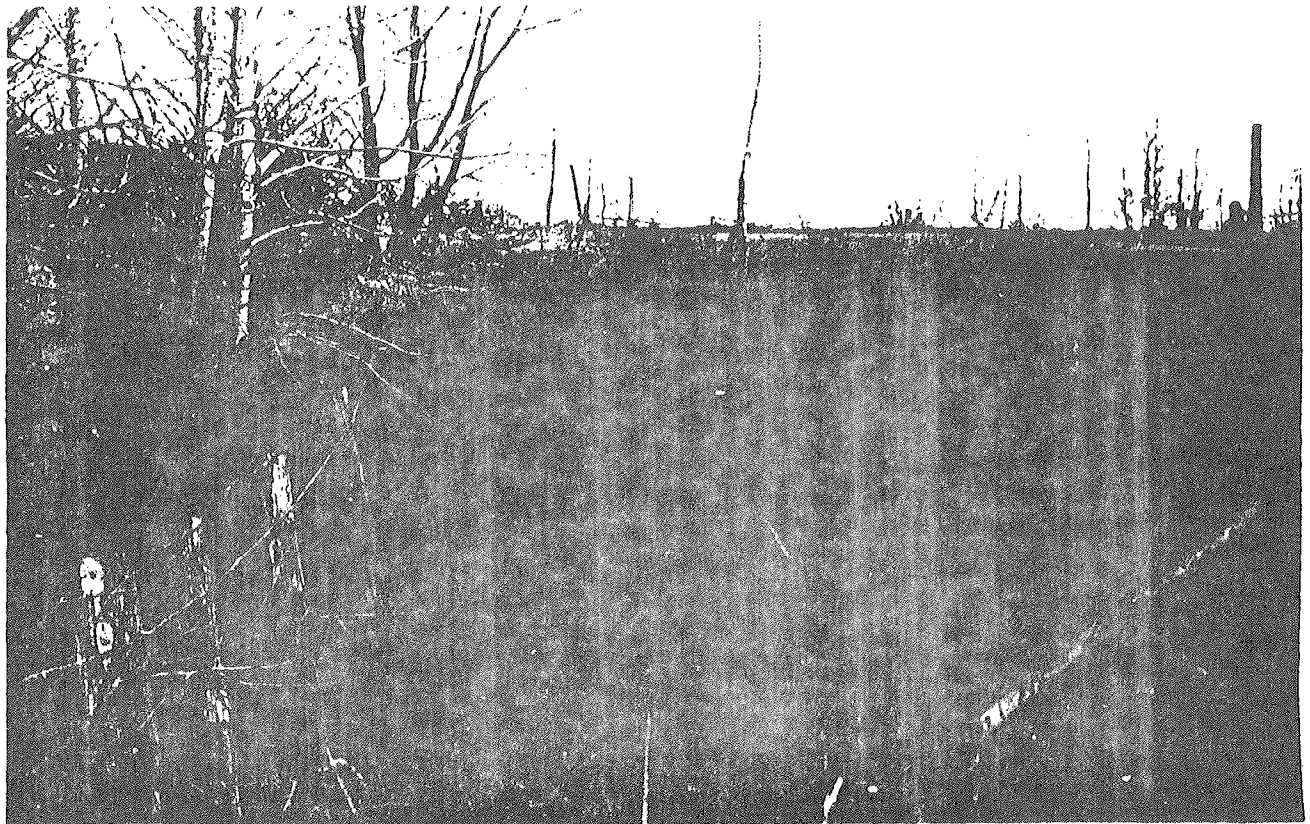
Figure 19. Close-up of Smuggler Mine Cave-in: Looking East

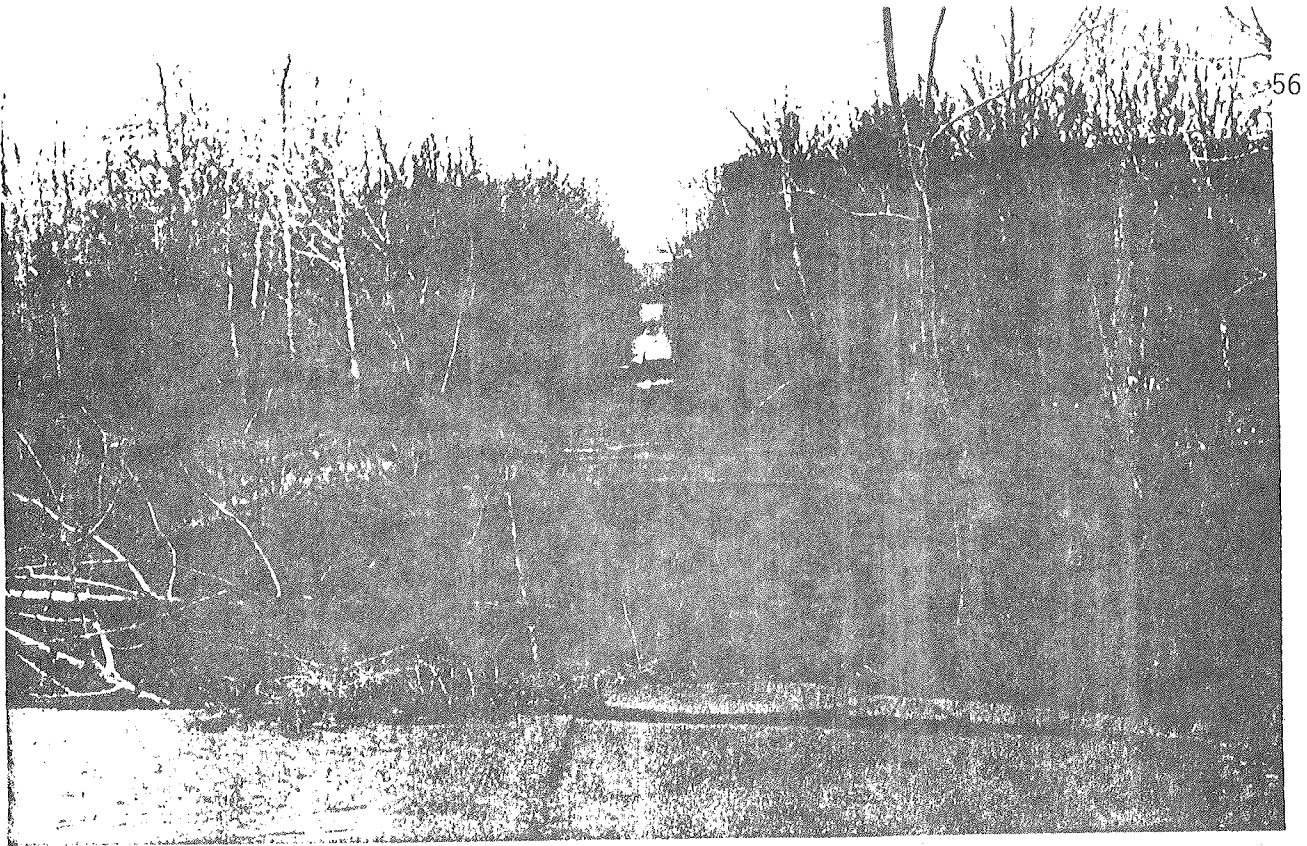
Figure 20. Smuggler Mine Cave-in on County Road 424: Looking West

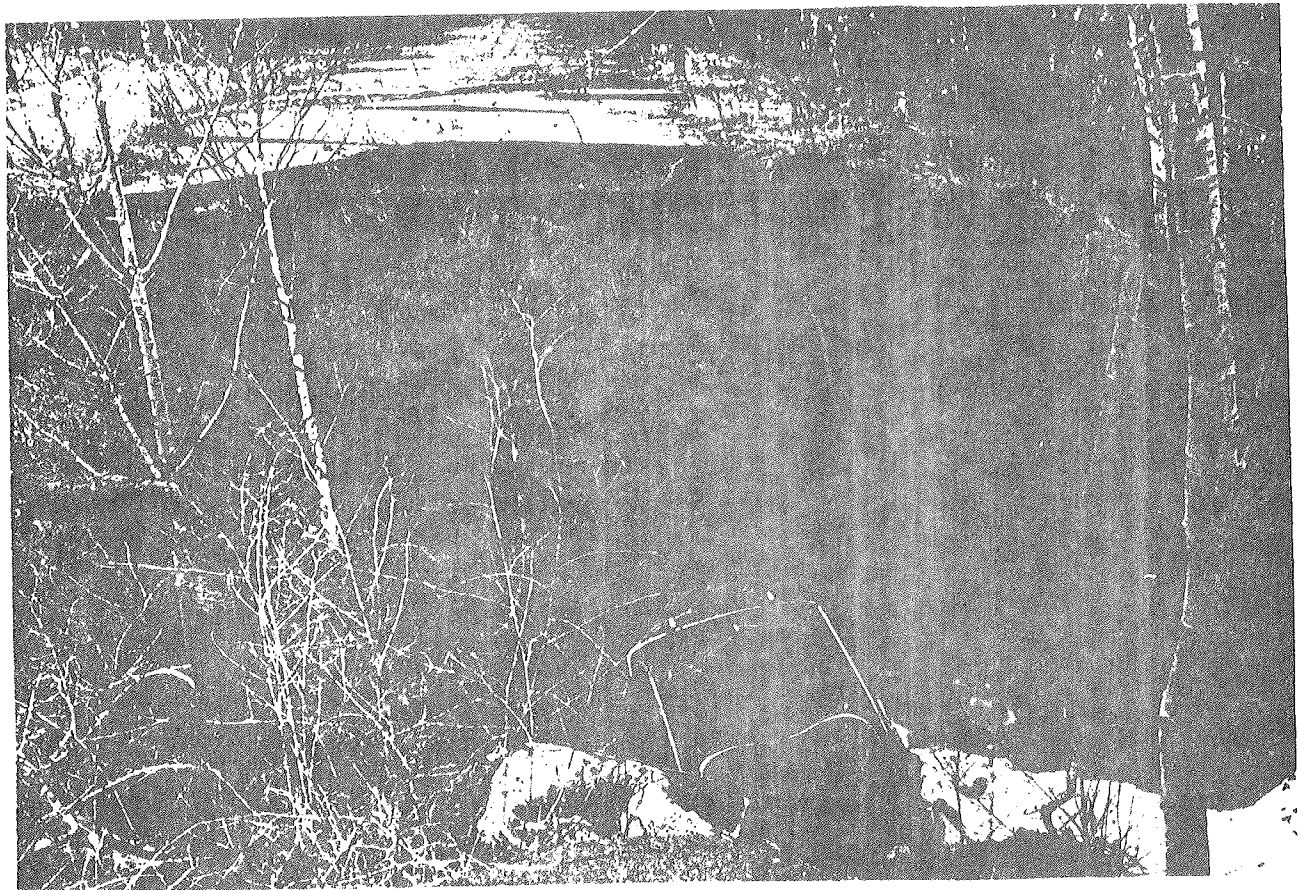
Figure 21. Close-up of Smuggler Mine Cave-in: Looking West

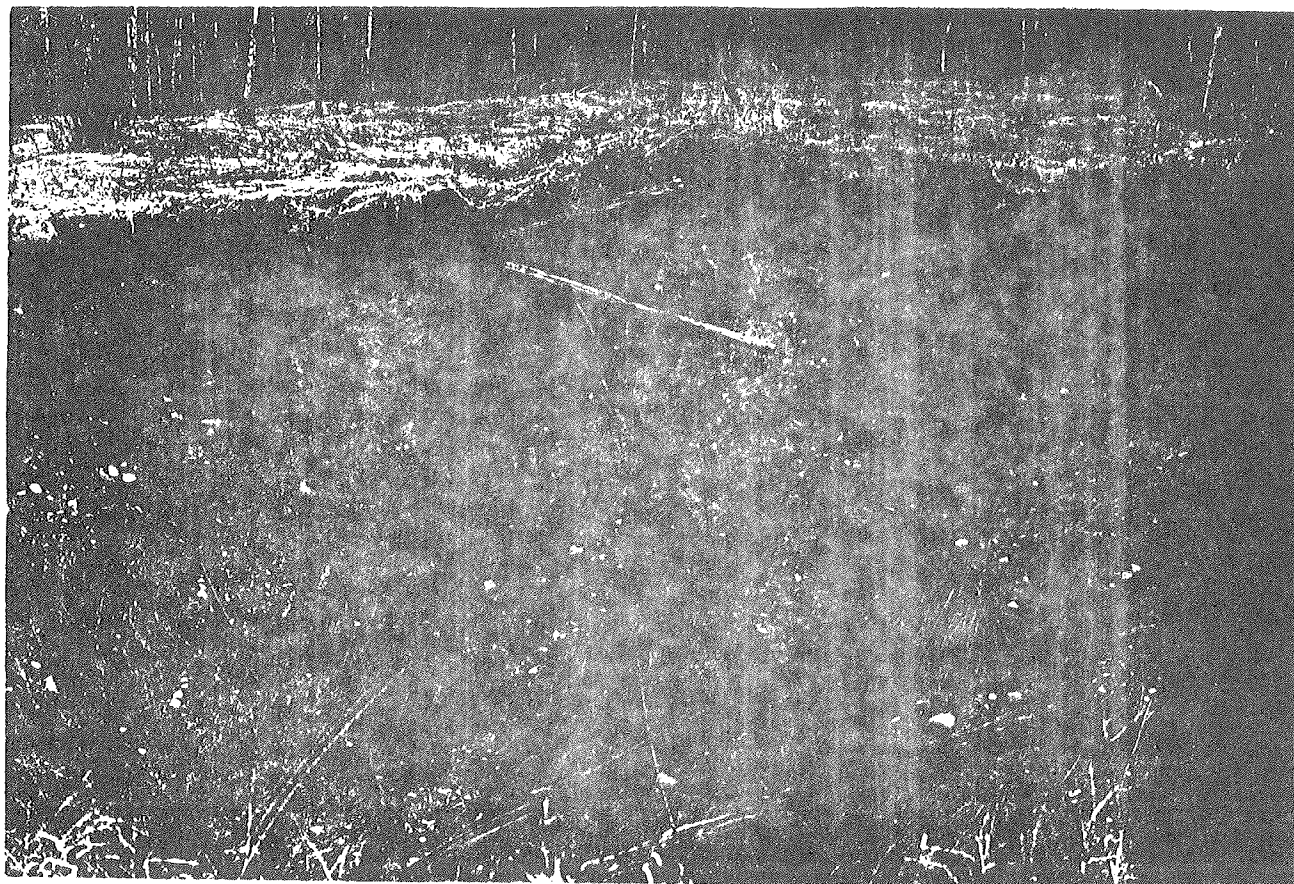
Figure 23. Small Subsidence Pit (50 ft diameter, 25 ft deep) South of County Road 424 above Smuggler Mine

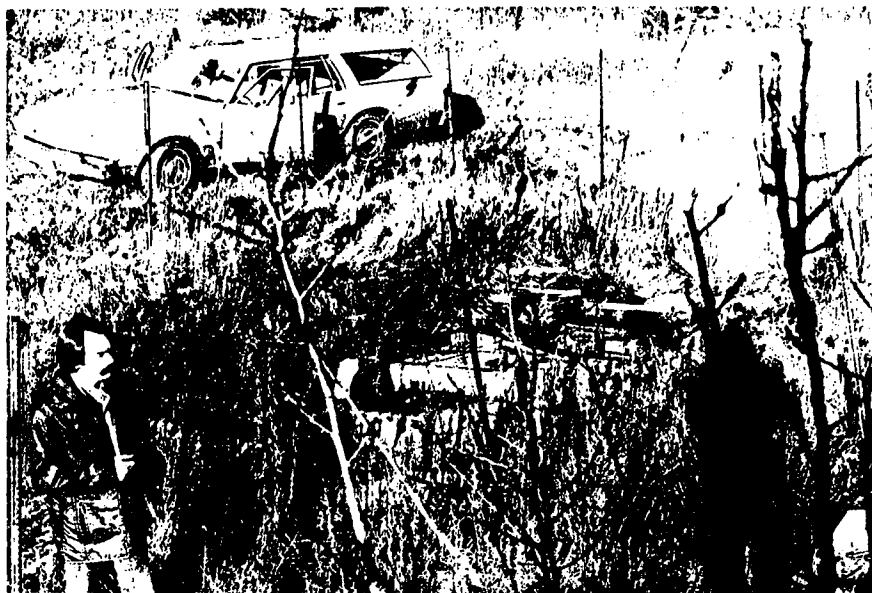
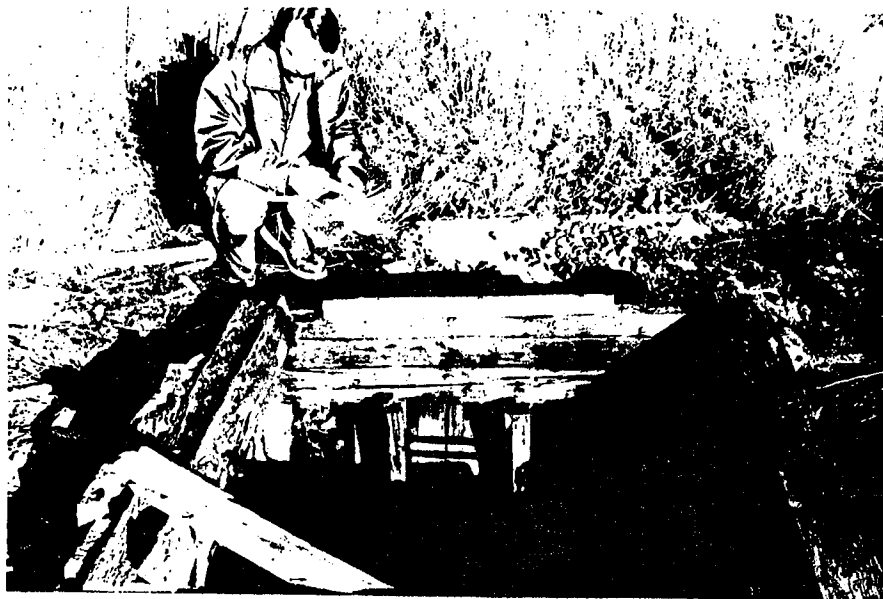
Figure 34. Photographs of Warner Mine Air Shaft

a. Overview of Warner Mine Air Shaft Looking Approximately Northeast

b. Close-up of Warner Mine Air Shaft

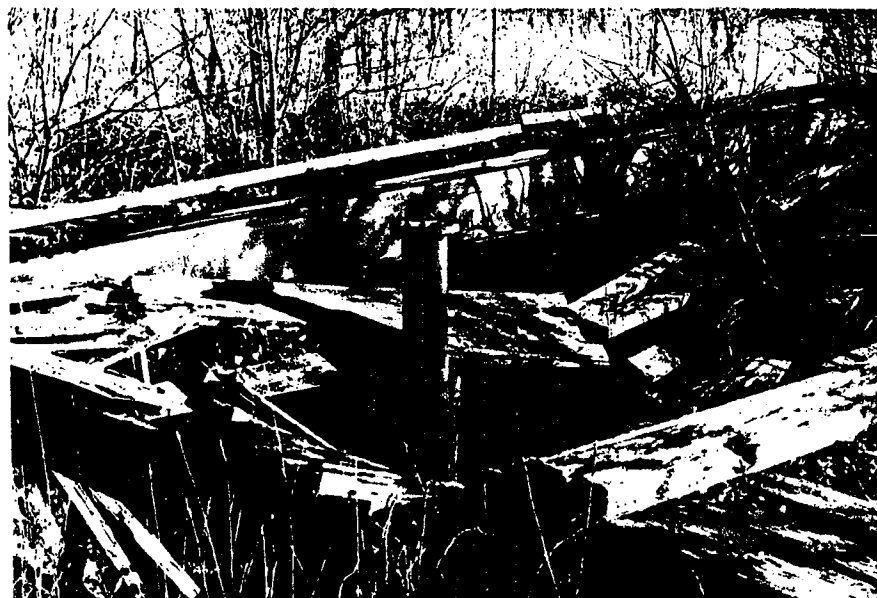
The Porter Mine is also located between Crystal Falls and Amasa, Michigan. It operated from 1914 until 1927, producing 733,000 tons of ore from seven levels. The main shaft was vertical, some 850 feet deep and was capped with heavy wood planking supported by two large steel I-beams. The I-beams have remained in position, but the wooden planking has rotted and collapsed. There is some subsidence around the shaft collar. A secure fence does limit access to the shaft. A photograph of the capping is shown in Figure 35.

Figure 35. Collapsed Wooden Plank Capping on Porter Mine Shaft

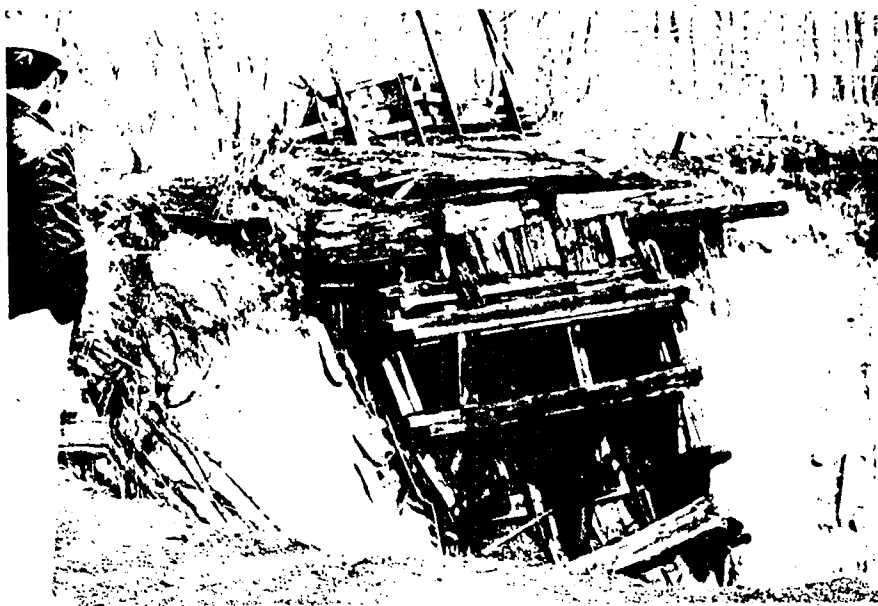
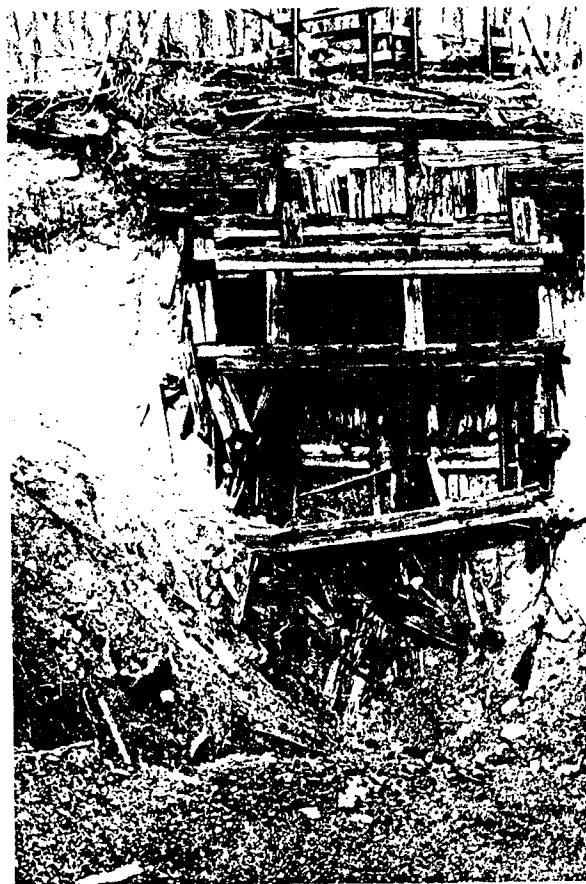
Figure 37. Photographs of Davidson No. 2 Mine Shaft

a. Davidson No. 2 Shaft: Looking Northeast

b. Davidson No. 2 Shaft: Looking North

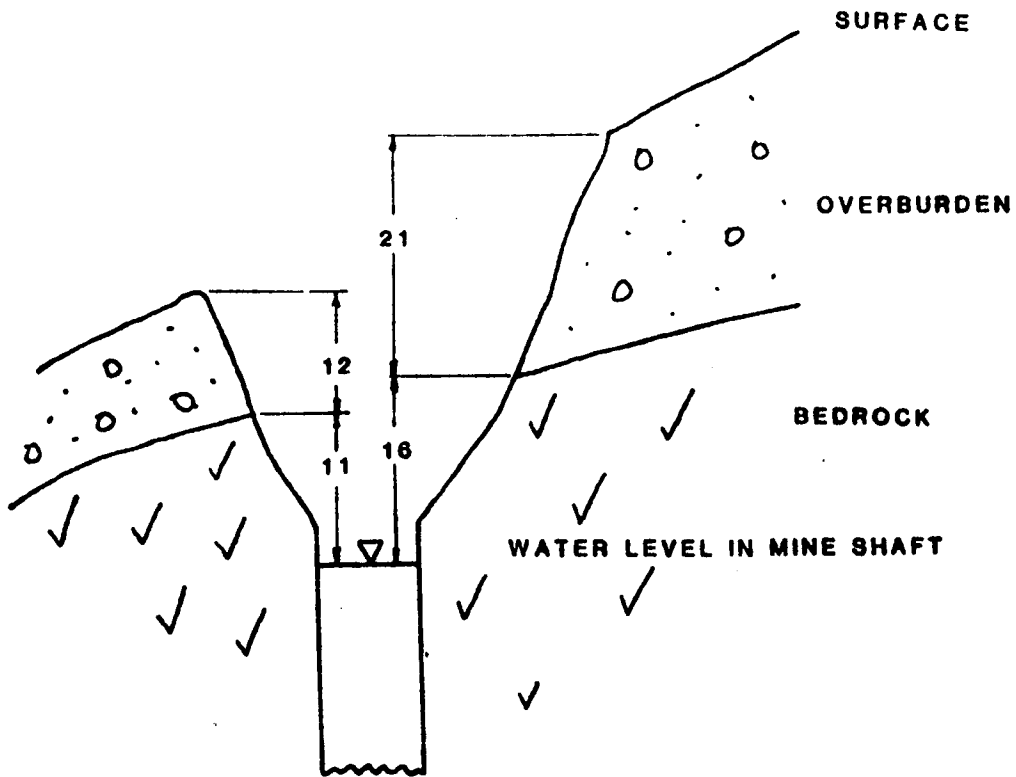
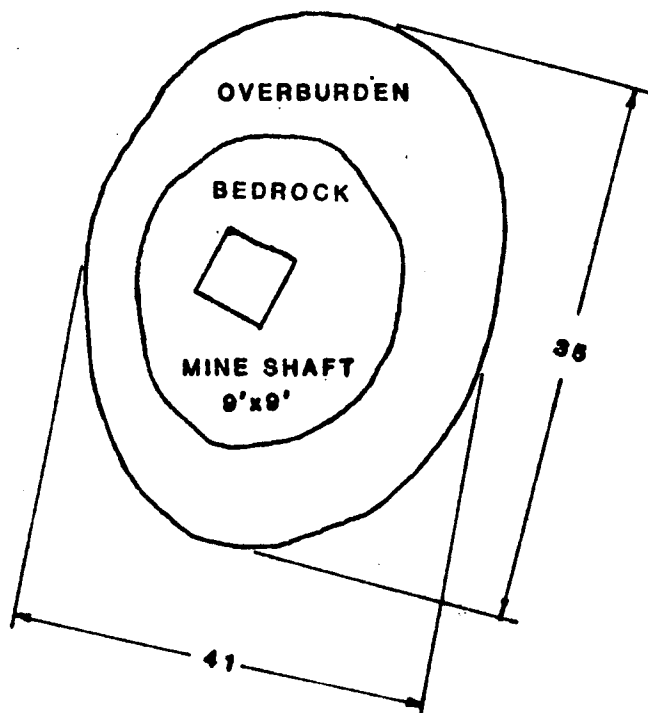
Figure 39. Sketch Map Showing Plan and Section Views of the Pike Mine No. 2 Shaft

On October 31, 1982, the Number 2 shaft of the Pike Mine caved to the surface. Subsequent investigations showed that the original timber capping over the shaft had failed. The ground surface had been brought to the contour of the west sloping hillside and had been maintained as a lawn area

A. CROSS SECTION SKETCH OF PIKE #2 MINE SHAFT : LOOKING APPROXIMATELY NORTHWEST

B. PLAN SKETCH OF PIKE #2 MINE SHAFT

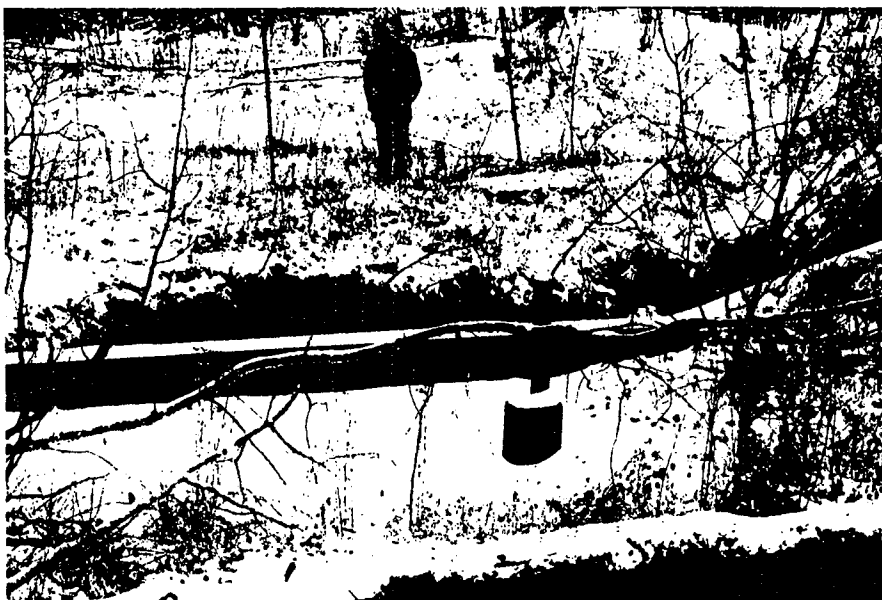
Figure 41. Photographs of Cayia Mine Shaft

The Cayia Mine shaft capping, although strong and well designed, failed because no consideration was given to the strength or durability of the

a. Cayia Mine Shaft: Looking North

b. Cayia Mine Shaft: Looking Southeast

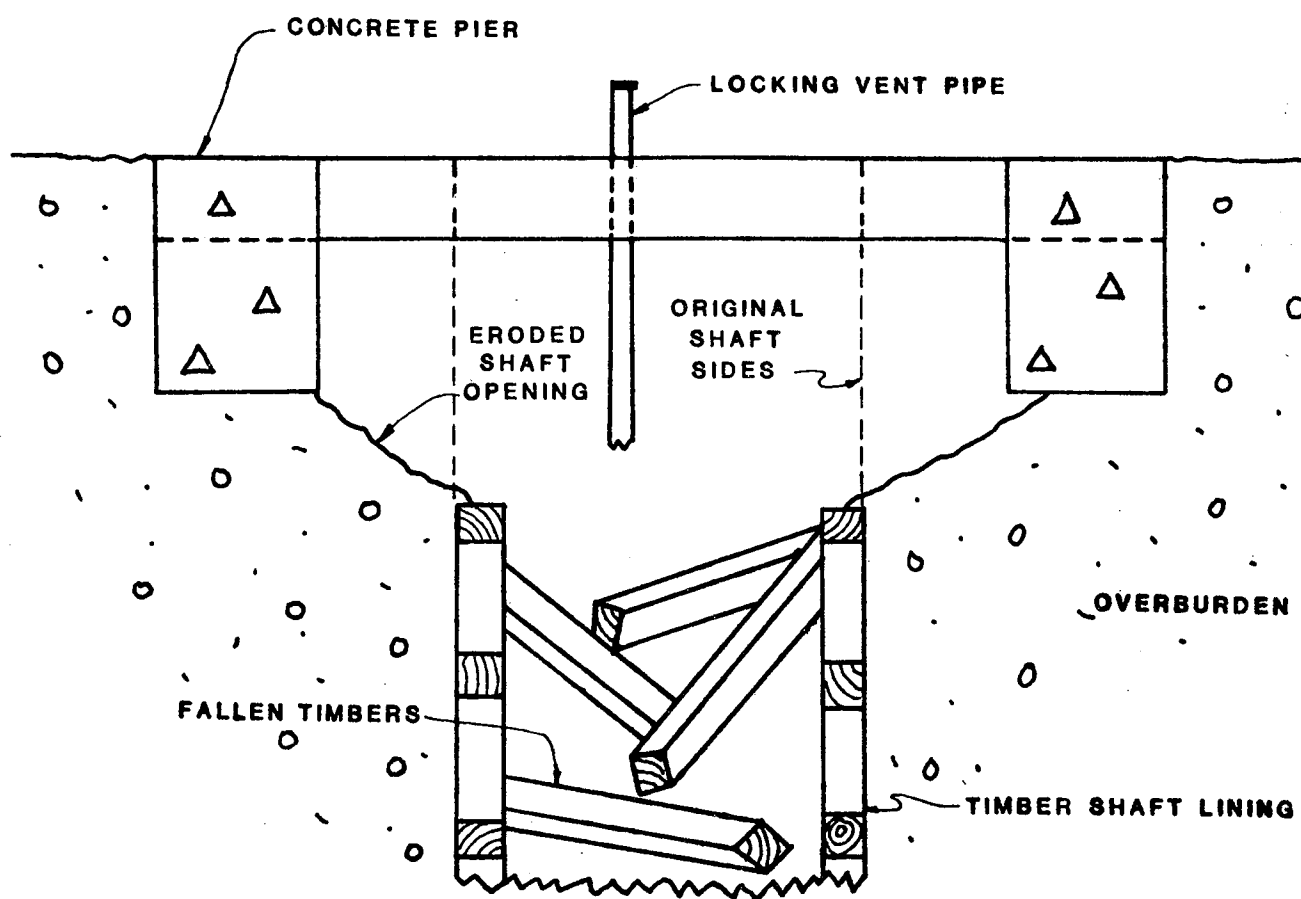
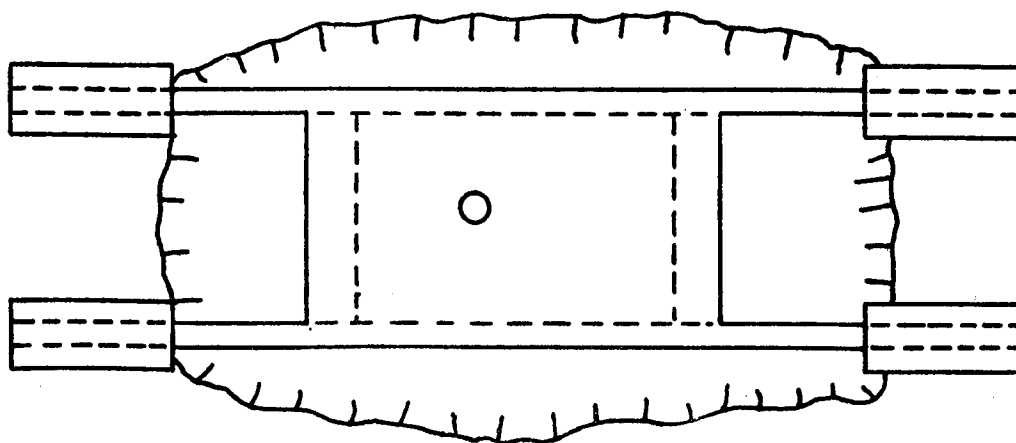
A. SIDE SKETCH VIEW OF CAYIA MINE SHAFT

B. PLAN SKETCH VIEW OF CAYIA MINE SHAFT

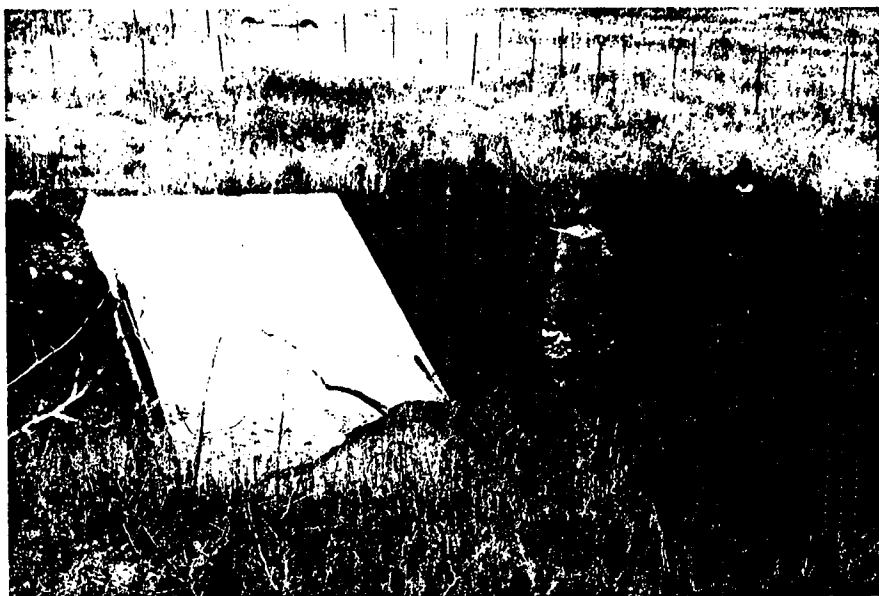
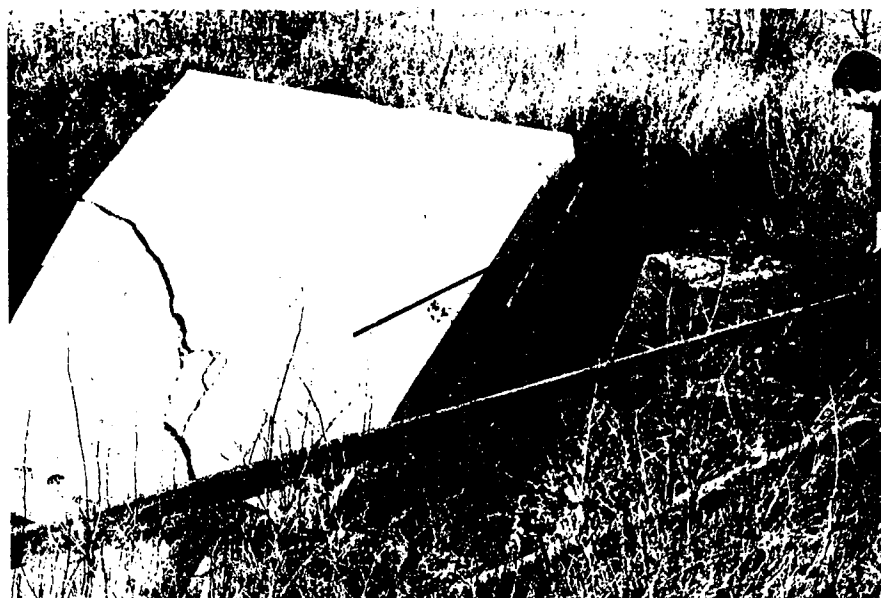
a. Bengal Shaft: Looking Northeast

b. Bengal Shaft Capping: Looking Northwest

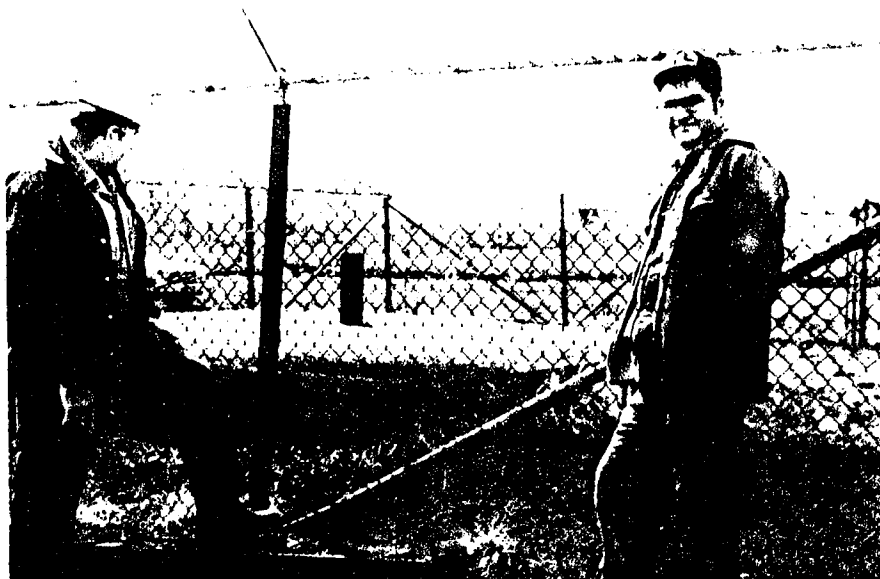
a. Minkler Mine Shaft, Looking Southwest: Note Soil on Near Corner of Shaft Capping

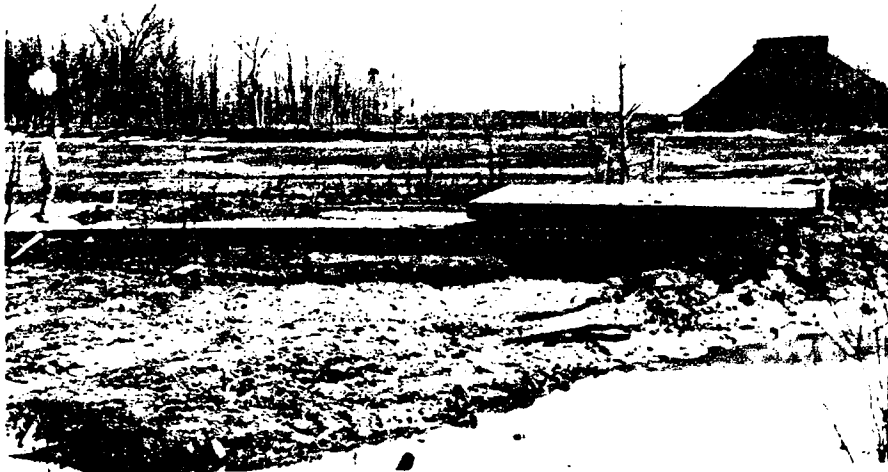
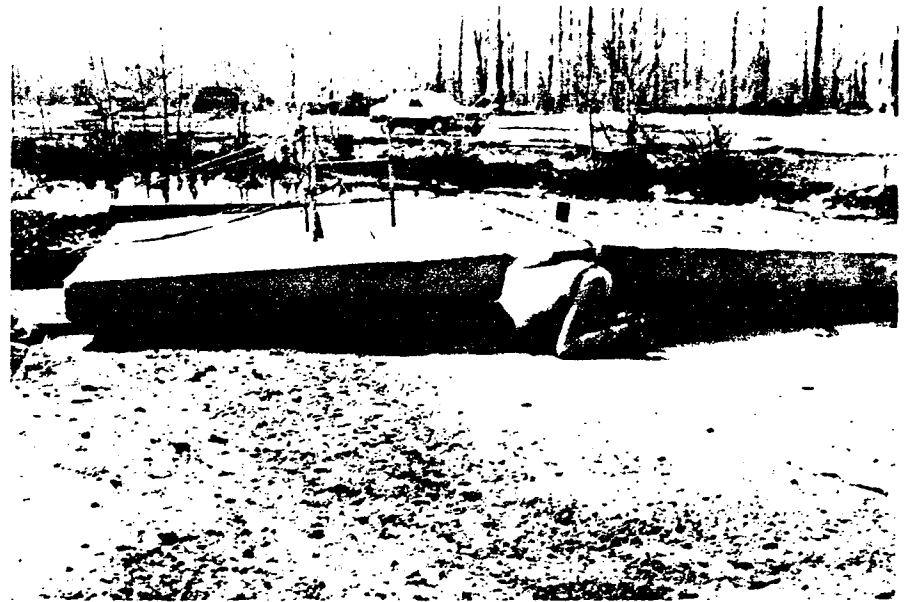
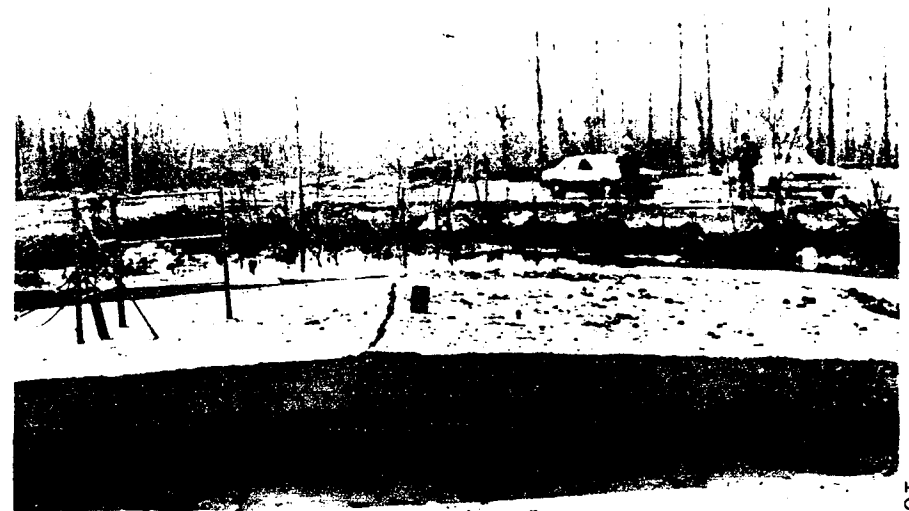
Figure 49. Photographs of Sherwood Mine Air Shaft

a. Lifted Shaft Capping: Looking South

b. Looking Approximately West

c. (to right) Close-up: Looking West

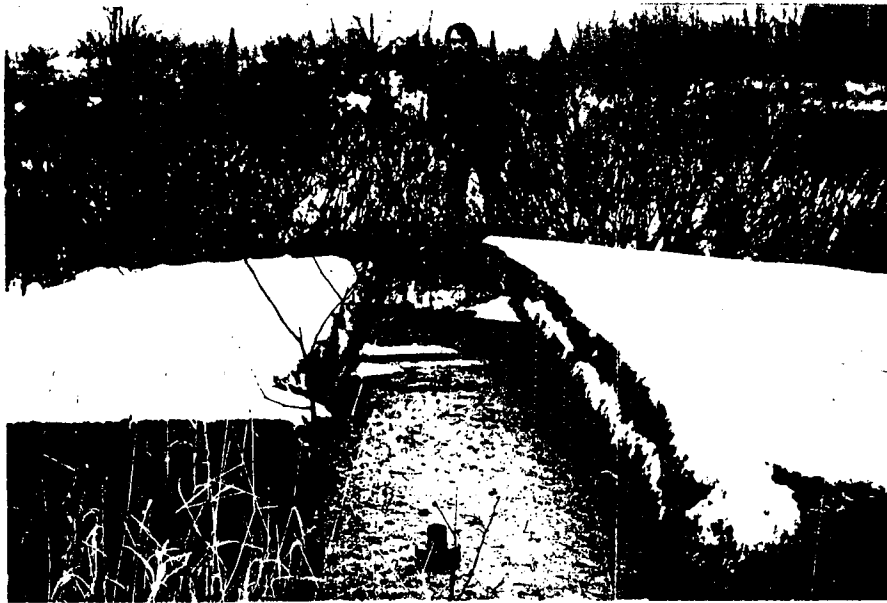
The shaft serving the Monongahela Mine is vertical and 633 feet deep as scaled from mine maps. The shaft is flooded to very near the collar elevation. Matted grass south of the shaft indicates that water occasionally flows from the shaft in this direction. The shaft is capped with concrete reinforced with steel rails. The concrete cap is 16 feet by 16 feet and about one foot thick. The data marked in the concrete of the cap is October 21, 1963. Since that time, some disruptive event has caused

Figure 50. Photograph of Monongahela Shaft Capping
