THE DEVELOPMENT OF GUIDELINES FOR
CLOSING UNDERGROUND MINES:
MICHIGAN CASE HISTORIES

Institute of Mineral Research
C.W. Schultz, Director
Michigan Technological University
Houghton, Michigan 49931

Allan M. Johnson
Research Leader

Date prepared June 28, 1984

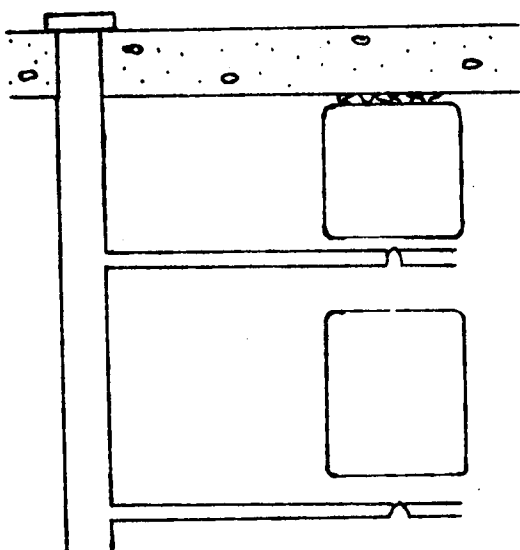
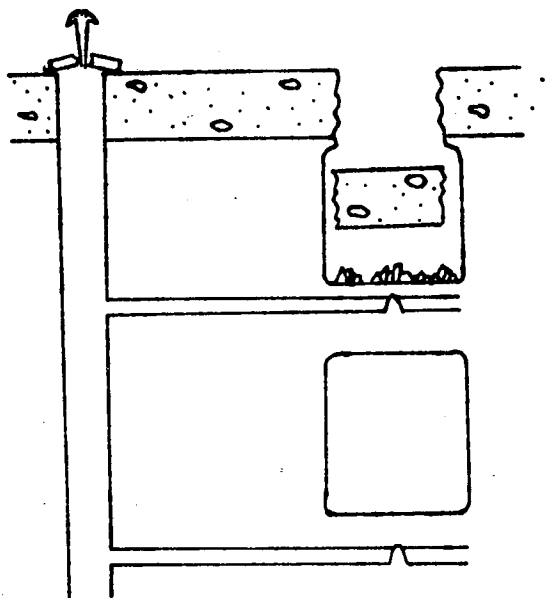
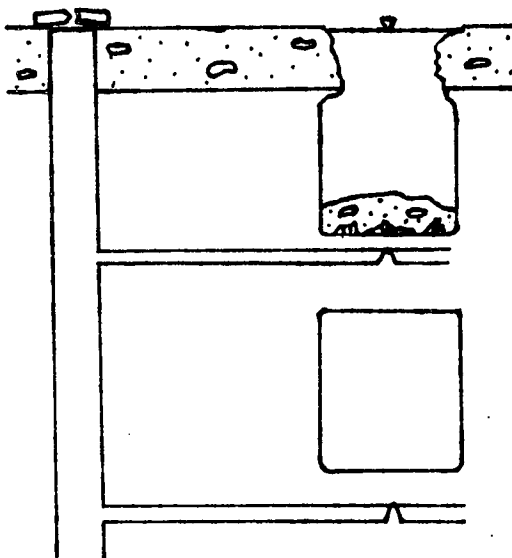
A. Mine shortly after ceasing operation; shaft capped, mine not flooded.

B. Mine nearly flooded, sloughing of back in upper stope implies imminent surface subsidence

C. Subsidence occurs. Large mass of falling overburden generates hydraulic forces in mine which disrupt cap and create temporary geyser effect.

D. Subsidence no longer active, mine flooded to equilibrium level, mine shaft capping disrupted.
