**Information Circular 9072**

# **Ground Subsidence and Structural Damage Over an Abandoned Room-and-Pillar Coal Mine at Hegeler, IL**

**By Gennaro G. Marino, James W. Mahar, Larry R. Powell,  
and Richard E. Thill**

**BUREAU OF MINES**

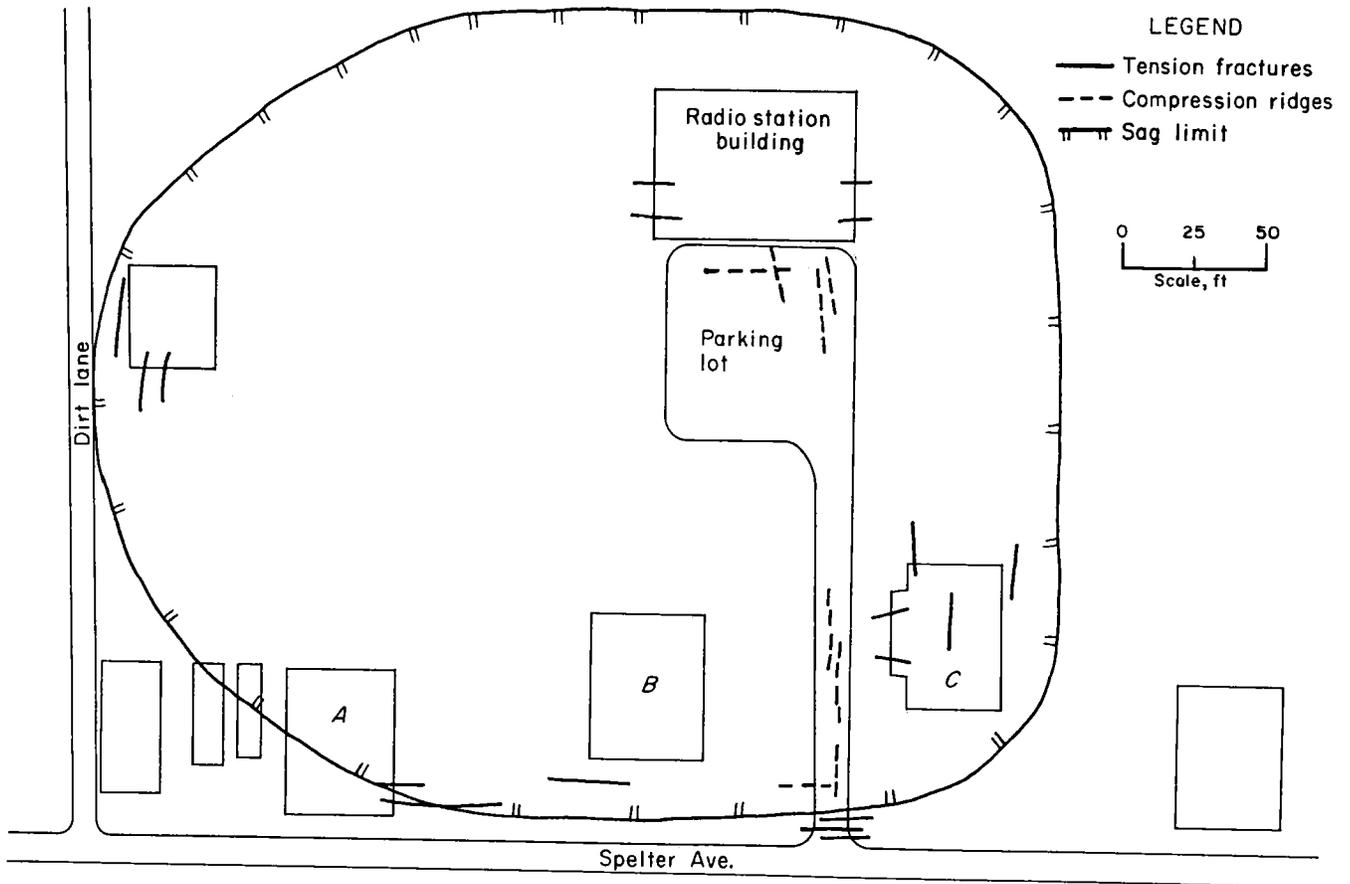
FIGURE 6. - Sketch map of sag 1 tension and compression features in 1967.  
 (Courtesy of Illinois State Geological Survey.)

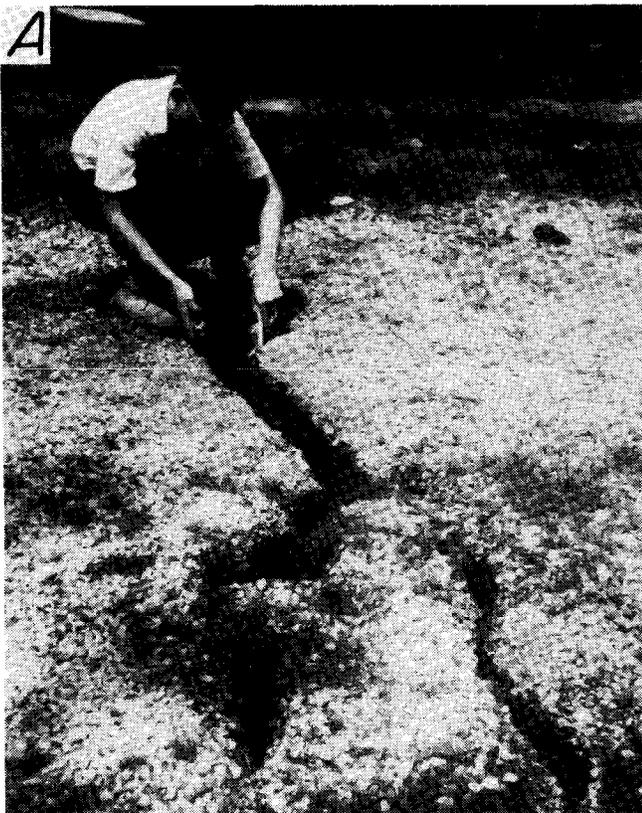
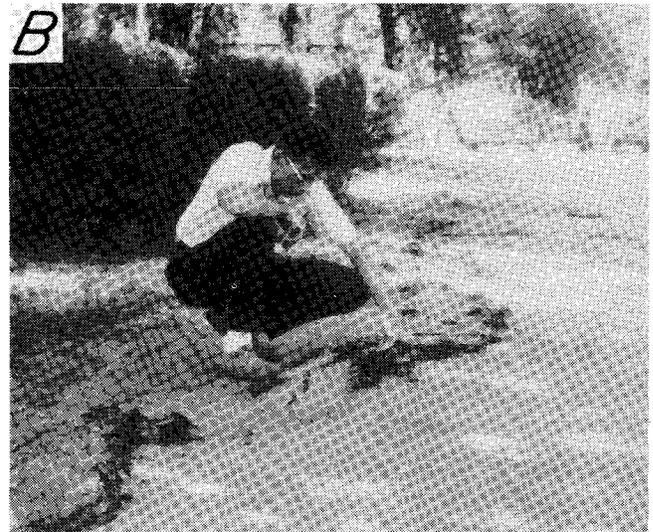
FIGURE 11. - Photographs of 0.33-ft-wide tension cracks (A) and 0.25-ft-high compression ridges (B) from sag 1 on June 24, 1967. (Courtesy of Illinois State Geological Survey.)

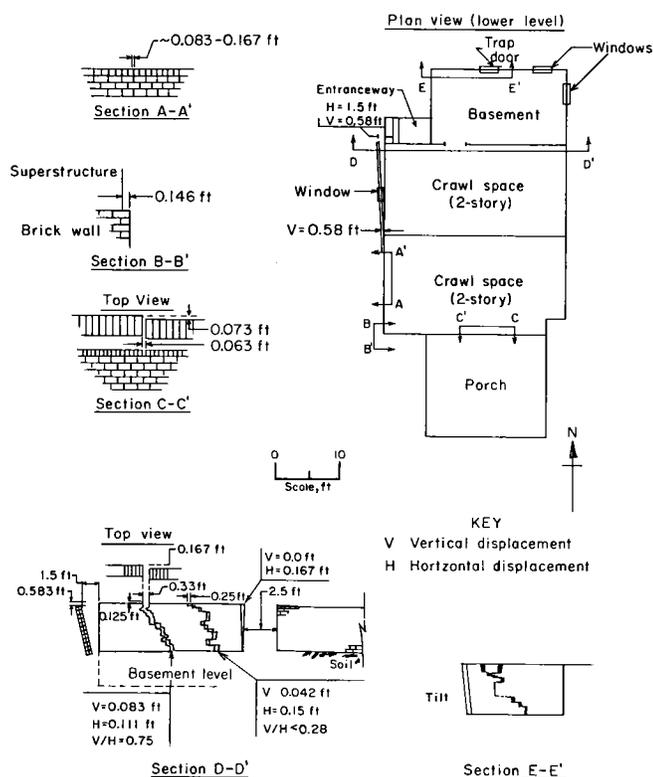
FIGURE 15. - Plan of damage to house C. The damage was measured in May 1978. (Sections shown are not to scale.)

The bearing walls and on-grade members cracked, separated, and tilted in response to the ground movements. Cracks opened as much as 0.33 ft, and walls separated as much as 1.5 ft. The west brick wall of the crawl space tilted, settled, and moved laterally away from the superstructure (fig. 15, sec. D-D'). At the north end, it separated horizontally 1.5 ft and vertically 0.58 ft from the interior bearing wall. These wall displacements occurred because there was no foundation-superstructure attachment between the exterior and interior walls. The vertical separation prevented the development of frictional resistance between the sill and wall, thus there was essentially no restraint against outward movement. Most of the damage to the west

The relationship between profile slope and wall tilt is illustrated by the wall separations and crack widths in the northwest corner of the basement (fig. 15, sec. E-E'). Here crack widths and wall separations are two to three times greater at the top than at the bottom. The average tilt of the north and west walls is estimated to be about 0.08. This is comparable to the slope of 0.07 calculated for this section of the sag.

Figure 15, section C-C', shows that the south bearing wall has undergone displacements similar to the north wall. The crack in the south wall has a low vertical-to-horizontal displacement ratio. Measurements of the vertical crack separation on both the north and south

The northward horizontal ground movement caused the superstructure to move north with respect to southern foundation walls. A horizontal offset of 0.15 ft was measured between the superstructure and the west end of the south bearing wall (fig. 15, sec. B-B').

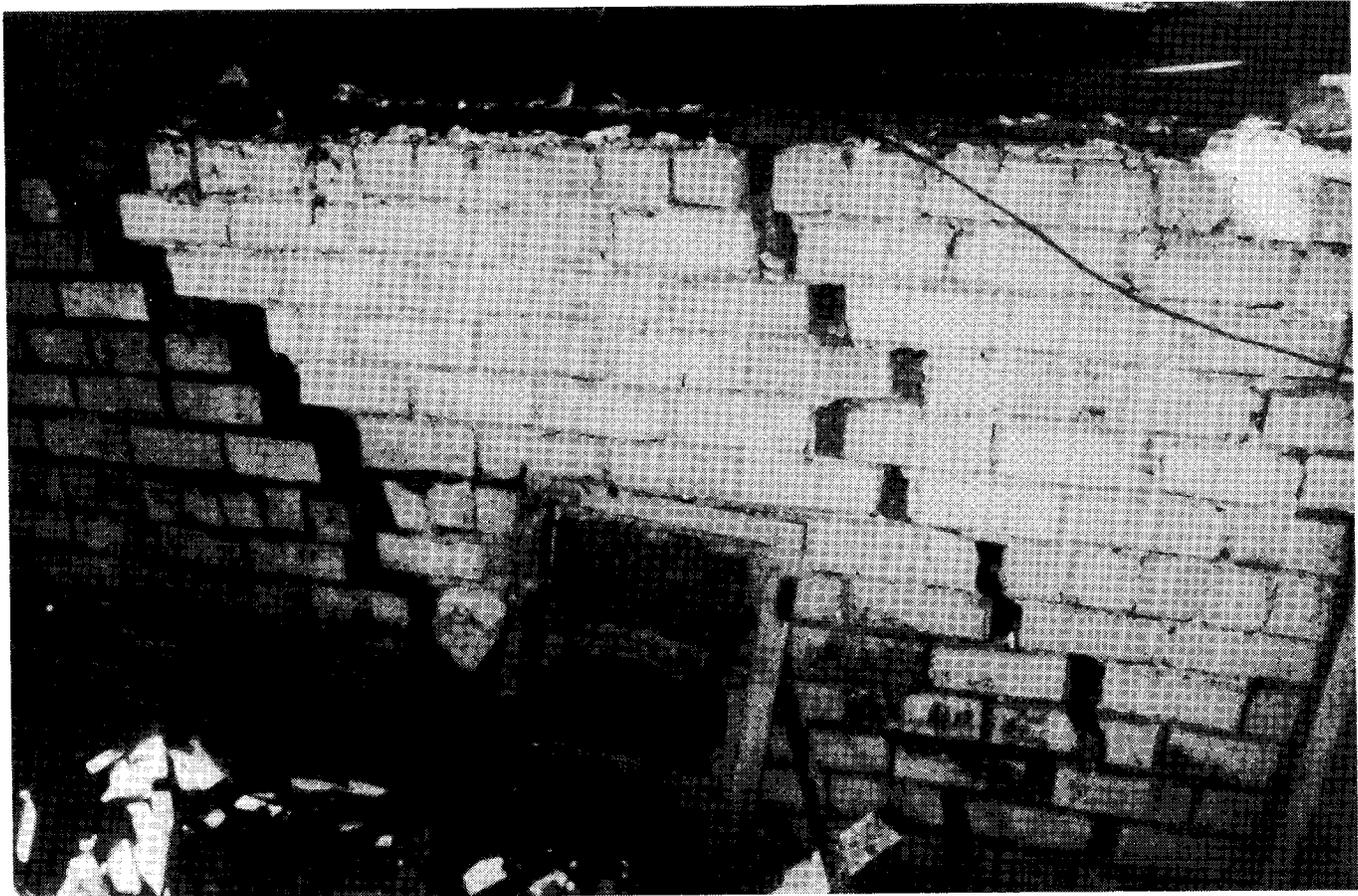
Figure 17 shows the western part of the north interior wall of the crawl space (also figure 15, section D-D'). The ground movements produced two major diagonal cracks in the wall. At floor level, the west crack opened 0.11 ft

FIGURE 17. - North bearing wall of crawl space in house C in 1978 (looking north). The picture shows the change in the nature of separation of the two cracks in the west portion of the wall. Refer to section D-D' in figure 15.

horizontally, and the east crack opened 0.15 ft. Both cracks increased about 0.08 ft in width from bottom to top in response to rigid body tilt. The western crack had a vertical displacement of 0.08 ft that developed as a result of angular distortion. The eastern crack was affected more by horizontal ground movement. This is demonstrated by comparing the ratios of the vertical-to-horizontal crack width (V/H), which is 0.75 for the west crack and 0.28 for the east crack. The west crack also has 0.17 ft of north-south offset at the top.

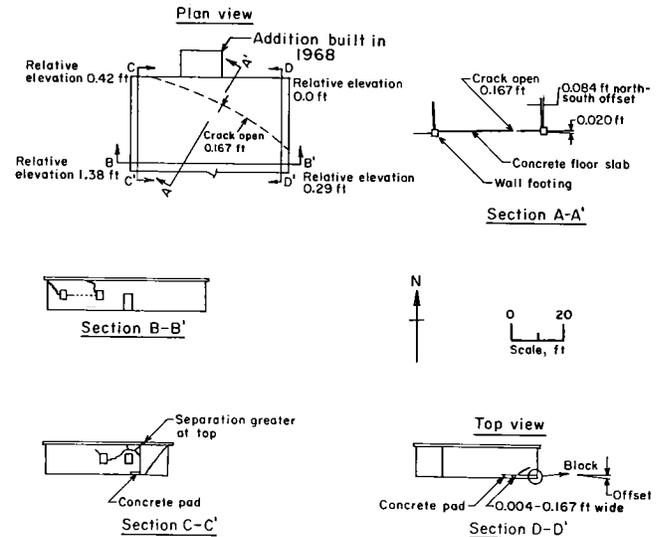
The southwestward horizontal ground movements caused cracking and separation of the foundation and floor slab. A vertical crack in the concrete floor opened 0.167 ft and is oriented subparallel to the vertical-displacement contours (fig. 18, sec. A-A'). The superstructure was

FIGURE 18. - Plan of damage to radio station building. The damage is not inclusive. The relative elevations on the structure were surveyed on July 30, 1967.

displaced horizontally along with the southern part of the foundation. On the north wall, the superstructure failed in shear along the mortar joint just above the foundation and was offset 0.083 ft southward relative to the footing. In addition, the southwest corner of the building was offset by the southwest movement of the foundation. The superstructure appears to have been subjected to angular distortion and tension. The torsional deformation was produced by a change in direction and magnitude of ground movements from south to southwest within the building.

About 80 to 90 pct of the damage occurred within 2 days after the initial movement. The damage included jammed doors and windows, a tilted front wall, and cracks in the floor slab, foundation, and exterior masonry block walls. Several months later, the building was remodeled. This work included a false floor, interior repairs, exterior siding, and a brick facade. A permanent shoring system was also installed to support the south wall.

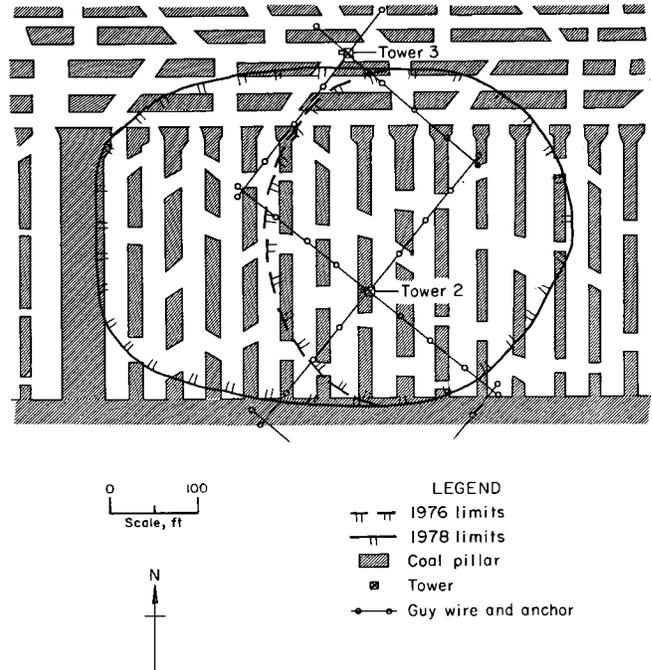
FIGURE 19. - Postulated progression of subsidence associated with sag 3.

In July 1978, additional subsidence occurred, and sag 3 developed in a westerly direction (fig. 19). The renewed subsidence caused additional settlement of the tower 2 base. The cumulative settlement of the tower 2 base is 2.5 ft. The additional movements in sag 3 produced tightening of tower 2 and 3 guy wires. The upper 150 ft of tower 3 was bent as a result of the southwest pull of the guy wire anchor blocks. Guy wires to both towers were retensioned.
