# **Worker Deaths by Electrocution**

## **A Summary of Surveillance Findings and Investigative Case Reports**

# **WORKER DEATHS BY ELECTROCUTION**

**DHHS (NIOSH) PUBLICATION No. 2000-115**

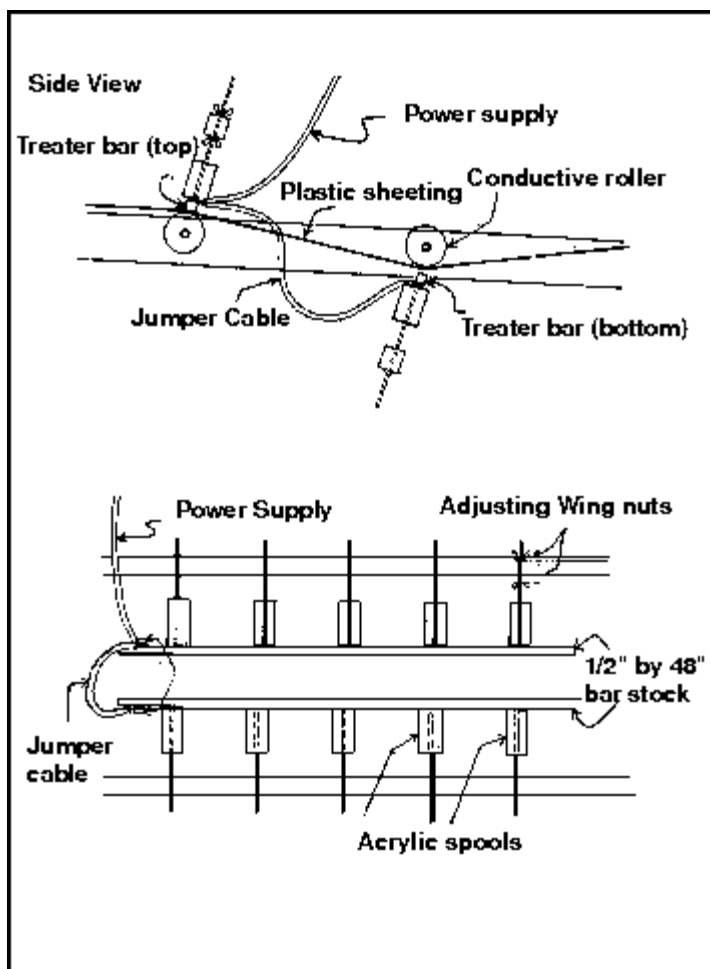
*Figure. Corona Treatment of Polyurethane Sheets*

Discussion: Corona treater equipment requires the use of high voltage electricity. Maintenance personnel and machine operators require a certain level of expertise to install, maintain, repair, and operate this equipment. The manufacturer suggests that specific pieces of test equipment be available for these functions. The employer should provide test equipment and should insure that personnel are trained properly concerning the maintenance and use of this equipment.

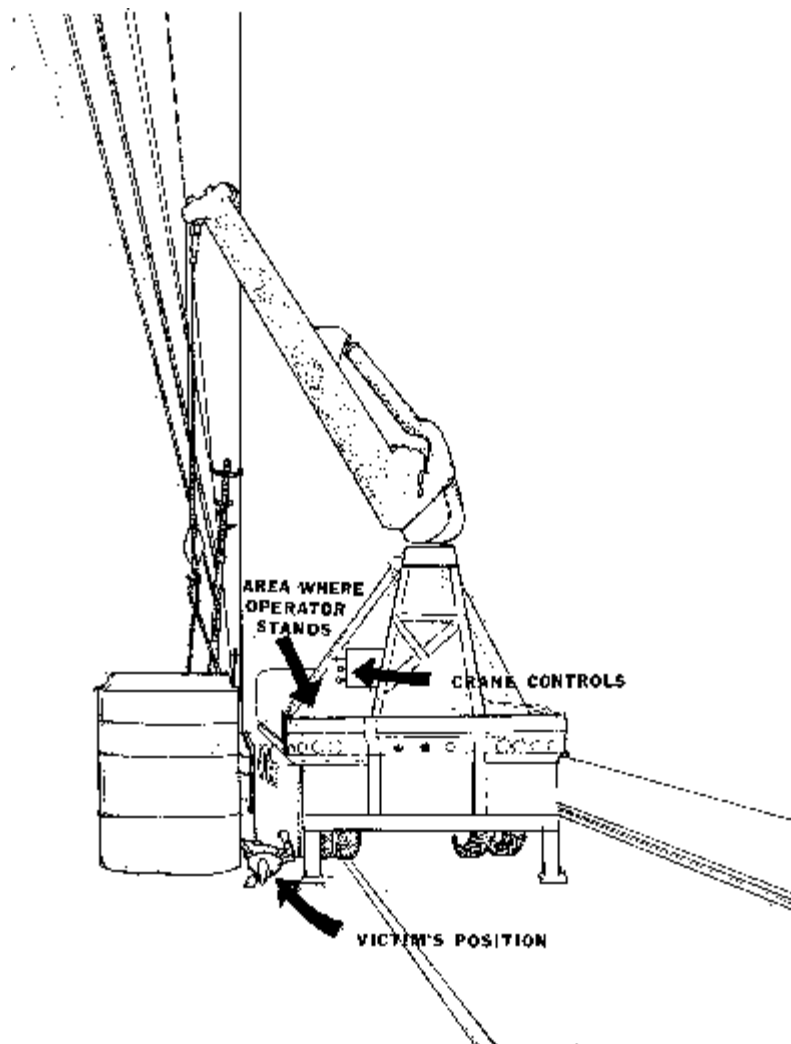
***Figure 1. Accident Scene***

Discussion: Loading, unloading, and storage sites away from overhead powerlines decreases the chance of inadvertent contact between crane booms and these lines. The need for safe storage sites is particularly true at construction sites and at areas used for permanent storage areas. The owner of the company instructed the victim to unload at an area away from the overhead lines. Had the victim followed these instructions, this fatality would not have occurred.

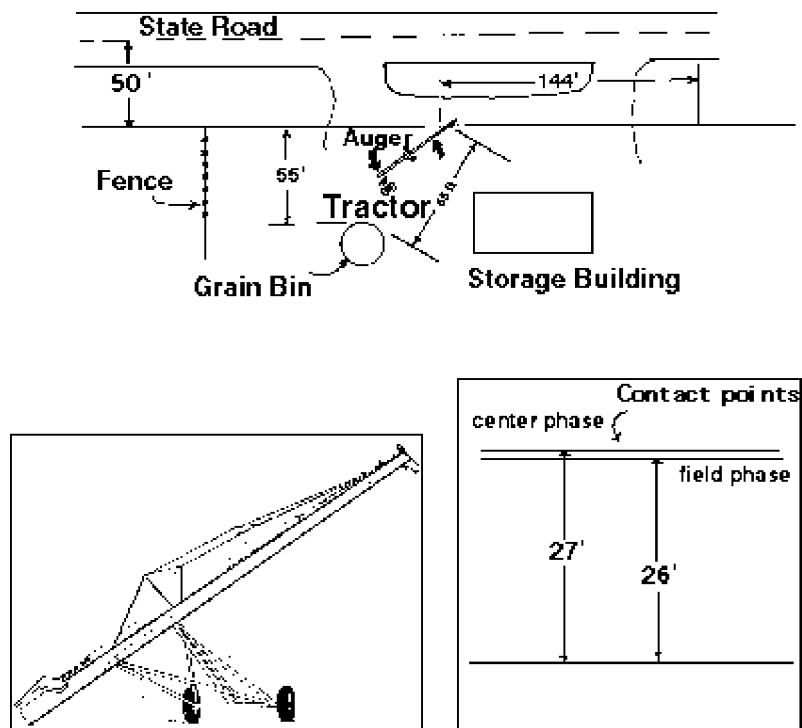
*Figure. The Accident Scene*

Discussion: The grain auger is a portable piece of farm equipment that has the ability to be raised to heights above 25 feet. This capability makes the piece of equipment dangerous in two ways; first, it can tip over if being moved in the upright position, and secondly, when elevated it is high enough to contact high voltage lines. Therefore, a warning sign affixed to the auger alerts workers to the overhead danger - powerlines.

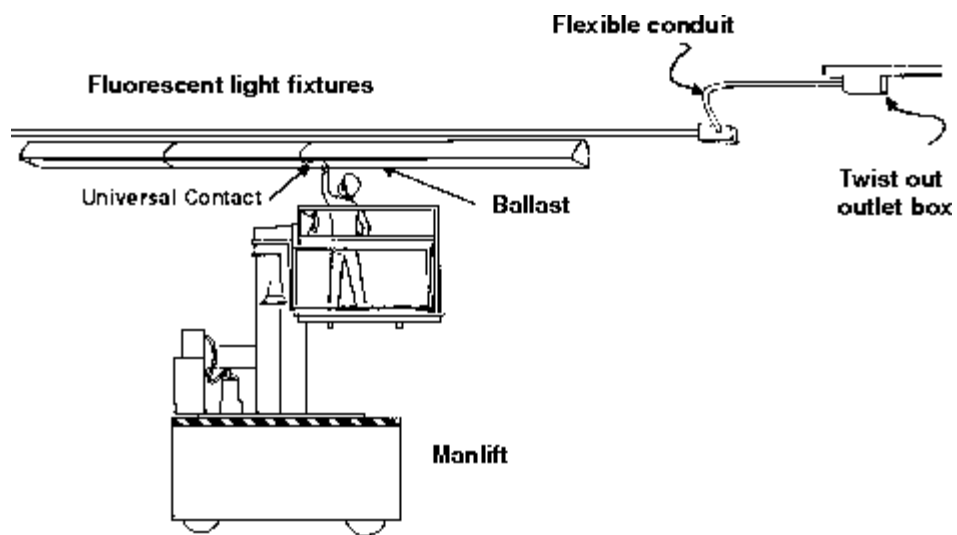
**Figure.** *Worker Replacing Ballast from Manlift Platform*

Discussion: The busway within the universal lighting duct is marked + and -. The twist out outlet box should be installed within the universal lighting duct so that polarity is maintained. The twist out outlet box and the universal contact involved in this incident were not polarized. One of these two units was installed backwards which caused reverse polarity. The twist out outlet box involved in this accident had been installed in 1965. Newer outlet boxes are polarized and will maintain polarity in the universal lighting duct. All electrical systems at the manufacturing plant should be evaluated to assure correct polarity is maintained.

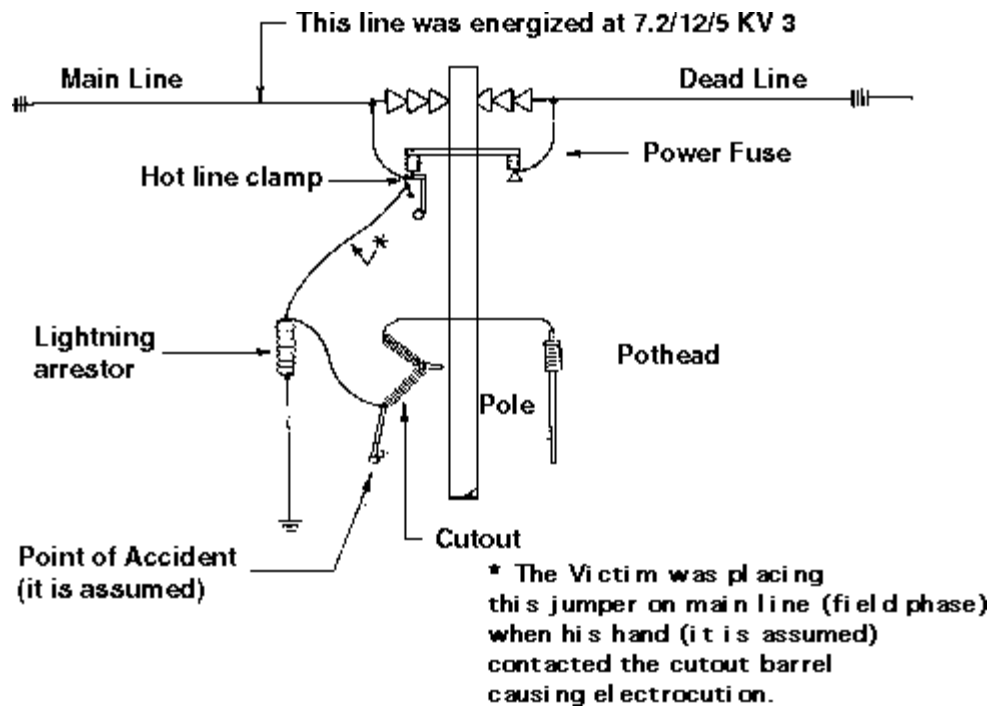
**Figure 1. Profile of Accident Pole**

Discussion: The victim did not use any insulative barriers to cover the 7200 VAC power line system. When working in close proximity to high voltage powerlines, all exposed conductors in contact distance within a work area must be covered to eliminate the occurrence of an accident.

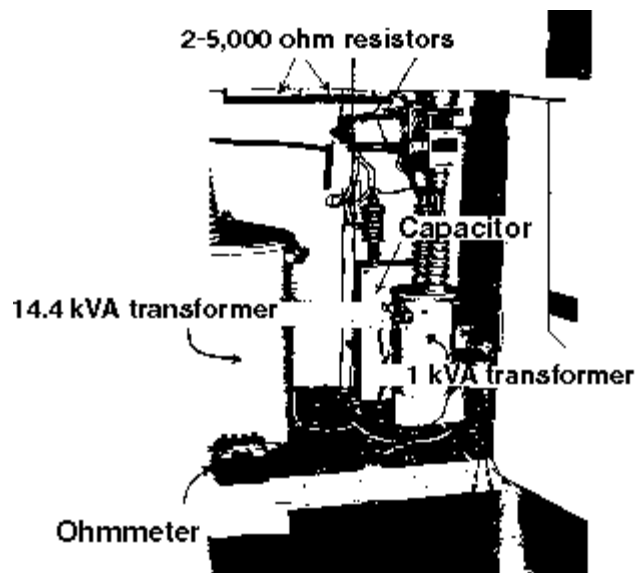
***Figure.*** Cabinet Containing Power Transmission and Distribution Equipment Involved in Fatality

Discussion: The current design of these cabinets does not include (1) a power ON indication for the cabinet, (2) interlock of the access to the cabinet, (3) adequate insulation of the conductors inside the cabinet to safeguard against accidental contact, or (4) appropriate warning signs. Design considerations similar to the above should be incorporated into these cabinets. For instance a power ON indicator could be installed in a conspicuous location, as near as possible to the service entrance of the metal cabinet. The indicator would serve as a reminder that electrical energy is being fed into the cabinet. The victim had repaired many similar pieces of equipment previously and he was considered an experienced electrical technician. The indicator may have alerted him to the fact that the cabinet was energized.

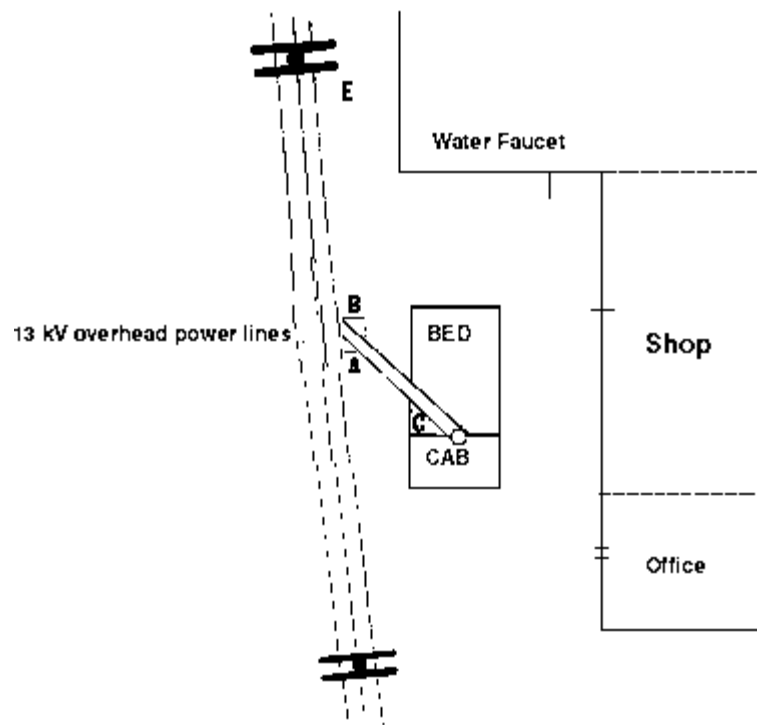
Discussion: While there seems to have been no attempt made to maintain the required clearance, one may question whether the distance between a vertical hoist cable and horizontal power line can always be determined accurately from the operator's position. The fact that another employee ("E" on sketch) warned of proximity to the power line immediately before the accident suggests that a safety observer could have helped prevent this fatality.

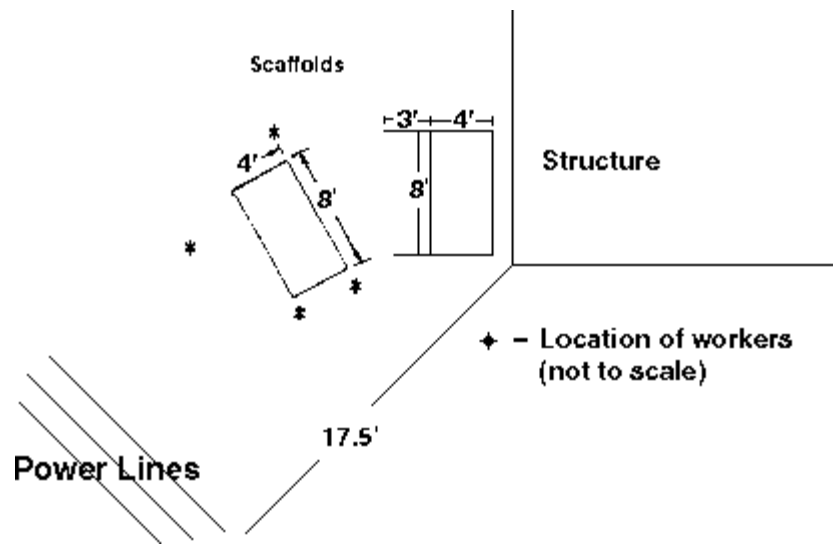
*Figure. Top View of Accident Site*

Discussion: California OSHA regulations require that six feet of clearance be maintained between power lines and scaffolding. Although California OSHA does not have jurisdiction in the case, it is smart and safe work practice to maintain at least a six foot distance as clearance. Additionally, when scaffolding is being moved in the vicinity of power lines a person should be appointed to constantly monitor the clearance between the power lines and the scaffolding.

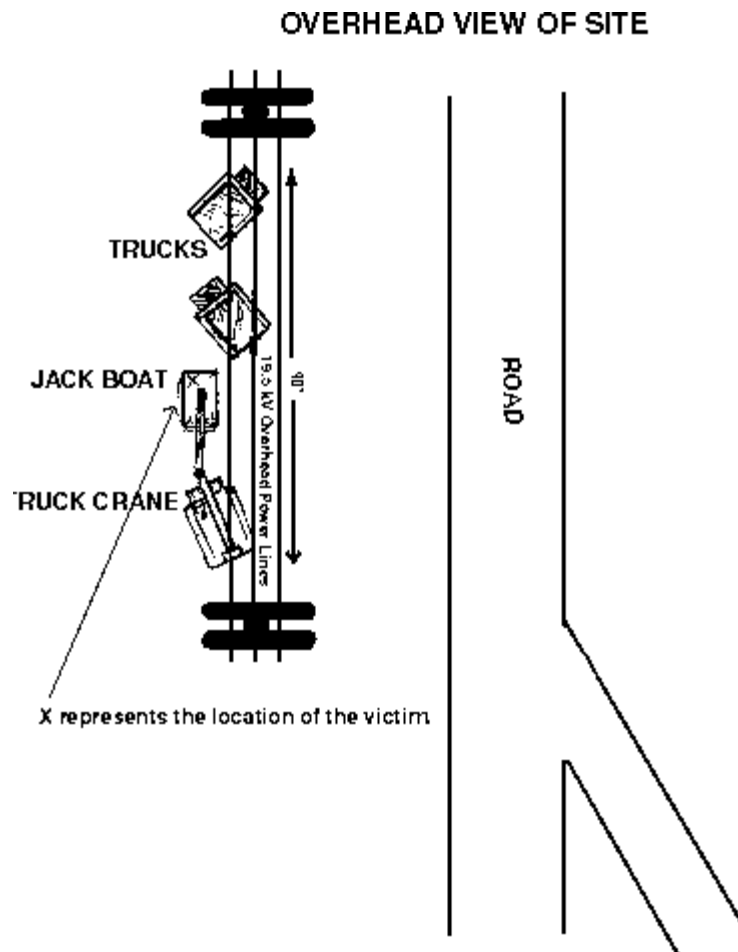
*Figure. Overhead View of Site*

Discussion: Employers should designate an observer for all operations where it is difficult for the operator to maintain desired clearances by visual means. The accident occurred just before noon, and the sun may have made it difficult for the operator to adequately judge the clearance. The use of an observer might have prevented the accident.

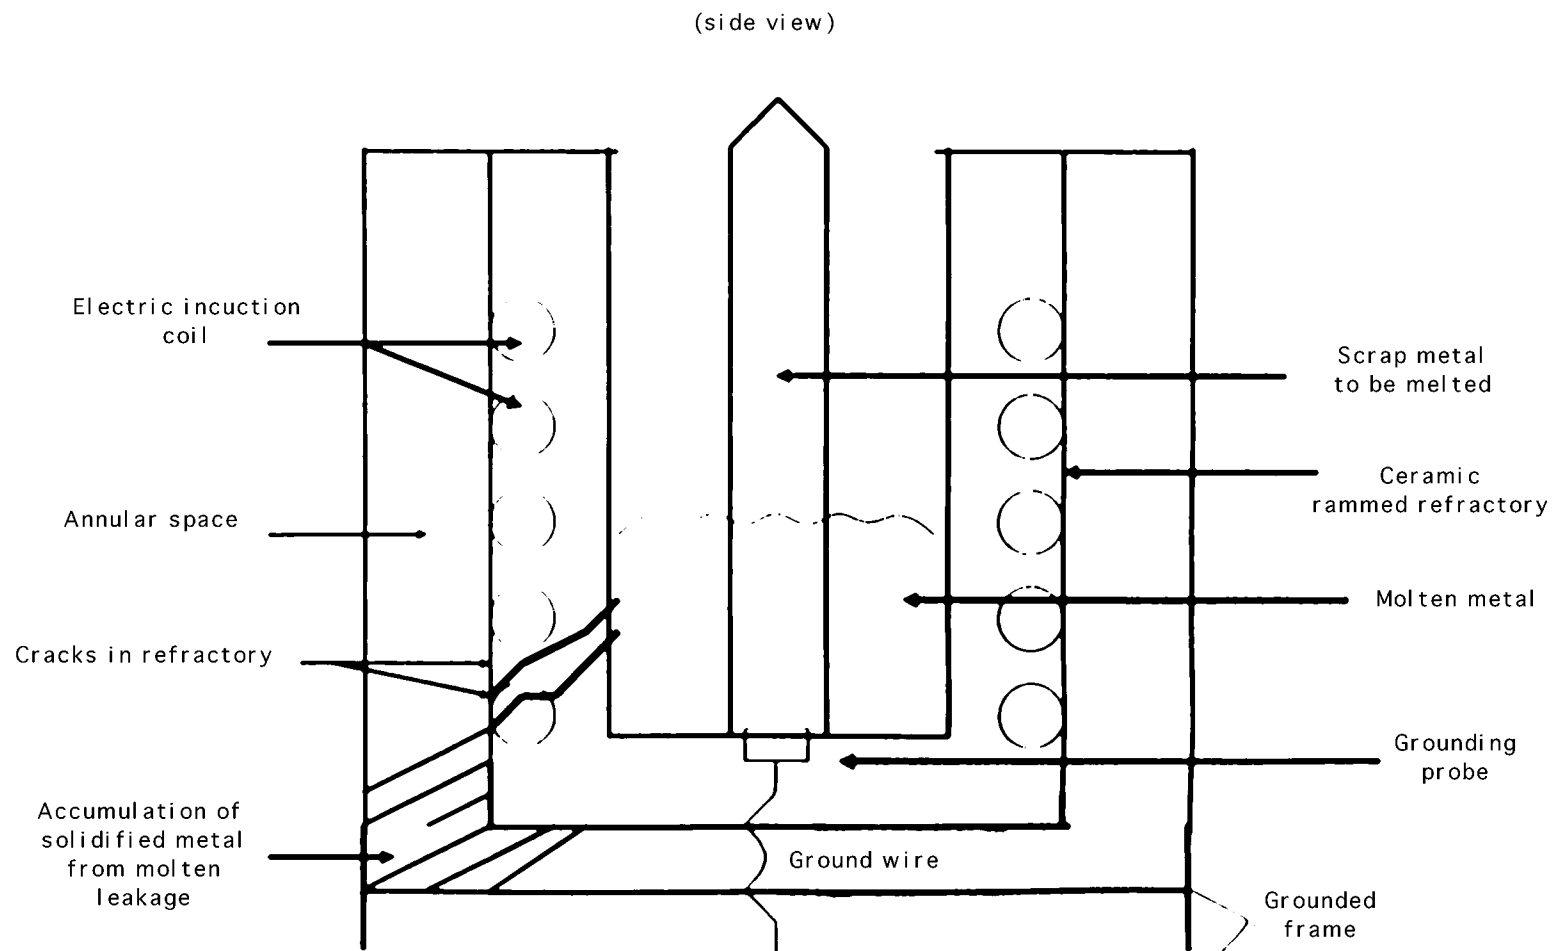
**Figure.** *Electric Induction Furnace*

Discussion: Because of the small interior size of the induction furnaces, each is basically a one-man loading operation. The scrap metal piece being loaded into the induction furnace in this incident weighed approximately 150 lbs. The co-worker was therefore unable to load it into the furnace by himself, so he was assisted by the victim. Since the scrap piece was so large and heavy, it jarred and damaged an already weakened refractory as it was lowered into the furnace. Therefore, such large scrap pieces should be cut into smaller pieces that one worker can easily handle. The employer should determine and specify a maximum scrap metal weight and dimension for manual loading into this type of induction furnace.
