# SERIOUS INJURY REPORT

REPORT F2025-08 • December 2025

## ***Nine Career Firefighters Injured at Residential Structure Fire – Texas***

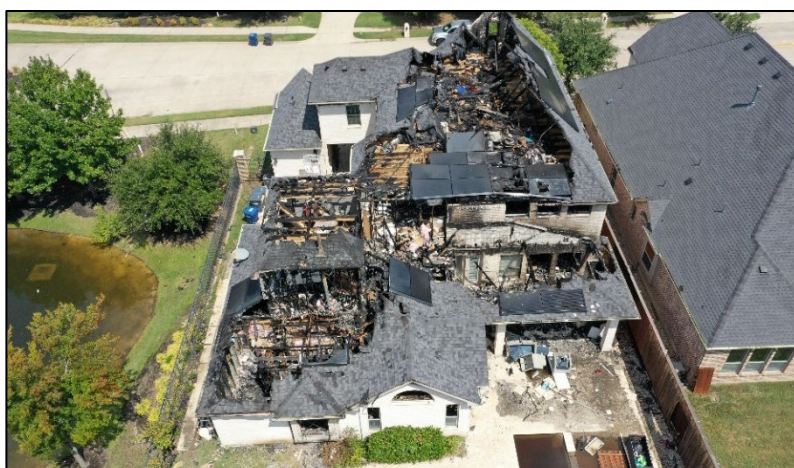
**Photo 1: View of the rear of structure, post-fire.**  
*(Courtesy of the fire department)*

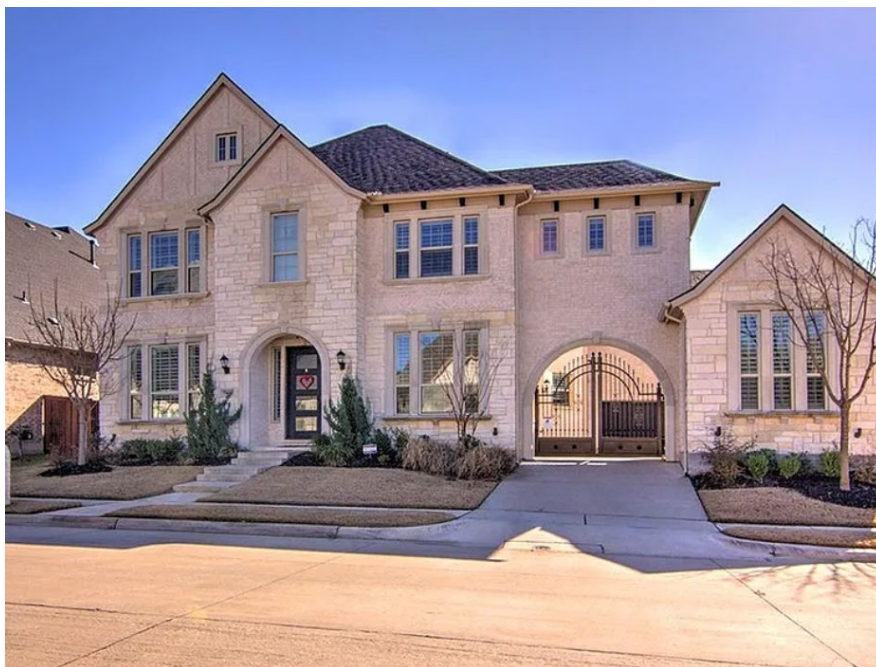
This incident involved a type V, large-area residential structure that was built in 2016 (see **Photo 2**). It was two stories, contained 4,450 sq ft of living space, and included a surrounding security fence. The structure contained high ceilings and a winding staircase to the second division (see **Photo 3**). The structure layout included five bedrooms and a raked (sloped floor) media (theater) room (see **Photo 4**).

**Photo 2: View of structure, pre-incident.**  
*(Courtesy of the fire department)*

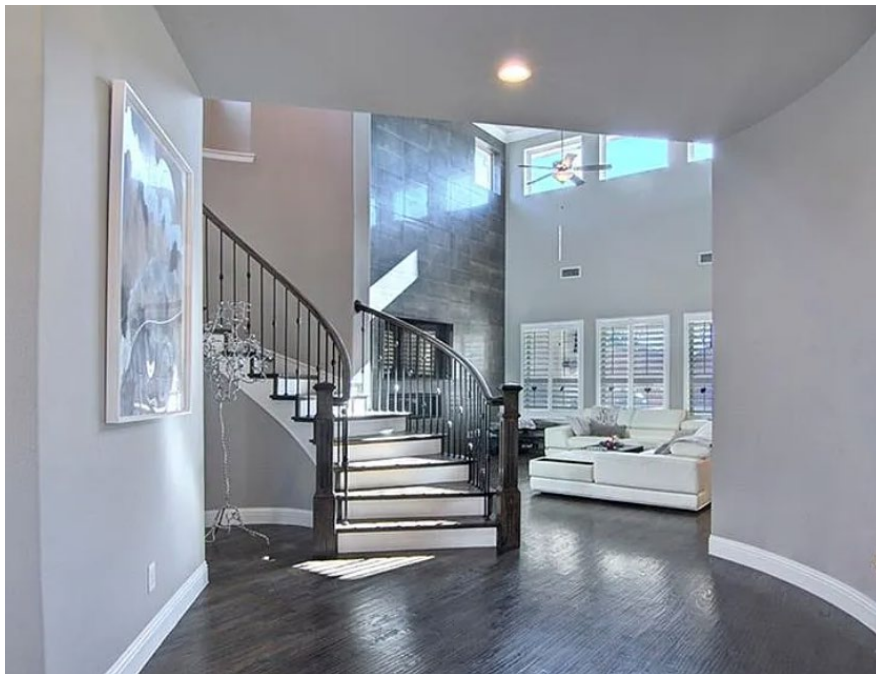
**Photo 3: Winding staircase, pre-incident.**  
*(Courtesy of the fire department)*

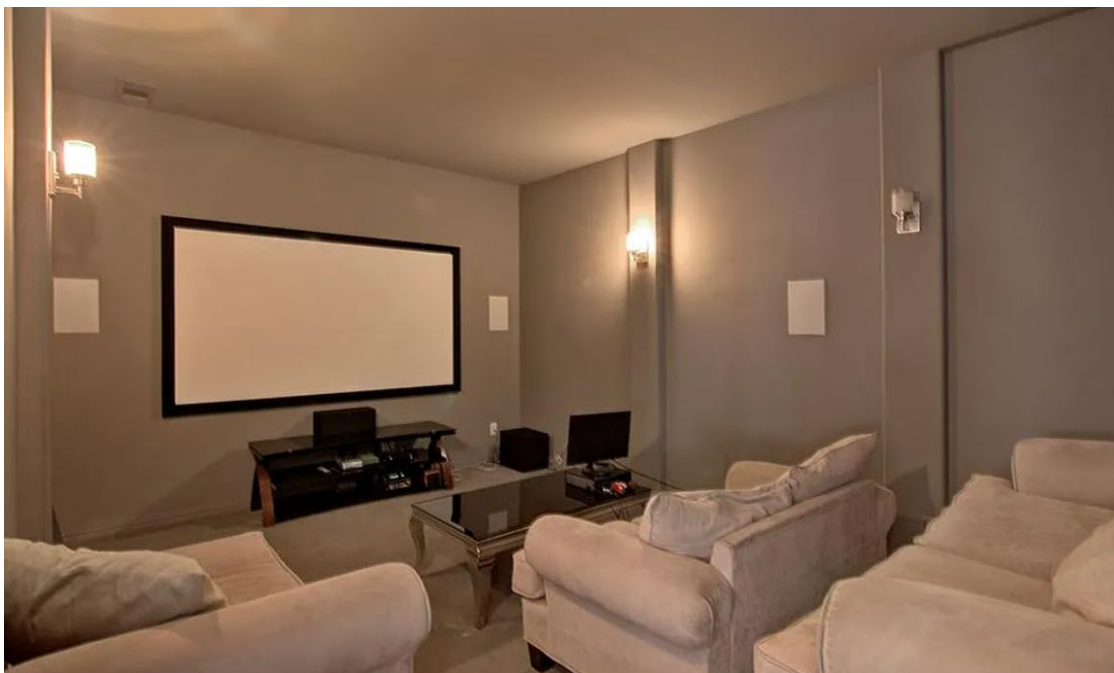
**Photo 4: Media room, pre-incident.**  
*(Courtesy of the fire department)*

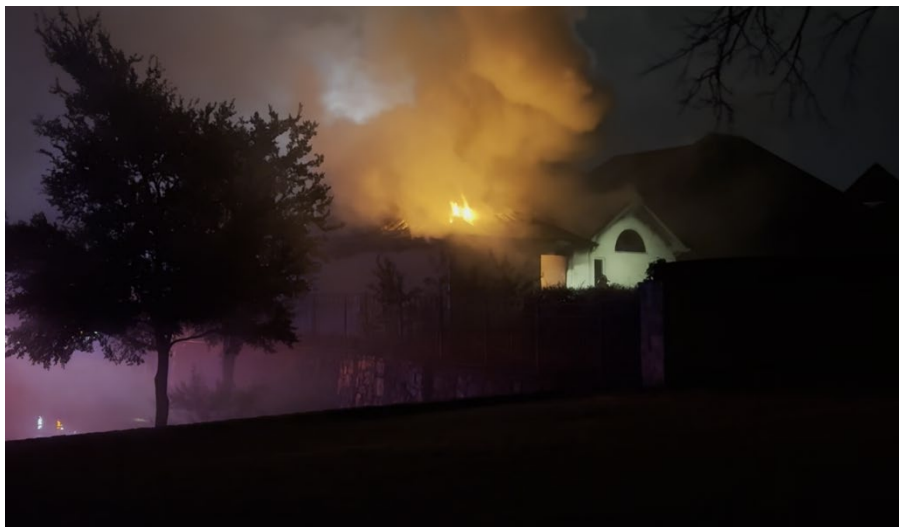
**Photo 5: Fire conditions on Side Charlie/Delta corner.**  
*(Courtesy of the fire department)*

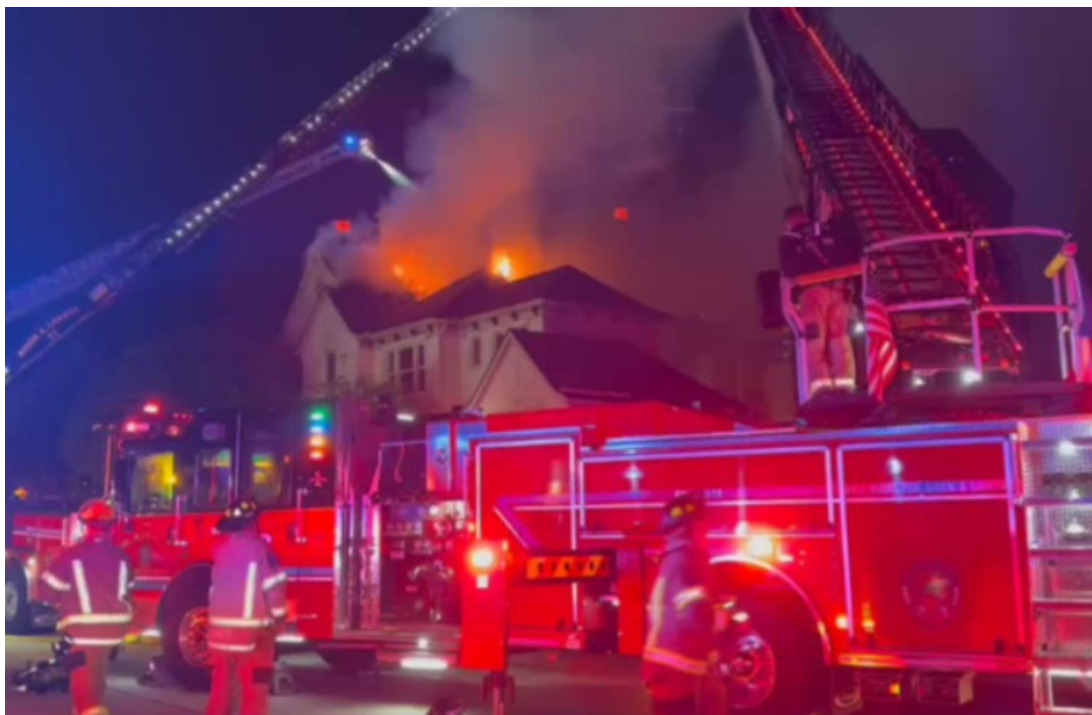
**Photo 6: Defensive operations on Side Alpha, post-extrication.**  
*(Courtesy of the fire department)*
