## Remediation of novel sources linked to an outbreak of Legionnaires' disease in a manufacturing facility

BRIEF REPORT

In September 2022, public health officials identified a legionellosis outbreak among workers at a manufacturing facility. Upon recognition of the outbreak, public health officials and company management investigated to identify the source and prevent additional cases. Facility management assembled an inventory of potential water sources and worked with a consultant to conduct sampling. *Legionella* bacteria were cultured from bulk water samples collected from two water jet cutters and a floor scrubber. All other sampling locations had no *Legionella* identified by culture. Legionellosis cases were distributed throughout the facility. Floor scrubbers were used to clean up water that spilled from the water jet cutters and to clean the floors adjacent to employee work areas. After multiple cycles of cleaning and disinfection of the water jet cutters and floor scrubbers, repeat sampling revealed no *Legionella* detected. Company management returned the equipment to service in November 2022 with a maintenance, disinfection, and monitoring plan; no additional cases of

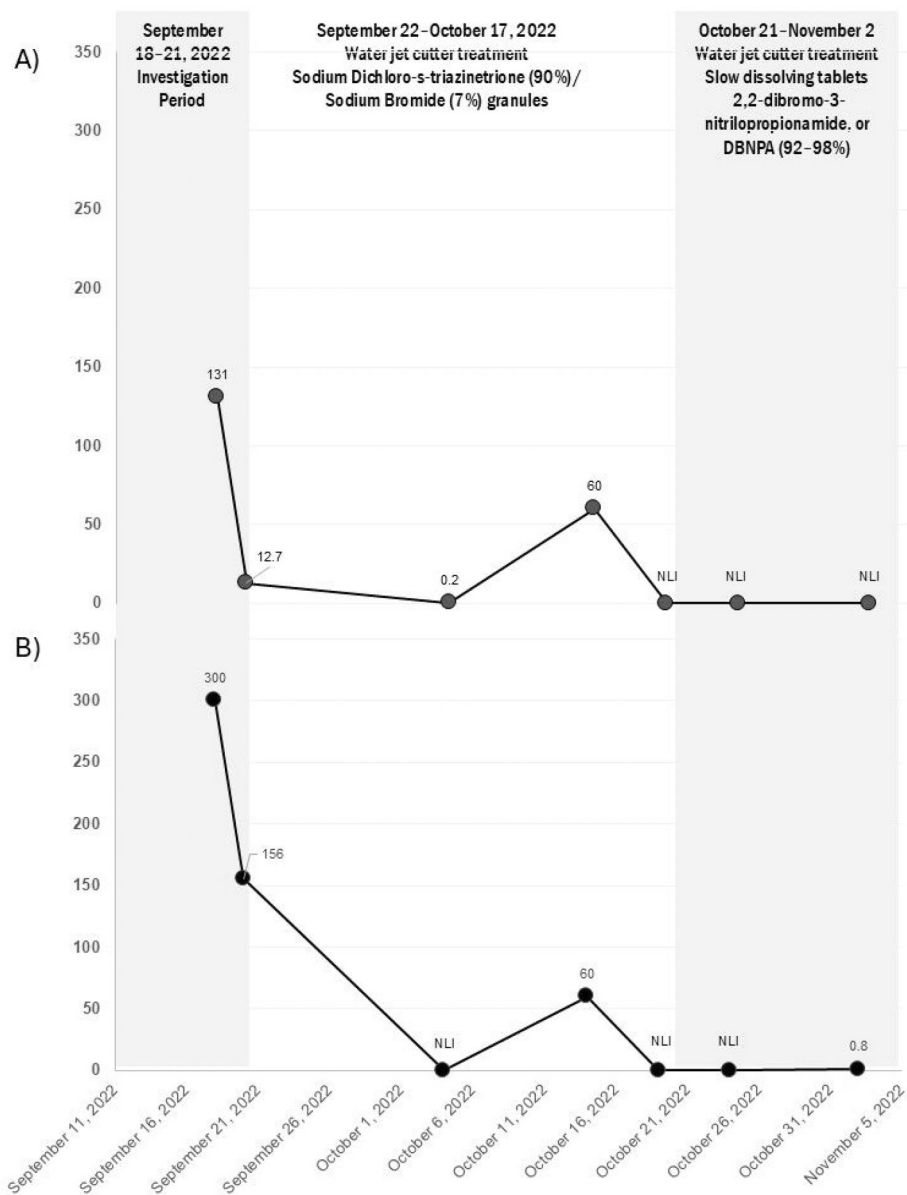
*L. pneumophila* serogroup 1 was isolated from initial bulk water samples from both water jet cutters (>100 colony-forming units [CFU] per milliliter [mL]) (Figure 1) and one floor scrubber (6 CFU/mL). No *Legionella* were isolated from samples collected from other sources. Cases occurred in workers with workstations throughout the facility, including areas distant from the water jet cutters, indicating that exposure was likely not confined to a specific area of the facility.

**Figure 1.** Culture results for *Legionella* from bulk water samples (range: 200–1,000 milliliters [mL]) collected from two water jet cutter basins (A and B) during September–November 2022, and how sampling results aligned with timing of remediation steps. All positive samples were *L. pneumophila* serogroup 1, except the sample from water jet cutter 2 collected on November 2, which was *L. pneumophila* serogroup 2–15. All samples collected after November 4, 2022, had no *Legionella* growth detected. Collection volumes ranged from 150–1,000 milliliter and the minimum reporting level of tests ranged from 0.2–1 CFU/mL. NLI = no *Legionella* isolated.

jet cutters were filled with water from the premises plumbing system; water was automatically added as needed to maintain an adequate level. Garnet was used as the abrasive (or grit). Heat generated by the water jet cutting process increased the temperature of the water basin to 35–40°C. The water basin was drained and refilled quarterly.

consumables (e.g., filters) and added biocide as per the biocide manufacturer's recommended disinfection dosage. Initially, management treated both water jet cutter basins with bromine microbicide sodium dichloro-s-triazinetriene (90%)/sodium bromide (7%) granules. However, testing of samples collected at least 48 hr after treatment revealed *Legionella* remained in the basins of both water jet cutters (Figure 1). Subsequently, management treated both water jet cutters with slow-dissolving tablets of 2,2-dibromo-3-nitropropionamide, or DBNPA (92–98%), a wide-spectrum biocide. After multiple cycles of cleaning and disinfection, two rounds of testing of bulk water samples from both water jet cutters collected at least 48 hr apart were found to have no *Legionella* detected, and the water jet cutters were returned to use in November 2022.
