# SERIOUS INJURY REPORT

REPORT F2025-01 • March 2026

## ***Senior Captain and Two Firefighters of Ladder Company Burned During Primary Search in Garden Apartment Fire – Texas***

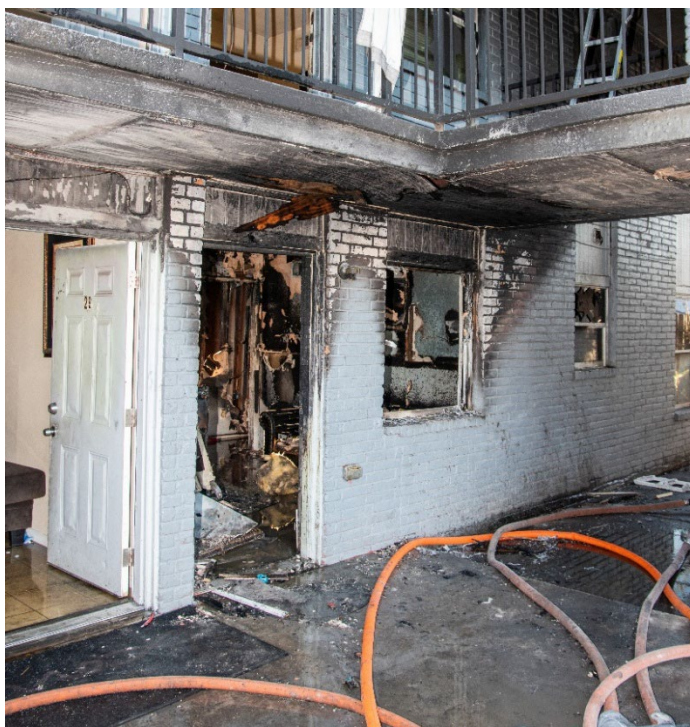
District Chief 46 (DC46) arrived on scene with smoke showing in the courtyard. DC46 pulled past Side Alpha to view Side Charlie where fire had self-ventilated through a window. DC46 positioned across the street from the apartment complex facing the courtyard of the building and provided a size up of “District 46 on scene, fire showing on a two-story apartment, establishing command.” DC46 updated Engine 35 (E35) that the fire appeared to be on the first floor past the courtyard (see **Photo 1**).

**Photo 1: View from the courtyard into the fire apartment, Side Alpha.**  
(Courtesy of the fire department)

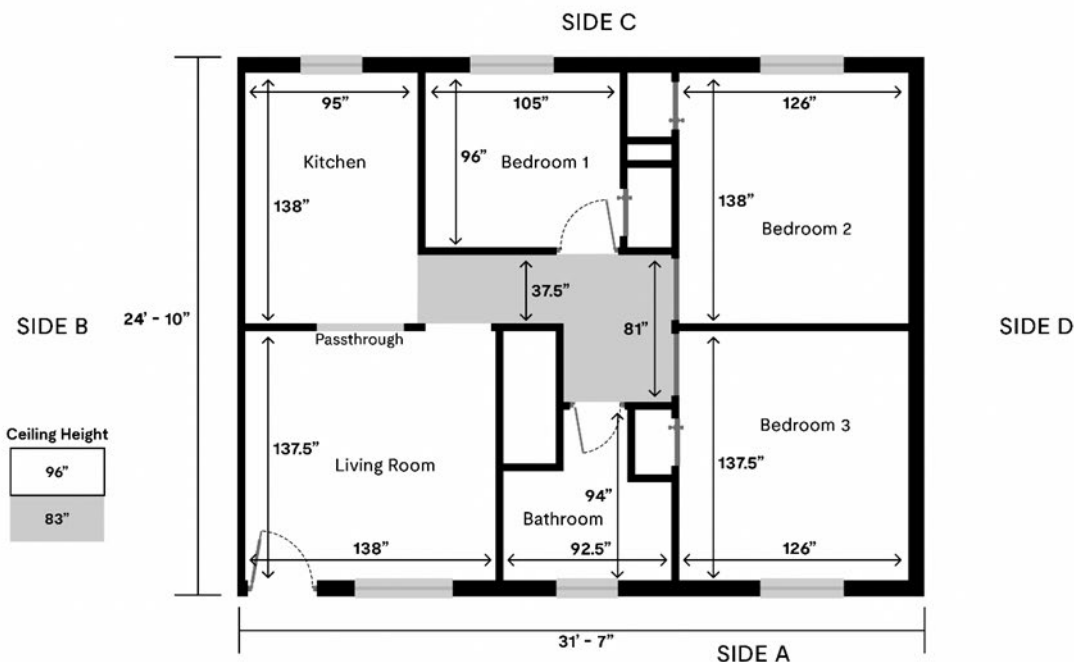
**Figure 1: Dimensioned floor plan of the fire apartment. Note that the ceiling height of the hallway is 13 inches shorter than the ceiling height of the rooms. The lowered ceiling height in the hallway provided space for the HVAC duct work. (Courtesy UL FSRI)**

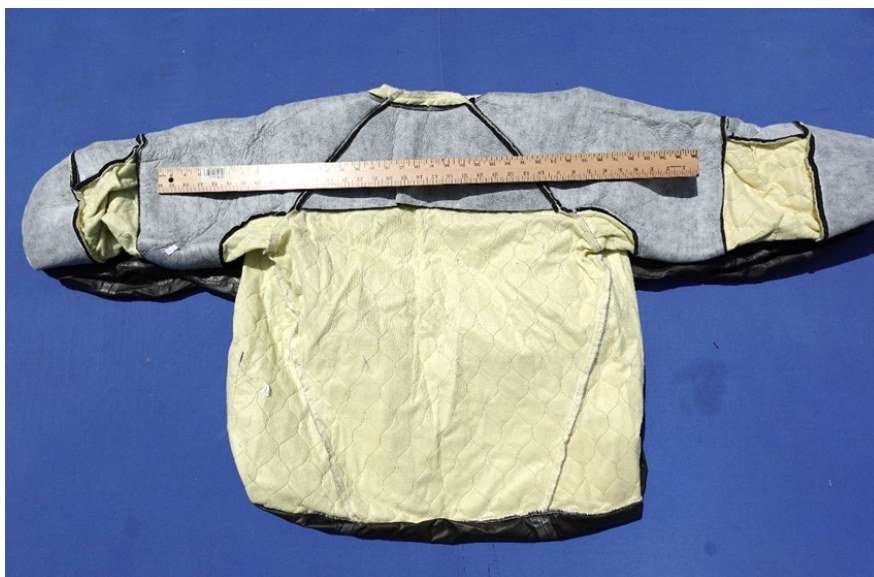
- The protective coat had additional insulation throughout the upper back, shoulder areas, upper front, and sleeves. Proportionally, the protective coat had about 20% more coverage with four or more layers compared to the standard three-layer composite that solely consists of the outer shell, moisture barrier, and thermal barrier. **Photos 2 and 3** compare the extra insulation between the coat used by the incident department and a coat from a different fire department.

**Photo 2: Incident department insulation in upper portion of protective coat. (Photo courtesy of Jeff Stull)**

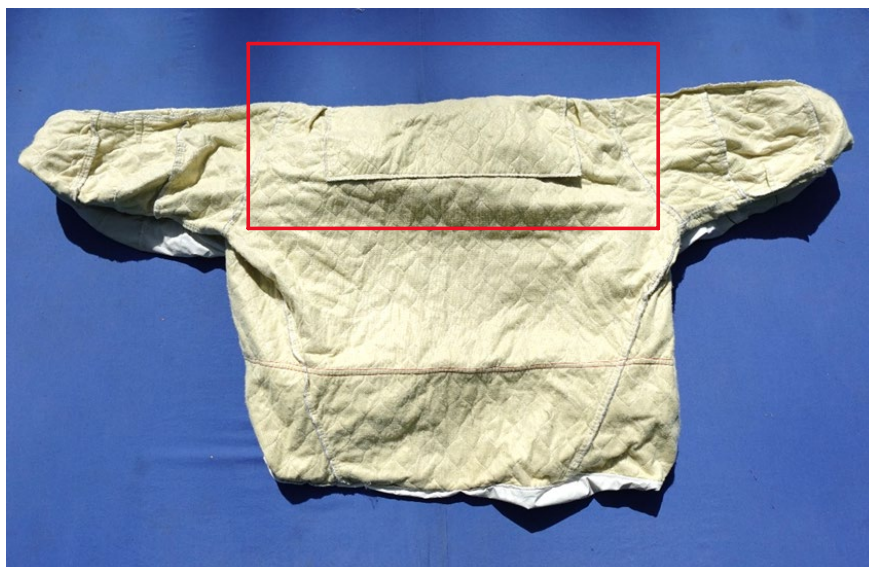
**Photo 3: Different fire department protective coat with less insulation in upper portion [where additional shoulder insulation layer would be outlined in red rectangle]. (Photo courtesy of Jeff Stull)**

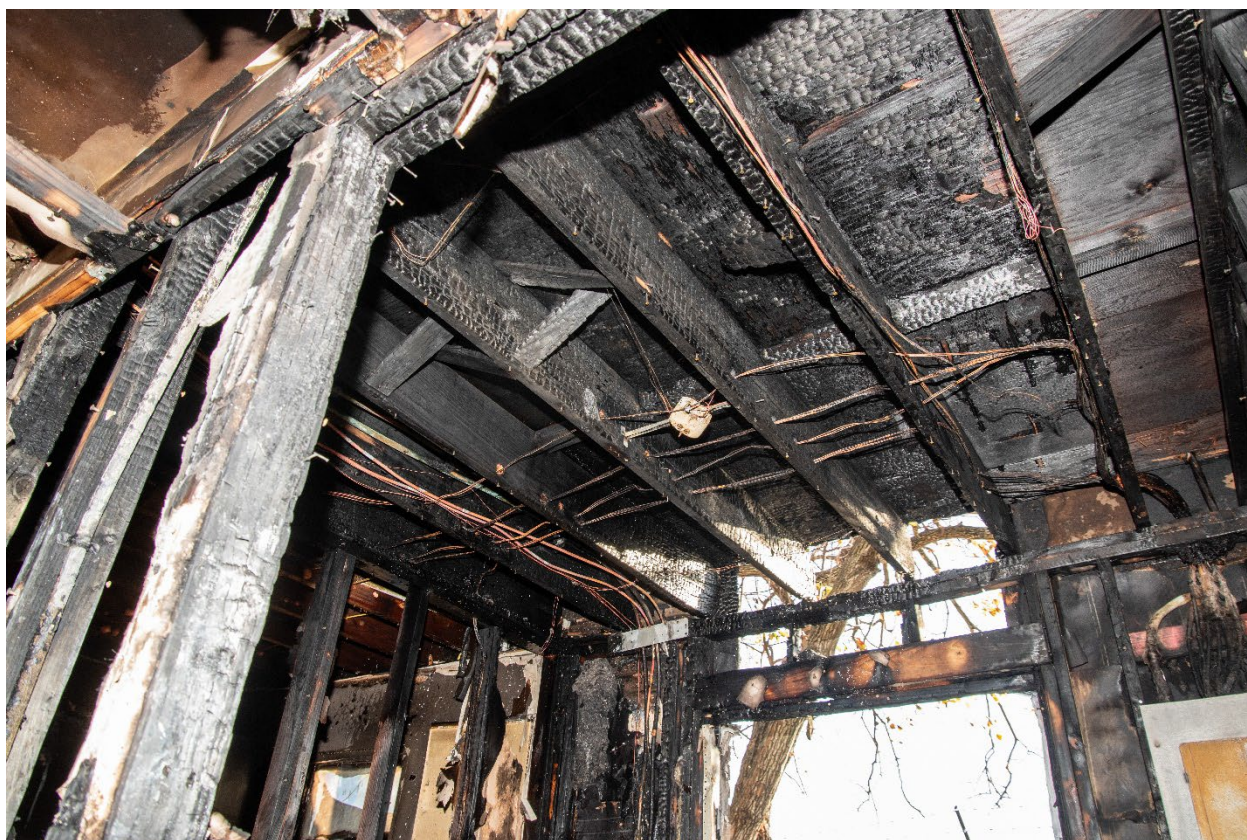
**Photo 4** shows how the structural elements contributed to the fire, indicating a longer burning duration than might have been recognized on arrival. As the crew entered the hallway, the visibility decreased and the heat increased. This was partly from the reduced ceiling height in the hallway and the proximity to the room of fire origin.

**Photo 4: Detail of ceiling construction in bedroom 1. Charring and evidence of mass loss from the joists and bottom of the subfloor of division 2 are shown.**

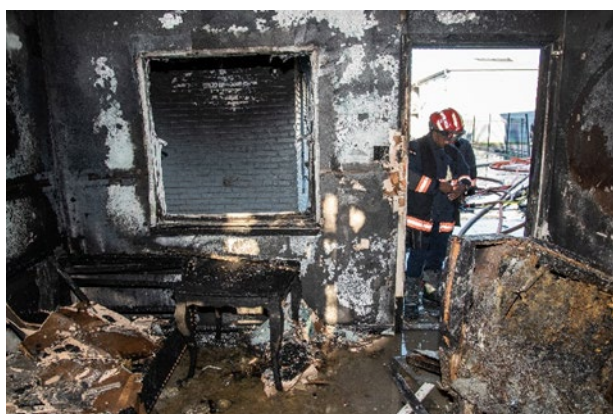
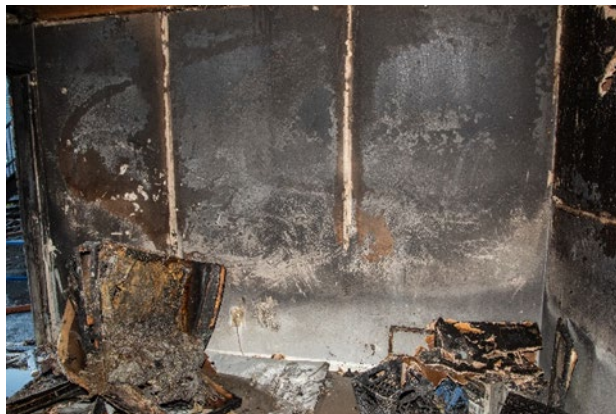
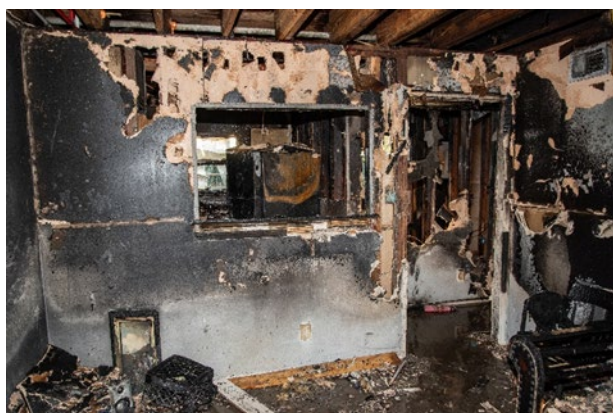
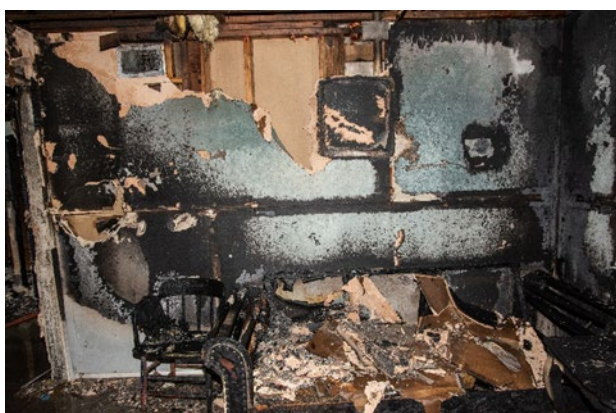
From the L46 search crew perspective, the living room flashed over. The fire damage in the living room indicates that technically, the living room did not complete the transition through flashover as shown in **Photos 5, 6, 7, and 8**. However, the flames from the chair would have:

The closed door reduced the flow of fresh air to the living room, which interrupted the transition through flashover (i.e., full room involvement in fire). The closed door reduced the oxygen available for combustion, so flames decreased in the living room. This also trapped heat and smoke in the living room until suppression occurred from the two hose streams. The fire development time from the 911 call to water on the fire was about 10 minutes.

**Photo 5, 6, 7, and 8: Vantage points of the living room. Top left - Side Alpha, top right - Side Bravo, bottom left - Side Charlie, bottom right - Side Delta. (Photos courtesy of the fire department)**

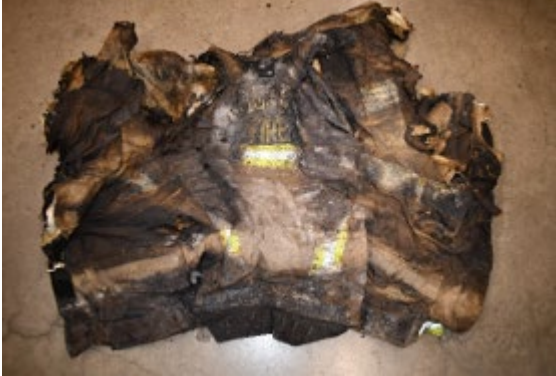
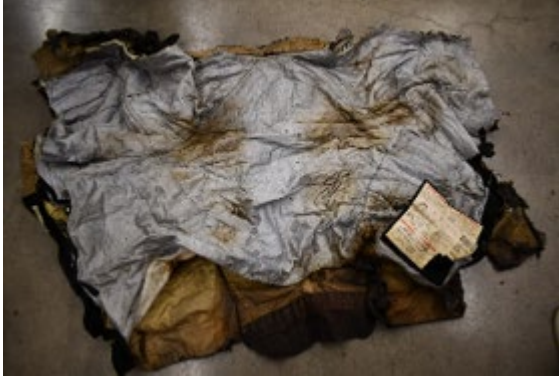
| L46A Outer Shell Exterior Side | | L46A Liner Interior Side | |

| <b>Firefighter</b> | <b>Burn Injury</b> | <b>PPE Damage</b> |
|---|---|---|
| L46A | Left shoulder | Coat: Heat penetration observed |

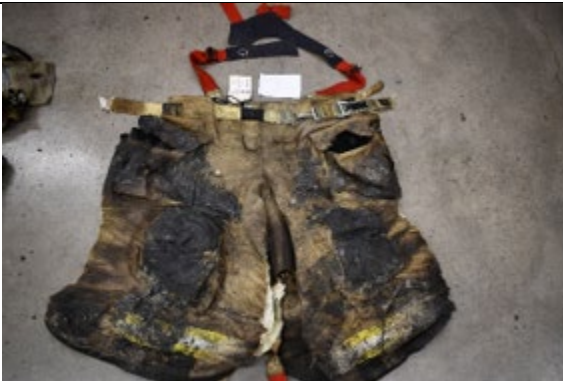
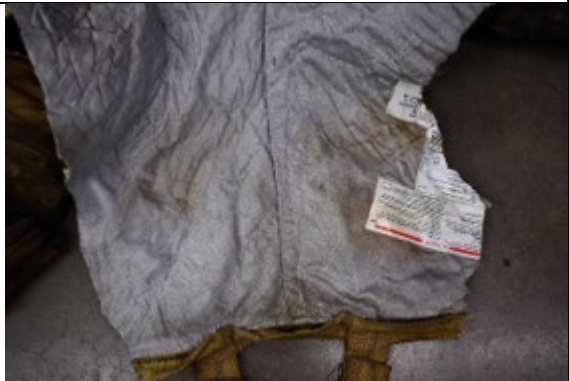
| L46C Outer Shell Exterior Side | | L46C Liner Interior Side | |

One firefighter was likely more susceptible to some burn injuries due to the accidental misfit of their gear. Properly fitting gear may provide better protection from burns. L46C wore pants that were too big. The loose fit of the pants allowed hot air to move up the pant leg. The firefighter also wore boots that were too small. This reduced the air gap in the boots between the inner surface and the firefighter's skin and allowed for greater heat transfer from the outside of the boot to the skin.
