**F2025-01**

Senior Captain and Two  
Firefighters of Ladder Company  
Burned During Primary Search in  
Garden Apartment Fire – Texas

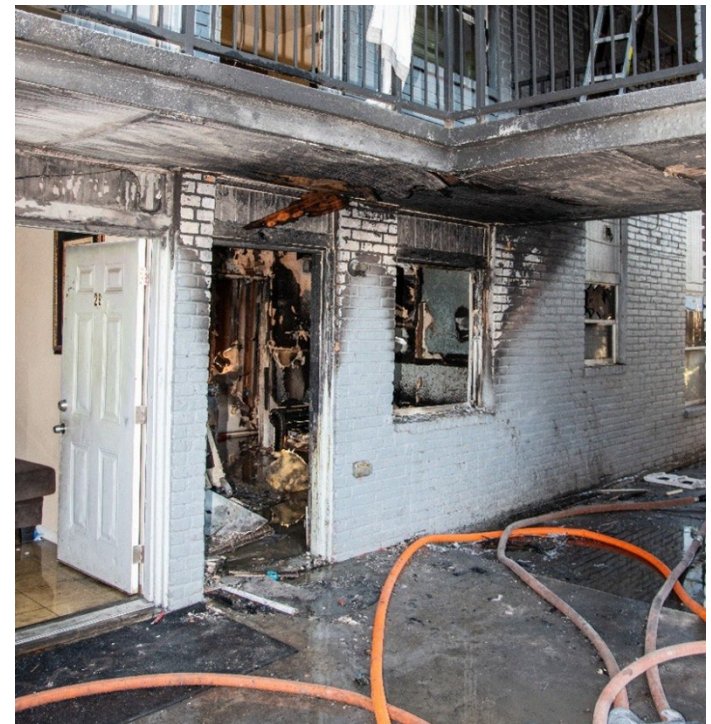
View from the courtyard into the fire apartment, Side Alpha.  
(Courtesy of the fire department)

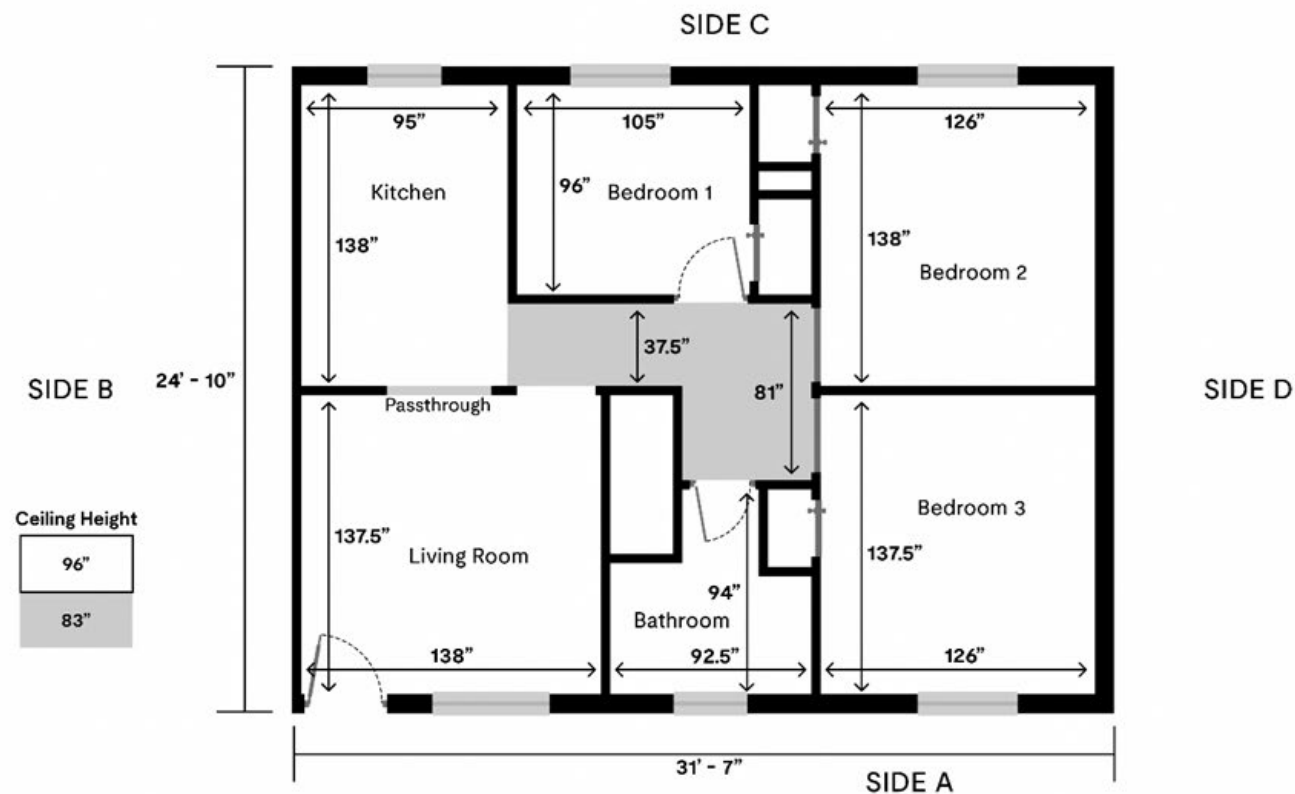
Dimensioned floor plan of the fire apartment. Note that the ceiling height of the hallway is 13 inches shorter than the ceiling height of the rooms. The lowered ceiling height in the hallway provided space for the HVAC duct work. (Courtesy UL FSRI)

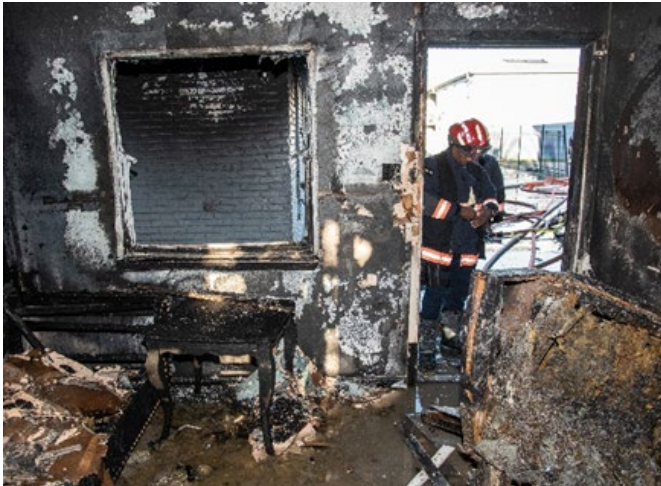
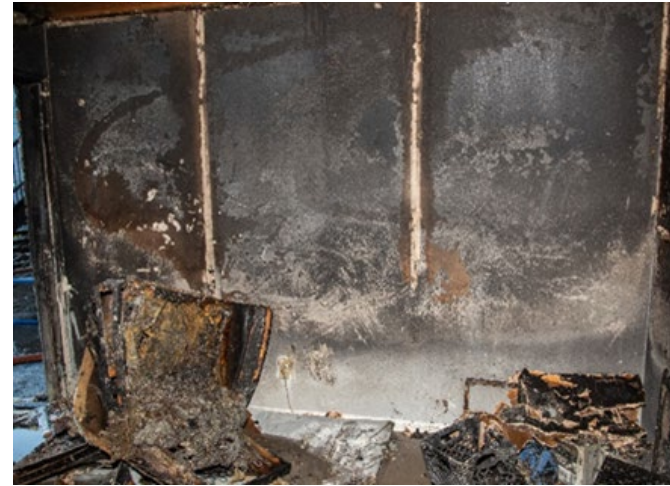
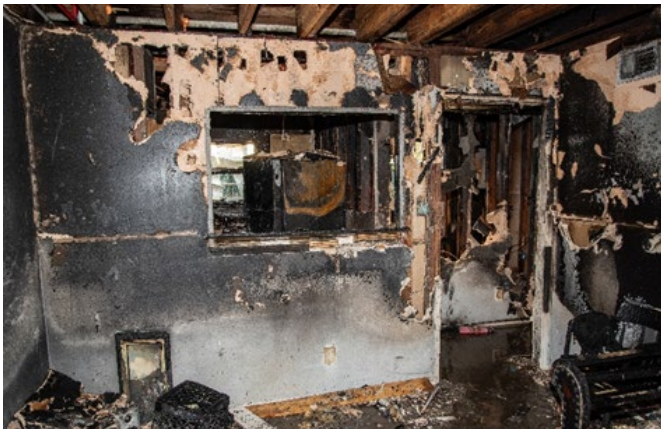
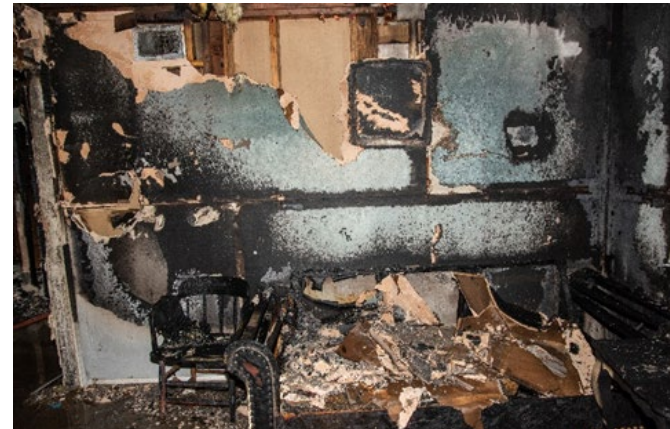
Vantage points of the living room. Top left - Side Alpha, top right - Side Bravo, bottom left - Side Charlie, bottom right - Side Delta. (Courtesy of the fire department)
