**REPORT#: 23CA005**

**REPORT DATE: APRIL 10, 2025**

## A Welder Dies from Methylene Chloride Exposure While Removing Oil Residue from the Inside of a Motor Oil Tank — California

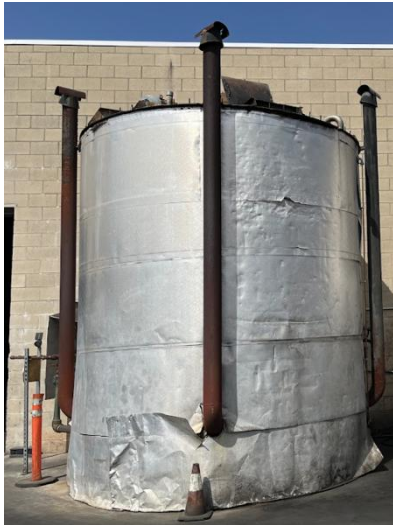
The incident scene was an empty motor oil tank located at an oil manufacturing facility (Exhibit 1). The tank was 20 feet high by 10 feet wide and was used to prepare motor oils. The tank did not have a ladder, and the only entrance was through a manhole located on the top of the tank. There were no confined space warning signs on or around the tank.

**Exhibit 1: Exterior of the oil tank. Photo courtesy of the CA/FACE program.**

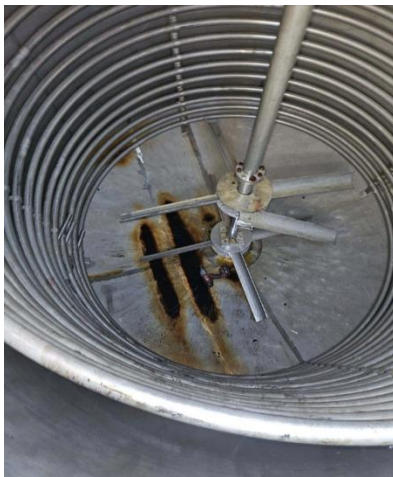
A few days prior to the incident, an oil company employee (oil mixer) noticed a bolt came through a hose, indicating that a blade inside the tank may have come loose (Exhibit 2). The victim was called by the oil company to inspect and repair the blades. On the day of the incident, the motor oil tank was empty, and

**Exhibit 2: Blades inside the motor oil tank. Photo courtesy of the oil company.**

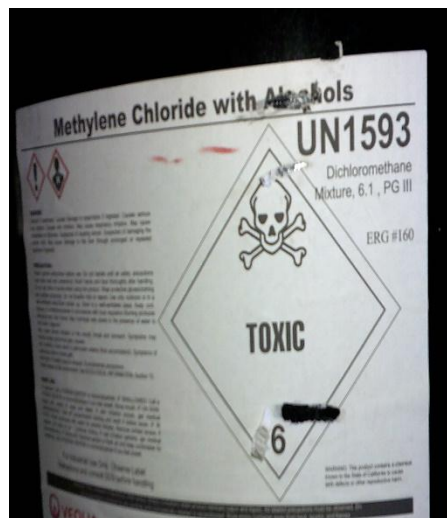
The victim inspected the work area and told the warehouse cleaner that he was slipping on the oil residue left at the bottom of the tank. The victim requested a liquid product to remove the oil residue. The cleaner gave the victim a 5-gallon container (product name unknown) that contained methylene chloride that had been purchased more than 1.5 years prior to the incident and was stored onsite. There was a warning label on the outside of the container (Exhibit 3). Based on the police report, the warehouse cleaner mentioned to the victim that the container was almost empty and an alternative procedure to clean the oil tank (self-heating system to evaporate the residual oil) could be used instead. However, this procedure was not implemented on the day of the incident, and the victim used the product with methylene chloride. According to the warehouse cleaner, the victim used approximately two cups of the methylene chloride product to clean the bottom of the tank.

**Exhibit 3. Label on the outside of the container. Photo courtesy of the police department.**

### ***Recommendation #1: Avoid purchasing, storing and/or using products that contain methylene chloride.***

The immediately dangerous to life or health (IDLH) exposure limit for methylene chloride is 2300 parts per million (ppm). In this case, the victim used approximately 2 cups (473 milliliters) of the product inside the tank. Assuming the product contained 60% methylene chloride, the estimated concentration of methylene chloride inside the tank was 2437 ppm, above the IDLH level for methylene chloride. The toxicology report after death found 25 micrograms per milliliter (mcg/mL) of methylene chloride in the victim's blood. This level of methylene chloride is consistent with the levels that have been found in other workplace fatalities. The carboxyhemoglobin level was < 10% saturation indicating that there was not a very high level of interference with oxygen delivery to his tissues. In many cases of immediate death due to methylene chloride vapors, the carboxyhemoglobin level was less than 10% saturation. In these cases, it is likely that methylene chloride acts directly on the brain as an anesthetic, and/or causes the amount of oxygen in the workplace air to be reduced. In addition, the victim had methamphetamine in his body on post-mortem testing. It is possible that methamphetamine may have made the victim more susceptible to the effects of methylene chloride by causing his heart to have an irregular heartbeat (ventricular tachycardia) that led to his death.

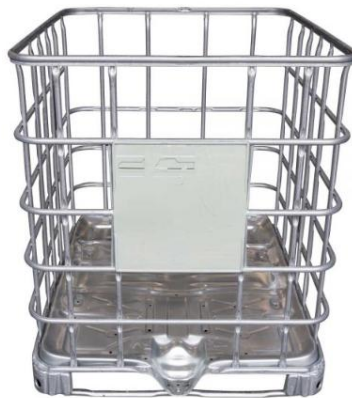
According to the police report, police officers arrived on the scene at 11:42 a.m. They were dispatched to respond to a man down inside an oil tank. Multiple fire engines and personnel responded and arrived on the scene at 11:46 a.m. Emergency responders, along with the employees of the oil company, used a forklift, tie-down straps and a cage to successfully extract the victim (Exhibit 4). The victim was pronounced dead at the scene at 12:29 p.m.

**Exhibit 4: A steel cage like the one used to lift the victim up and down with a forklift.**  
Photo courtesy of Global Industrial.
