# SERIOUS INJURY REPORT

REPORT F2026-01 • April 2026

## ***Four Career Firefighters Injured from a Floor Collapse in an Abandoned Residential Structure Fire – Kansas***

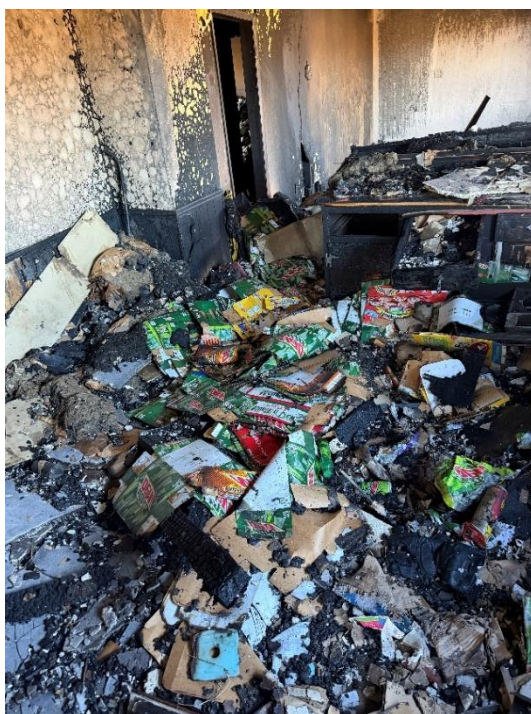
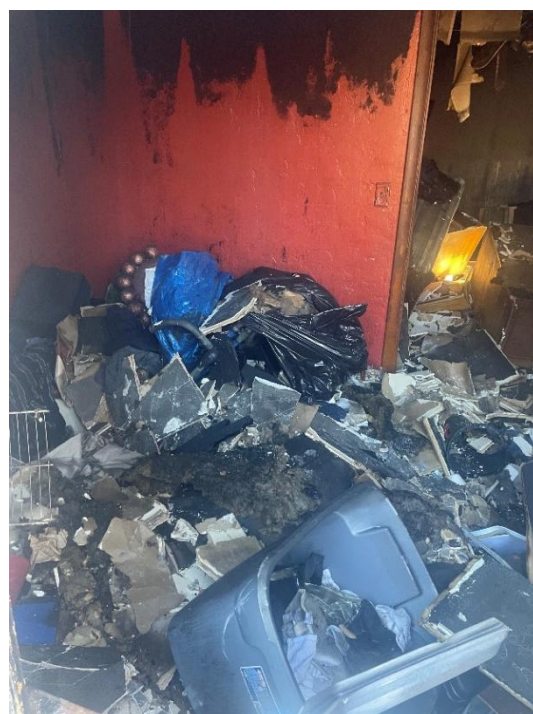
The structure was reported to be abandoned for 18 months, with a significant amount of furniture, trash, and debris spread throughout the interior (see **Photo 3 and 4**). Many of the structure openings were unprotected and consequently, there were reports of unauthorized people accessing and using the space.

**Photo 3 and 4: View of trash on first floor.**  
*(Courtesy of the fire department)*

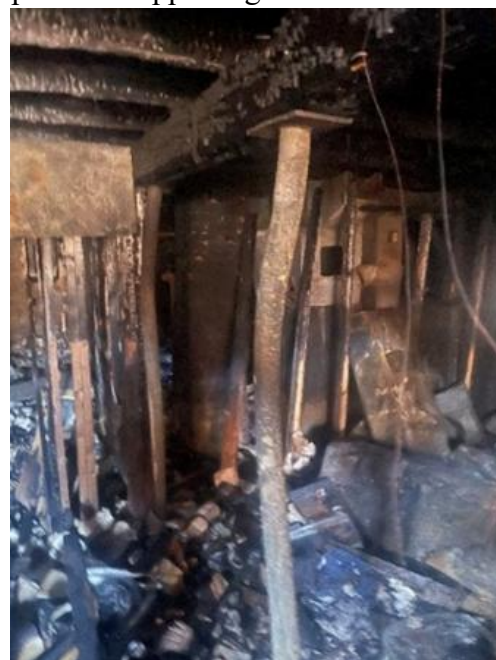
During the post-incident assessment of the structure, several steel lally columns located in the basement were observed to have significant bowing and twisting deformation (see **Photo 7**). These conditions are consistent with loss of compressive strength in structural steel due to prolonged exposure to elevated temperatures during the fire event. As temperatures approach approximately 1,000°F (538°C), structural steel can lose roughly 50 percent of its load-bearing capacity, and as temperatures continue to rise toward 1,100-1,200°F, the material begins to experience substantial reductions in both yield strength and modulus of elasticity [AISC 2011]. Based on the fire conditions present in the basement area, it is likely that the compartment experienced significant heat buildup due to limited ventilation and the presence of combustible contents, allowing temperatures to increase rapidly. Fire dynamics within a confined

As the fire progressed, the steel columns would have absorbed heat energy through convective and radiant heat from flame impingement and superheated gases, as well as conduction through connected structural elements. As the steel columns were exposed to elevated temperatures, the internal crystal structure of the metal began to change, causing thermal expansion followed by a progressive loss of tensile strength and stiffness. This weakening allowed the columns to deform under the existing structural loads they were designed to support. The observed bowing of the columns indicates compressive instability, where the steel members were no longer capable of supporting the vertical loads from the structure above. Additionally, the twisting deformation (**Photo 7**) suggests uneven heating and thermal expansion, likely caused by asymmetric fire exposure or varying heat intensities across the surface of the column. As portions of the steel heated more rapidly than others, differential expansion would have produced torsional stresses within the column, contributing to the twisting observed during the examination. These deformation patterns are consistent with heat-induced structural compromise, indicating that the basement compartment was subjected to temperatures sufficient to significantly reduce the load-bearing capacity of the steel support system. Once the tensile strength of the columns was reduced beyond their design limits, the structural members began to deform under load, leading to the visible bowing and twisting noted during the investigation. The condition of the lally columns provides important physical evidence supporting the conclusion that the basement fire produced sustained high-temperature conditions capable of impacting structural stability, and that the failure of these support elements was the result of thermal degradation of the steel rather than mechanical impact or pre-existing structural deficiencies.

**Photo 7: Twisting of steel column.**  
(Courtesy of the fire department)

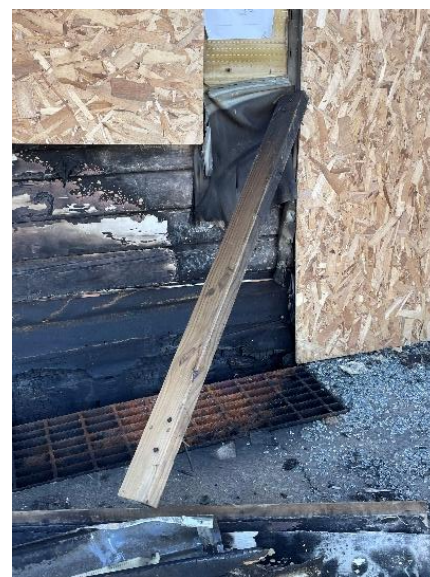
**Photo 9: Grate cover over basement window.**  
(Courtesy of the fire department)

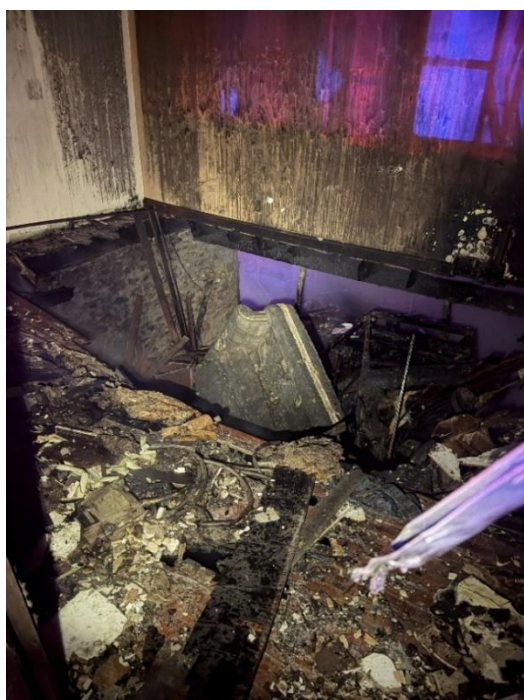
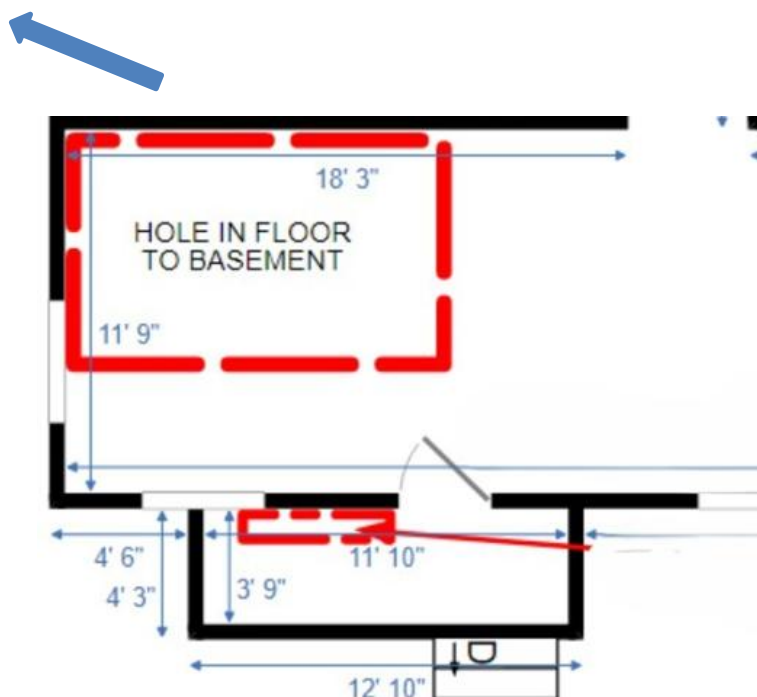
**Photo 10 and Diagram 2: View of first floor collapse.**  
*(Courtesy of the fire department)*

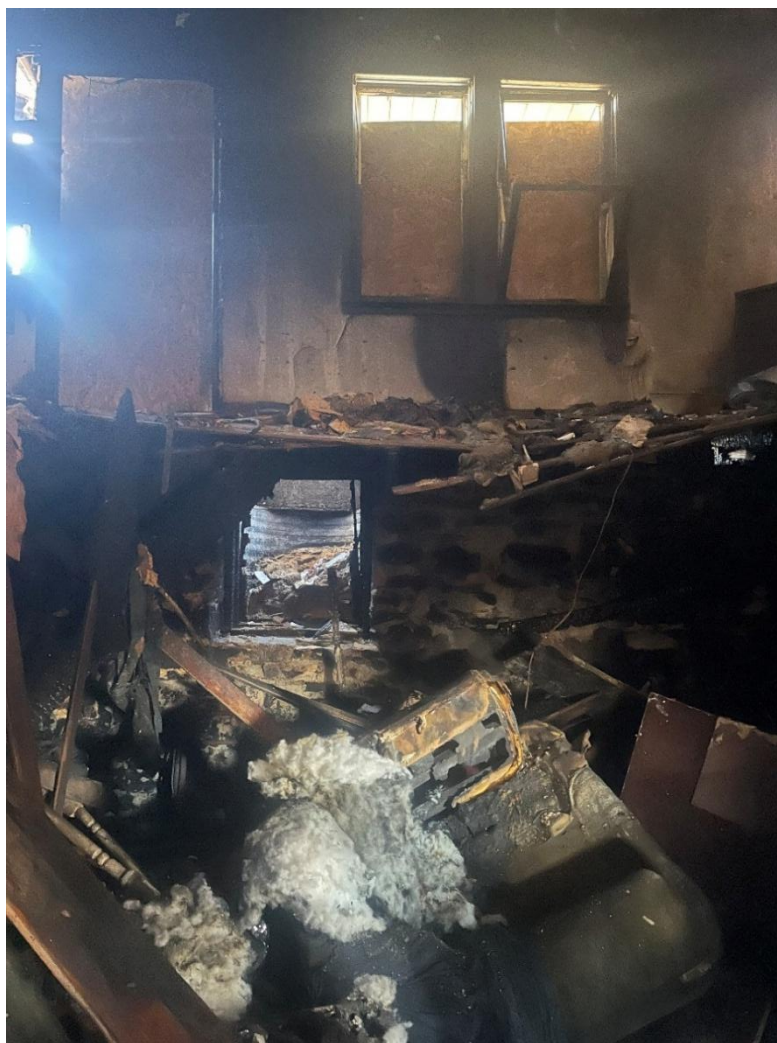
**Photo 11: View of area of collapse with debris.**  
*(Courtesy of the fire department)*

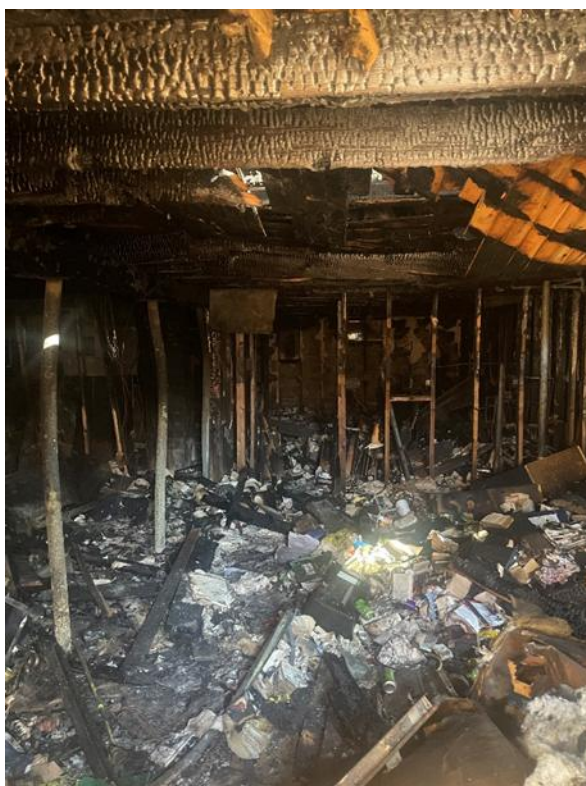
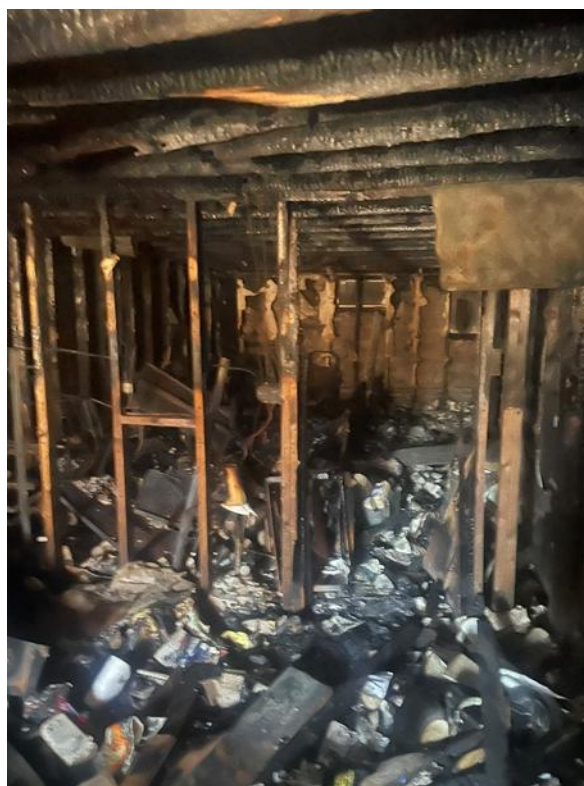
into the basement (see **Photo 12 and 13**), he located a downed firefighter (Pumper 18 firefighter). IC tried again to radio Pumper 18 and did not get a response. IC radioed Pumper 11 with their officer responding that they were RIT and were making entry into the basement. Pumper 14 officer reported they had found the Pumper 18 firefighter and were working to get her “un-trapped.” IC acknowledged Pumper 14’s message and confirmed the firefighter was located in basement. Pumper 14 officer gave the attack line to a second member of Pumper 14, who continued to extinguish fire in the rear of the basement.

**Photo 12 and 13: Basement with debris, post-fire.**  
*(Courtesy of the fire department)*
