# State FACE™ Fatality Narrative

## Laborer Falls through Guardrail

**REPORT #:** 71-277-2026s REPORT

**SCENE:** Residential construction site

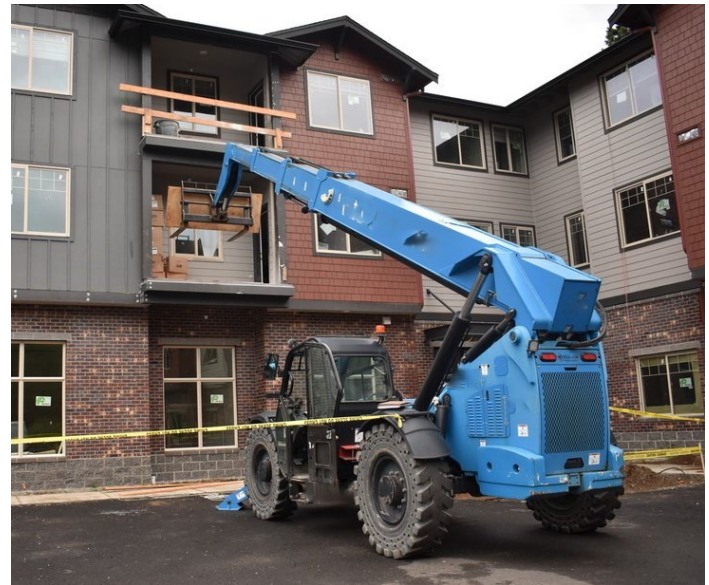
**Image 1.** Scene where worker fell.

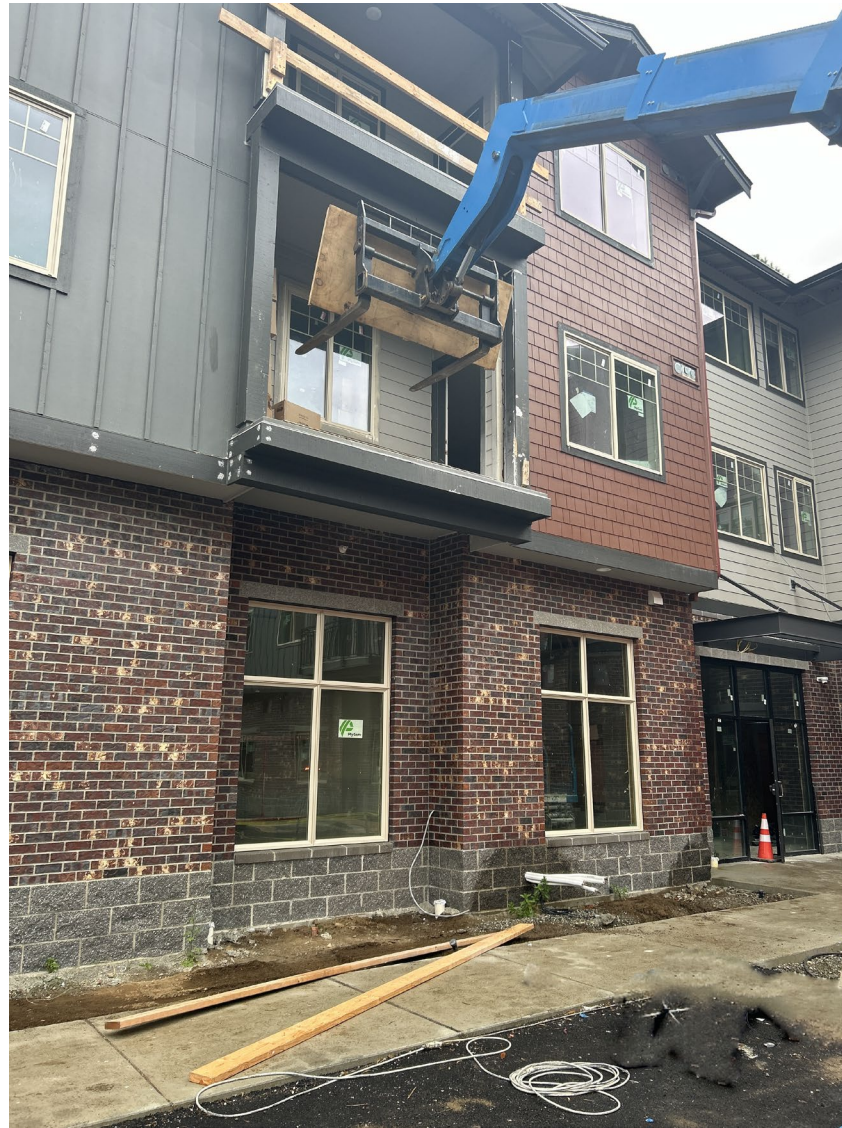
- The pair of two-by-six-inch wood guardrails did not have a mid-way post for their 10-foot span as required for a span of more than eight feet. The guardrails were fastened to the front of the supporting posts of the balcony using just one two-and-a-half-inch wood screw on each end. The actual thickness of the nominal two-by-six-inch board is one inch and three-quarters, which allowed only a half inch of the screw to thread into the post. One of the boards also had a screw that was not fully seated into it.
- The worker weighed over 300 pounds, but the guardrails were unable to withstand at least a 200-pound outward load applied to them, as required.
- The site supervisor did not check the guardrail installation, nor did he know who had installed them.

**Image 2.** Second-floor balcony where worker fell from, and failed guardrails on the sidewalk below.

- **Perform a pre-job review of guardrail requirements with workers.** Have supervisors review and ensure that workers understand specific guardrail requirements at the job site before they begin work.
- **Inspect guardrail systems before and during work.** Arrive on-site each day before work begins or appoint a supervisor to check that guardrails are installed according to requirements. Do not begin work until requirements are met. Spot check guardrails throughout the day to ensure they are in good condition.
- **Make fall prevention a company priority.** Emphasize fall protection in one-on-one worker check-in meetings, daily crew meetings, monthly safety meetings, annual stand-downs, and company media.

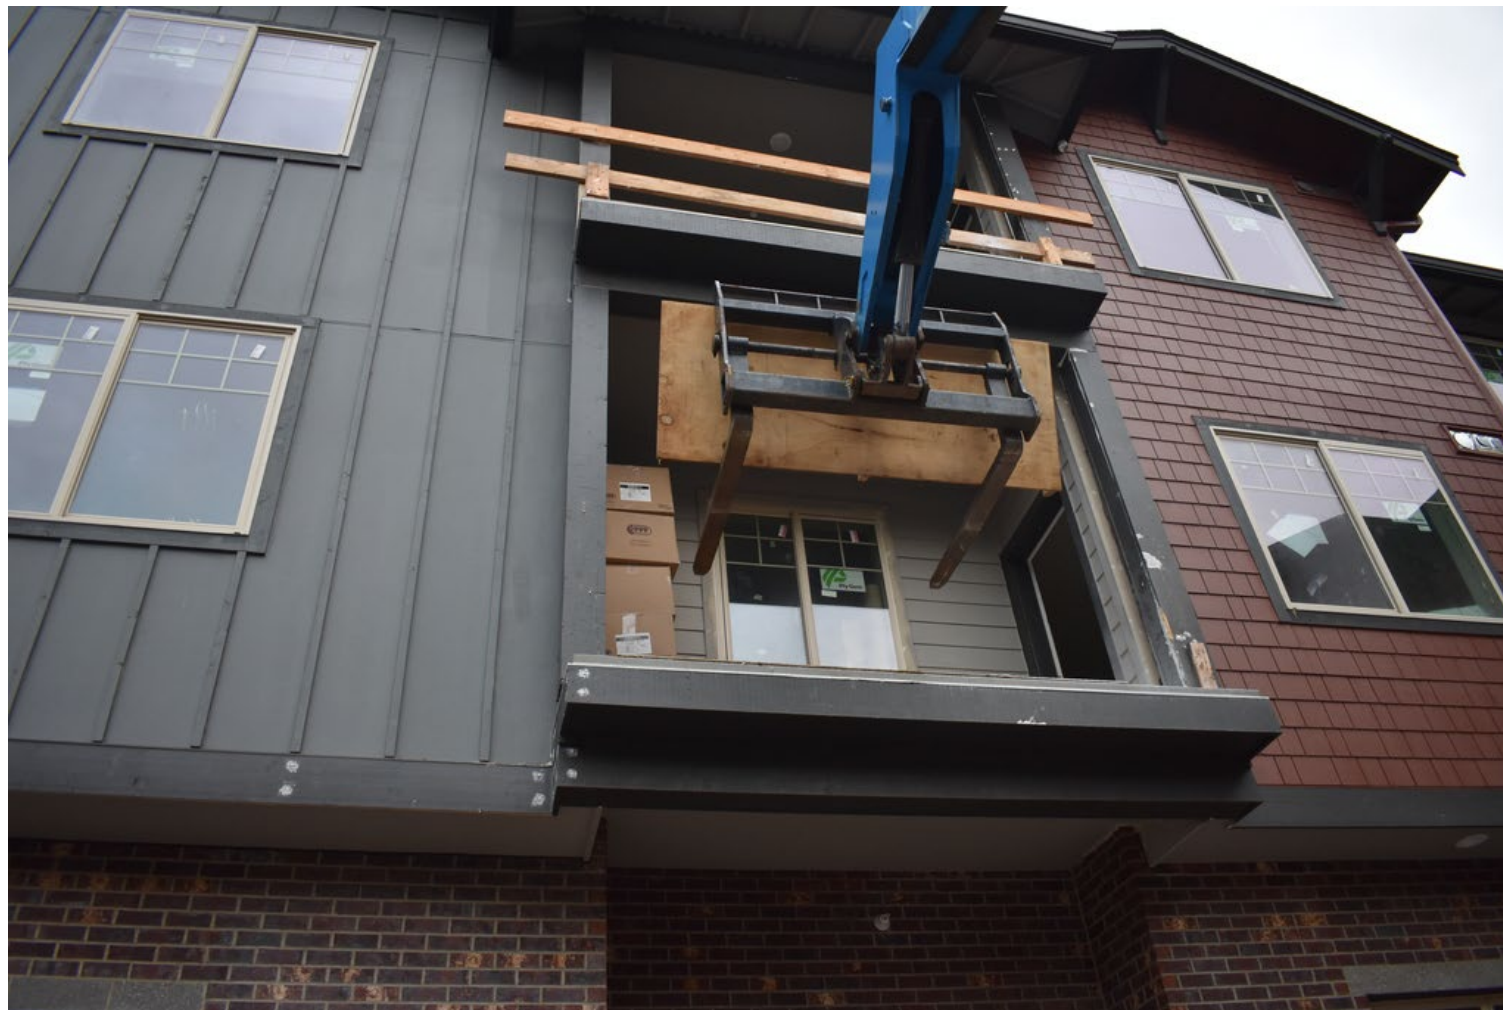
**Image 3.** Close-up view of balcony where worker fell from.

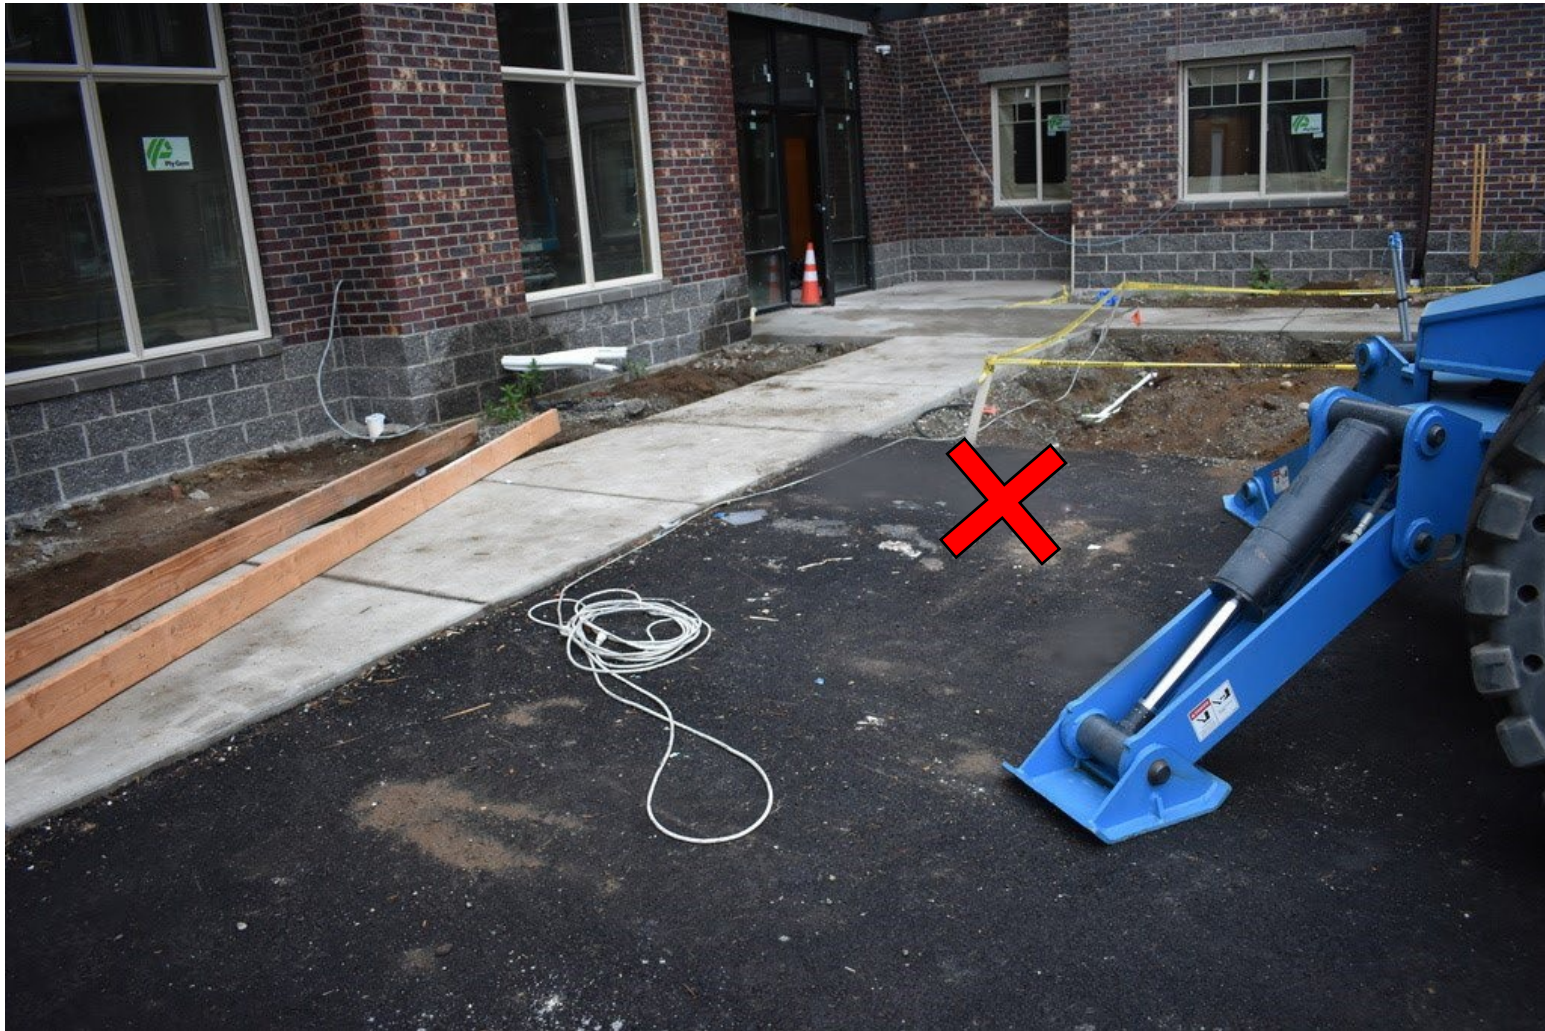
**Image 4.** Location where worker landed after falling.

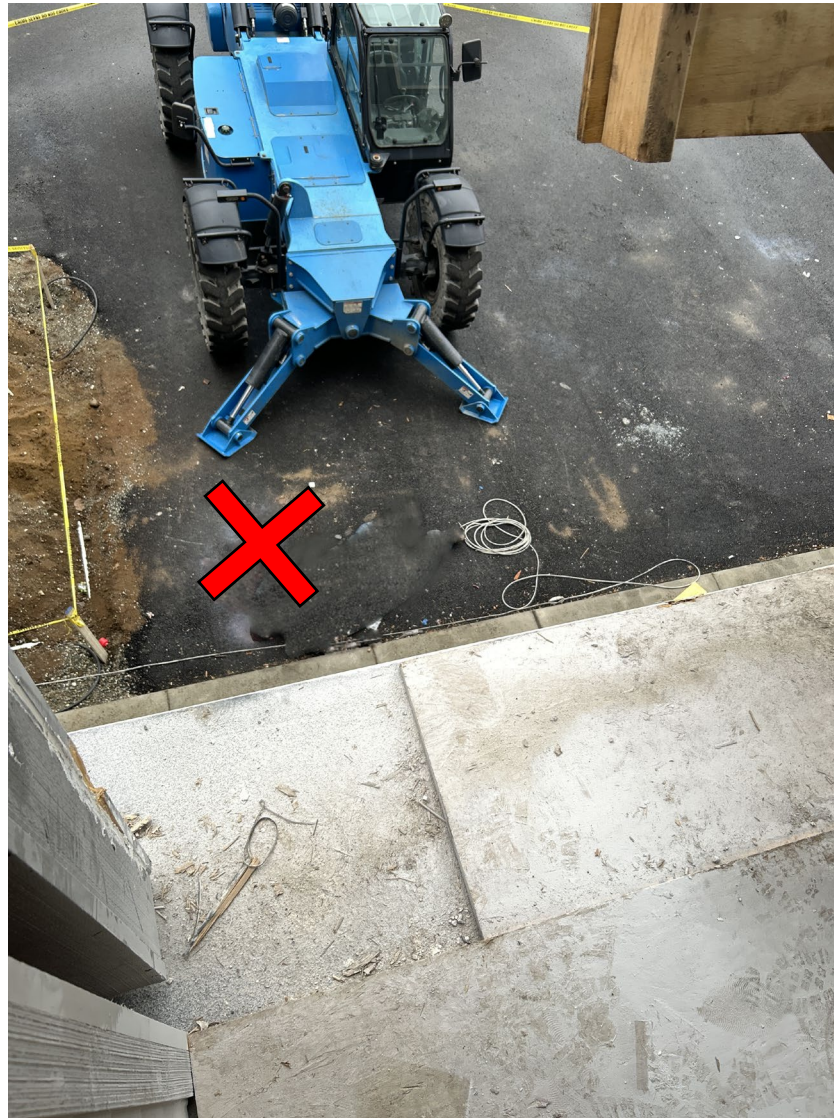
**Image 5.** View looking down from second-floor balcony.

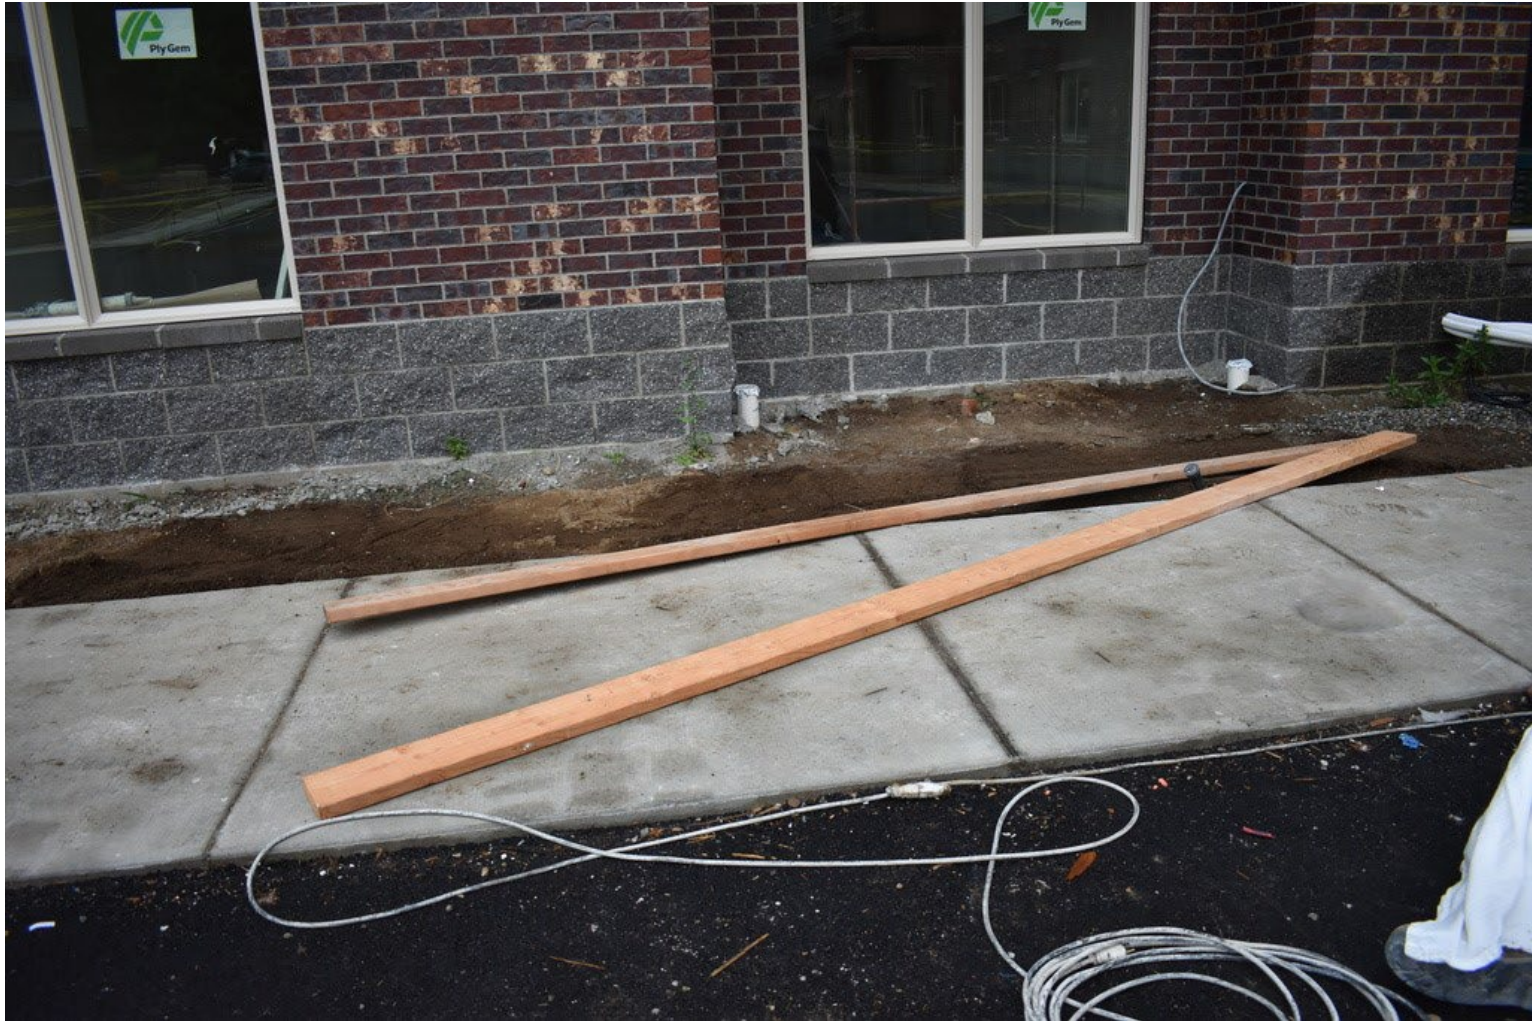
Image 6. Guardrails that failed.

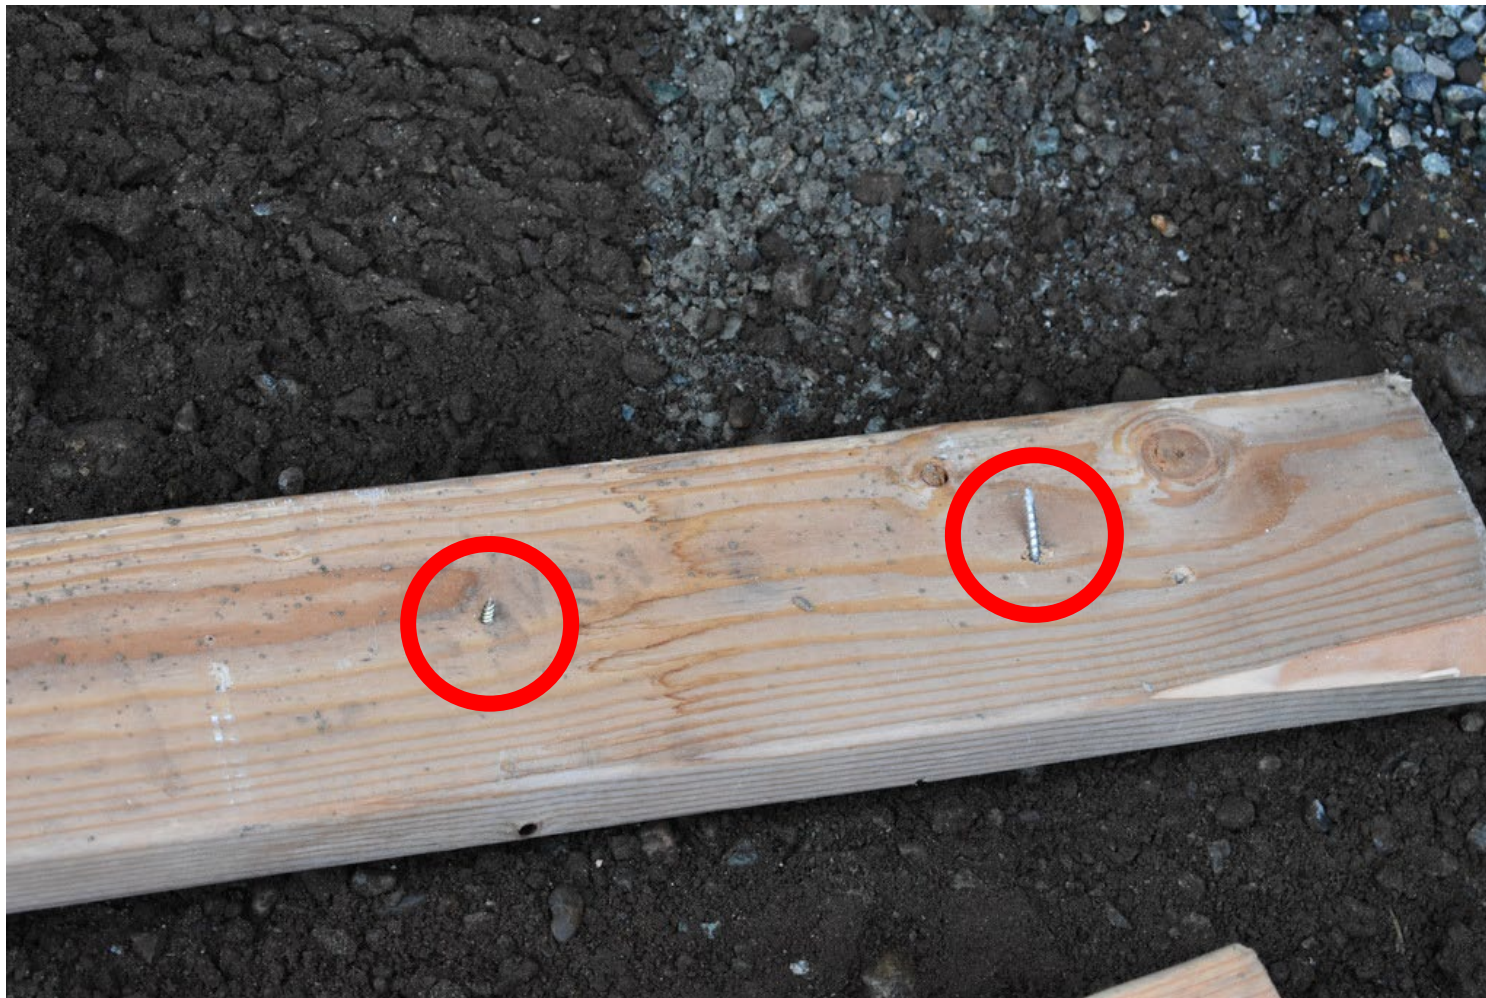
**Image 7.** Ends of wood screws on failed guardrails.
