# State FACE™ Fatality Narrative

## Framer Struck by Wall, Falls through Floor Opening

**REPORT #:** 71-274-2026s REPORT

**SCENE:** Residential construction site

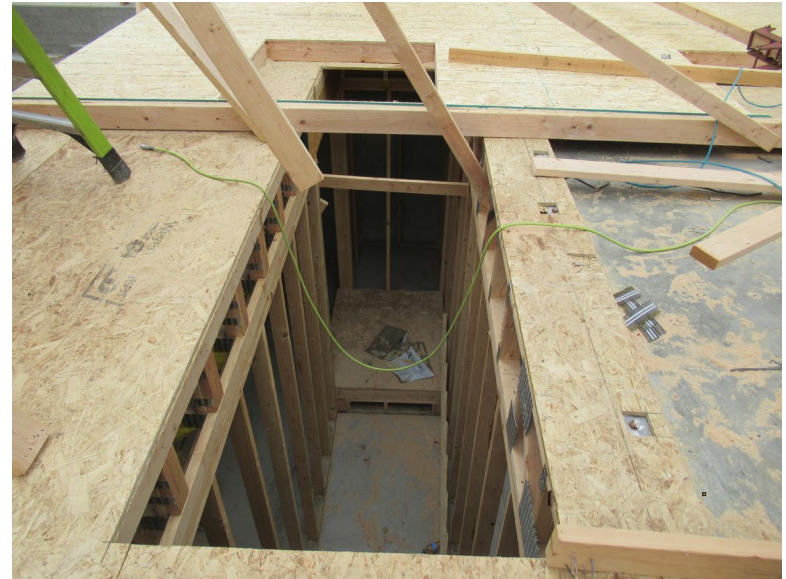
**Image 1.** Unguarded floor opening.

- The floor opening had been covered by the wall before it was raised. The employer did not ensure that workers used a guardrail, cover, or other fall protection system to prevent falling into the opening.
- Crew stated they did not have enough lumber to cover the opening as they usually did.
- The crew had recent guardrail systems and overhead hazards training and much experience raising walls.

- Protect employees from falling into or through holes four feet or more to the ground or lower level by one of the following fall protection systems: (i) A standard guardrail system, or the equivalent, as specified in WAC 296-880-40005, on all open sides, except where there is entrance to a ramp, stairway, or ladder. The guardrail must be provided with a standard toeboard wherever, beneath the open sides, persons can pass, or there is moving machinery, or there is equipment with which falling materials could create a hazard; (ii) A cover, as specified in WAC 296-880-40015; (iii) A warning line system erected at least 15 feet from all unprotected sides or edges of the hole and meets the requirements of WAC 296-880-40040;

- **Develop accident prevention program (APP) policies.** Policies should require workers to (1) manually support and secure walls after raising, and (2) install and secure covers before working around openings.
- **Create a restricted access zone.** Its length and width should equal the wall plus 4 feet on both sides of it. Mark the zone and continuously monitor it to prevent access while the wall is being raised and secured.

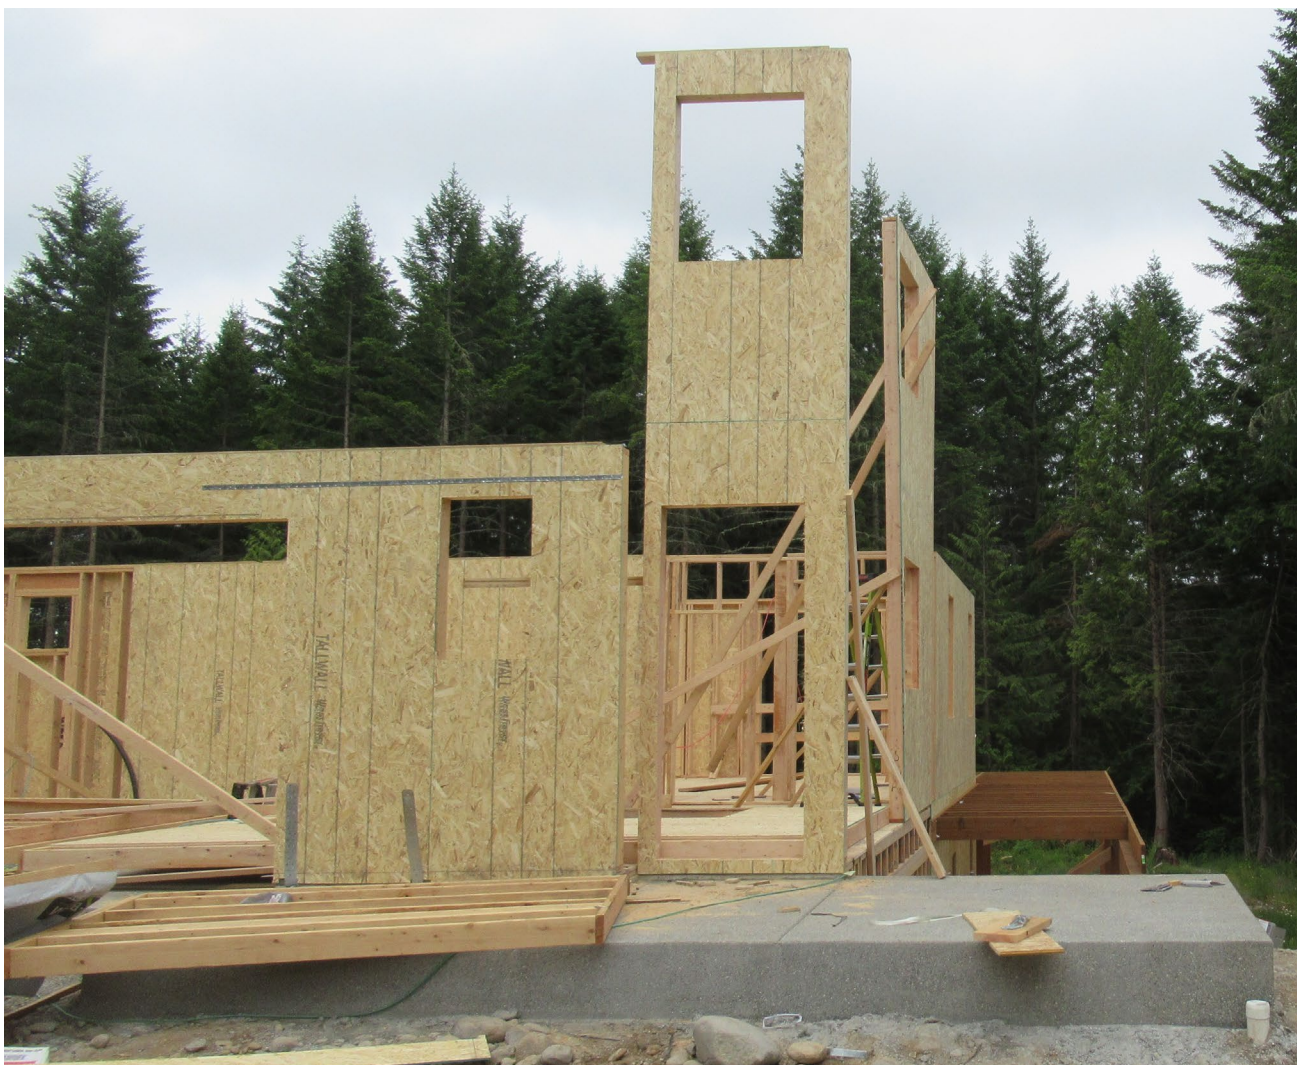
**Image 2.** Residential home under construction where crew was working.

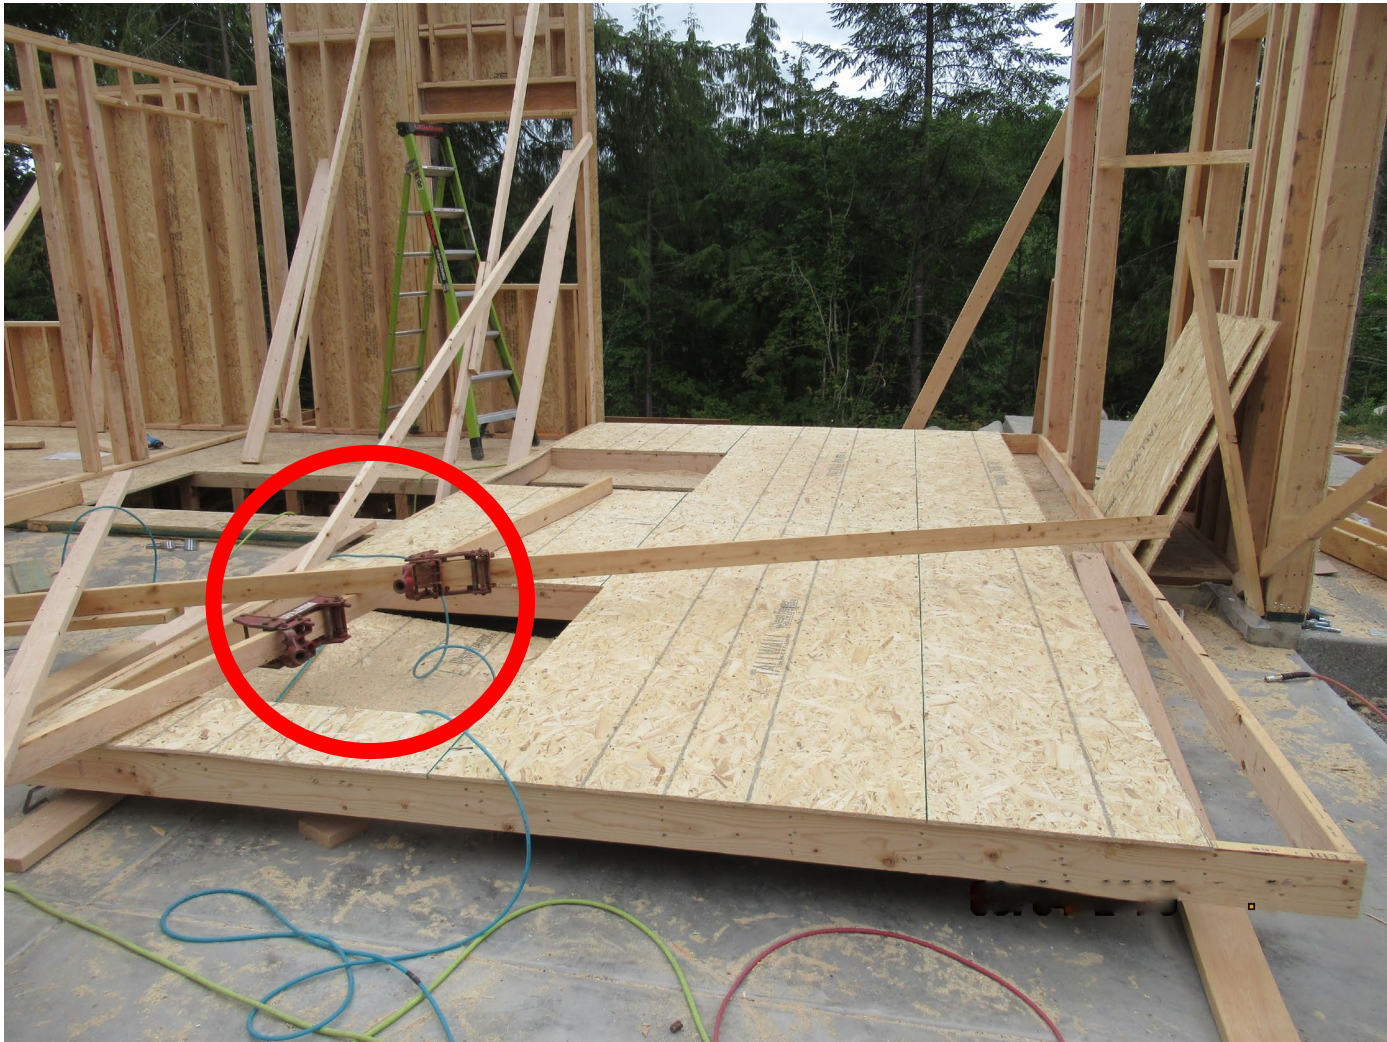
**Image 3.** Collapsed wall with wall jacks on posts.

Once the wall was up, the wall jack posts were free standing. Before the wall could be secured, a worker yelled, "watch out," as a brace on the right side gave way. The wall collapsed and struck the framer in the back of his head.

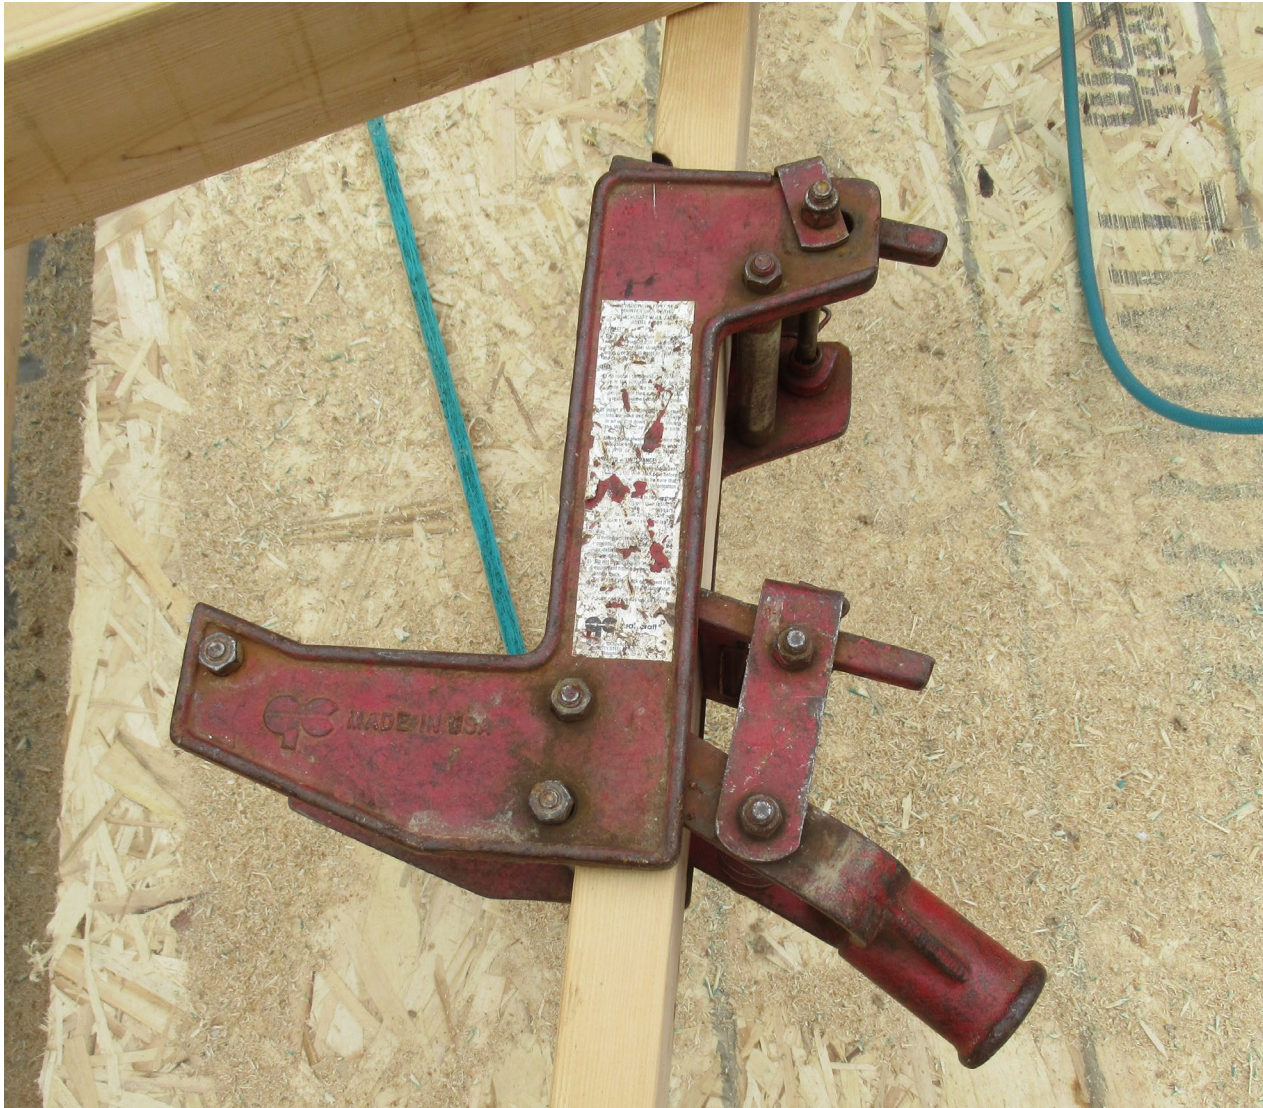
**Image 4.** Wall jack attached to wood post.

The crew was using two portable iron wall jacks installed on two 12-foot-high two-by-four lumber posts. The jacks were under the wall's top plate, and the posts were standing straight up and unsecured on the floor. Their plan was to manually ratchet the jacks up the posts to lift the wall into place.

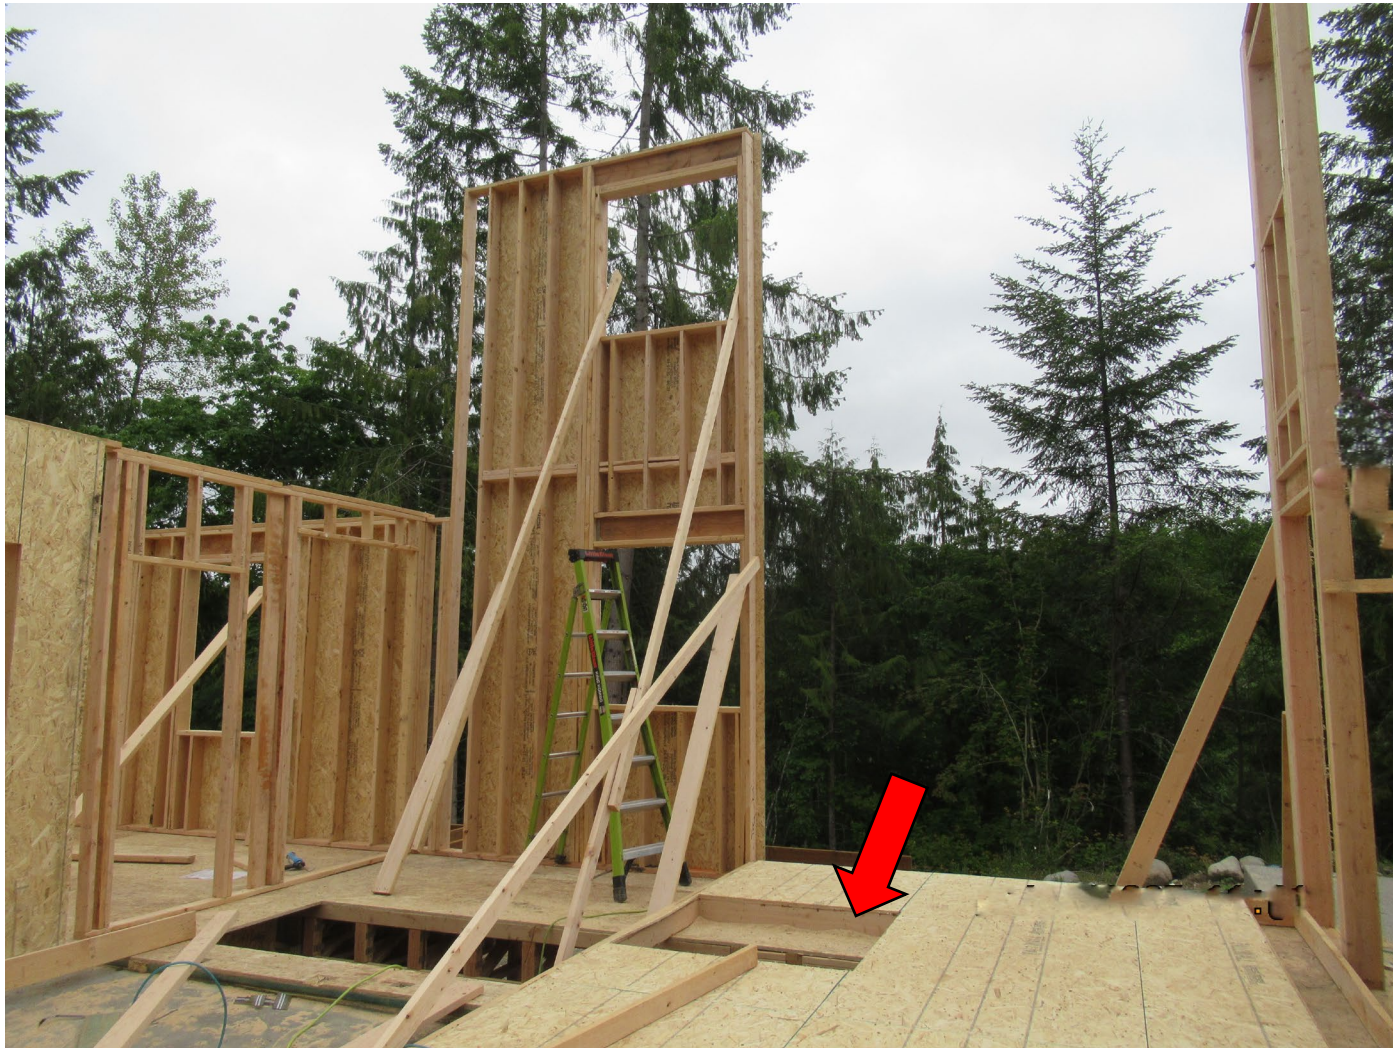
**Image 5.** Arrow shows approximately where framer was struck by wall and fell through opening.

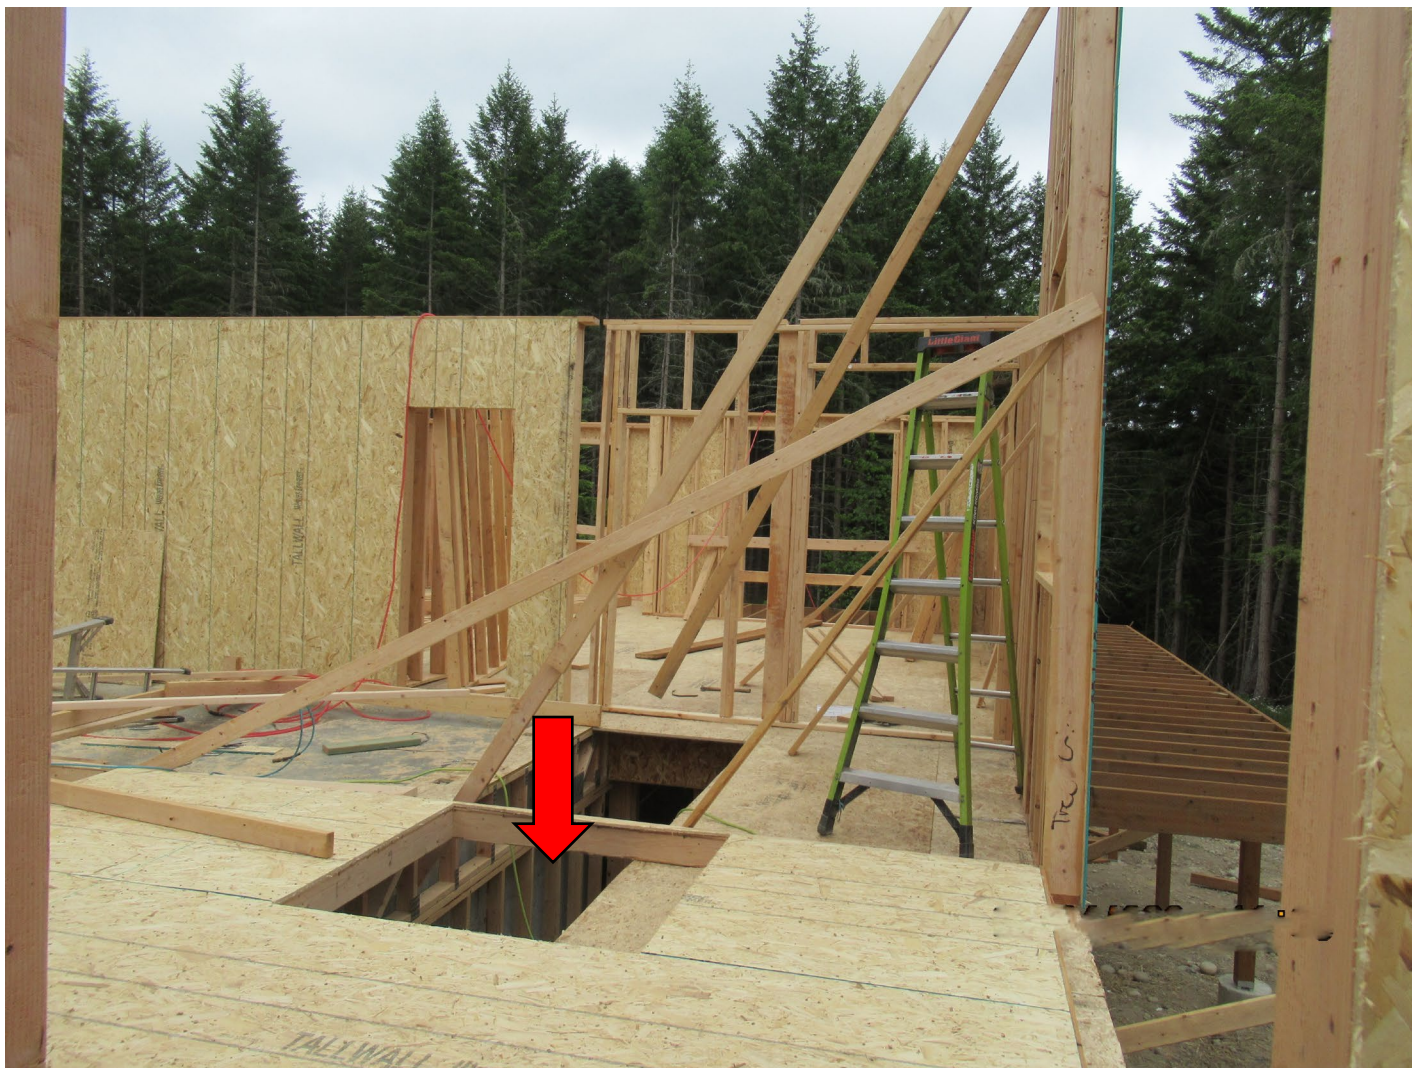
Image 6. Floor opening where framer fell.

The impact made him fall through an unguarded four-foot by eight-foot floor opening beside him. He fell eight feet to the concrete floor below.

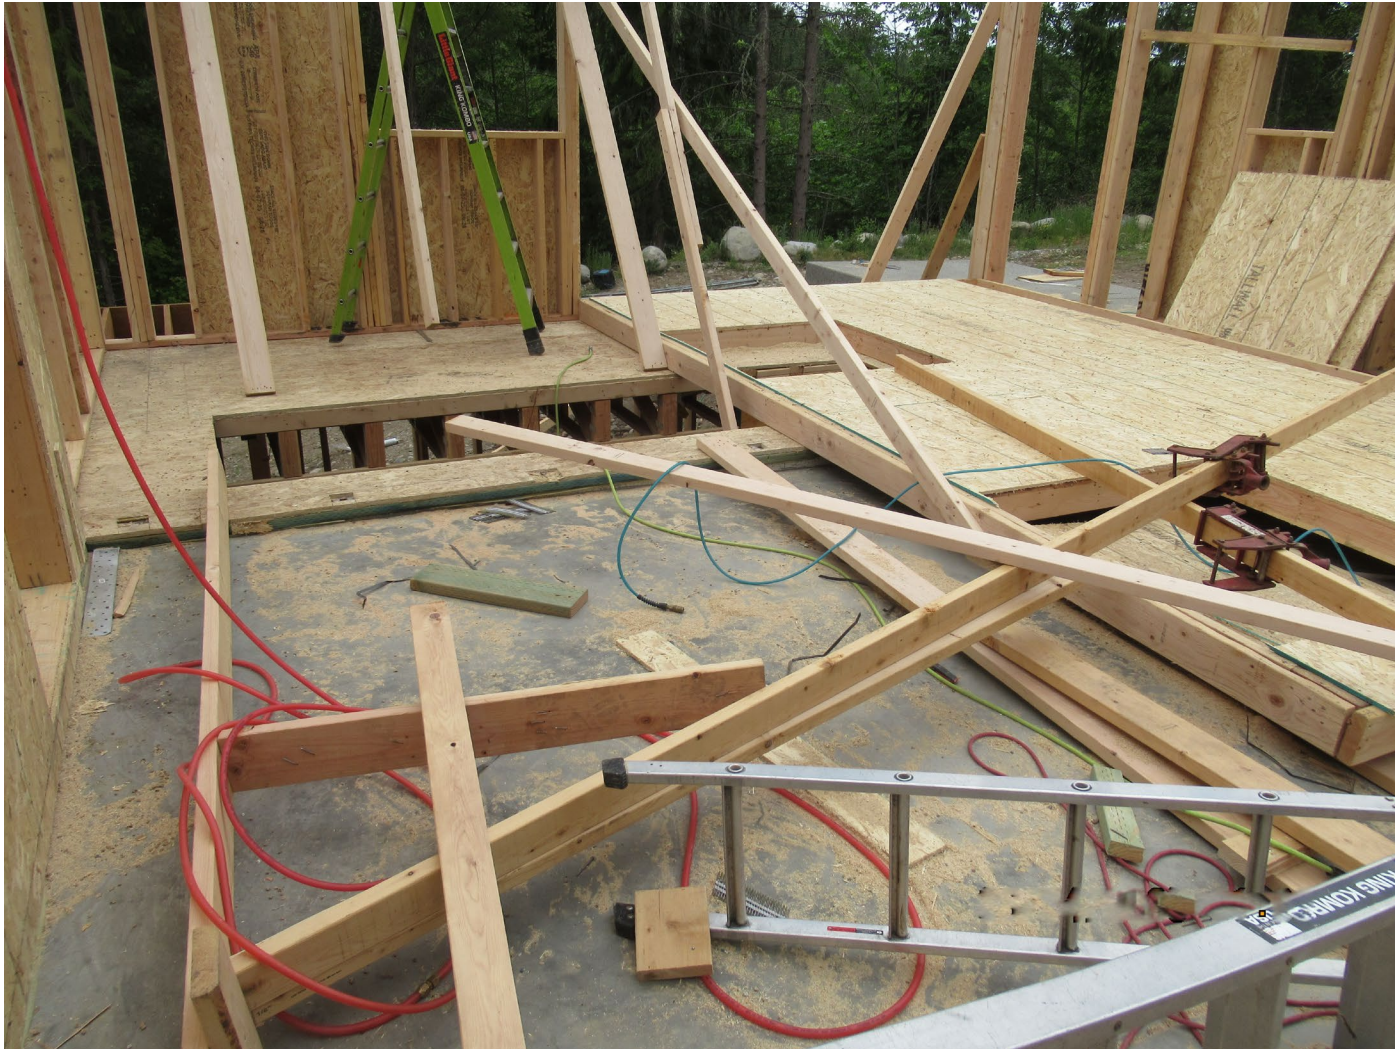
**Image 7.** Fallen wood bracing in work area where wall collapsed.

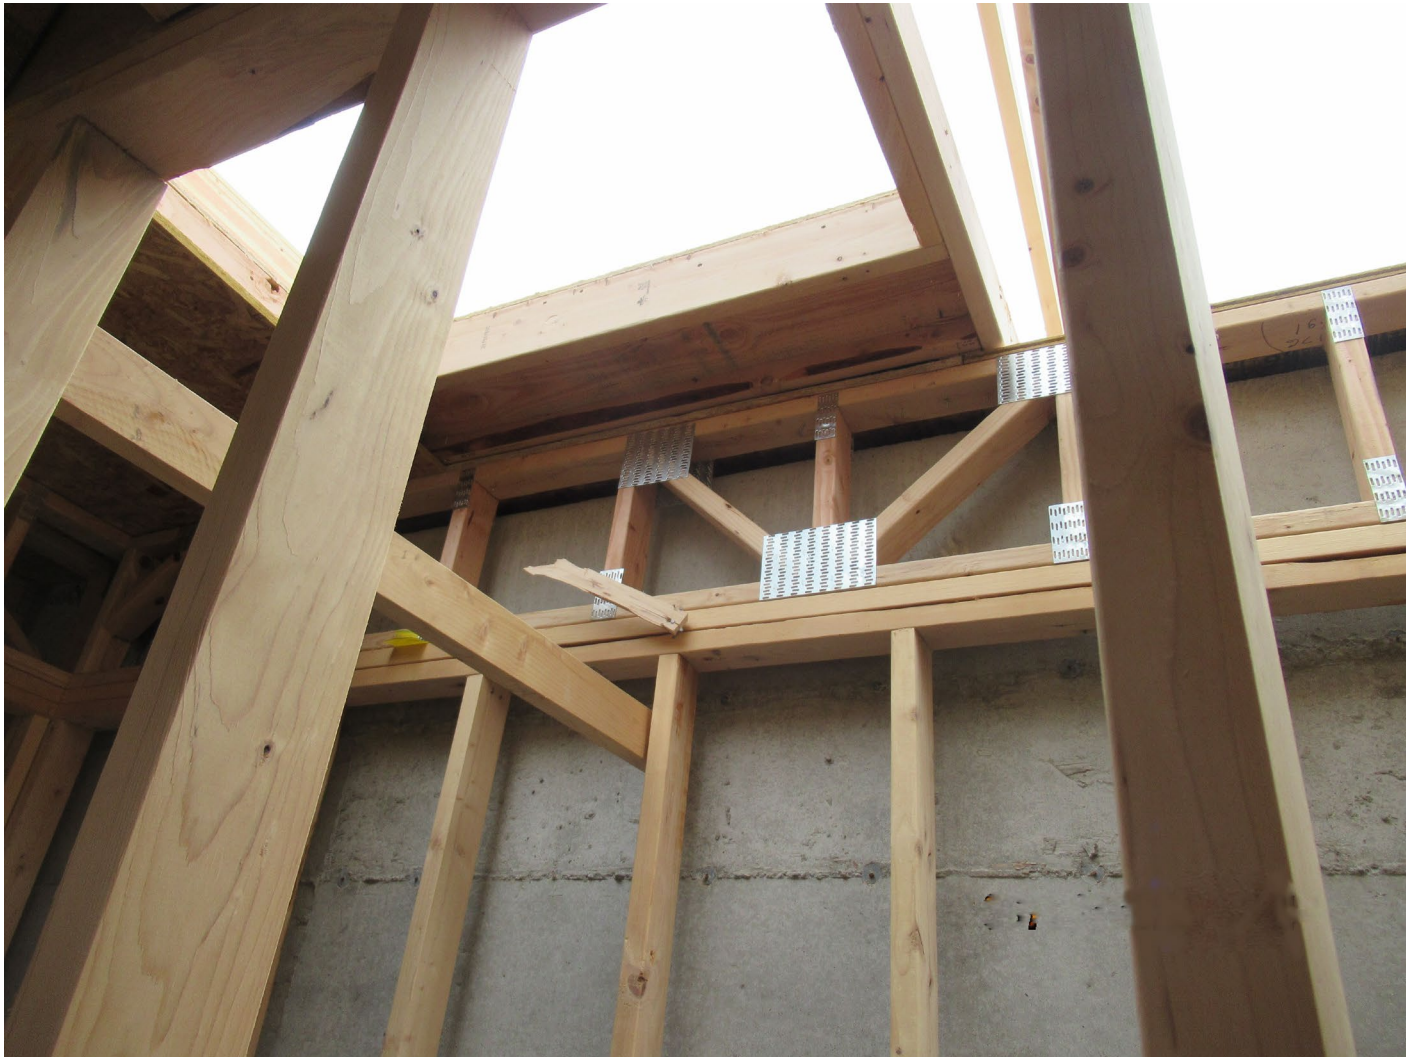
**Image 8.** View of floor opening from the basement.

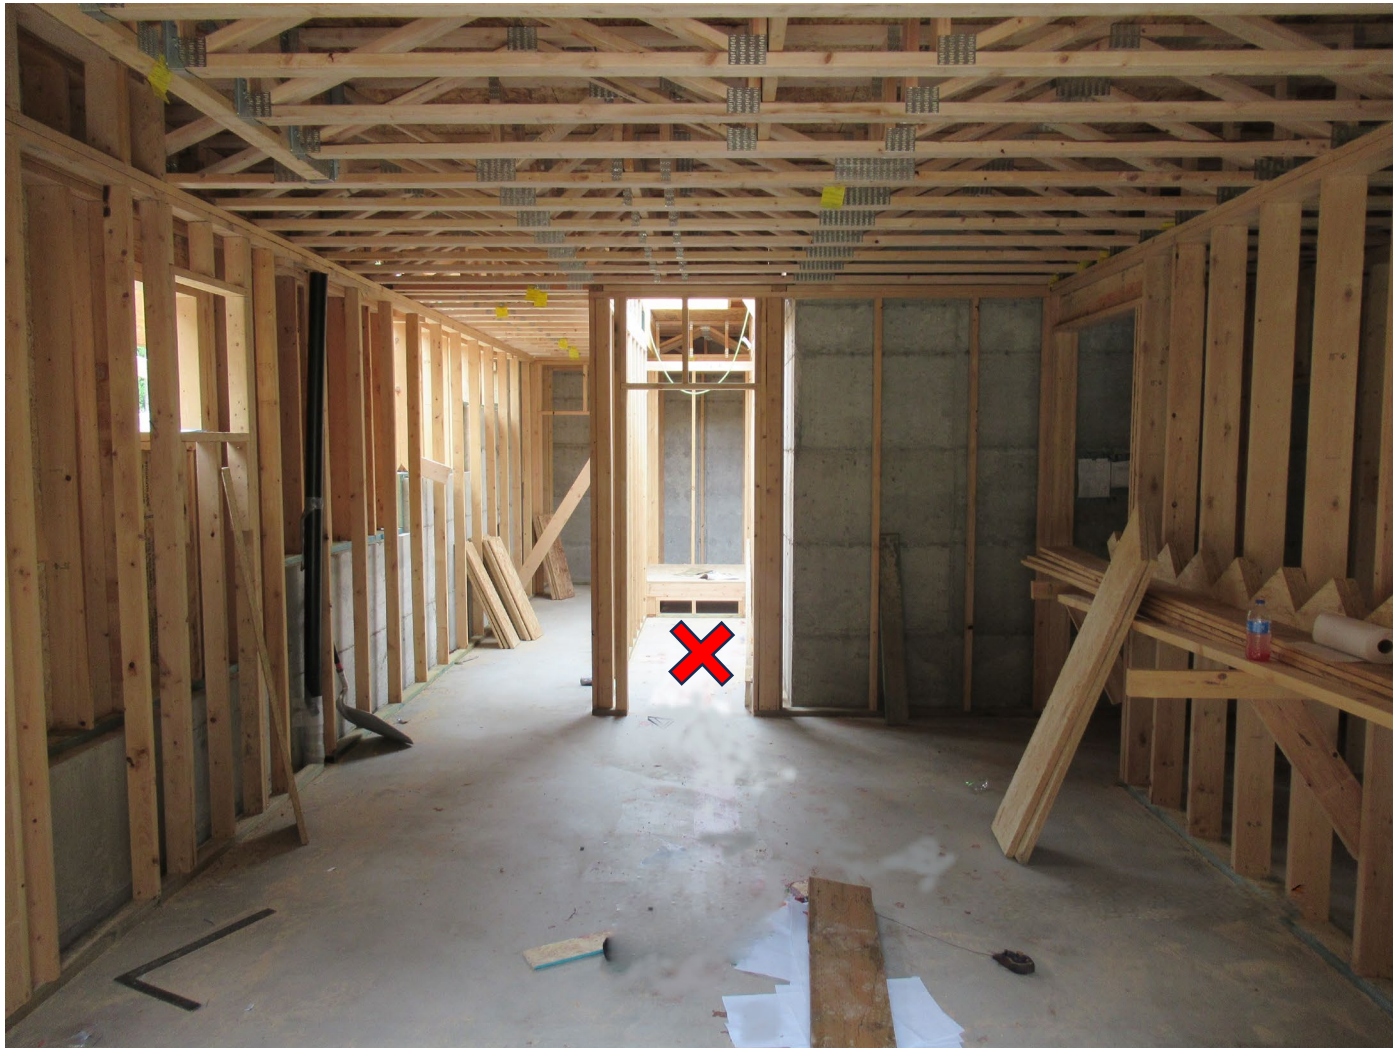
**Image 9.** X marks where framer fell. Co-workers brought him into the foreground area and began CPR.
