**REPORT #:**  
71-272-2025

## SERVICES FATALITY NARRATIVE

### Technician Killed When Tire Explodes

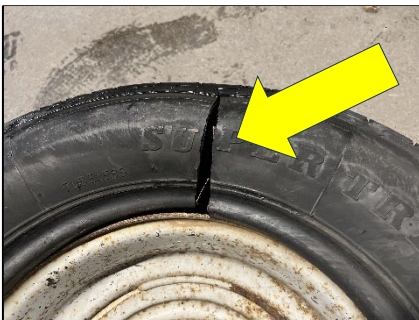
Ruptured sidewall on tire  
that exploded.

He leaned over the tire and began striking it with a mallet to seat the bead on the rim. The tire exploded, bursting from the bottom side. The explosion shot the tire and rim straight up into the technician's face, neck, and chest. It hit the ceiling 20 feet above the floor.

- The technician did not use a [tire restraining device](#), such as an OSHA-compliant [inflation safety cage](#), or secure the tire before inflating it. He inflated the tire above the manufacturer's maximum air pressure of 40 psi. The air compressor tank was at 130 psi and did not have a pressure regulator.
- The 14-inch tire and 14.5-inch rim were incompatible. The tire was 19 years old, and the bead seat of the rim was corroded.
- The employer did not have a written [accident prevention program](#) (APP) nor documented [training](#).

- Make sure workers follow these procedures for inflating single-piece rim wheels: **1)** Inflate tires only when contained within a restraining device or bolted on the vehicle with the lug nuts fully tightened; **2)** Make sure tires are not inflated when any flat, solid surface is in the trajectory and within one foot of the sidewall; **3)** Stay out of the trajectory when inflating a tire; **4)** Make sure, when inflating tires, that the inflation pressure stamped in the sidewall isn't exceeded unless the manufacturer recommends a higher pressure; and **5)** Make sure tires aren't inflated above the maximum pressure recommended by the manufacturer to seat the tire bead firmly against the rim flange. See [WAC 296-864-50020](#)

- **Provide training and certification.** Have new and experienced technicians attend reputable, hands-on comprehensive tire service and safety certification training. Keep training documented and current.
- **Demonstrate safety leadership.** Show technicians how to use the proper equipment and procedures. Proactive leadership inspires workers to uphold positive safety beliefs and practices.
