# State FACE™ Fatality Narrative

## Technician Killed When Tire Explodes

**REPORT #:** 71-272-2025s REPORT

**REPORT DATE:** November 20, 2025

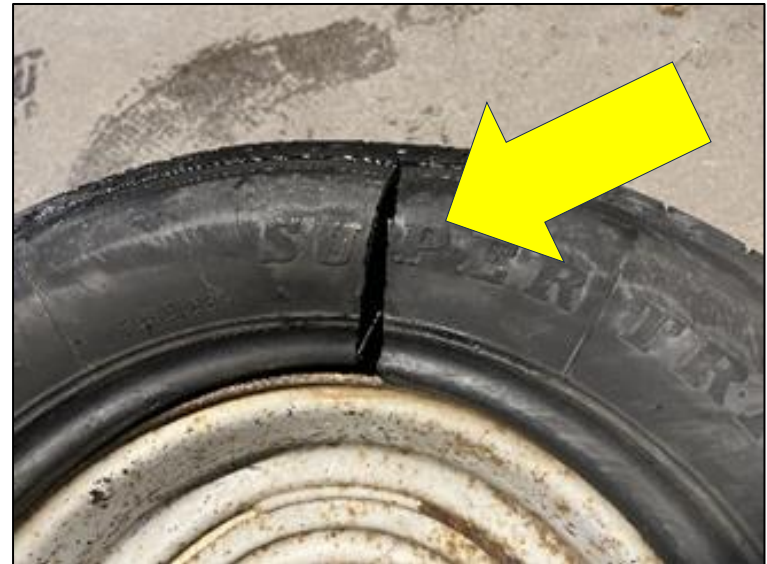
**Image 1.** Ruptured sidewall on tire that exploded.

- He leaned over the tire and began striking it with a mallet to seat the bead on the rim. The tire exploded, bursting from the bottom side. The explosion shot the tire and rim straight up into the technician's face, neck, and chest. It hit the ceiling 20 feet above the floor.
- The customer was also knocked on the floor by the explosion. When he looked up, he saw the technician lying on the floor badly injured and yelled for someone to call 911.
- Paramedics arrived in five minutes, but the technician stopped breathing when they began medical aid. The paramedics were unable to intubate or give him oxygen due to severe injuries to his face, neck, and throat.
- He was taken by ambulance to the hospital and stabilized there. He was later flown by helicopter to a trauma hospital, where he died the next day.

- Make sure workers follow these procedures for inflating single-piece rim wheels: 1) Inflate tires only when contained within a restraining device or bolted on the vehicle with the lug nuts fully tightened; 2) Make sure tires are not inflated when any flat, solid surface is in the trajectory and within one foot of the sidewall; 3) Stay out of the trajectory when inflating a tire; 4) Make sure, when inflating tires, that the inflation pressure stamped in the sidewall isn't exceeded unless the manufacturer recommends a higher pressure; and 5) Make sure tires aren't inflated above the maximum pressure recommended by the manufacturer to seat the tire bead firmly against the rim flange. See [WAC 296-864-50020](#)

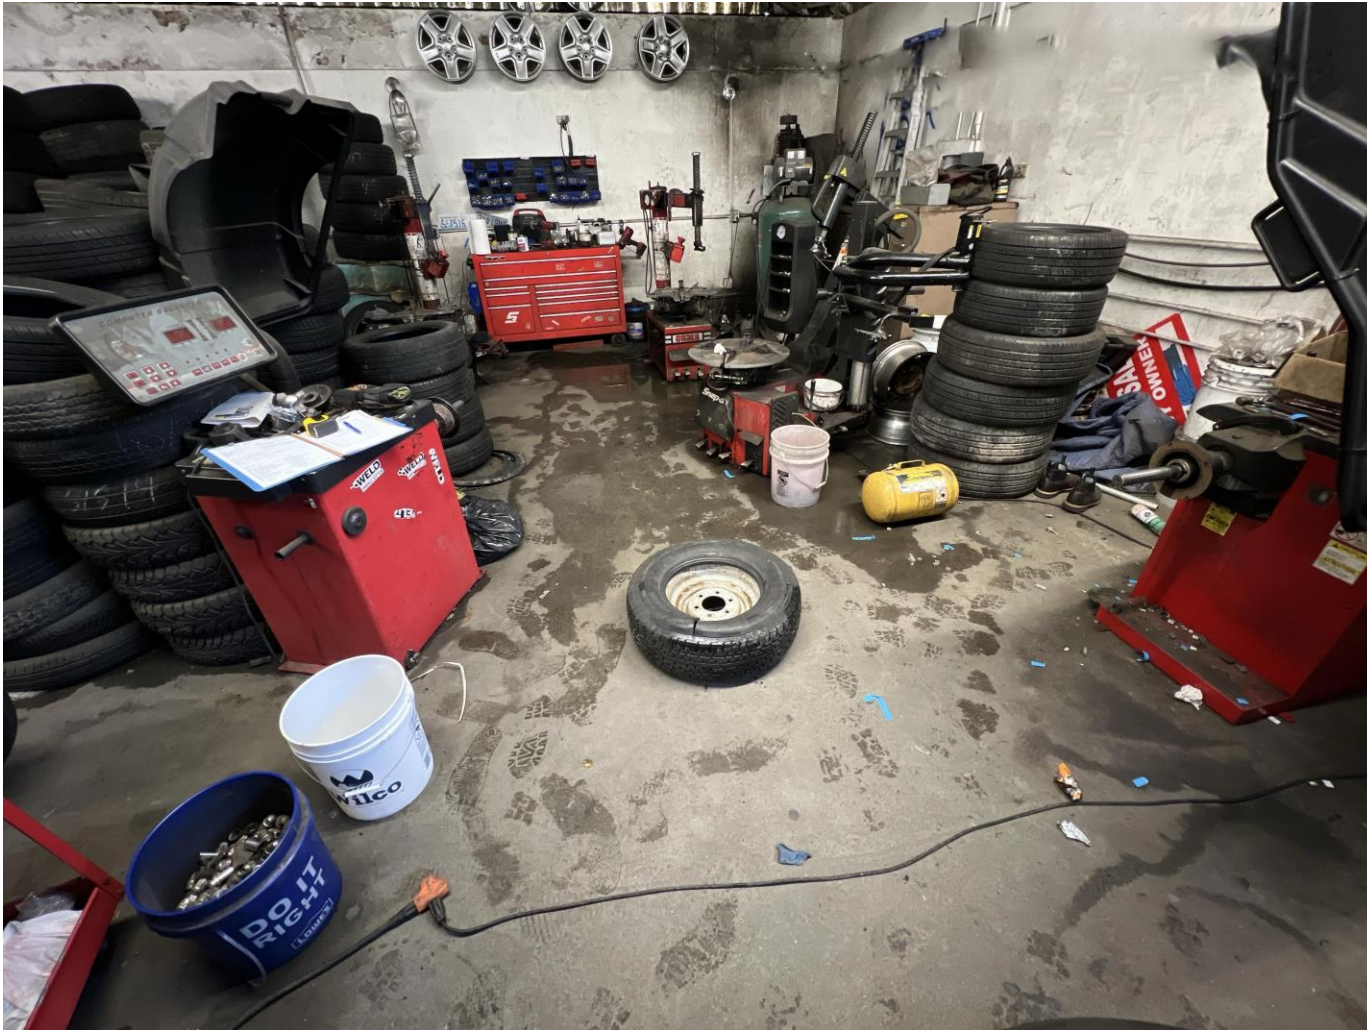
- The technician did not use a tire restraining device, such as an OSHA-compliant inflation safety cage, or secure the tire before inflating it. He inflated the tire above the manufacturer's maximum air pressure of 40 psi. The air compressor tank was at 130 psi and did not have a pressure regulator.
- The 14-inch tire and 14.5-inch rim were incompatible. The tire was 19 years old, and the bead seat of the rim was corroded.
- The employer did not have a written accident prevention program (APP) nor documented training.

**Image 2.** Service bay in tire shop where incident occurred.

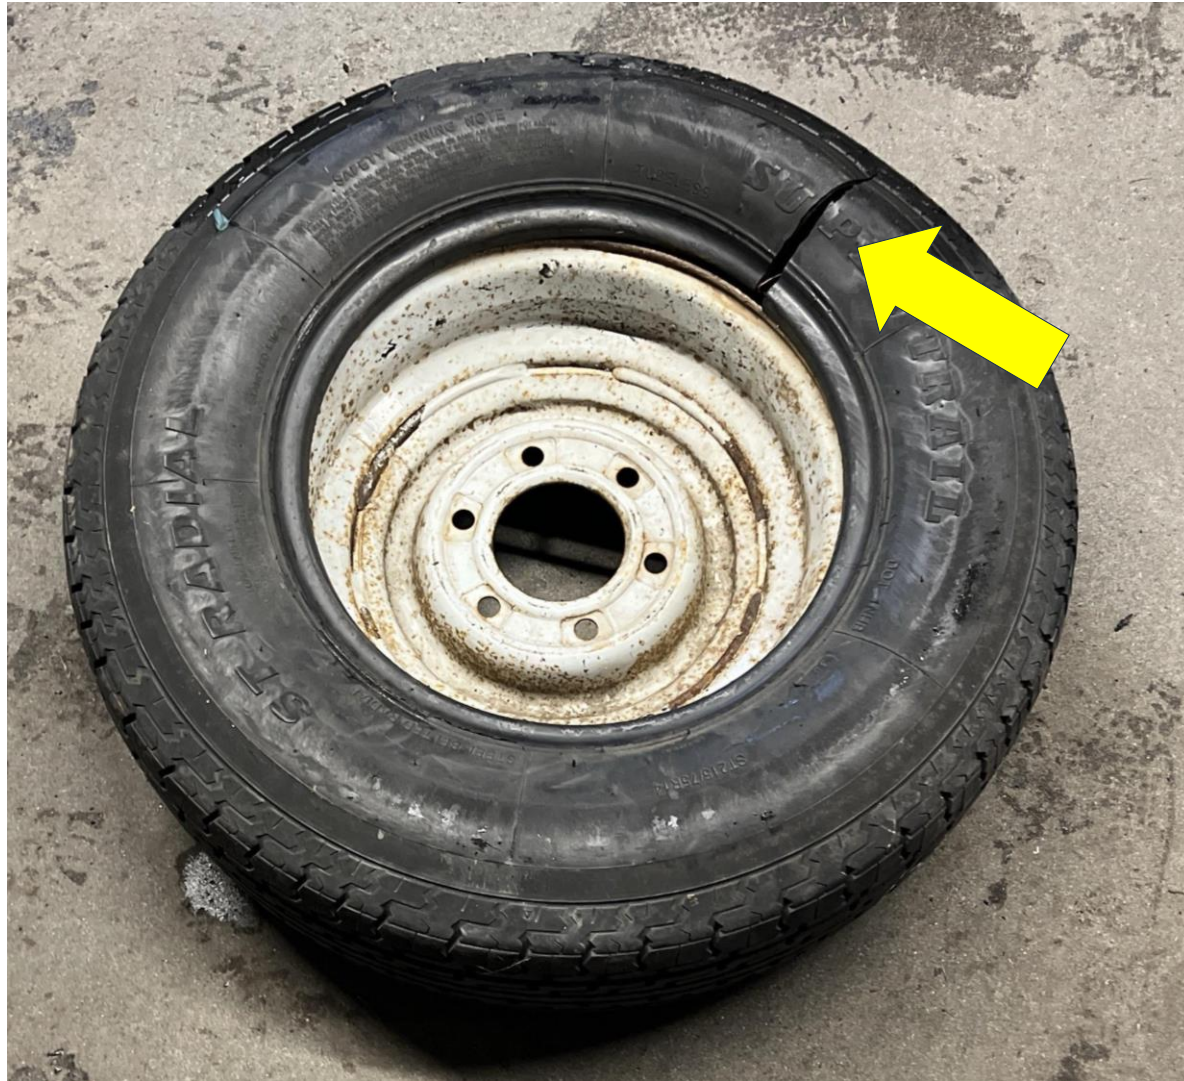
Image 3. Ruptured tire after explosion.

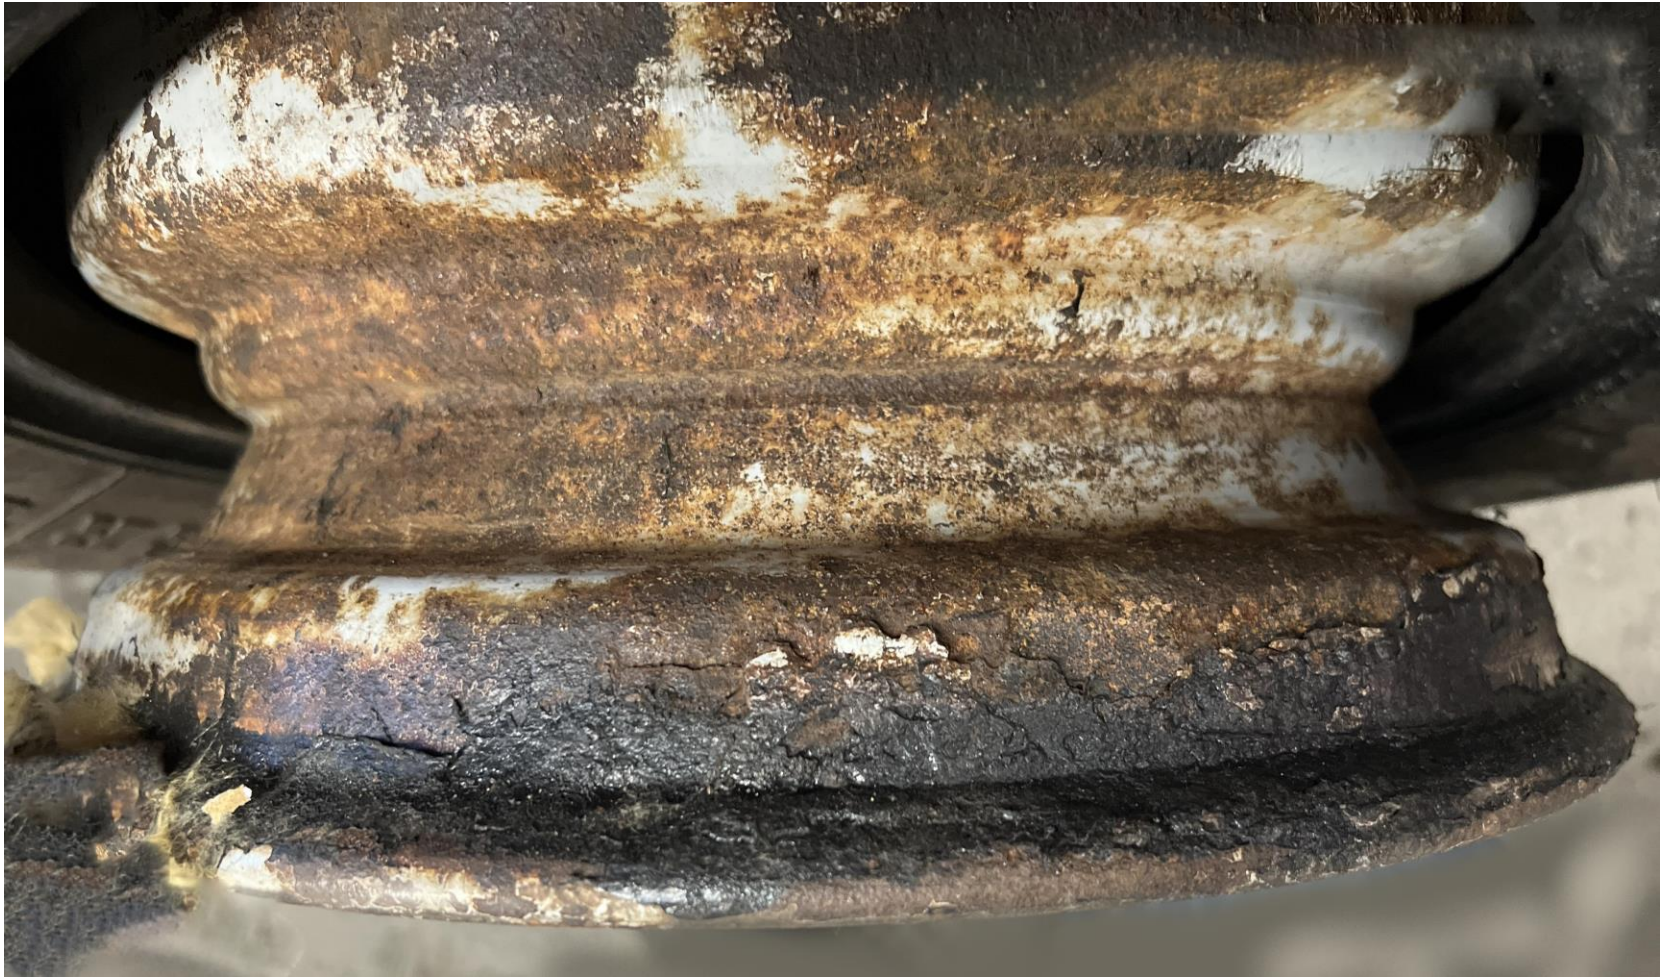
**Image 4.** Corrosion on tire rim and bead seat.

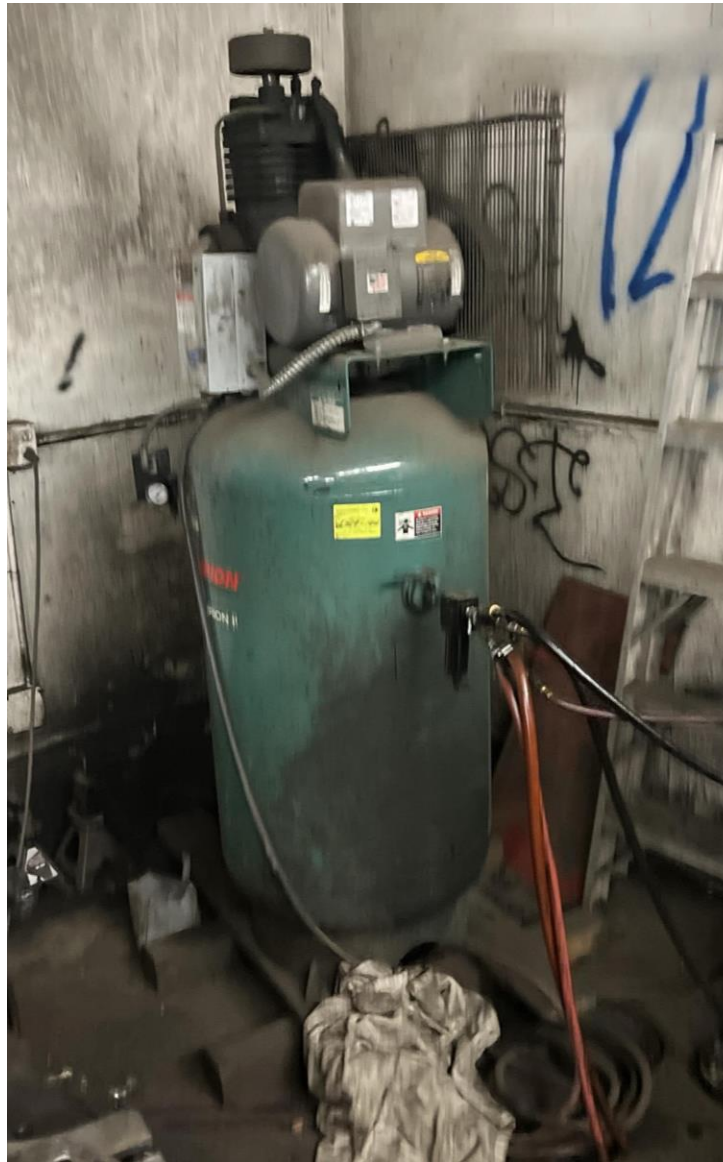
**Image 5.** Air compressor.
