Career Fire Captain Electrocuted After Contacting Overhead Powerline From the Platform of an Elevating Platform Fire Apparatus – Pennsylvania

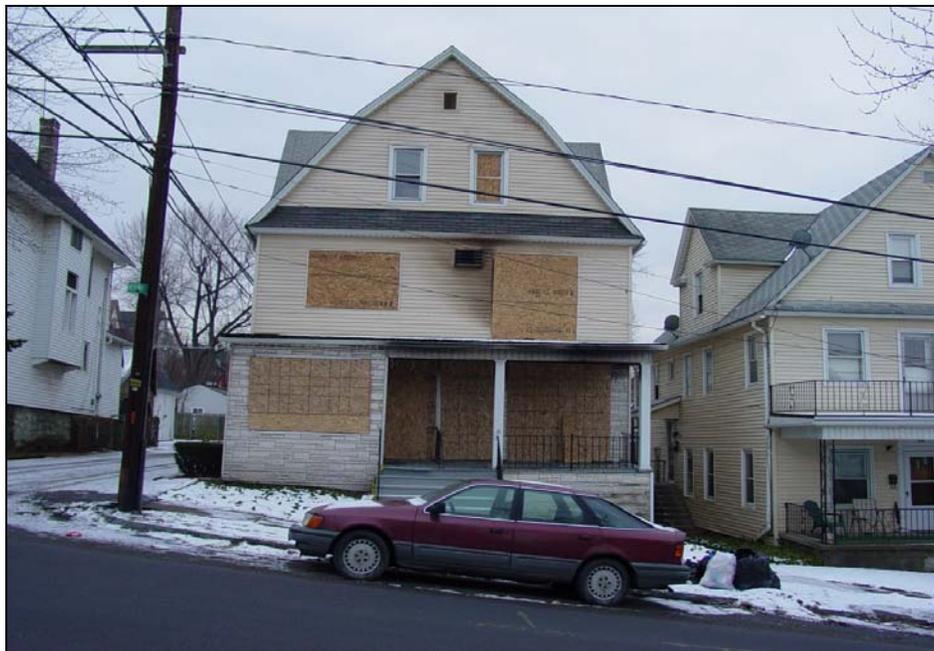
The fire building was a three-story residential house of wood frame construction that had been converted into three individual dwelling units, and was built sometime in the 1940's. The exterior consisted of aluminum siding, and asphalt shingles covered the roof. A three-phase 12,400-volt overhead powerline was located about 35-feet from the A-side of the structure and approximately 25-feet above ground level (see Photos 1 and 2).

R1's crew, being one of the first units to arrive on scene at about 0714 hours, gave a size-up of a three-story apartment building with heavy smoke showing (see Photo 1). Incident Command was established at the A-B corner of the fire structure, 1 ¾-inch attack hoselines were laid to the A-side of the structure, supply lines were stretched to the engines, and a water supply established. Forcible entry was made into the structure, and fire fighting and primary search activities commenced. Soon thereafter, fire fighters located an unconscious occupant inside the building on the second floor. The occupant was removed to the outside after the incident, and later pronounced dead at the scene by the local coroner. *Note: Sometime later in the incident, another occupant of the building was found on the second floor and also pronounced dead at the scene by the local coroner.*

Photo 1. Side-A of three story apartment building (incident scene).
(NIOSH photograph.)

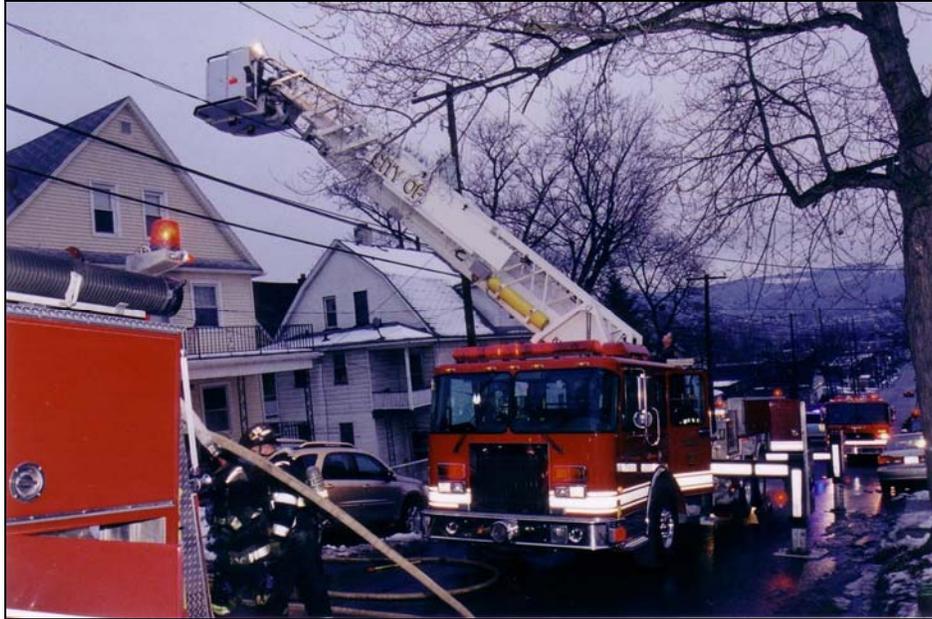
In this incident, a decision was made to ventilate the apartment building by using the elevating platform on T2 to gain access to the roof. T2 had been spotted in a position that required the aerial device to be maneuvered around a 12,400 volt powerline. Believing the powerlines had been de-energized the victim raised the elevating platform and extended it between the powerlines and communication lines. During this process, his neck and back came into contact with the energized powerline.

Photo 2. Truck 02 - 2002 model, 85-foot mid-mount, elevating platform.
(Photograph taken shortly after the incident occurred by off duty fire fighter Bill Boock.)

Recommendation #2: Fire departments should ensure that a distance of at least 10 feet (3 m) is maintained between aerial devices and overhead powerlines.

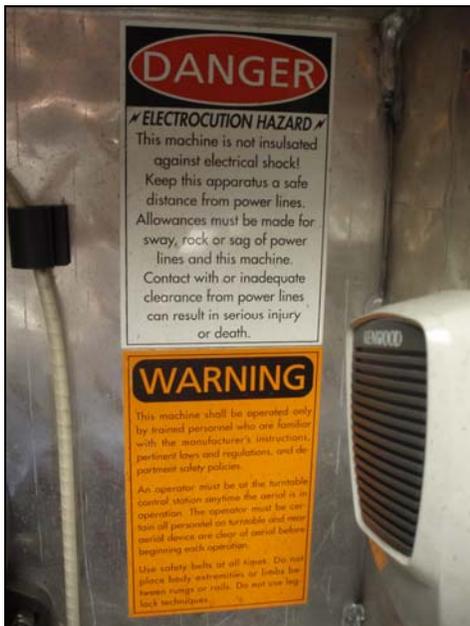
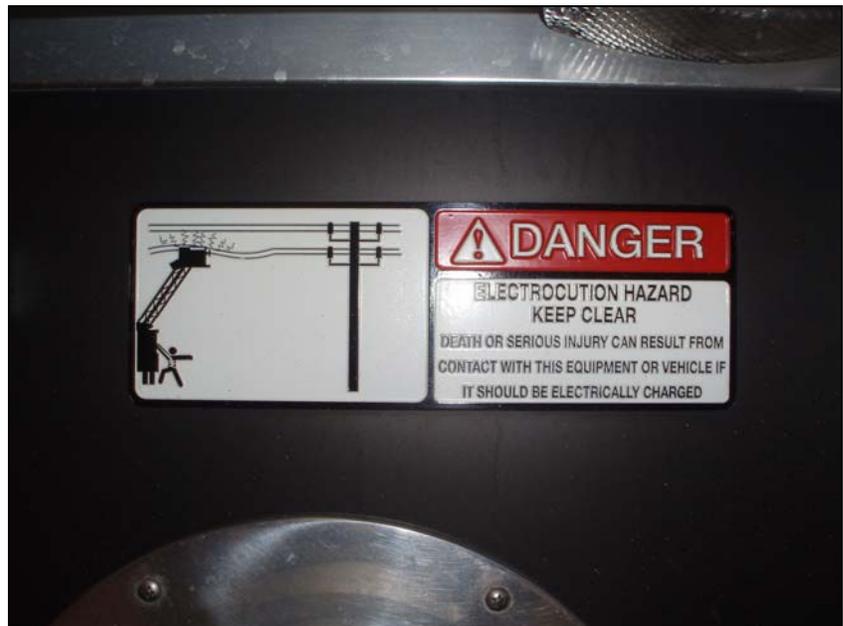
The apparatus involved in the incident (Truck 2) was a 2002 model, 85-foot mid-mount, elevating platform. Four warning signs were present on Truck 2. A sign was located on the turntable operator's controls cover and a similar sign was located on the back side of the platform. The signs stated – *Danger -Electrocution Hazard - This machine is not insulated against electrical shock! Keep this apparatus a safe distance from power lines. Allowances must be made for sway, rock or sag of power lines and this machine. Contact with or inadequate clearance from power lines can result in serious injury or death.* Also, a sign was located on the pump panel on both sides of the apparatus. The sign stated – *Danger - Electrocution Hazard - Keep Clear – Death or serious injury can result from contact with this equipment or vehicle if it should be electrically charged.* (See Photos 3 and 4).

Discussion: The following safety warning was printed in the manufacturer's "Trained Engineer's Manual" for operation of the elevating platform apparatus used at this incident: "Safety Warning! Avoid overhead electrical power lines! The aerial ladder is not insulated. If the ladder comes into close proximity/and or contacts any electrical power source, severe injury or death may occur to the Ladder Engineer, Ladder occupants, and possibly persons in close proximity to any part of the apparatus. Remember, the only safe power line is NO power line."¹⁰ In this incident, the fire department did not verify the utility company's report that the powerlines had been de-energized. Manufacturers' warnings for safe operation of equipment should always be followed.

Photos 3 and 4. Shown here are two of the four warning signs affixed to Truck 2.

Recommendation #6: Fire departments should follow apparatus manufacturers' safety warnings.

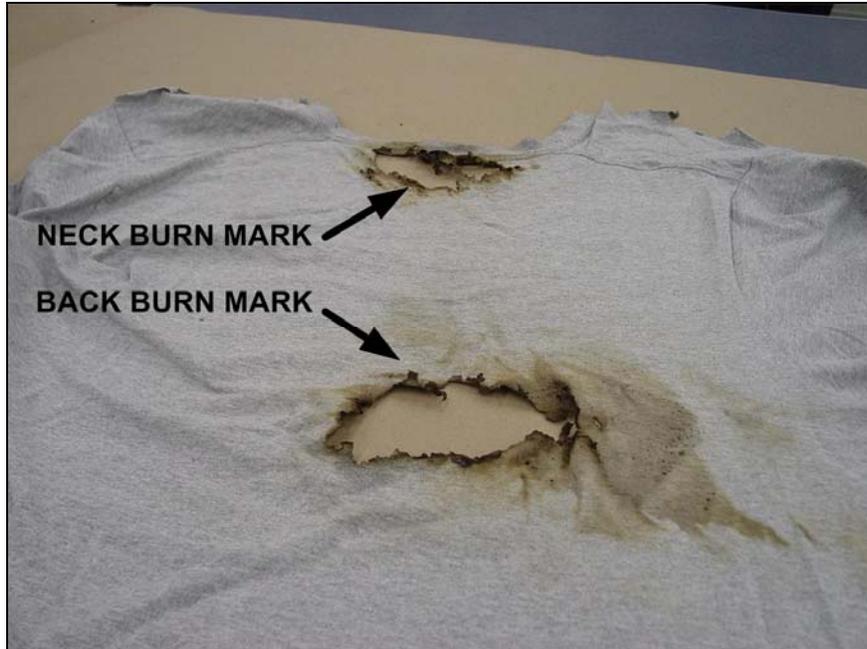
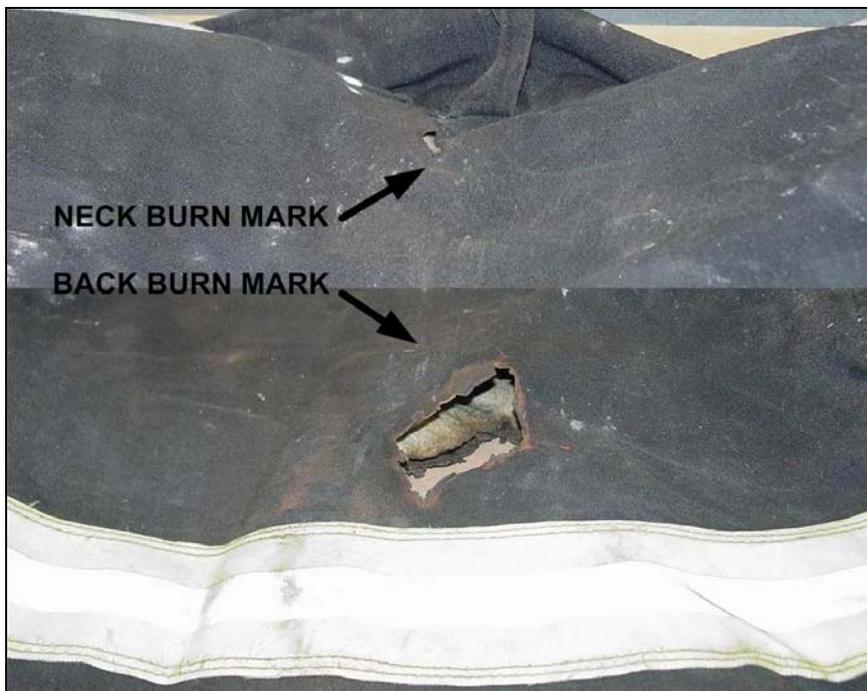
The victim instructed the fire fighter that they were going up in the platform. The victim retrieved a chain saw and he and the fire fighter climbed onto the platform of the elevating platform. Using the controls in the platform, the victim swung the platform out of its bed and toward the fire structure, and started extending the boom (see Photo 2). As the platform approached the overhead electrical wires, the fire fighter crouched down onto the platform and then heard an electrical arching (crackling) noise. The fire fighter looked up and saw a wire on the victim's back (see Photos 5 and 6). The arching stopped as the victim slumped down over the controls and fell back onto the platform.

The coroner listed the cause of death as electrocution.

NECK BURN MARK

BACK BURN MARK

**Photos 5 and 6. Victim's T-shirt and bunker jacket with burn marks on the neck and back area from contact with the energized electrical powerline.
(NIOSH photographs.)**

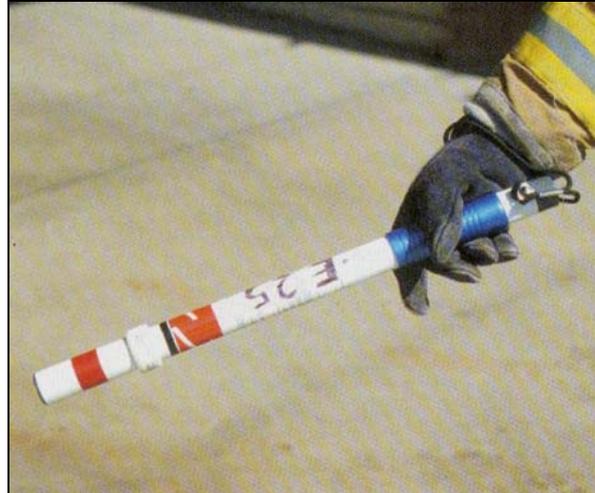
Discussion: Written standard operating guidelines (SOGs) or standard operating procedures (SOPs) enable individual fire department members an opportunity to read and maintain a level of assumed understanding of operational procedures. Fire departments can suffer when there is an absence of well developed SOGs or SOPs. The NIOSH Alert: “Preventing Injuries and Deaths of Fire Fighters” identifies the need to establish and follow fire fighting policies and procedures.¹ Guidelines and procedures should be developed, fully implemented, and enforced to be effective. Periodic refresher training should be provided to assist fire fighters in remembering and understanding departmental guidelines and procedures. These SOGs or SOPs should include hazardous energy control procedures. The use of alternating current detectors to verify that powerlines are de-energized should be included in any hazardous energy control procedures developed by fire departments. *Note: Alternating current (AC) detectors can detect unshielded AC through snow, ice, and many solid objects. These battery-operated devices are handheld wands similar in size and shape to a police officer’s baton. In the presence of an AC, they emit an intermittent beep. The more rapid the beep, the closer the source is. The detection range (distance from the source at which the wand detects the current) varies with the situation. In general, the higher the voltage, the greater the ranges will be² (see Photo 7).*

Photo 7. Alternating current detector.
(Photograph courtesy of the International Fire Service Training Association.)

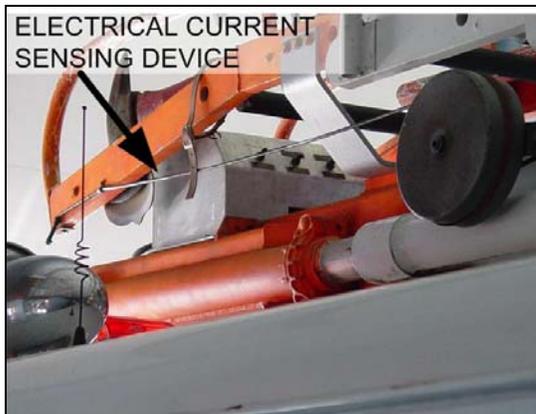
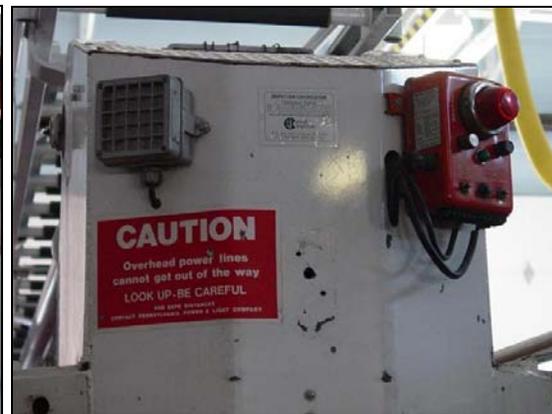
Discussion: Proximity warning devices are used to detect the electrostatic field of any alternating current (AC) power line. They provide both audible and visual warning signals to alert the operator and attendant or ground personnel when the boom comes within the proximity of an energized high-voltage power line.⁹ These devices can help verify that lines are de-energized (see Photos 8, and 9).

Photos 8 and 9. Example of proximity warning device used on aerial ladder truck at neighboring fire department. Photos left to right – electrical current sensing device, and alarm and control box.
(Photographs courtesy of neighboring fire department.)

Recommendation #5: Fire departments should use proximity warning devices to detect electrical current when working near exposed potentially energized parts (e.g. overhead powerlines) as a secondary/redundant means of protection.
