# **WORKER DEATHS IN CONFINED SPACES**

## **A Summary of NIOSH Surveillance and Investigative Findings**

**U.S. DEPARTMENT OF HEALTH AND HUMAN SERVICES**  
Public Health Service  
Centers for Disease Control and Prevention  
National Institute for Occupational Safety and Health

**DHHS (NIOSH) Number 94-103**

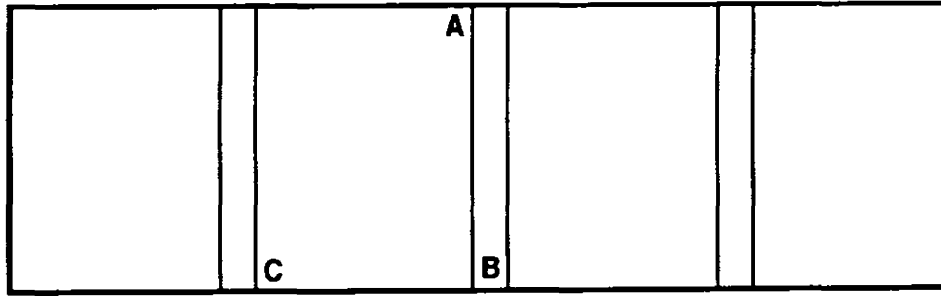
**BAFFLE AREAS**

Discussion: This incident emphasized the need to address all of the potential hazards in confined spaces. Locating the clogged baffle drain before entering the tanker compartment allowed the baffle to be drained of trapped chemicals. However, if the clogged drain had not been located, the concentration of chemical vapors in the tanker compartment may have been sufficient to place both the victim and the assistant in an oxygen deficient or toxic environment. The need to inform employees about the hazards of confined spaces in all respects should be a priority of the employer. Information concerning confined space entry procedures is available from various NIOSH documents including:

A. Location of leak.

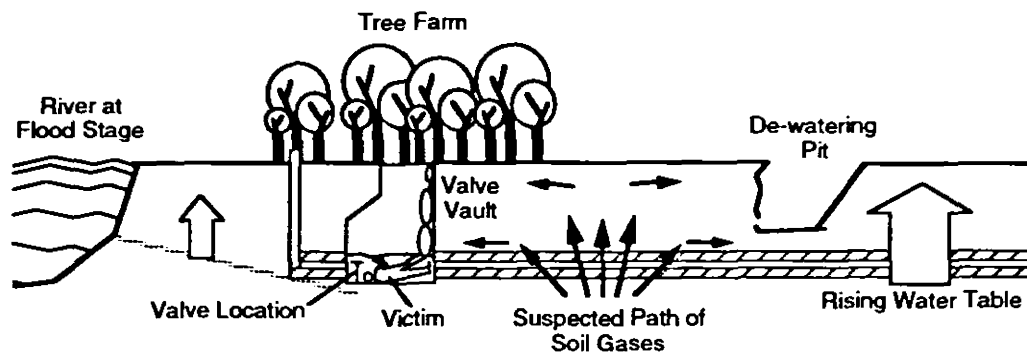
(Figure, FACE 91-17)

- c. the rising water table forced gases and liquids normally trapped deep within the surrounding soils toward the surface;
- d. the clay soils and sands used by the municipality for the surface of the valve vault field inadvertently formed a seal, or cap, forcing the gases and liquids to flow into the only two openings into the ground, the valve vault and a sewage dewatering pit (Figure);

- e. the soil gases (carbon dioxide, methane, and hydrogen sulfide) entered the valve vault through the drain hole in the center of the concrete floor and possibly through the joints between the sections of preformed concrete pipe forming the walls of the valve vault; as gases filled the valve vault, they displaced oxygen to below the minimal level to support human life; the victim lost consciousness upon entering the oxygen-deficient environment.

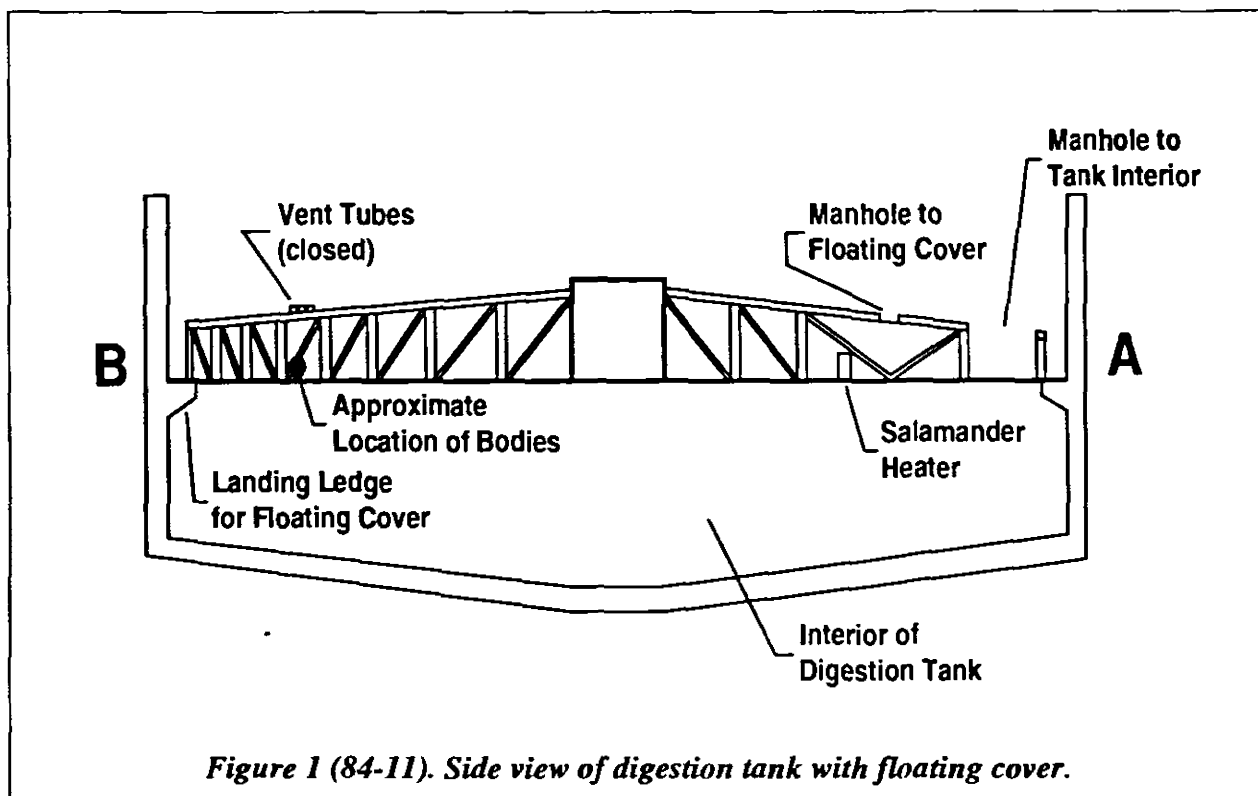
*Figure 1 (84-11). Side view of digestion tank with floating cover.*

Future efforts should evaluate the feasibility of designing and/or providing automatic pilot valves whose reset buttons cannot be intentionally or unintentionally made inoperative.
