Decontamination of a Centrifuge After a Rotor Explosion

FREDERICK SCHAEFER, BS
DANIEL LIBERMAN, PhD
RICHARD FINK, BS

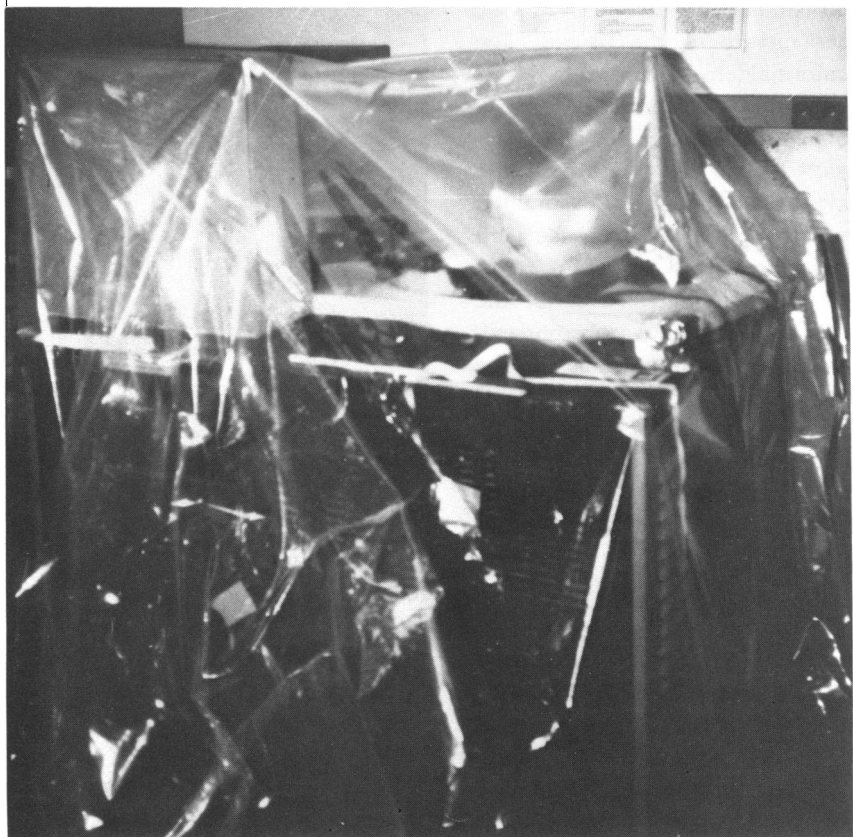
Figure 1. Canopy with electric frying pan in place

A protocol based on the procedure for the decontamination of a biological safety cabinet was used (4). A canopy of 4 mil polyethylene sheeting was constructed over the centrifuge (fig. 1). To make a gas-tight, leak-proof enclosure, the canopy was sealed to the floor with 3-inch duct tape (fig. 2). All seams in the plastic were sealed with duct tape. In this procedure, formaldehyde gas is generated from paraformaldehyde flakes. If this decontaminant is to be effective, the relative humidity must be raised above 60 percent (5); this was accomplished by boiling water in a frying pan placed under the canopy until condensation appeared on the inner surface of the plastic. The paraformaldehyde was then vaporized by the heat from a second frying pan containing 0.3 gram per enclosed cubic foot of air under the enclosure. In this case, we estimated the volume to be 56 cubic feet and therefore used 18 grams of paraformaldehyde flakes. After all the paraformaldehyde was vaporized, both electrical connections for the frying pans were disconnected and the canopy was kept sealed for 1 hour. The use of formaldehyde gas as a fumigant has been proved effective against bacteria, bacteriophages, and viruses (5).

is contrary to the operational instructions that were clearly posted on the wall above the centrifuge (fig. 1). These instructions indicate that the operator must be present until the desired speed is obtained. If the technician had been present she may have seen that the rotor had exceeded 17 or 19 krpm and corrected the situation. If the technician had not noticed the overspeed condition, she could have been seriously injured.

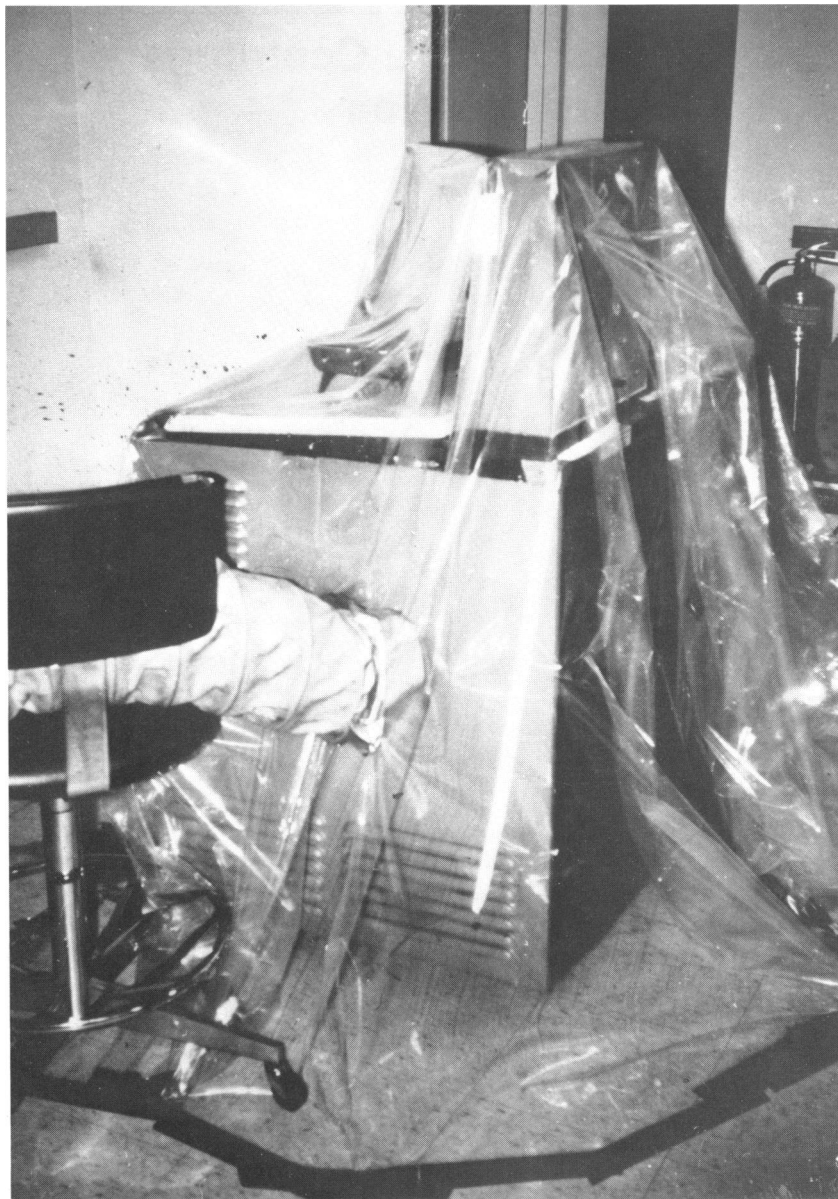
Figure 2. Exhaust connection and sealed canopy

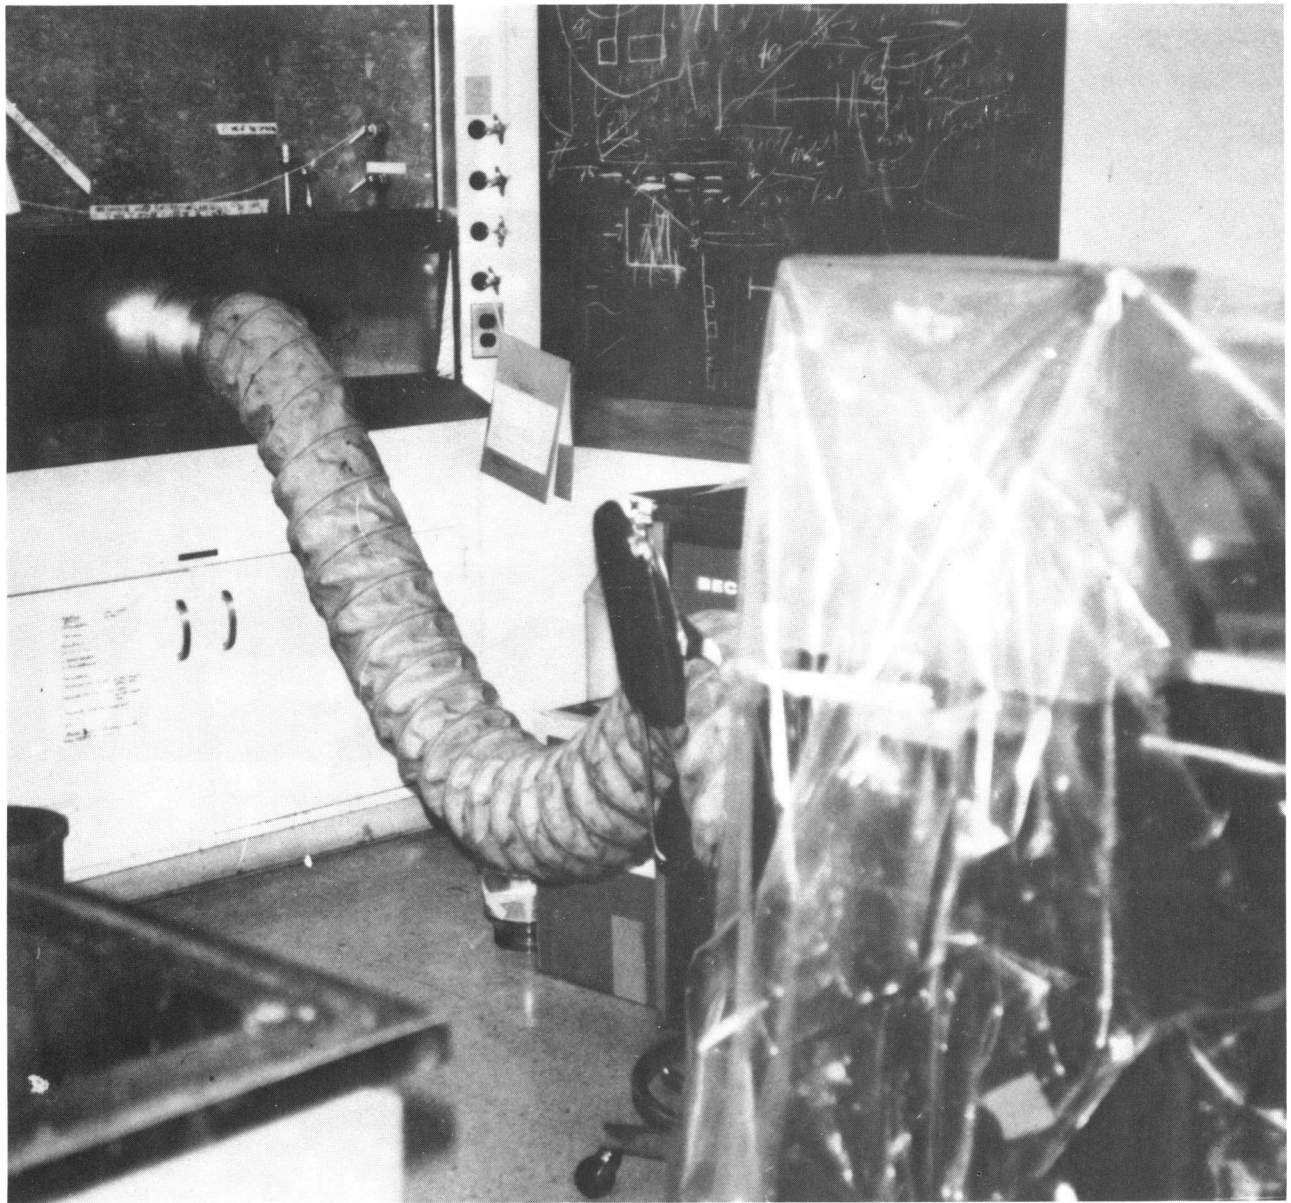
The canopy was then ventilated. The exhaust ventilation was provided by a laboratory fume hood with a face velocity of 119 linear feet of air per minute. A 10-foot length of 8-inch diameter flexible duct was attached to a galvanized sheet-metal flange fabricated to fit the front opening of the fume hood

(fig. 3). The canopy was removed after 20 hours of exhaust ventilation.

Figure 3. Exhaust connection to fume hood

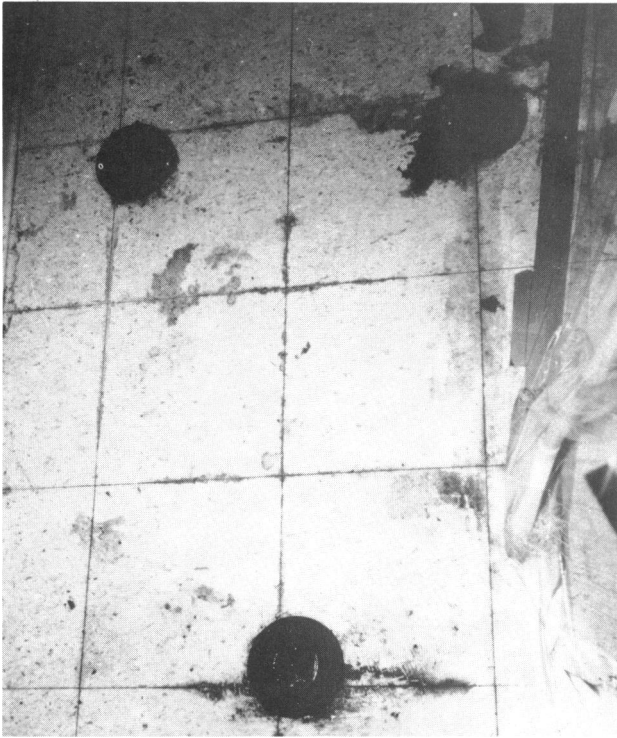
1. The force of the explosion was so extensive that the centrifuge was lifted from its leveling stabilization footings (fig. 4), turned 180°, and moved about 4 feet.

Figure 4. Leveling-stabilization footings

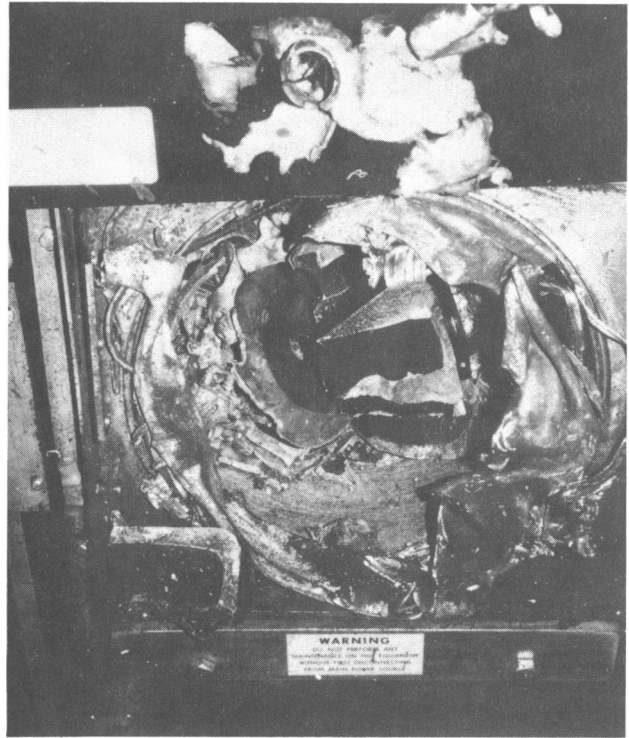
2. The centrifuge rotor and chamber were destroyed (figs. 5, 6, and 7). The white object in figure

- 5 is what remained of a centrifuge bottle. Close examination revealed that the rotor overspeed safety pins had been removed before the equipment was used (fig. 7).

Figure 5. Centrifuge chamber and bottle

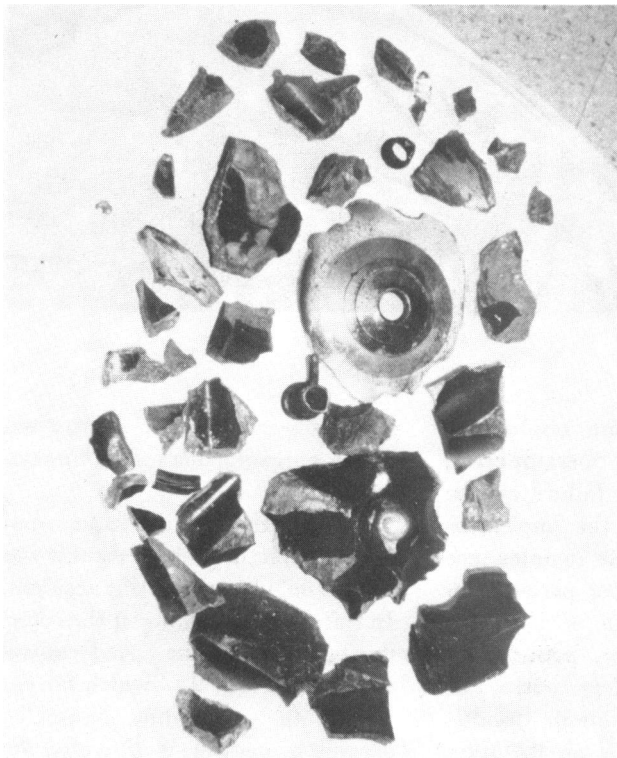
Figure 6. Pieces of exploded rotor removed after decontamination

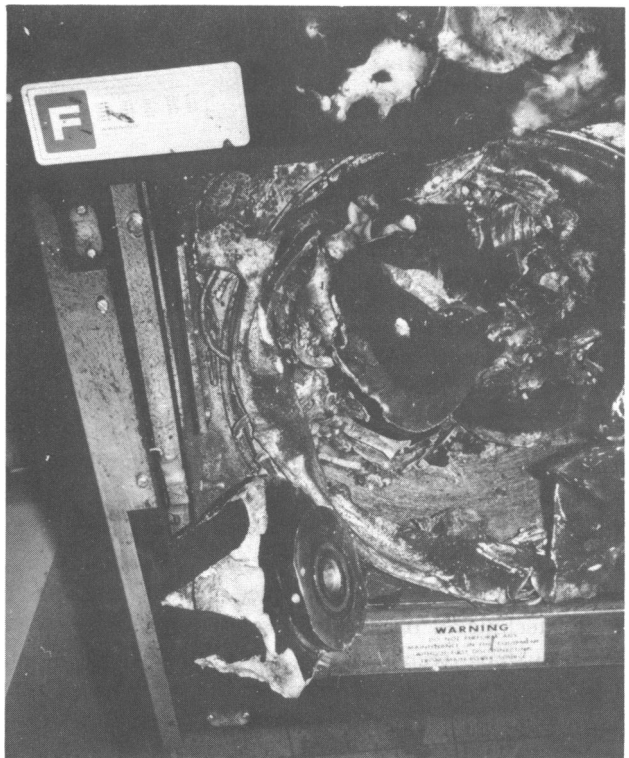
Figure 7. Base of rotor, with overspeed safety pin removed, and centrifuge chamber

moved from this rotor (fig. 7), and the rotor and centrifuge were purchased before the overspeed decal system was implemented by the Beckman Company.

Centrifuge accidents result from equipment failure or operator error, or both. Equipment failure can be minimized through the implementation of a preventive maintenance program that includes periodic inspection and service of both the centrifuge and rotor, periodic inspection of rotor safety control elements (overspeed pins or decals), and accurate records on the rotor used. While operator error can be reduced by adequate supervision,

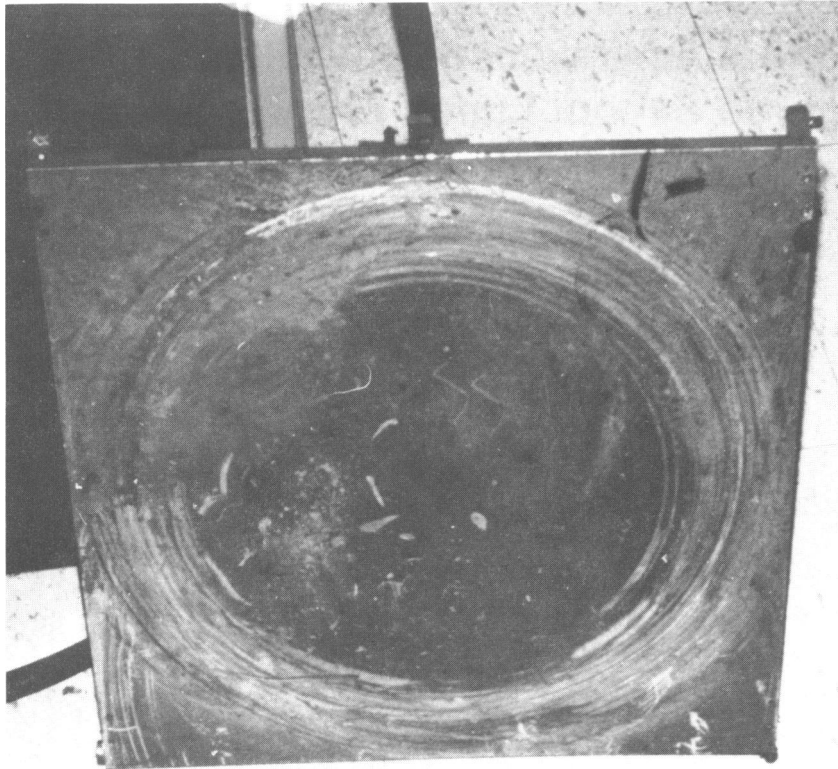
3. The force of the explosion blew the half-inch stainless steel door from its support tracks and bent it slightly (fig. 8).

Figure 8. Centrifuge chamber cover

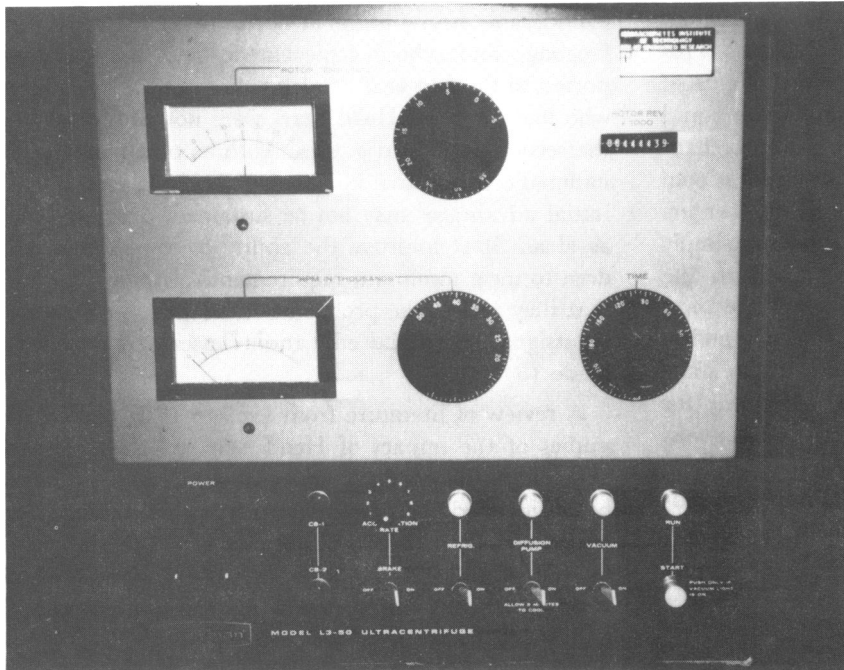
In this situation, the sequence of events was so improbable that it was not possible to predict this accident. In spite of the derating of the rotor, the operator set the speed control at 41 krpm (fig. 9)—which far exceeded the maximum. Normally, overspeed control is provided by speed control pins or decals. Unfortunately, the pins had been re-

Figure 9. Control pan Model L3-50 Ultracentrifuge; speed control knob is set at 41 krpm
