Analysis of extensometer, photogrammetry and laser scanning monitoring techniques for measuring floor heave in an underground limestone mine

B.A. Slaker and M.M. Murphy

Mining engineer and mining engineer, respectively, National Institute for Occupational Safety and Health, Pittsburgh, PA, USA

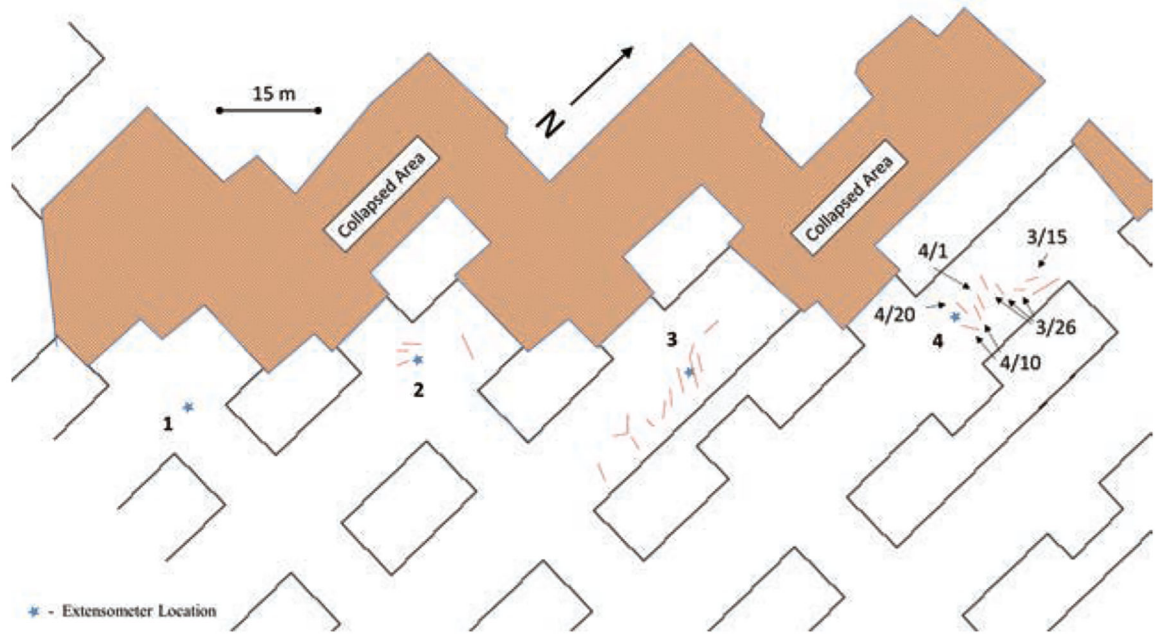
The instrumentation consisted of four roof-to-floor string potentiometers, hereafter referred to as extensometers, installed near four separate intersections following the N35°E trending roof collapses, shown in Fig. 1. The extensometers were anchored to roof bolt plates using a strong magnet and anchored to the floor by a weighted metal plate. Each extensometer was wired into a MIDAS data logger (Jones, 2012) where a measurement was recorded once every hour. Extensometers #1 and #2 were proactively placed in intersections that had no visible cracking, but were expected to heave if the failures progressed. Extensometers #3 and #4 were placed approximately 6.1 m (20 ft) and 15.2 m (50 ft), respectively, outby the first observed cracks, anticipating the heave would progress down the entry. An example of the extensometer placement with a nearby floor crack is shown in Fig. 4. An orange spray paint was initially used to mark visible floor cracks, and as the cracking progressed, the extensometers were placed near the cracks that appeared to show the most movement.

Figure 1 -
Extensometer locations, shown as blue stars, along with crack locations and orientations, shown as red lines, and the dates they were first observed.

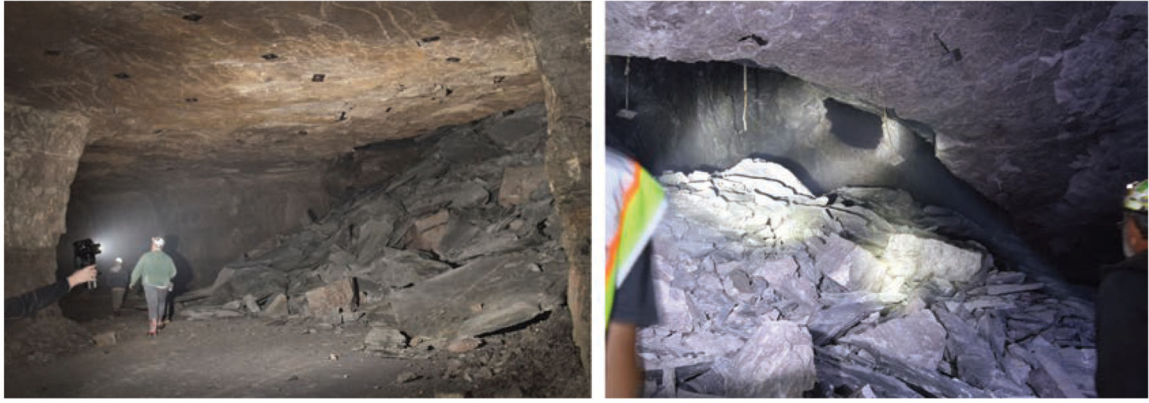
The roof collapses near the studied area began to occur in entry 2 (Fig. 1) on Feb. 24, 2016. It then moved to entry 1, followed by entry 3 and then entry 4, progressing through all four in less than a month. The crosscut floor in the collapsed zone between entries 5 and 6 was observed to have heaved an estimated 15.2 to 25.4 cm (6 to 10 in.) several days prior to failure of the roof. The failures, visible in Fig. 2, eventually extended upward to the overlying Lower Kittanning coal seam.

Figure 2 -
Roof collapse area.

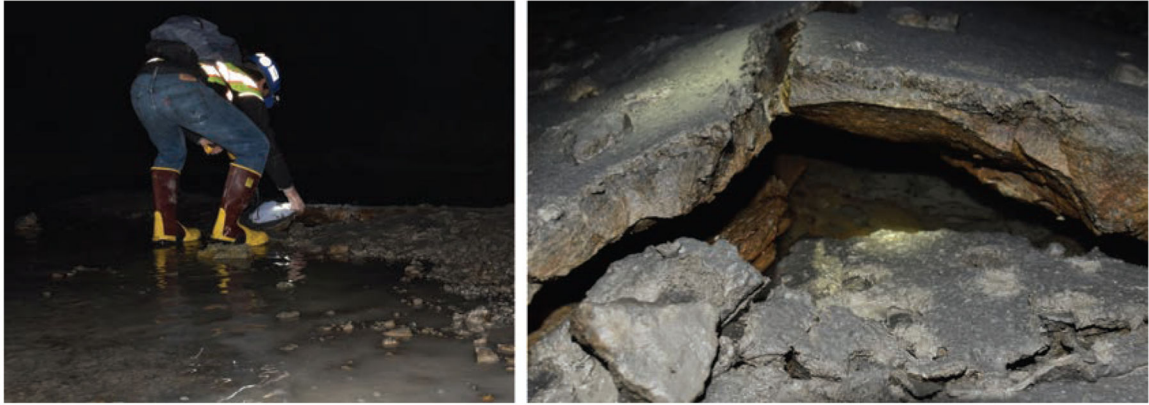
In addition to the roof collapses, observable floor heave, shown in Fig. 3, was present near the unstable sections of the mine. This floor heave was of particular interest because it was the most visible manifestation of the horizontal stress before roof failure renders an area inaccessible. Previous research by the U.S. National Institute for Occupational Safety and Health (NIOSH) found the maximum horizontal stress to be in the N-S direction (Ellenberger and Miller, 2012), rather than the N50–80°E direction indicated by the World Stress Map (Mark and Gadde, 2008; Zoback and Zoback, 1989).

Figure 3 -
Floor buckling.

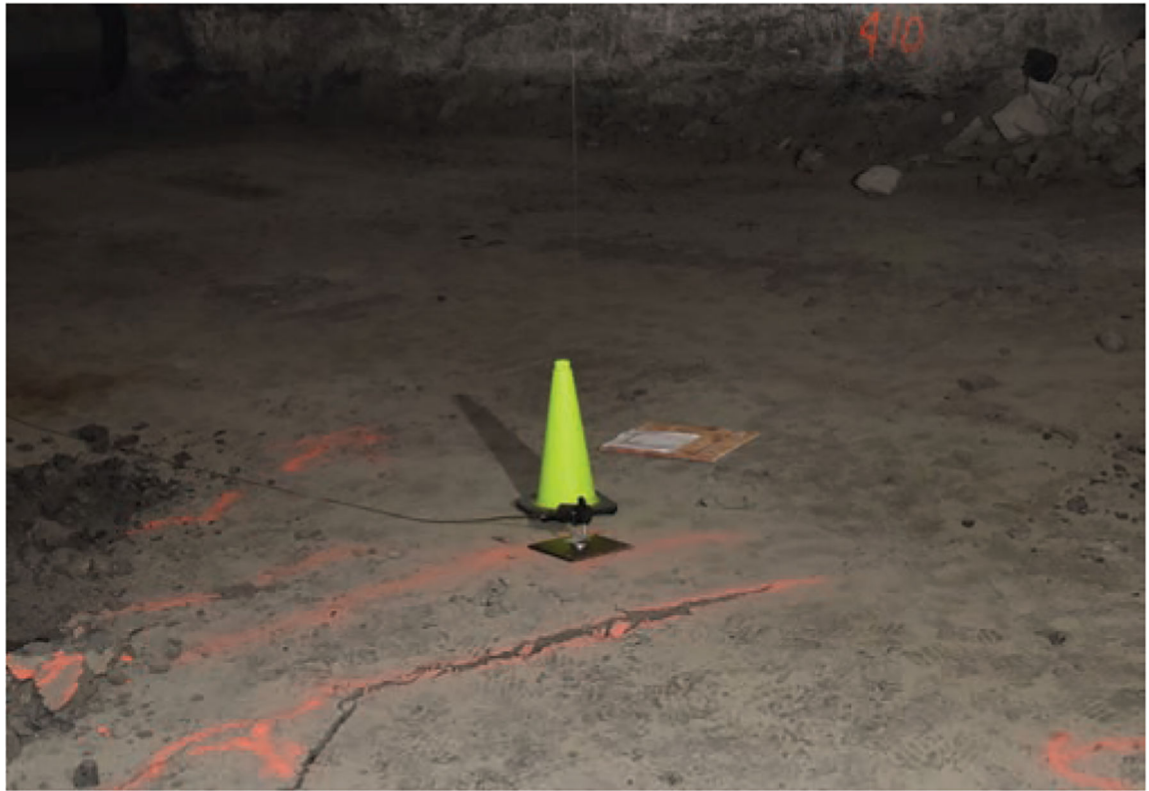
- Development of a crack near extensometer #3 where one side lifted up away from the other, creating a roughly 2.5-cm (1-in.) vertical difference between the sides.

Figure 4 -
Extensometer #3 located near a previously observed floor crack.

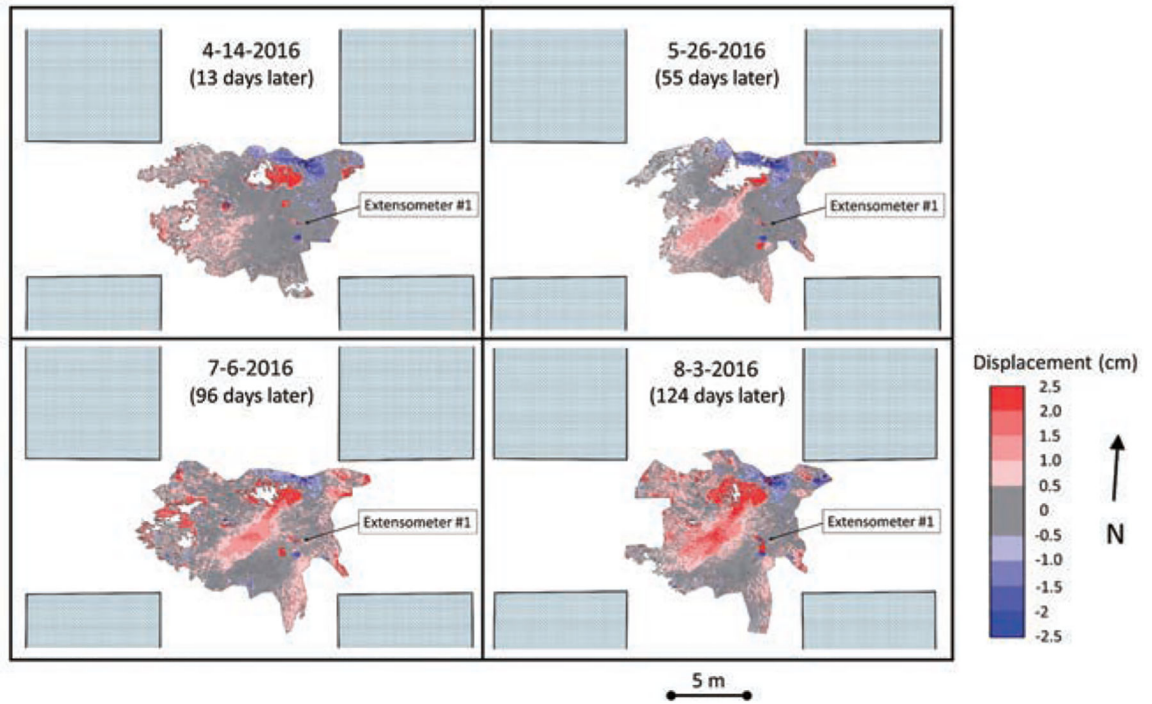
Beginning with the photogrammetric measurements, the reconstruction for the floor surrounding extensometer #1 is shown in Fig. 6. The reconstructions represent the difference in vertical displacement between April 1 and the listed dates. Displacement upward toward the roof is shown in warmer colors while displacement downward into the floor is shown in cooler colors. A N45°E trending heave clearly developed near the middle of the intersection, away from where the extensometer is located. The extensometer would have missed this heave development without the photogrammetry.

Figure 6 -
Floor movement according to the photogrammetric reconstruction at the extensometer #1 location.

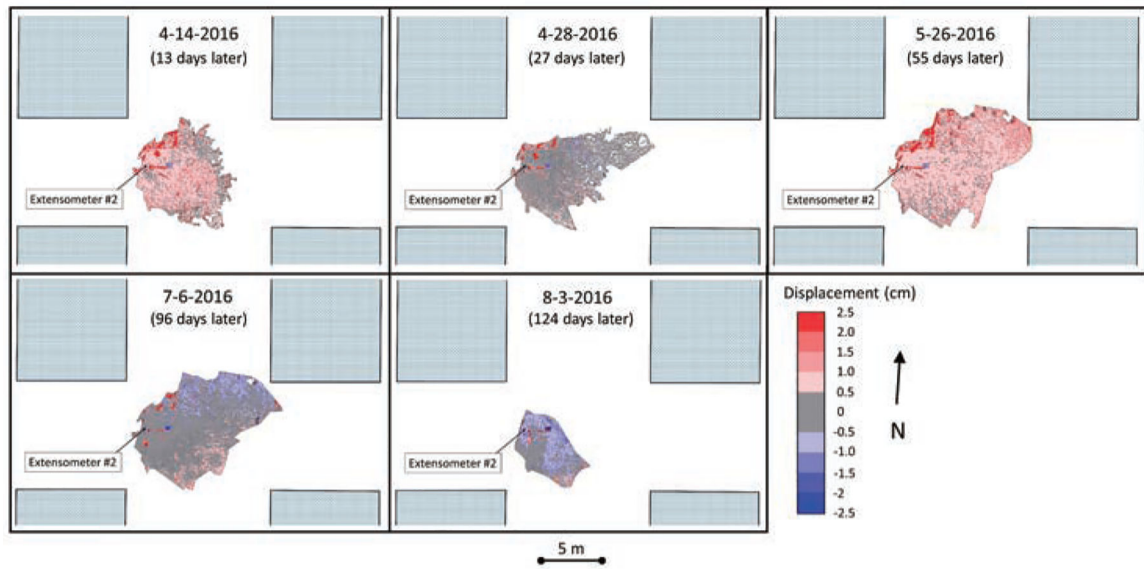
Very little appears to be occurring in the reconstructions of the extensometer #2 site, shown in Fig. 7. This is the area that shows the least movement among the extensometers, and the photogrammetry supports that inactivity. There does appear to be a small magnitude widespread heave movement through May 25 followed by a sinking movement through Aug. 3. The manner of widespread displacement without an apex that would be expected with floor heave could suggest a reconstruction, scaling, or alignment error.

Figure 7 -
Floor movement according to the photogrammetric reconstruction at the extensometer #2 location.

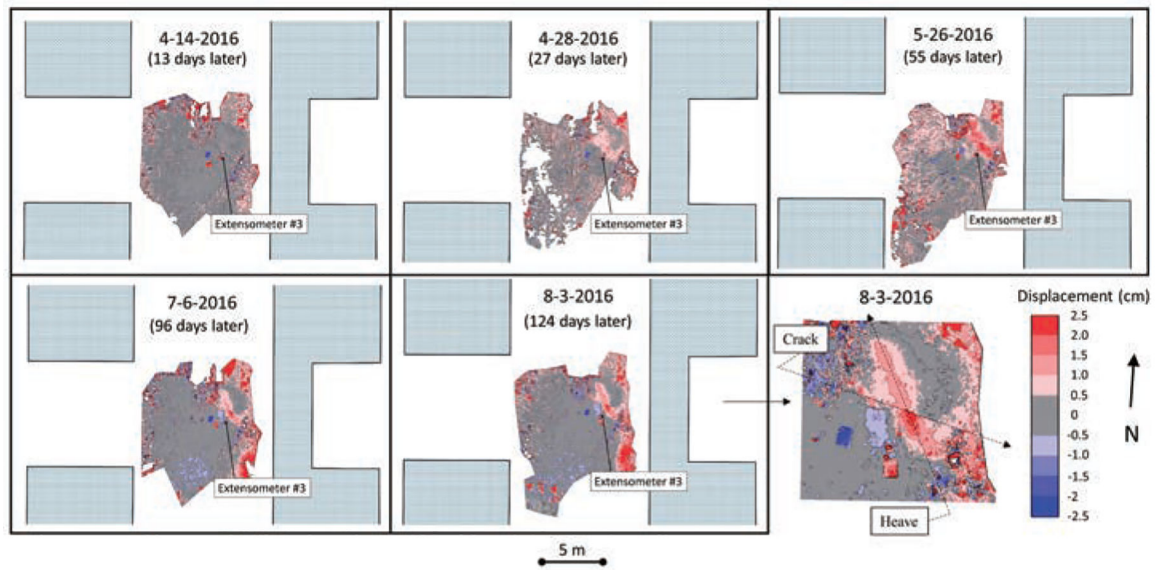
The extensometer #3 site had a large, visually distinct crack development slightly northwest of the extensometer on the east side of the intersection, which can be observed in the photogrammetric reconstruction, shown in Fig. 8. Oddly, the crack itself runs N75°W while the heave is oriented in a N25°W direction. Interestingly, the direction of the heave is offset by approximately 50° to the crack orientation, which was not immediately apparent upon visual inspection of the crack underground. While the large crack was present throughout each of the data collection visits, the N75°W heave did not begin until sometime after the

April 14 visit. The intersection immediately north of the extensometer was clear enough to walk through on March 18. However, progressive failure of the roof had completely sealed off the intersection by April 28. Additionally, southwest of the extensometer, an area approximately 4.6 m (15 ft) long, running parallel to the base of the pillar, was heaving upward.

Figure 8 -
Floor movement according to the photogrammetric reconstruction at the extensometer #3 location.

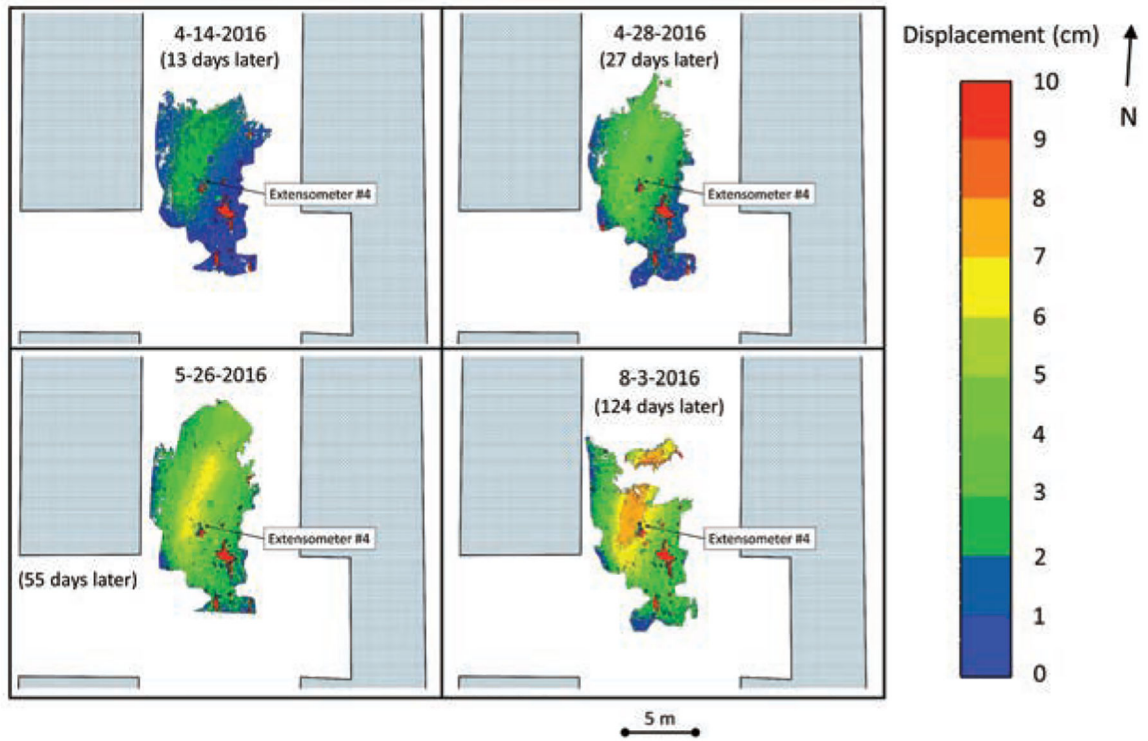
The last site, the extensometer #4 location, shown in Fig. 9, exhibited the most floor heave. Due to the high magnitude and exclusively heaving behavior, the scale has been changed to represent absolute difference rather than signed change. A large area oriented N10°E, roughly 6.1 m (20 ft) across and more than 9.1 m (30 ft) long, was heaving in between two pillars, north of the intersection. The extensometer was very fortunately placed near the apex of the heave, capturing the largest magnitude movements.

Figure 9 -
Absolute floor movement according to the photogrammetric reconstruction at the
extensometer #4 location.

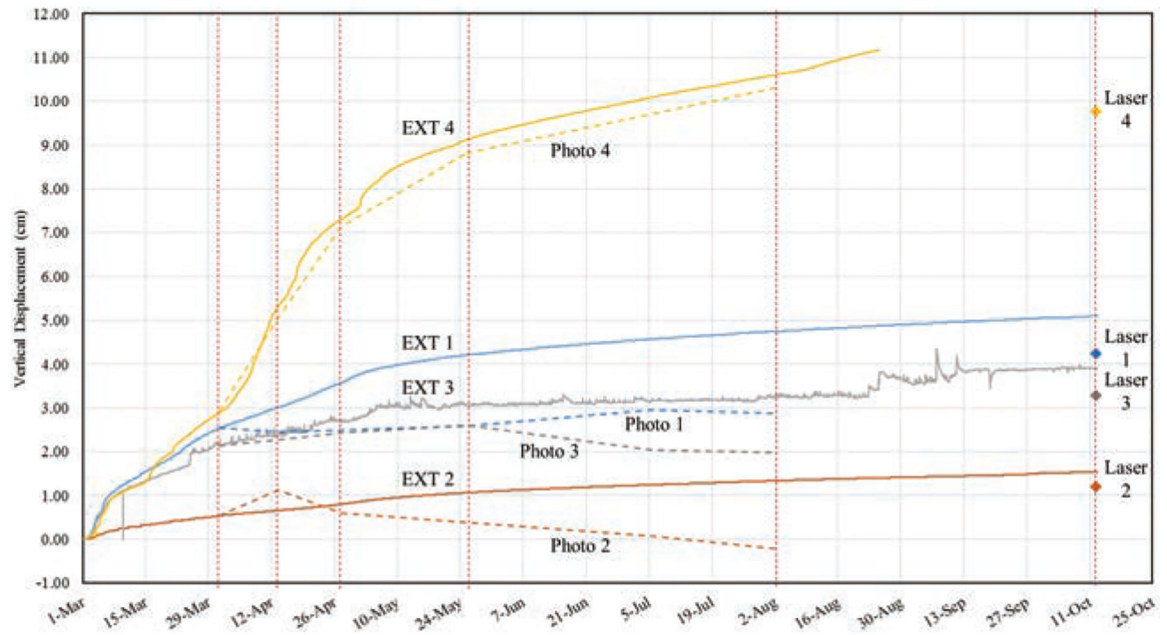
Figure 10 -

The roof-to-floor extensometers showed varying magnitudes of displacement, but all showed a convergence of the mine openings. Figure 10 compares the extensometer measurements to the photogrammetry and laser scanning displacement measured at the same location. The first half of the monitoring period showed the most movement for all the extensometers, with rates reaching as high as 0.15 cm/d (0.06 in./d) for extensometer #4 during April. By late May, the rate of convergence had significantly lessened and the frequency of roof falls in the vicinity subsided.

The largest increase seen during the study period was 11 cm for extensometer #4 between March 1 and Aug. 25, as read by the extensometer. This was tracked very closely by the photogrammetry measurements, which underestimated the heave by 0.2 to 0.5 cm on each reading. The laser scan for this area showed nearly 7 cm of heave between April 1 and Oct. 13. Extensometer #3 showed a slight jump on March 24, followed by unevenness for the remainder of the monitoring period. This extensometer was located on top of two cracks, which were present before March 24, and is nearby several others. The reason for this is unknown. However, this area appears to have consisted of an intact floor beam several inches thick, underlain by about 20.3 cm (8 in.) of crushed rock. It may be that the beam buckled somewhere nearby the extensometer on March 24, and the noisy movement is related to the crushed rock pushing up on the compromised beam, with the beam then settling back down on the crushed rock.

The photogrammetry results agree very well with extensometer #4, shown in Fig. 10, but does not show the same increase in vertical displacement seen at the other extensometer locations. The magnitude of displacement seen in extensometers #1 to #3 is very small, although generally positive across all of them. The magnitude of displacement seen in the photogrammetry, however, had time periods of negative change. This is mostly seen at locations #2 and #3, which would suggest the floor was sinking slightly from its April 1 position. A rock fall compromised the cable for extensometer #4 in late August, and any data after that event were discarded. There were five photogrammetry data sets collected throughout the course of the study. Set equal to the extensometer data on April 1, each photogrammetry convergence measurement is calculated by averaging the elevation of the

Extensometer and photogrammetry vertical displacement measurements on the floor at the four study sites. Dotted red lines represent the trips that were made to perform photogrammetry or laser surveys.
