Blasting-Related Carbon Monoxide Incident in Bristow, Virginia
By Marcia L. Harris, James H. Rowland III, and Richard J. Mainiero

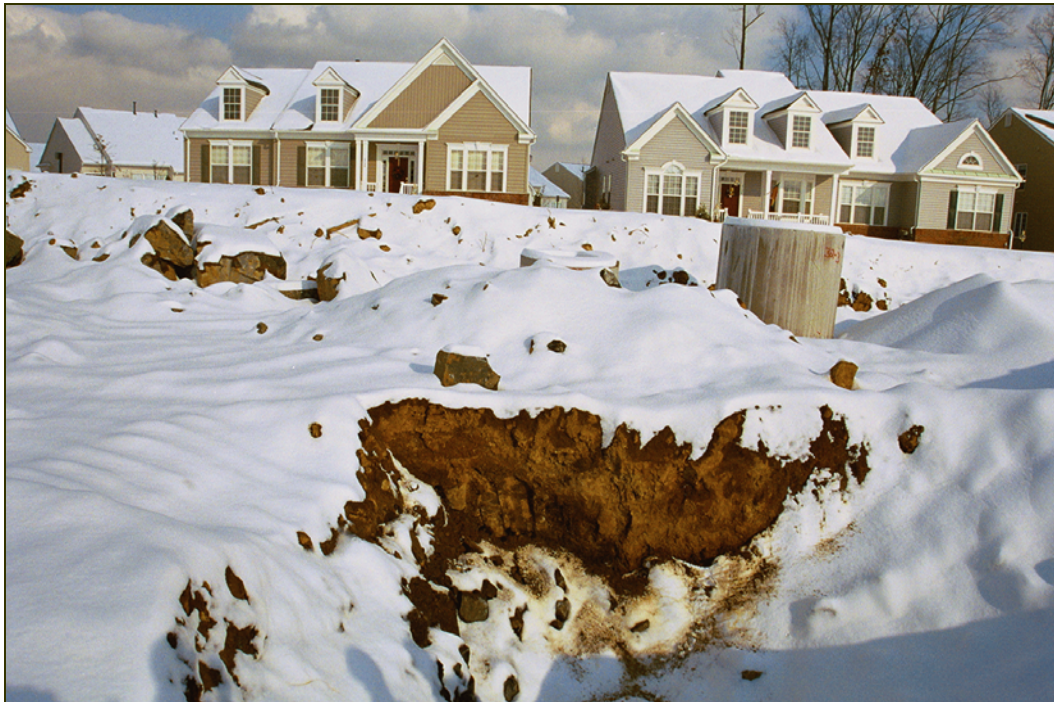
In this study, the first shot was not immediately mucked out, which may have contributed to CO migrating through the ground into the homes. Four excavated pits measuring 6 ft x 6 ft x 5 ft (1.8 m x 1.8 m x 1.5 m) were installed on the second and third shots to vent any generated fumes. No CO accumulated in the nearby homes after the second shot. However, the venting pits still were not sufficient to ventilate the detonation fumes of the third shot. CO appeared in the homes the same day as the shot.

Figure 2 - The first of four pits dug at the location of the trench blast in an effort to vent CO. Homes 1 and 2 can be seen in the background.

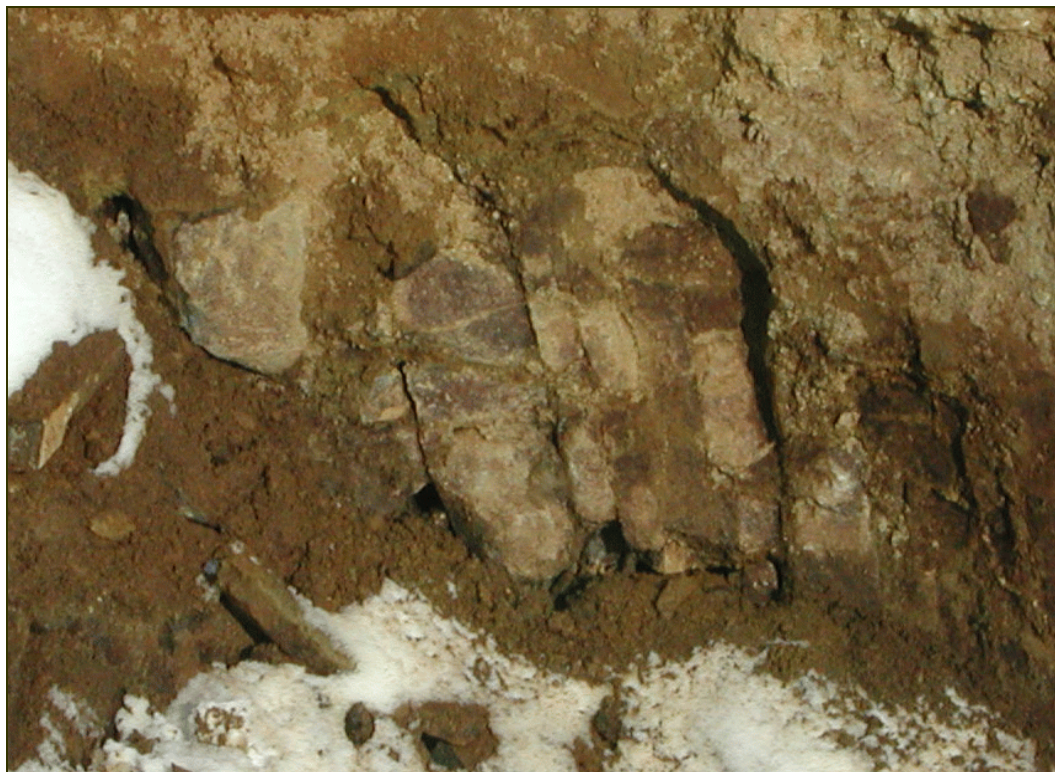
Before the meeting on December 6, the blaster took NIOSH personnel to the construction site where the incidents occurred to assess the geology and their blasting operation. In the venting pits, fractures with an orientation of approximately 20 degrees east of north were observed in the bedrock; this orientation lines up perfectly to intercept the homes affected by the CO migration after the blast shots 1 and 3 (Figures 2 and 3). Another observation was that the fractures appeared to be naturally occurring and not caused by blasting. It was not determined how deep the fracture system may extend. It may be entirely possible the fracture system may extend below the blast site and trenches. Also, the elevation of the bedrock in the pits excavated after blast shot #3 visually appeared to be at the same elevation as the basements of the houses affected by the CO migration. It appears that a fracture system is in place that is positioned just right to result in a strong conduit from the blasted material to the homes.

Figure 3 - A close-up of the bedrock seen in Fig. 2. Note the fractures are oriented towards nearby homes.
