CO Migration from Trench Blasting in Amherst, New York
by Marcia L. Harris and Richard J. Mainiero

Abstract

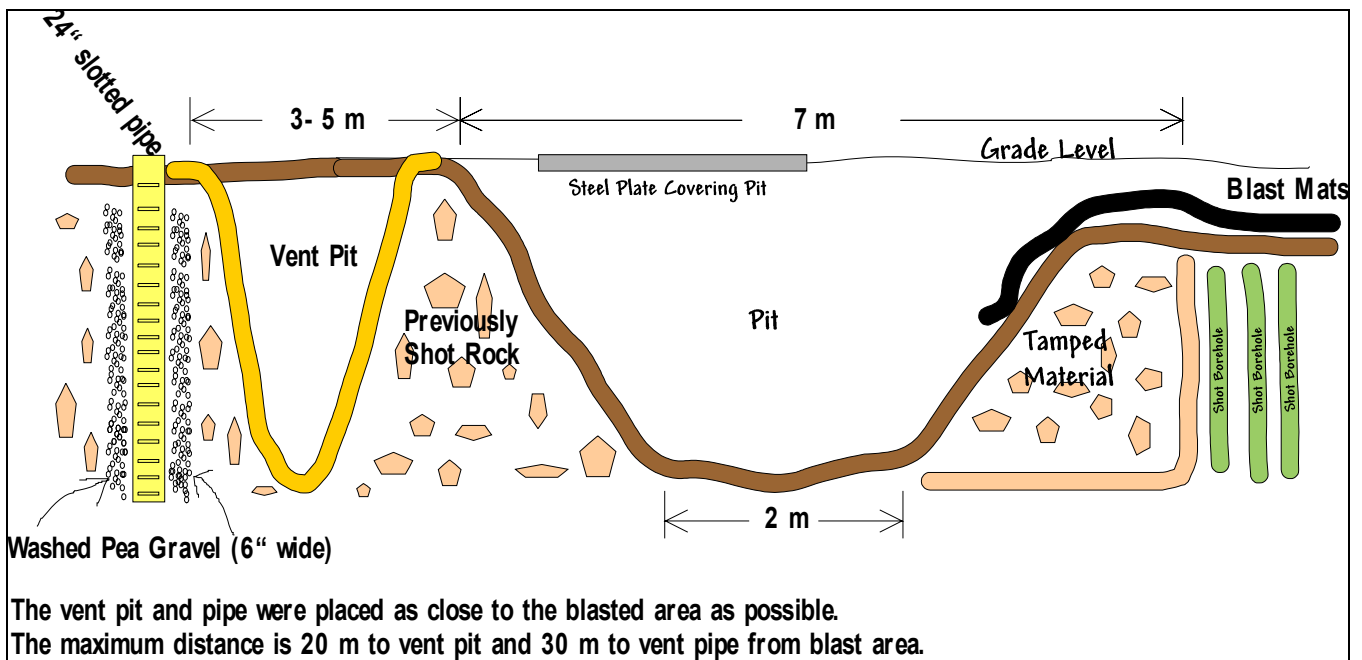
Figure 8 - Final Blast Layout.
