IC 9311

In-Mine Evaluation of Smoke Detectors

By G. S. Morrow and C. D. Litton

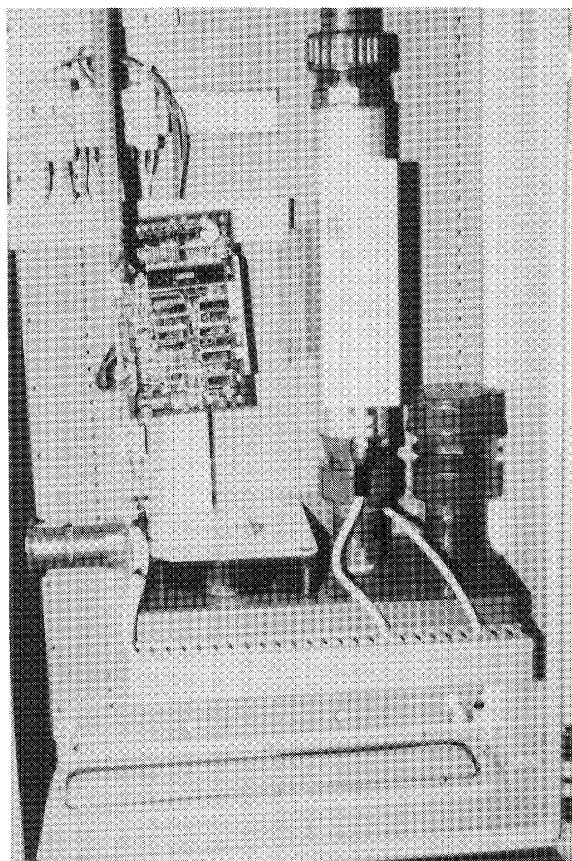
Figure 1.—HRD-2A smoke detector installed at Dilworth Mine.

The detector was installed February 7, 1990, on a main-line belt entry with an air velocity of 146 fpm. Power was obtained from a nearby CO sensor. The detector interfaced with the system via a 4- to 20-mA accessor provided by Conspec. The detector functioned properly until week 18, when the mine reported intermittent alarms lasting 10 to 20 min, but with no recurring pattern. The detector was removed, cleaned, and monitored continuously on a Conspec system at the Bureau with no alarms recorded. The mine had reported brief alarms from the detector while rock dusting. From July 30, 1990, to reinstallation in the mine on October 1, 1990, the detector was used for research purposes at the Bureau and functioned properly. The addition of a settling chamber on the sampling line, along with the insertion of honeycomb mesh at the end of the sampling tube, reduced but did not eliminate false alarms due to rock dusting. The detector remains in place to further research methods to reduce rock dust alarms.

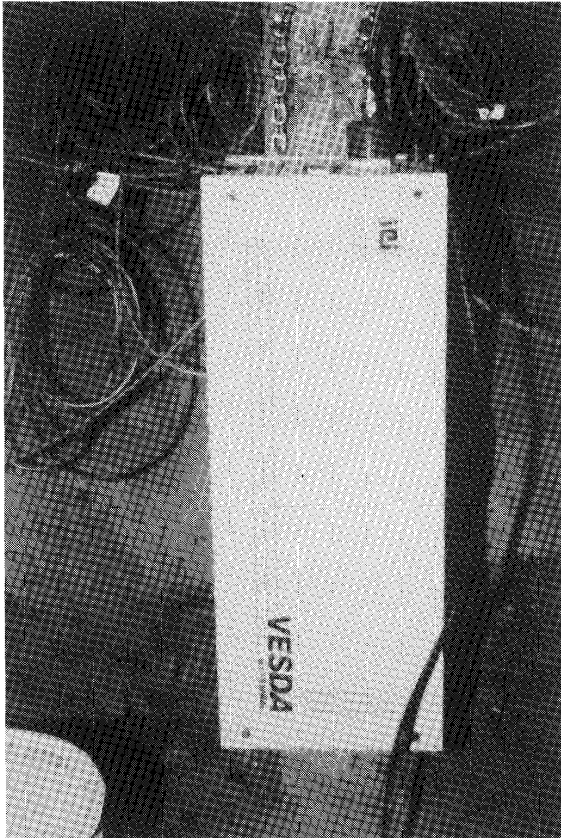
Figure 2.—VESDA smoke detector installed at McClure Mine.

Two detectors were installed on February 13, 1990, along a main-line belt. Air velocity at this location was 690 fpm at the time of installation, and increased to 1,000 fpm during the test period. Both detectors interfaced directly to the monitoring system, although the VESDA detector required mine power to operate a dc power supply.

During 47 weeks of operation the HRD-2A detector alarmed 488 times and the VESDA detector alarmed 4 times. Diesel contaminants accounted for 486 alarms on the HRD-2A detector and 2 on the VESDA detector. Rock dusting caused two concurrent alarms on both smoke detectors.

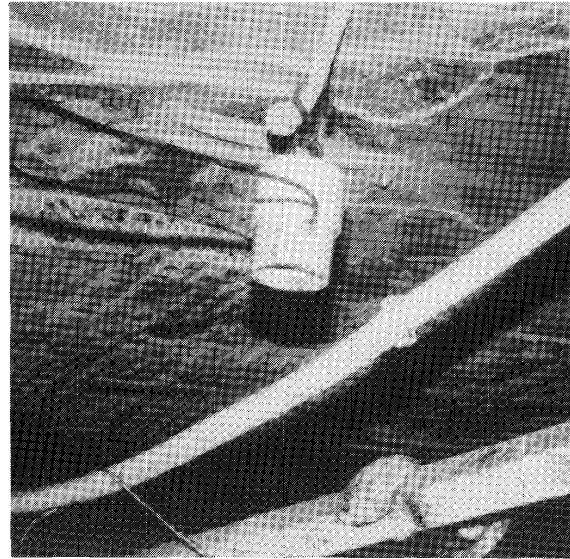
Figure 3.—End-of-line sampling port used at all test sites.

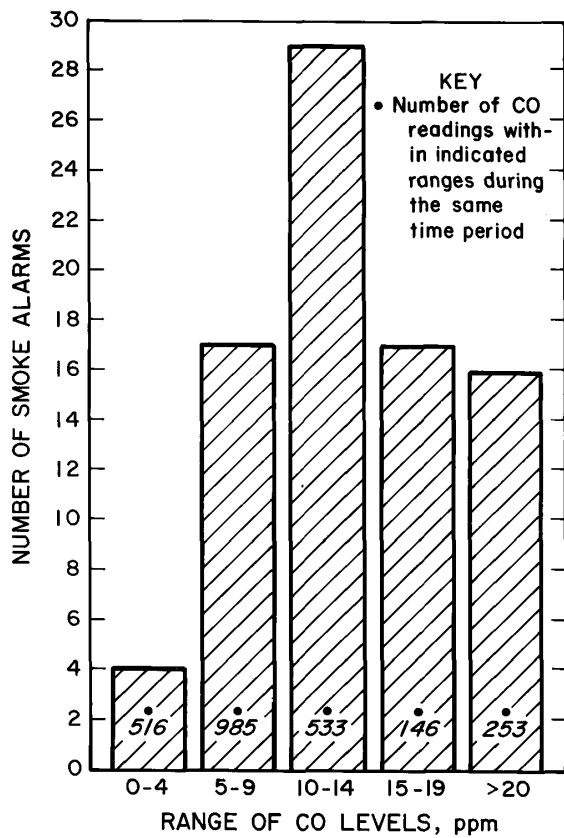
of the CO levels at the time of smoke alarm. As indicated in the following summary, the number of CO readings may be categorized in terms of exceeding some level of CO. Figure 5 shows the actual CO levels at the time of smoke alarm as discussed above.

Figure 5.—Smoke detector nuisance alarms versus CO levels for 42-day period at Shoshone Mine.

The detector was installed April 5, 1990, in a two-entry section in the belt entry return air. Eighty-three alarms occurred during the period of April 28, 1990, through June 9, 1990 (42 days); all were attributed to diesel emissions. During the same period, a companion CO sensor had 516 readings of 0 to 4 ppm, 985 readings of 5 to 9 ppm, 533 readings of 10 to 14 ppm, 146 readings of 15 to 19 ppm, and 253 readings in excess of 20 ppm.

These smoke detector alarms and CO levels due to diesel exhaust allow for a direct comparison of the nuisance alarm frequency for the two types of detectors. For the smoke detector, this alarm frequency is about two per day. For CO at the 10-ppm level, the alarm frequency is 22 per day. For CO at the 15-ppm level, the alarm frequency is 10 per day. At the 20-ppm CO level, the alarm frequency is still six per day, or three times greater than the alarm frequency for the smoke detector.

Even though the nuisance alarms are not eliminated, their frequency is reduced significantly. It is possible that by decreasing the smoke detector sensitivity by a small amount, these alarms could be reduced even further.
